Arborist Report

Jean-Luc Bengle

ISA Board Certified Master Arborist PN-5680B

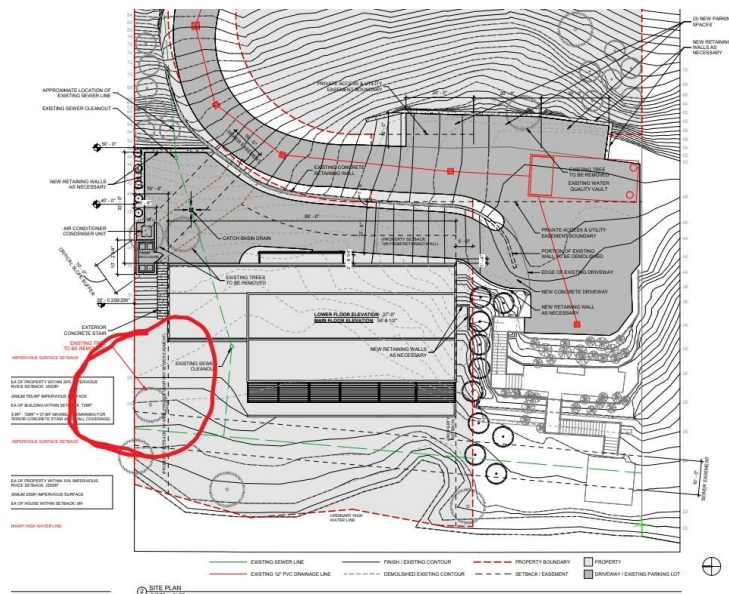
A1

This report is concerning is concerning 2 trees on the partially developed lot at 4041 W Mercer way. The 1st tree this report deals with is a *Prunus cerasifera* 'Thunder Cloud' (thunder cloud plum) in the Northwest corner of the property just East of the start of the fence (Image A2.) This tree has a DBH of 20 inches, a height of 32' and a spread of 22'. The tree was topped many years ago at 24', and has grown reactionary sprouts along the main trunks and below the old topping cuts (Image A3) there is also a very large old cut of a significant scaffold branch growing northward over the property line. The tree has a co-dominant split at about 4' off of the ground (Image A4) and a very weak connection with a long seam joining the 2 stems together. The tree appears to be in good vigor and has a normal twig density for the species. This tree will be negatively impacted by a new drainage system that will need to be hooked up the sewer line with excavation resulting in loss of roots leading to an unstable condition and a loss of adequate absorbing roots to maintain a healthy canopy (Image A1). It is my recommendation that the tree be removed before construction begins to avoid any future hazardous situations.

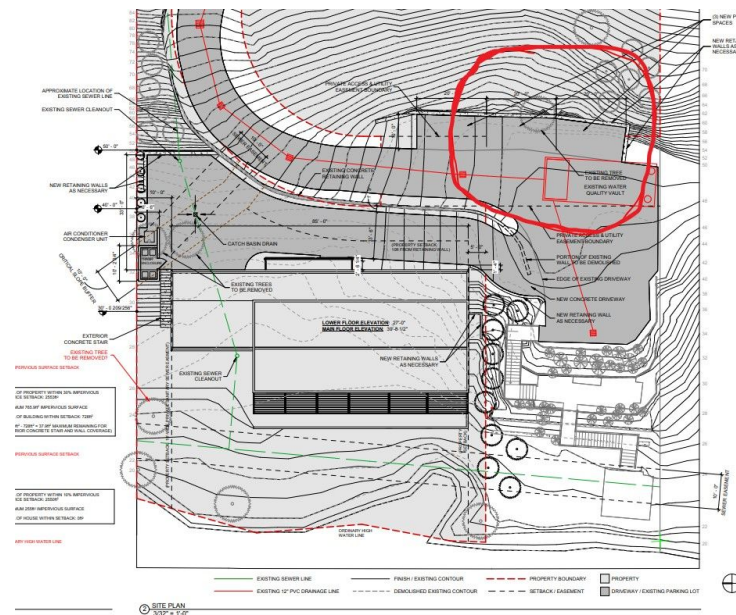
B1

The Second tree is a *Quercus coccinea* (scarlet oak) just East of the main parking pad (Image B2) This tree has a DBH of 27", a height Of 70', and a spread of 45'. The tree is leaning towards the West At a 70° angle. This was caused by phototropism due to other trees to the East of it, and the upper canopy has mostly self corrected into a more vertical growth pattern. There are several main scaffold branches Growing West making the tree very asymmetrical in its weight distribution. There is a large old wound about 20' up from the base that has signs of minor decay (Image B3). There is one large scaffold branch with a shear plane crack that is resting in another scaffold branch below it (Image B4). There are also several smaller broken branches hanging in the tree. The tree has normal health and vigor and normal branch density. The tree will be negatively impacted due to proposed construction of new parking spaces and retaining walls as the root zone will be greatly impacted making the tree unstable and unable to absorb enough water to keep the canopy healthy and vigorous (Image B1). It is my recommendation the tree be removed before construction to avoid any future hazardous conditions
