Arborist Report

TO: Gary Upper, JayMarc Homes
SITE: 4150 78th Ave SE, Mercer Island, WA 98040
RE: Site Assessment and Tree Inventory
DATE: February 1, 2016
PROJECT ARBORIST: J. Casey Clapp
ISA Certified Arborist #PN-7475A
ISA Qualified Tree Risk Assessor

January 3, 2019

Project: Pre-construction assessment for lot re-development at 4150 Boulevard Place SE, Mercer Island, WA. Parcel number 3623500174.

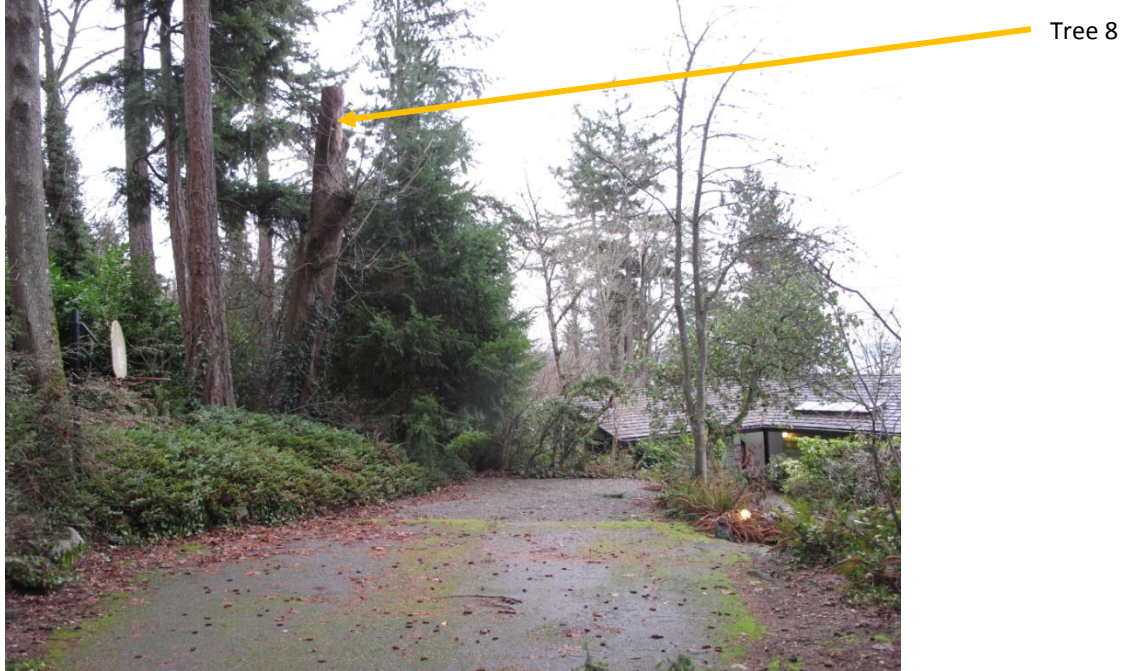
Tree 8 is a bigleaf maple that was previously removed down to approximately 15 feet and is now re-sprouting from the previous cuts. This tree had decay in its stem and at the base, and is essentially a sprouting stump.

Photo 1: A view looking south over the site. Tree 8 is pointed out.

There is a large maple stub, numbered 8 in the Tree Solutions report, which should be removed sooner than later during the project. It has advanced decay and little to no viable growth.

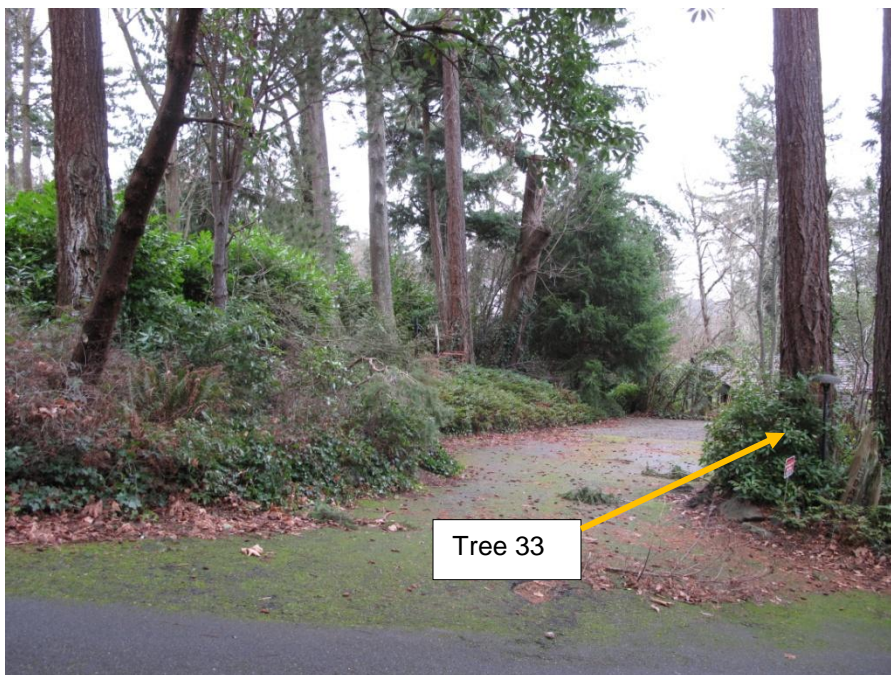
Photo 2: A view of the site looking south. The trees to the east (left) of the driveway are good candidates for retention, but some may require removal based on proposed grading. Tree 33 is shown, which may be possible to retain depending on plans for existing driveway.

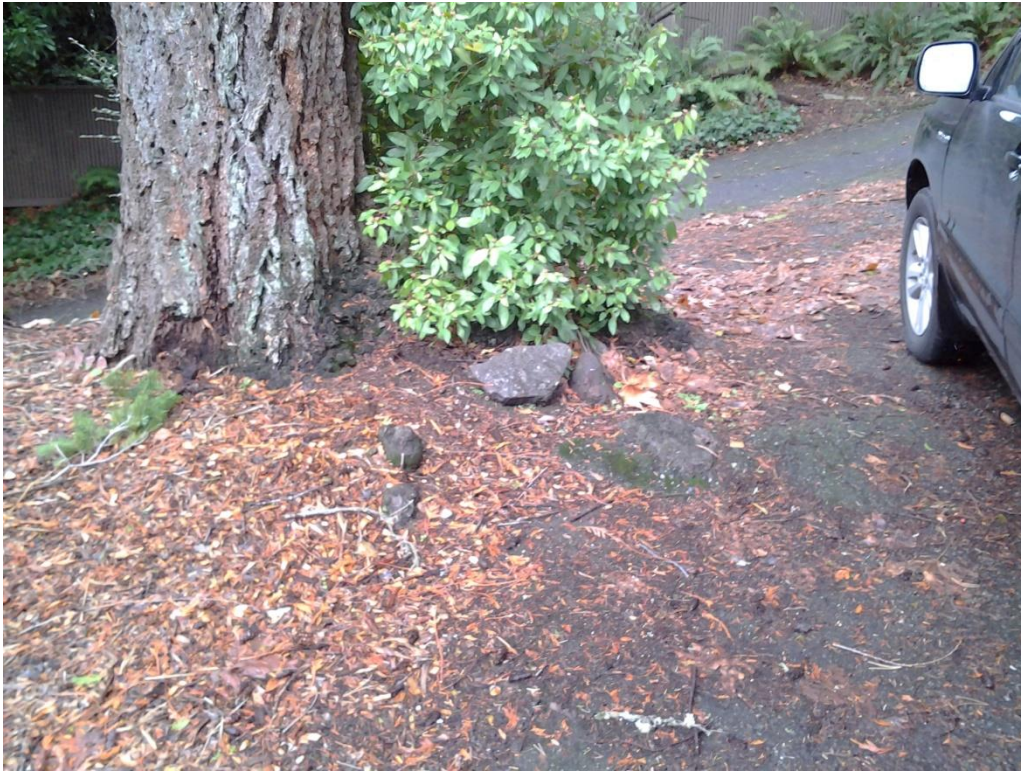
The #33 tree stands 3.5' west of the existing driveway and 9' south of the main drive as shown in Figures 1 and 2. Its roots protrude from the asphalt of the driveway in a multiple spots (Figures 3 and 4). The tree has cankers along its lower column (Figure 5) and its top appears to have been damaged more than fifteen years ago. It is in fair health with average new growth and color. The majority of its canopy is above the halfway mark. No decay was found in a core test but it did reveal less than average amounts of new wood being laid down.

The #33 fir in this case, with a significantly compromised Structural Root Plate, complete exposure to winter storm winds, and limited means of response growth due to the extensive loss in Critical Root Area, has a **probable likelihood of catastrophic failure**. Because of its size and placement has a **high likelihood of striking** the neighboring home to the north. Thus the tree is **likely to fail and impact** and, as the results would be **severe**, the tree is rated as being **high risk**.

Figure 1. Photo showing the base of the #33 fir looking north.

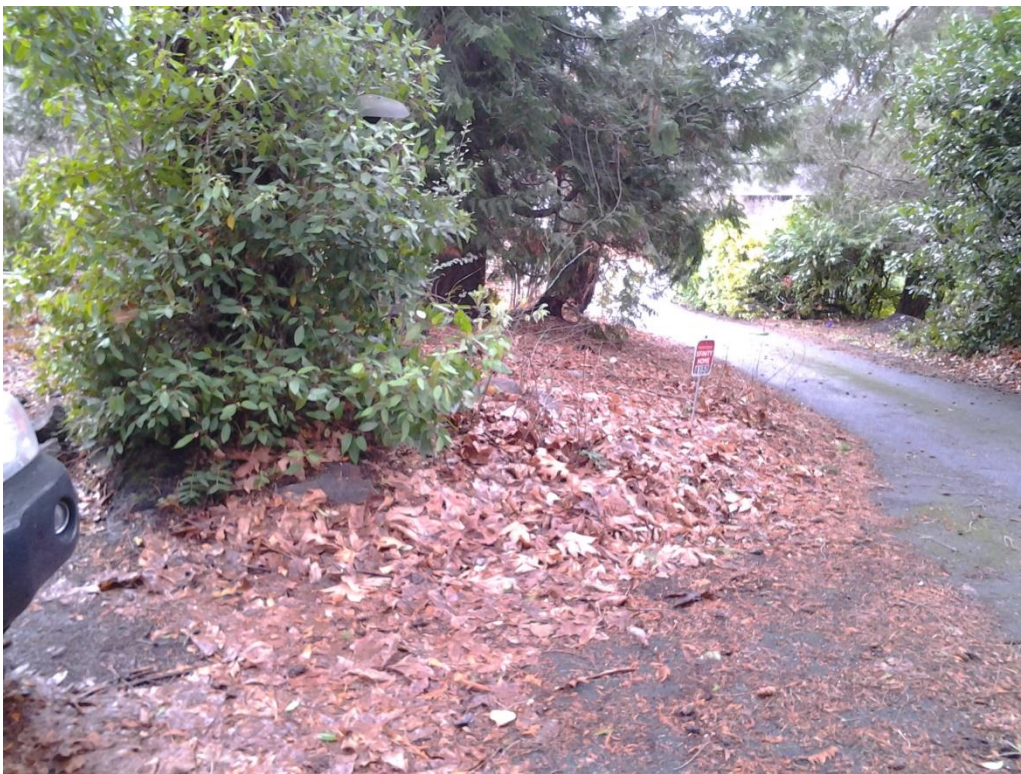
Figure 2. Photo looking at base of #33 fir (behind shrub) looking west.

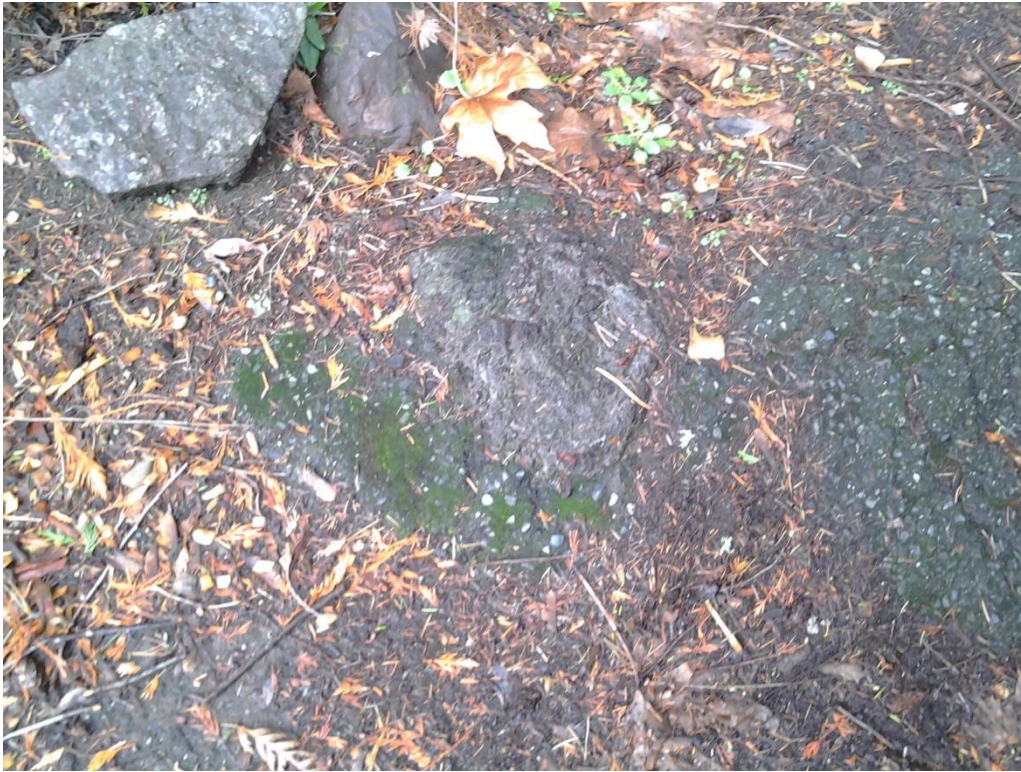
Figure 3. Photo of large root knotting up under driveway

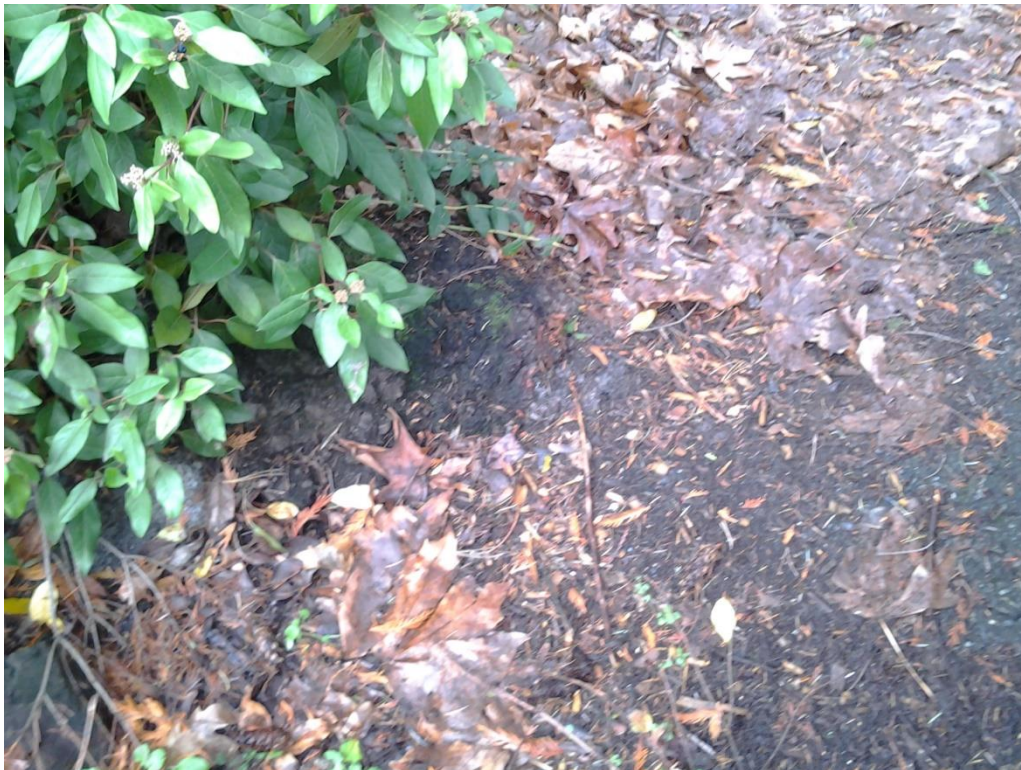
Figure 4. Another root photo.

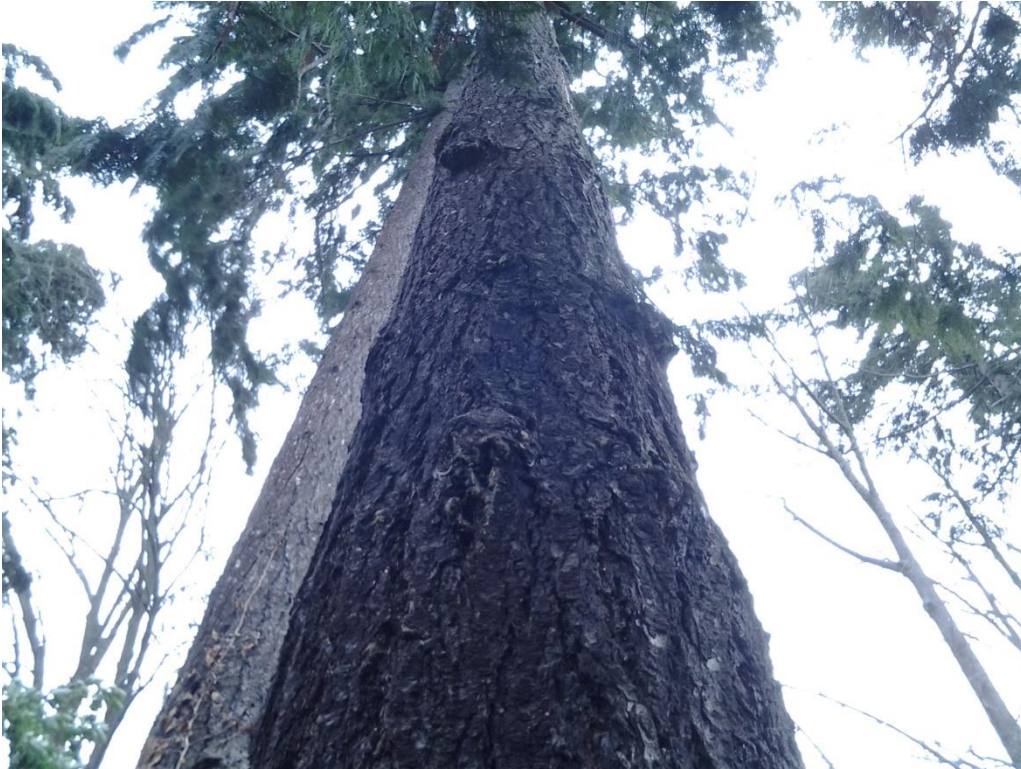
Figure 5. Cankers on lower stem of #33 fir.

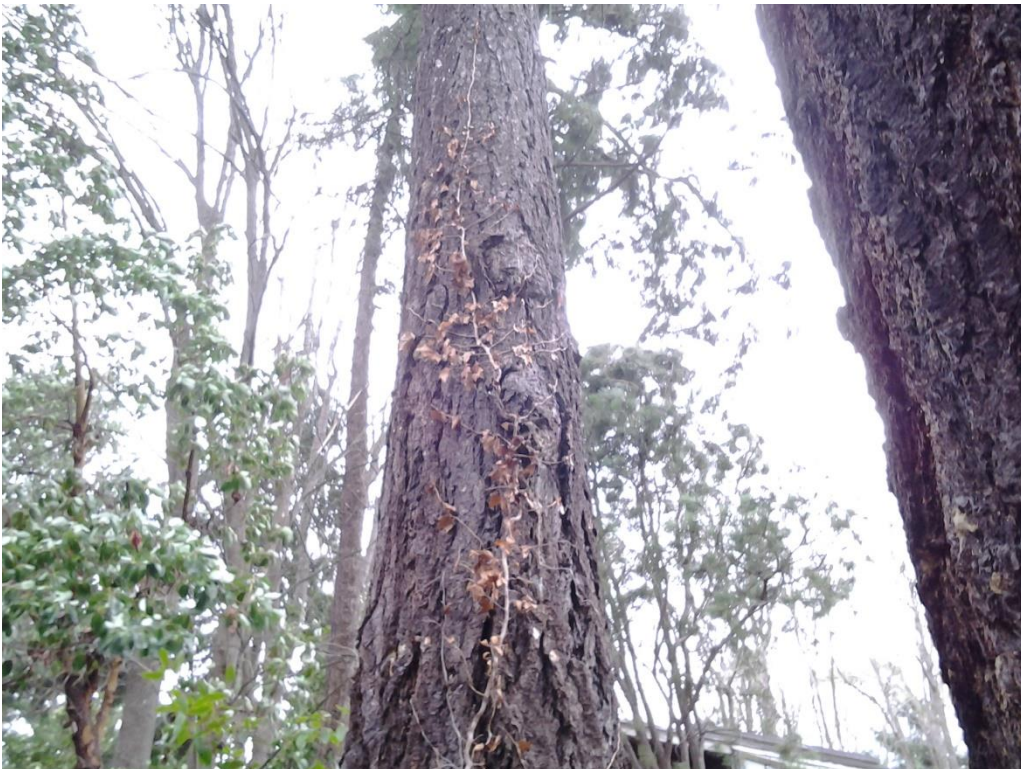
The #32 tree stands just west of the #33 and 12' south of the main drive. This tree has large cankers along the lower column (Figure 6) and evidence of a fracture plane on either side of the stem (Figures 7 and 8). Its top was significantly damaged and grew back malformed. Its entire canopy is in the upper half of the column. It is in fair health with average new growth and color. As with its neighbor no decay was found in a core test but less than average amounts of new wood was seen.

Figure 6. Cankers on lower stem of #32 fir.

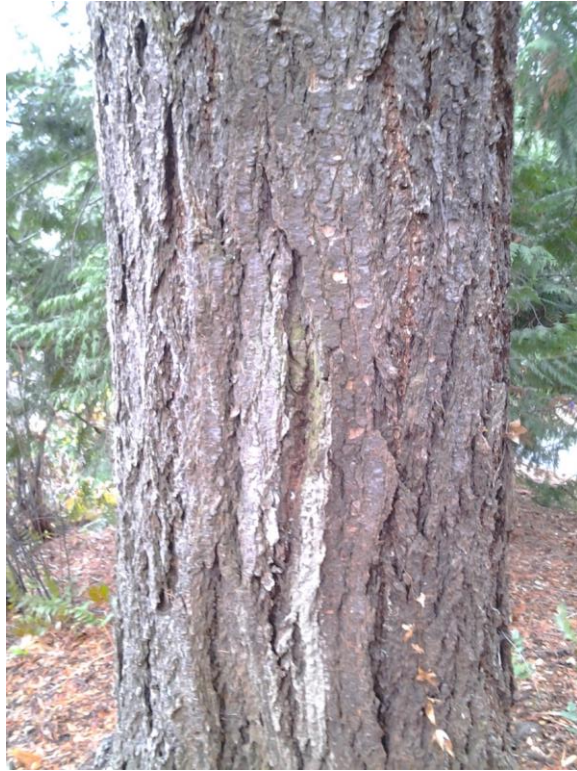
The #32 tree has less constraint to its rooting space but shows signs of having a beam fracture. With an over heavy top and full exposure to storm winds this tree also has a **probable likelihood of catastrophic failure**. It rates out as a **high risk** for the same reasons as the #33.

Figure 7. Photo of fracture on east face of #32 fir.

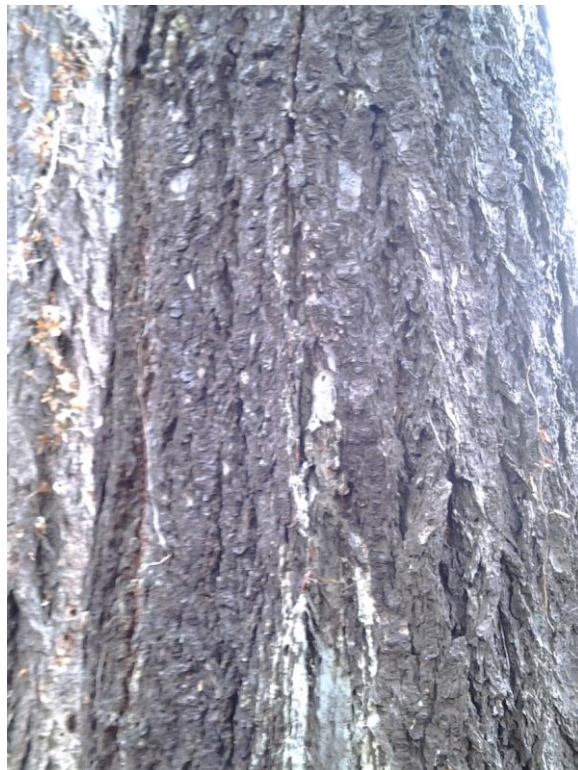
Figure 8. Photo of fracture plane on west face of tree #32.

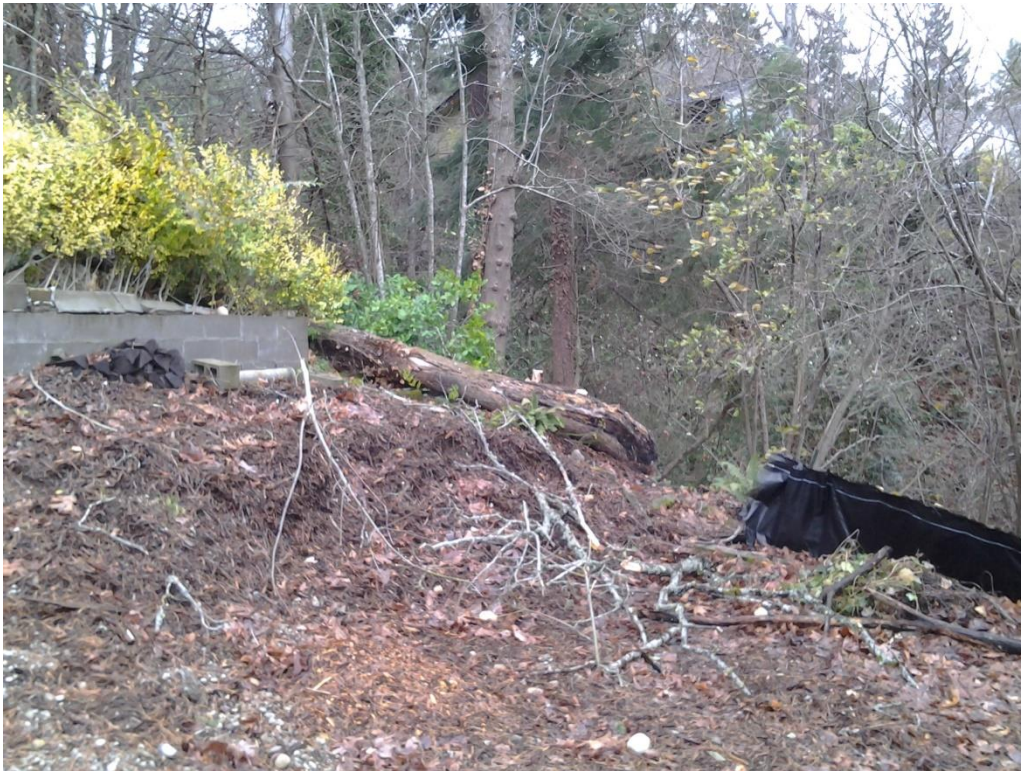
Also a maple (which might be the #20 tree from the report) failed in one of the latest storms as shown in Figures 13 and 14.

Figure 13. Photo of stem of the failed maple.

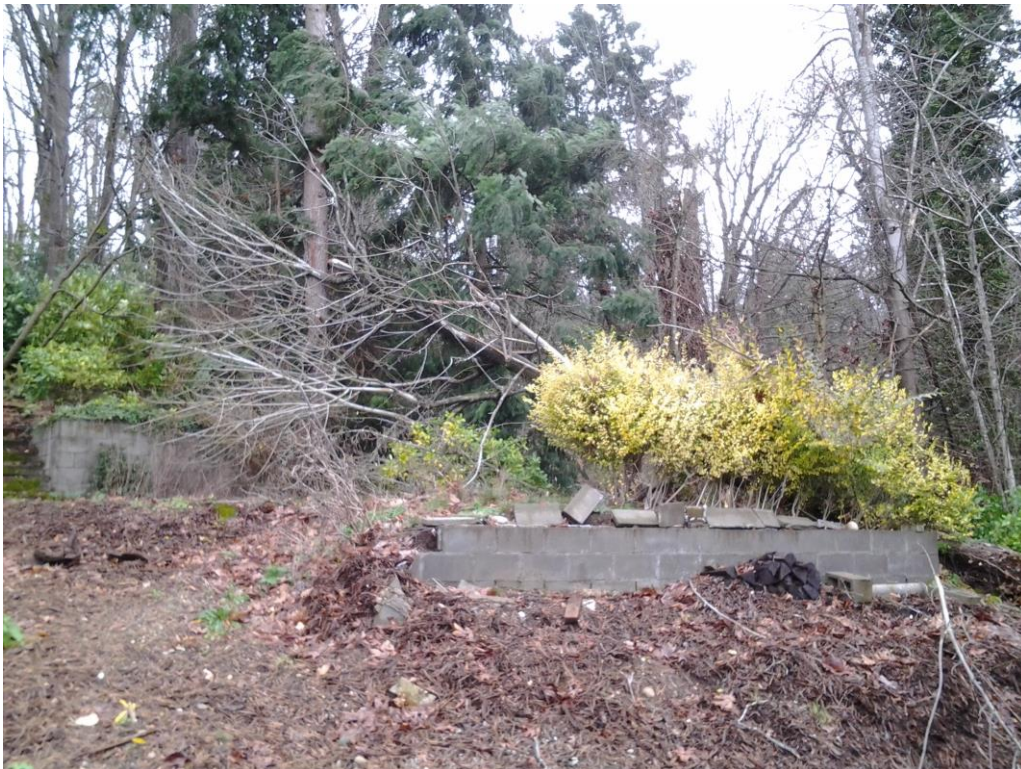
Figure 14. Photo of upper section of failed maple.
