**SITE PLAN**  
(AS - BUILT)

**LANDSLIDE REPAIR**  
9400 SE 47TH STREET  
MERCER ISLAND, WASHINGTON 98040

SHEET NUMBER  
**1**

PROJECT  
G-4149

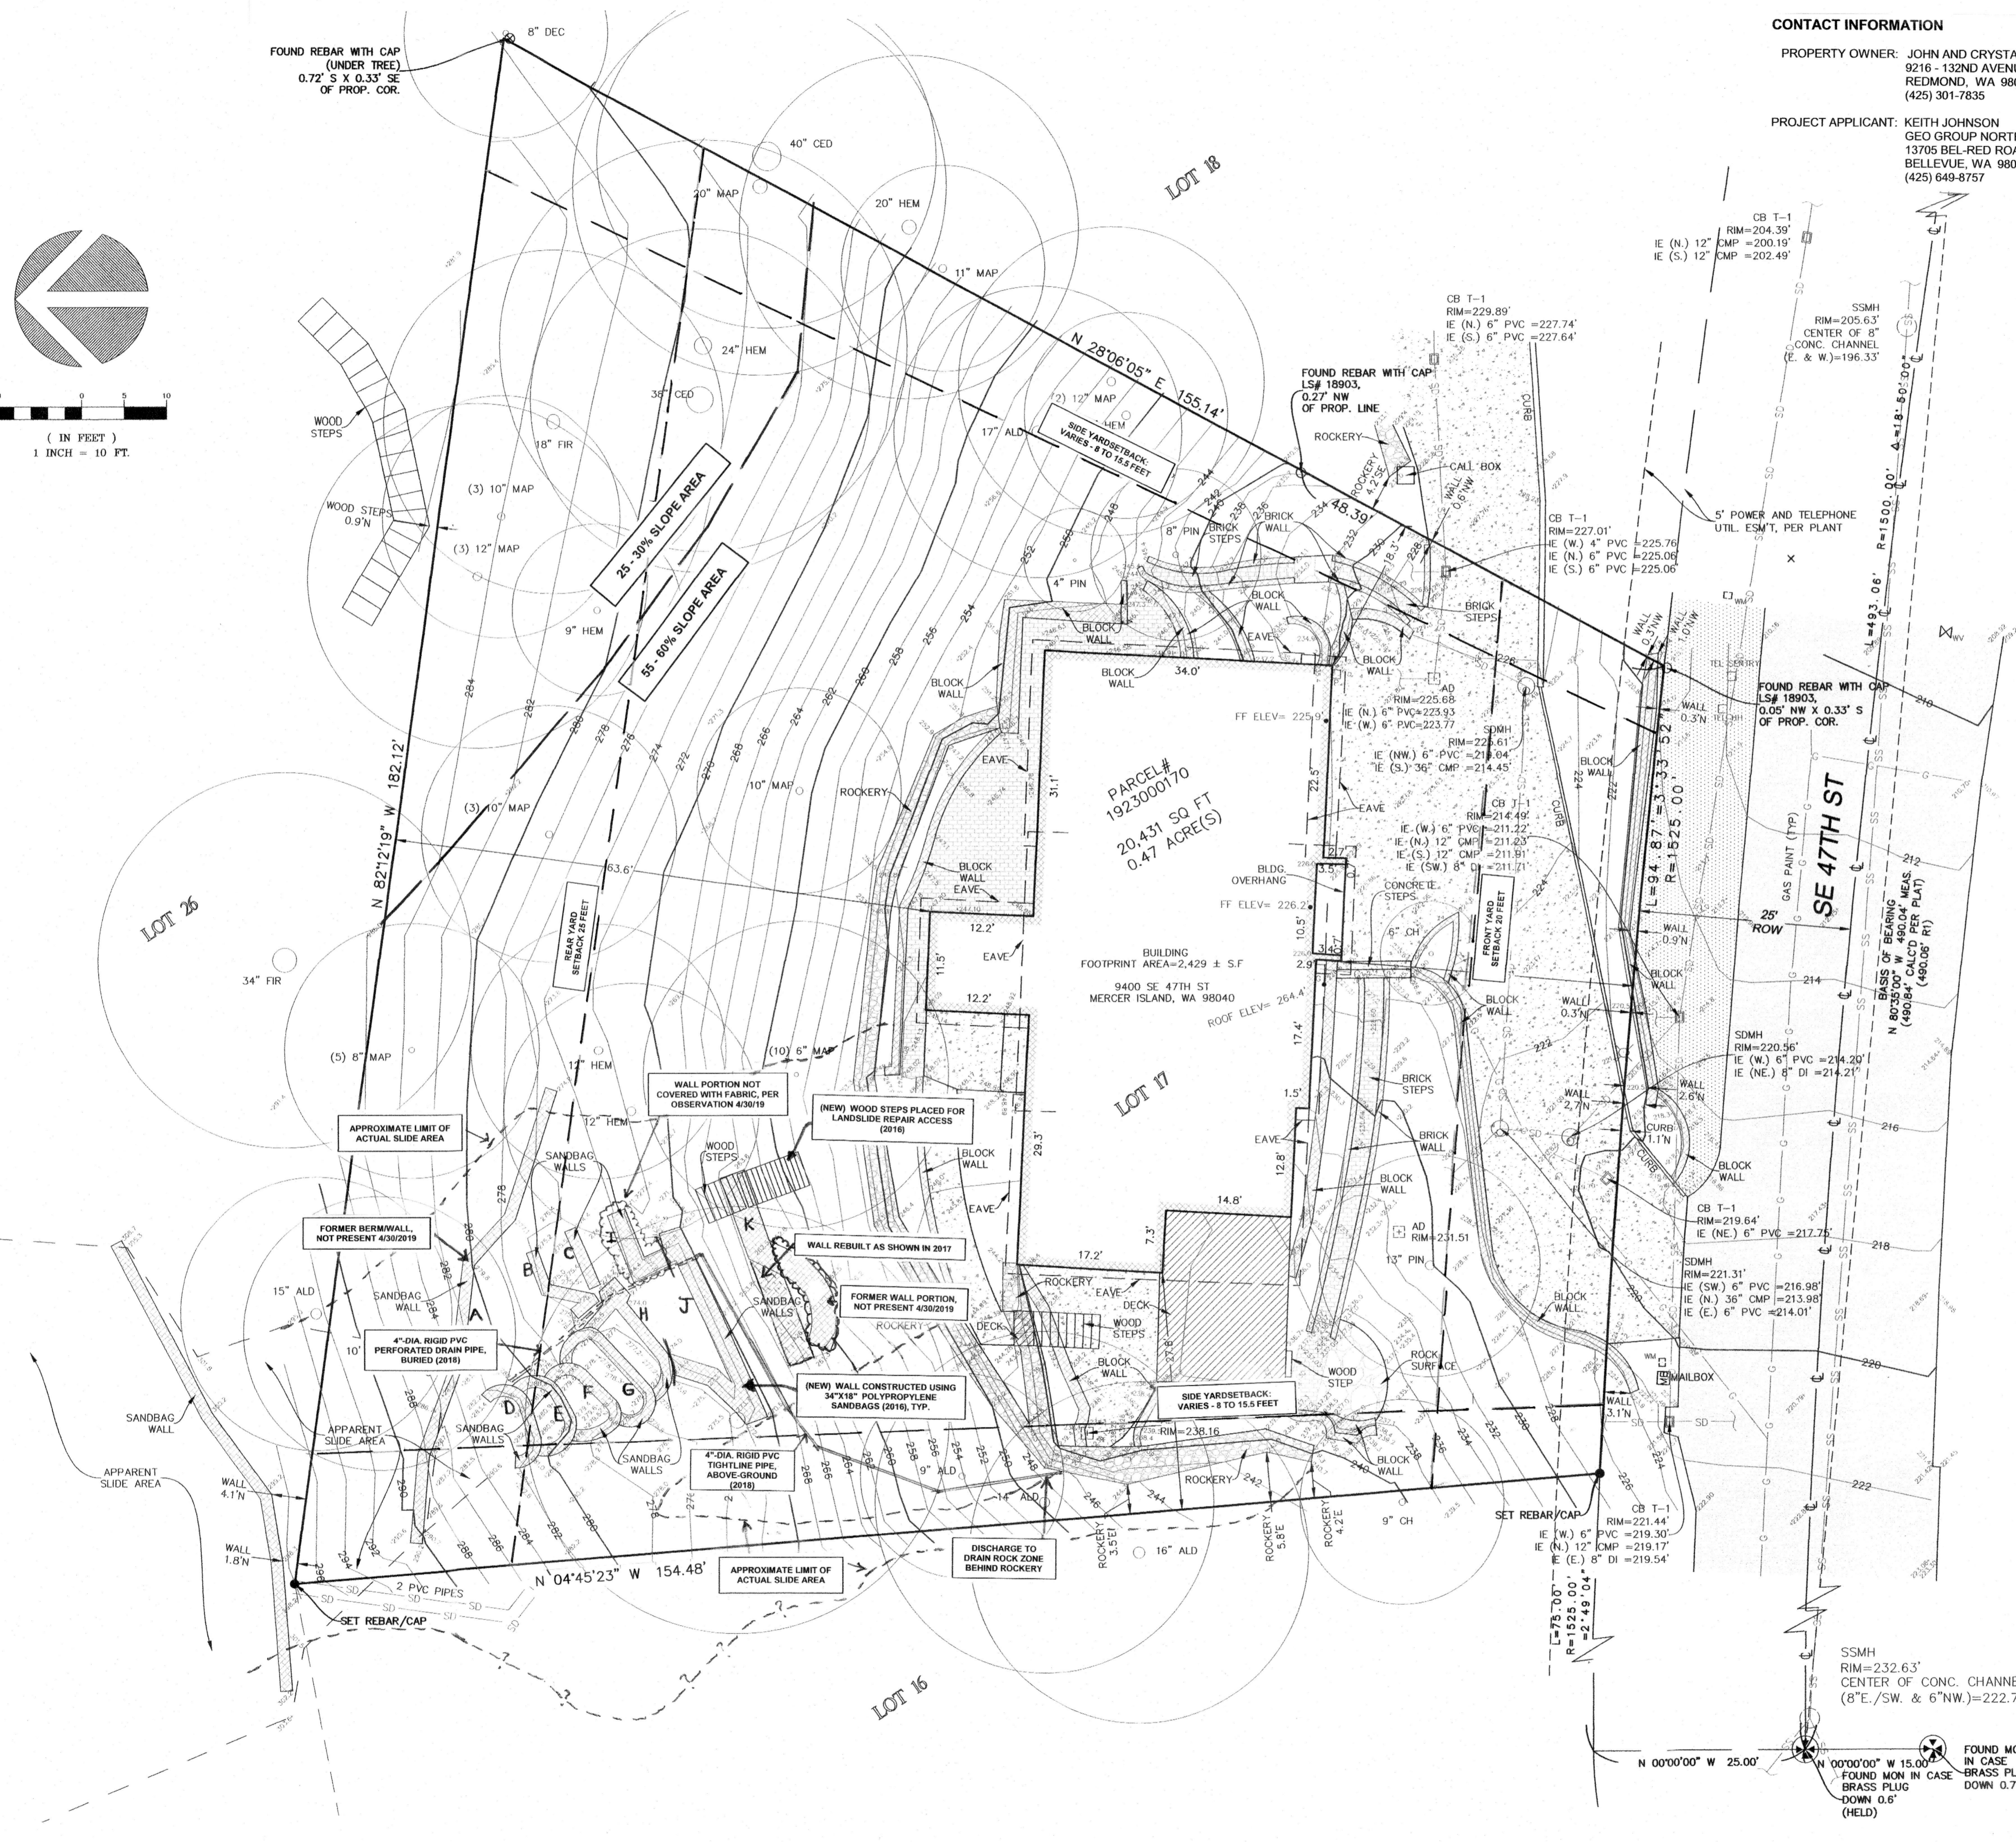
- THE 'APPARENT SLIDE AREA' INDICATED ON THE SITE PLAN IS BASED ON INTERPRETATION BY THE SURVEYOR IN THE FIELD DURING DECEMBER 2016, AFTER THE LANDSLIDE DEBRIS REMOVAL AND SANDBAG WALL INSTALLATION ACTIVITIES HAD BEEN COMPLETED. THE ACTUAL SLIDE AREA ALSO ENCOMPASSES THE CLEARED AND STABILIZED AREA OF THE SLOPE THAT WAS THE SUBJECT OF THE REPAIR ACTIVITIES, INDICATED AS 'APPROXIMATE ACTUAL SLIDE AREA'.

- THE PURPOSE OF THE PROJECT IS TO REPAIR DAMAGE TO THE PORTION OF THE SLOPE AREA ON THE SITE PROPERTY THAT WAS DAMAGED BY A LANDSLIDE WHICH OCCURRED IN DECEMBER 2015. ACTIVITIES TO REPAIR THIS DAMAGE, AND INDICATED IN THESE PLANS, CONSISTS OF THE CONSTRUCTION OF STACKED SANDBAG WALLS FOR TO STABILIZE AND RETAIN EXPOSED SOILS IN THE AREA WHERE THE LANDSLIDE OCCURRED.

- CONSTRUCTION OF THE SANDBAG WALLS OCCURRED DURING MAY TO JULY 2016, AND WAS PERFORMED BY THE PROPERTY OWNER. PRIOR TO THE CONSTRUCTION WORK, LANDSLIDE DEBRIS IN THE AFFECTED AREA WAS REMOVED, AND THE EXPOSED AND DISTURBED SOILS IN THE AREA WERE COVERED WITH TEMPORARY PLASTIC SHEETING UNTIL THE START OF CONSTRUCTION WORK.

- CONSTRUCTION OF THE SANDBAG WALLS WAS PERFORMED BY USING ON-SITE SANDY LANDSLIDE DEBRIS SOILS AND 10x10 WEAVE POLYPROPYLENE SANDBAGS OF 34"x18" SIZE THAT WERE FILLED MANUALLY ON SITE. THE FILLED SANDBAGS WERE PLACED ON A FIRM, LEVEL SOIL SUBGRADE WHICH WAS SHALLOWLY BENCHES AS NEEDED TO ACCOMMODATE THE TOPOGRAPHY. THE FILLED BAGS WERE PLACED IN AN OVERLAPPING SINGLE-WIDTH PATTERN FOR THE LOWER EIGHT WALLS, AND WERE PLACED IN AN OVERLAPPING TWO-DIMENSIONAL PATTERN FOR THE RELATIVELY TALLER WALLS (WALLS I, J, AND K). NO EARTHEN OR AGGREGATE FILL MATERIAL WAS BROUGHT ONTO THE SITE FOR THE CONSTRUCTION WORK.

- DURING 2018, A SHALLOW DRAINAGE LINE USING 4"-DIAMETER RIGID PVC PERFORATED PIPE WAS INSTALLED ALONG THE NORTH SIDE OF THE UPPER SANDBAG WALLS (WALLS D, E, F, G, AND H), AND ROUTED TO THE LOWER FACE OF WALL J. A 4"-DIAMETER RIGID PVC TIGHTLINE PIPE RUNS FROM THIS POINT ABOVE-GROUND TOWARD THE SOUTHWEST AND DISCHARGES TO THE DRAIN ROCK ZONE BEHIND AN EXISTING ROCKERY IN A DOWNSLOPE AREA TO THE WEST OF THE RESIDENCE.

- THE EXPOSED PORTIONS OF THE SANDBAG WALLS WERE COVERED DURING LATE 2018 AND APRIL 2019 WITH 2 TO 3 LAYERS OF HEAVY-DUTY LANDSCAPE WEEK BARRIER FABRIC FOR LONG-TERM PROTECTION FROM ULTRAVIOLET RADIATION FROM SUNLIGHT. THE FABRIC WAS AFFIXED TO THE SANDBAGS USING CONSTRUCTION-GRADE STAPLES.

- DURING LATE 2018 TO APRIL 2019, TOPSOIL AND SURFACE MULCHING WERE PLACED IN THE TERRACE BELOW THE CONSTRUCTION WALLS, AND VEGETATION WAS PLANTED TO PROVIDE FOR PERMANENT EROSION CONTROL.
