January 25, 2017

G-4149

Subject: Geotechnical Evaluation of Slope Stabilization Measures
9400 SE 47th Street, Mercer Island, Washington 98040

**SLOPE STABILIZATION EVALUATION
9400 SE 47TH STREET
MERCER ISLAND, WASHINGTON**

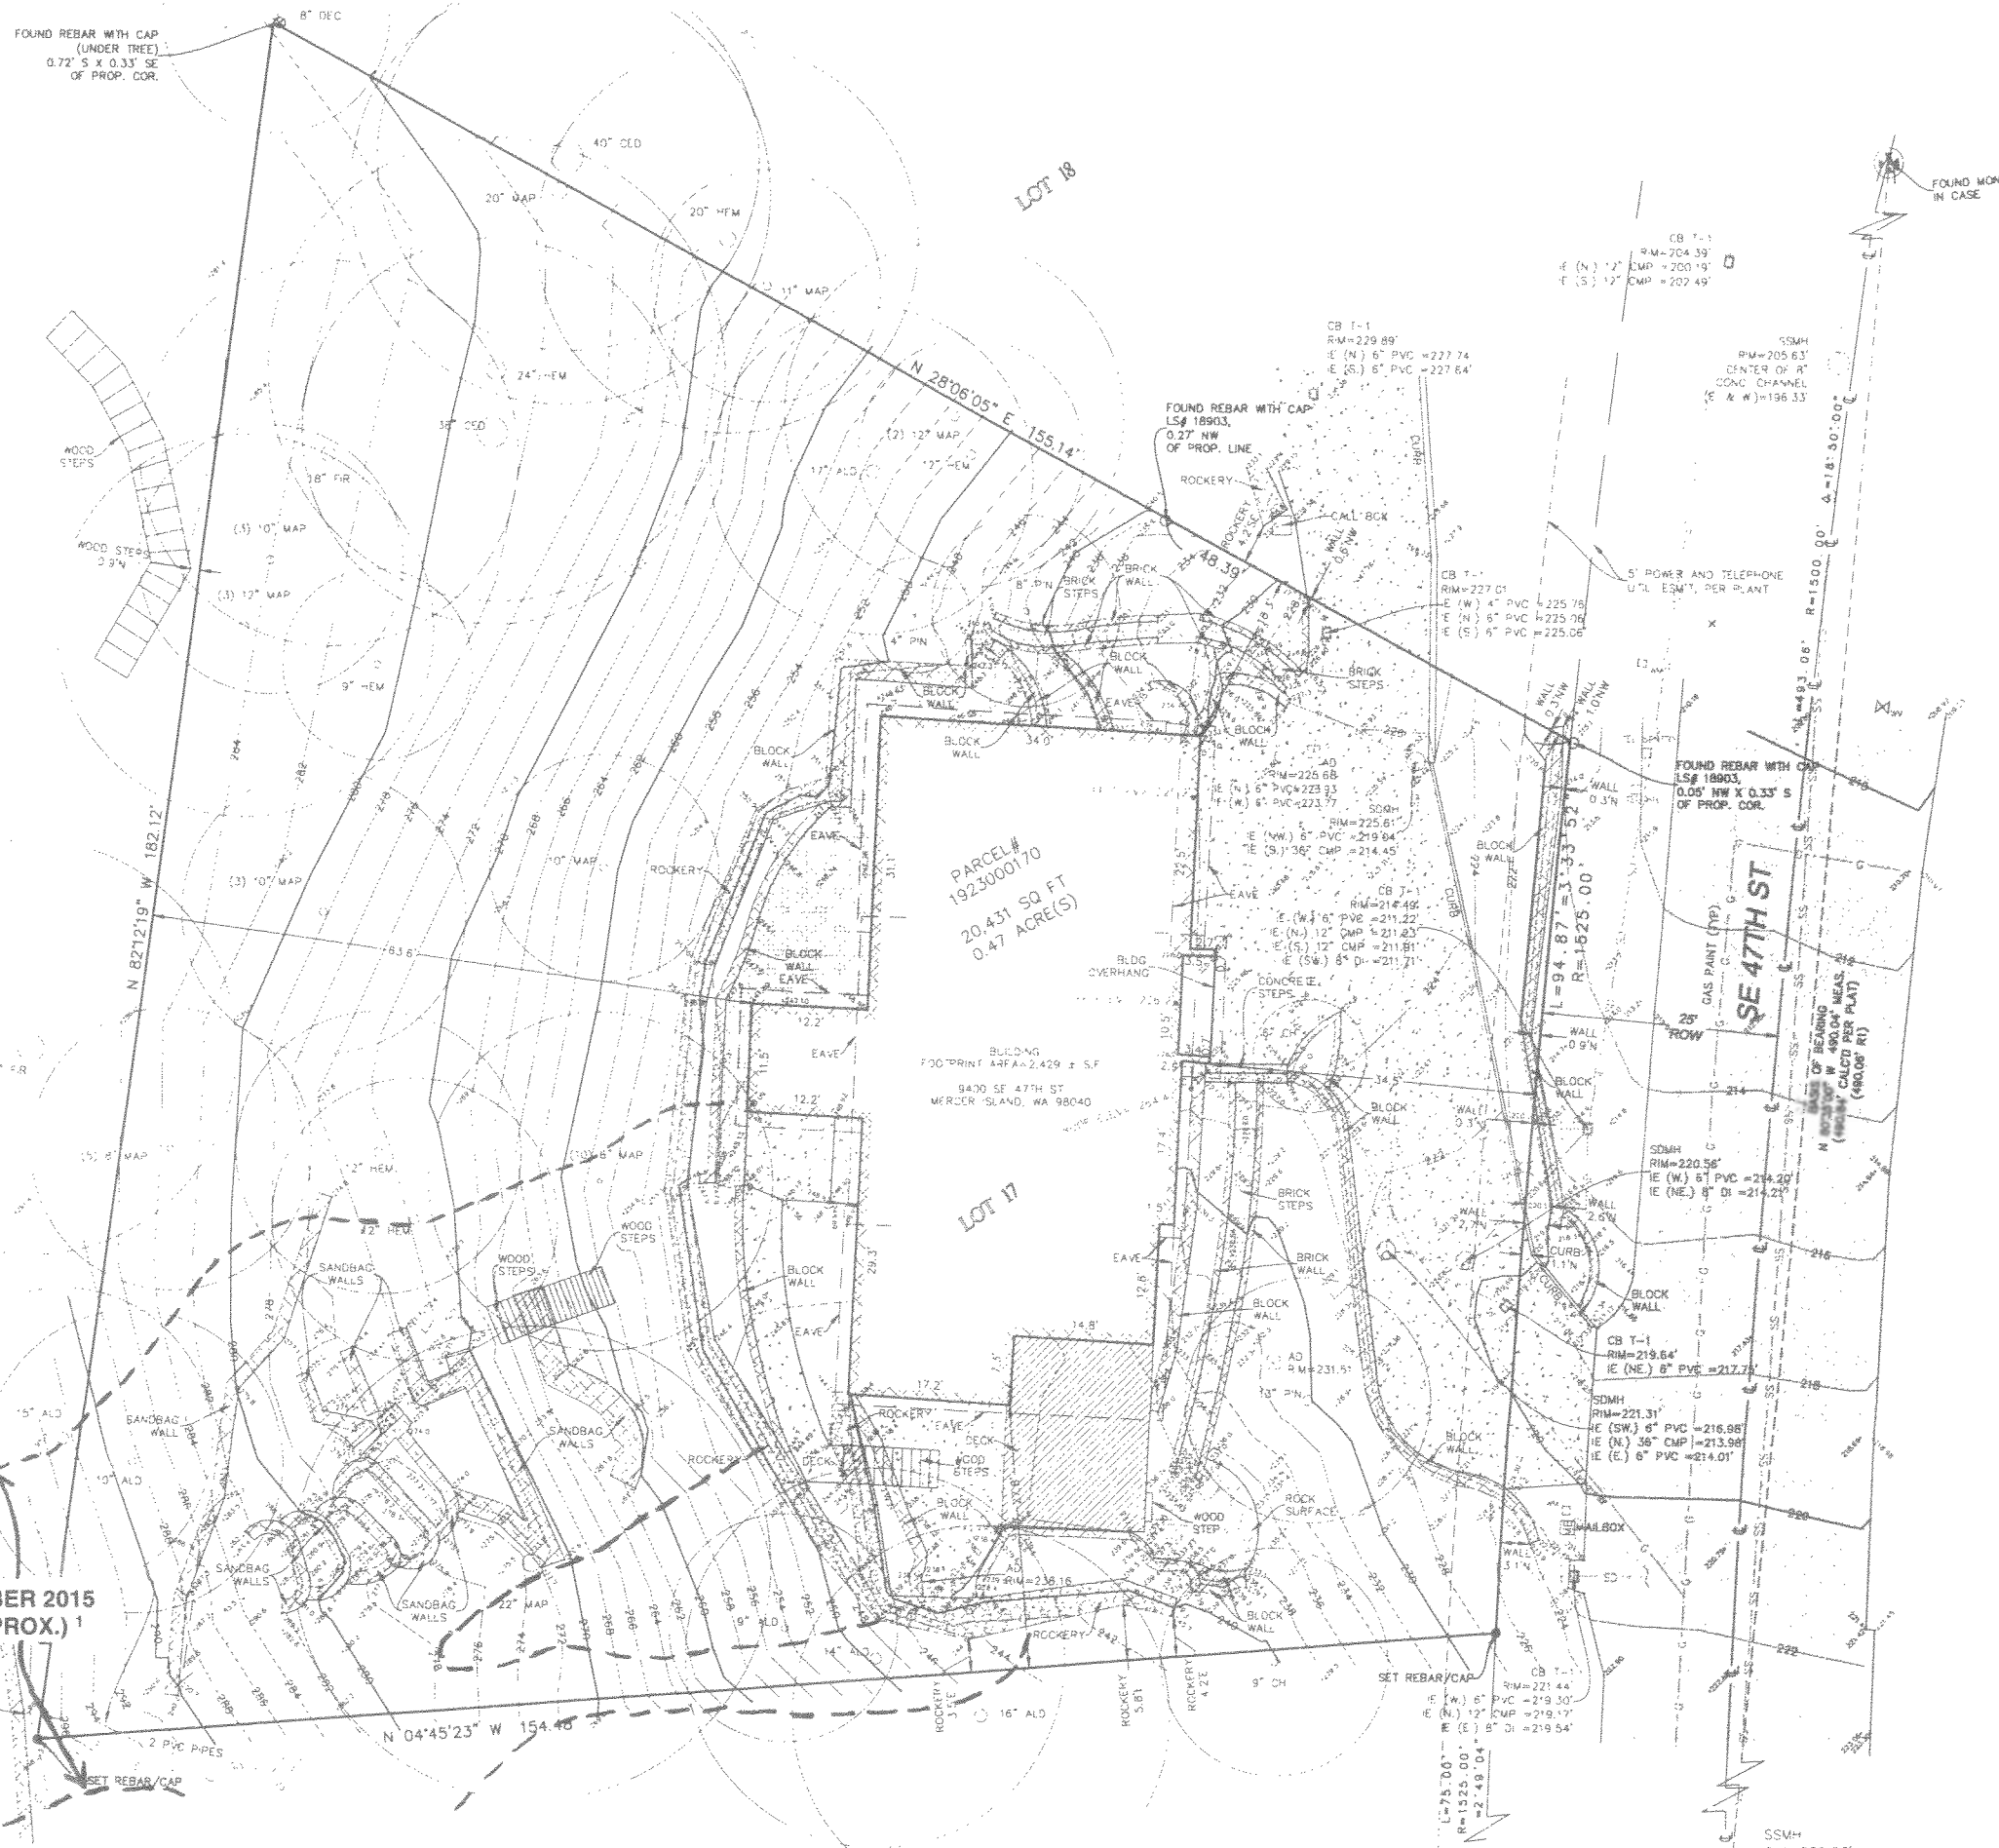
SITE PLAN
SLOPE STABILIZATION EVALUATION
9400 SE 47TH STREET
MERCER ISLAND, WASHINGTON

This slope experienced a debris flow type of landslide in December 2015. The top of the slide area is located near the existing residences on the two properties located immediately north and

northwest from the site (9231 and 9221 SE 46th Street, respectively). The bottom of the slide area is located at the north side of the residence on the site, as illustrated in Plate 2 – Site Plan. Debris from the slide impacted the residence and caused some damage, which subsequently has been repaired.

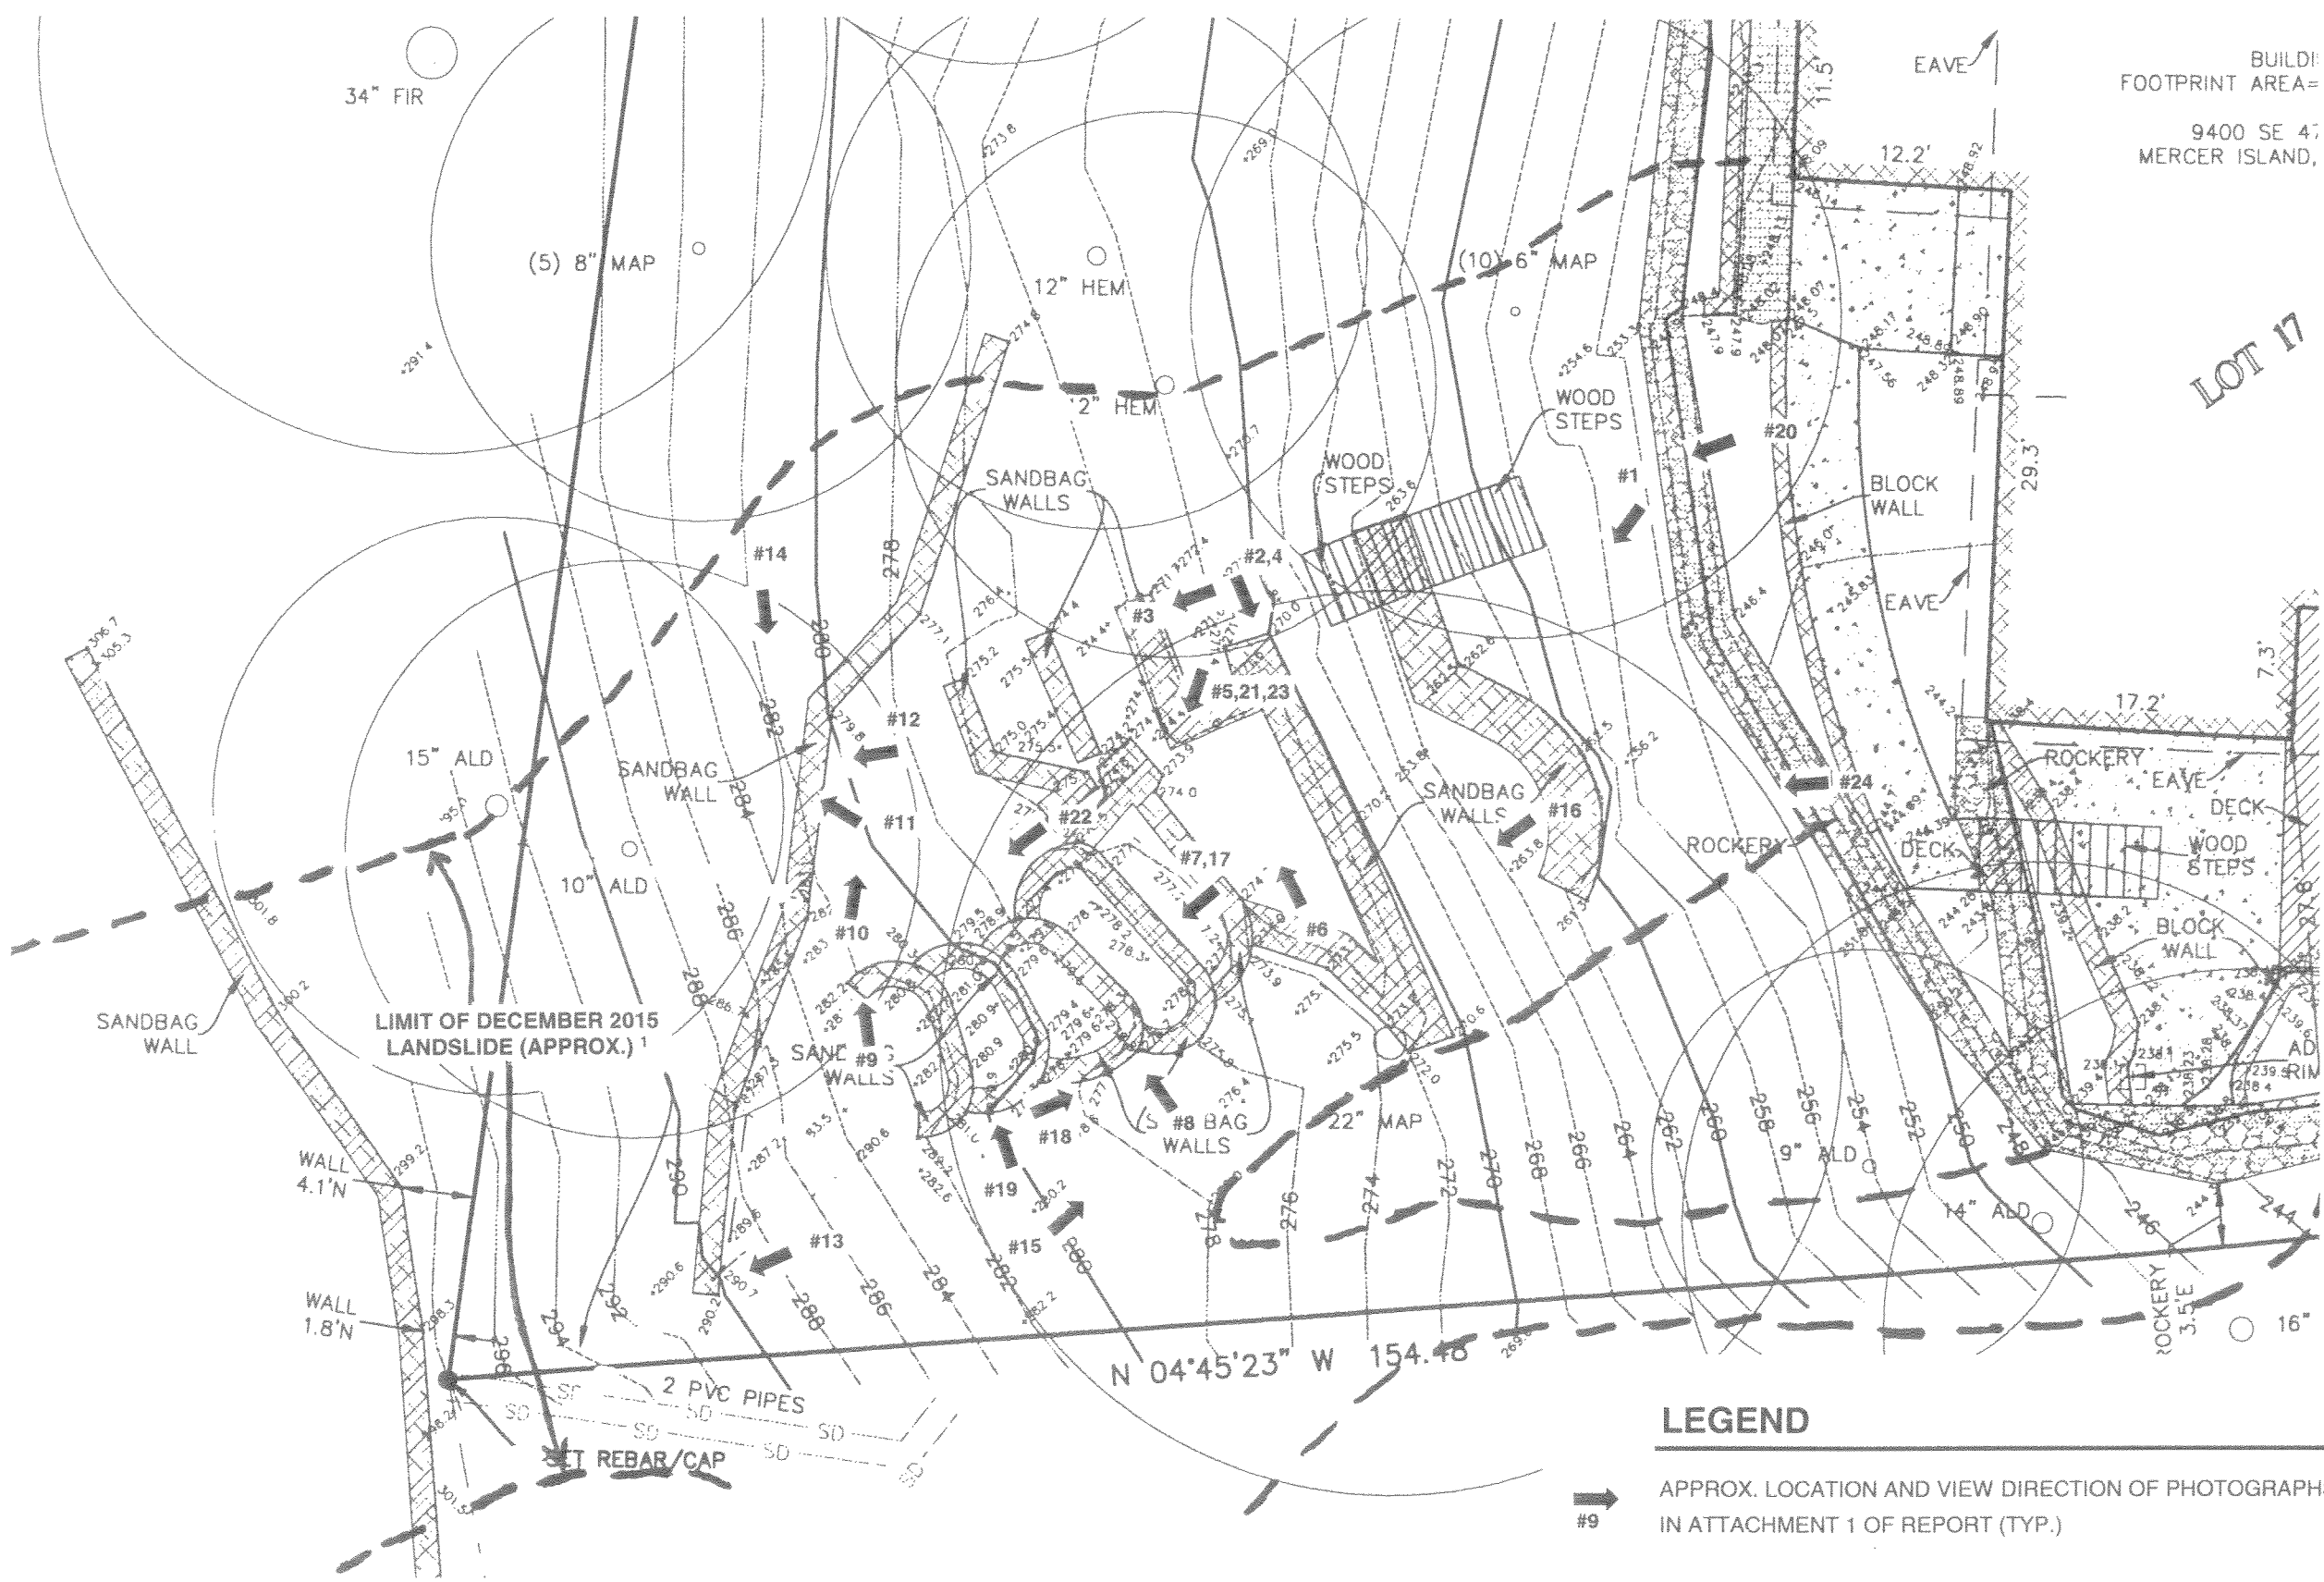
SITE PLAN DETAIL
SLOPE STABILIZATION EVALUATION
9400 SE 47TH STREET
MERCER ISLAND, WASHINGTON

Finished wall heights are 4 feet or less, except for a localized portion of one of the lower walls which has a maximum height of 5 feet. Grade elevations between the walls are indicated on Plate 3 – Site Plan Detail. Photographs showing the construction of the sandbag walls and the completed walls are provided in Attachment 1 to this report. The photograph locations are noted on Plate 3 – Site Plan Detail.

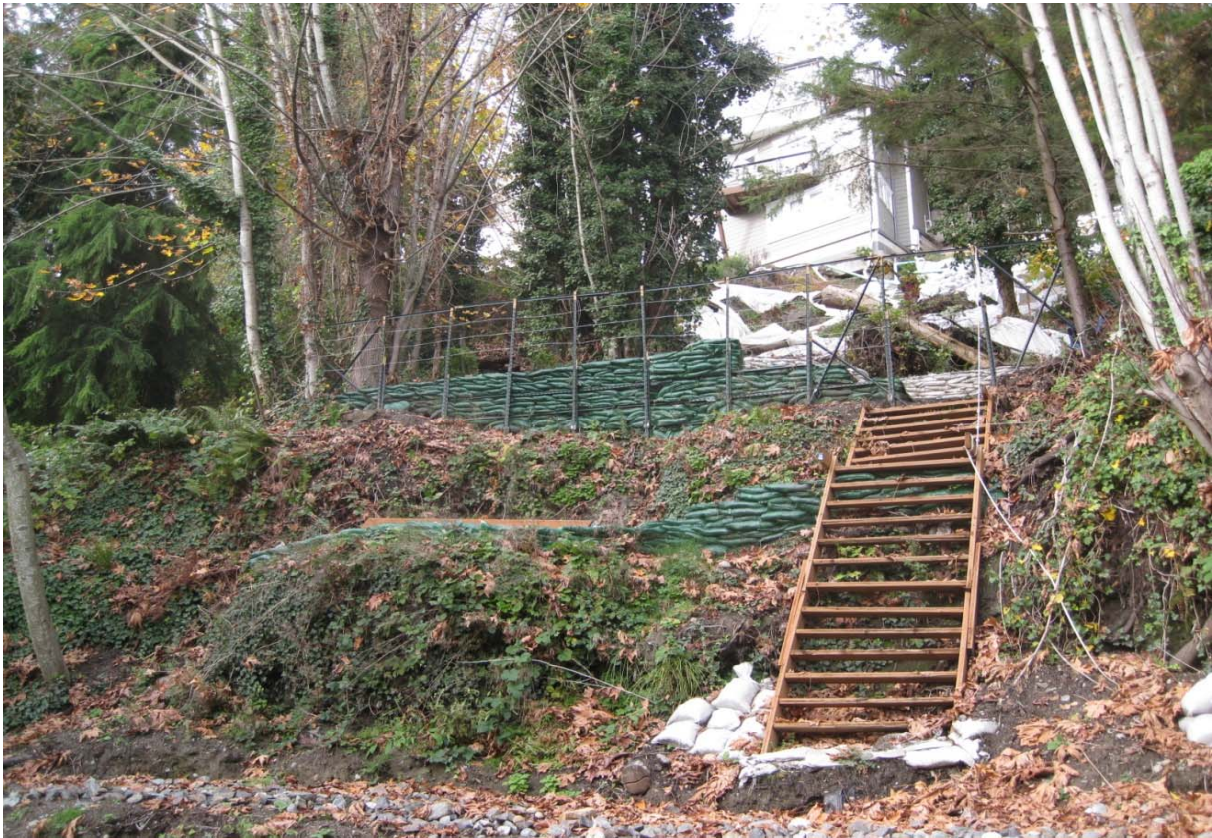
Photo #1: View of the slope behind the residence at the project site (Nov 7 2016).

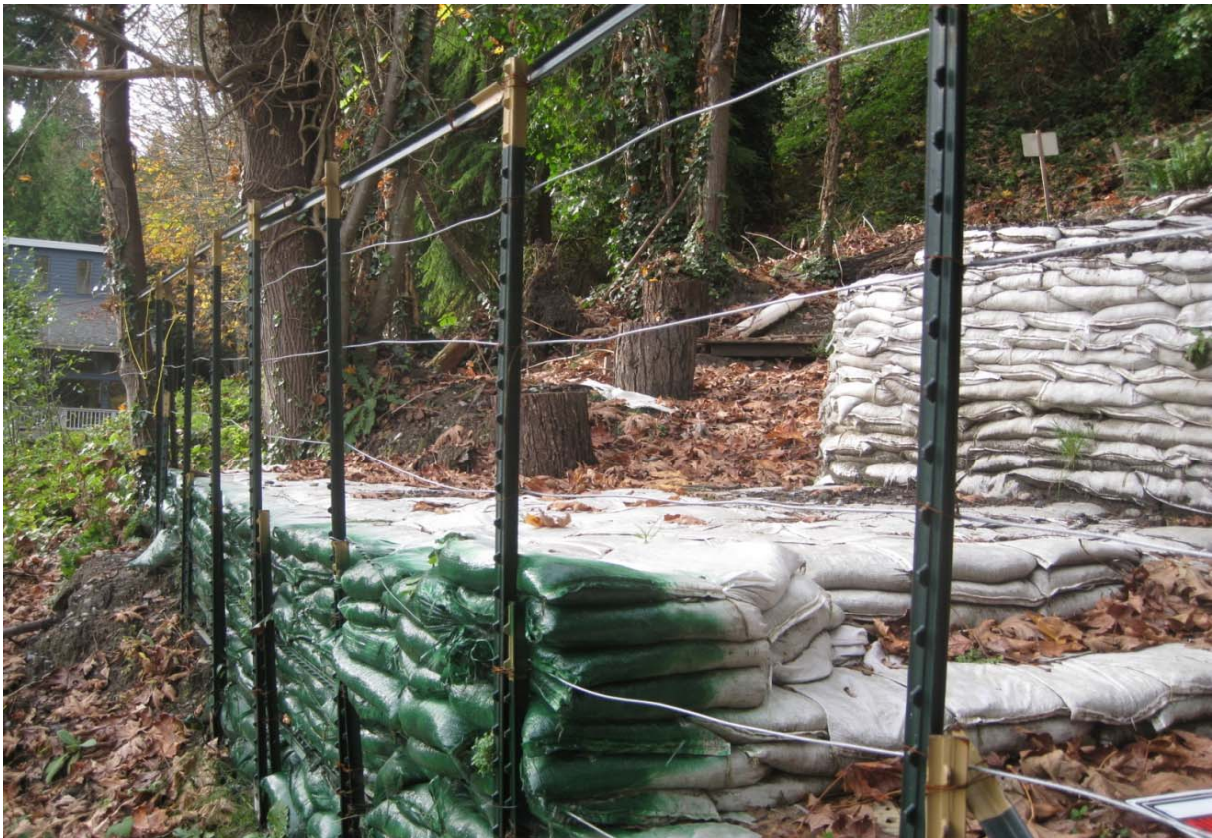
Photo #2: View of one of the sandbag retaining walls on the lower part of the slope (Nov 7 2016).

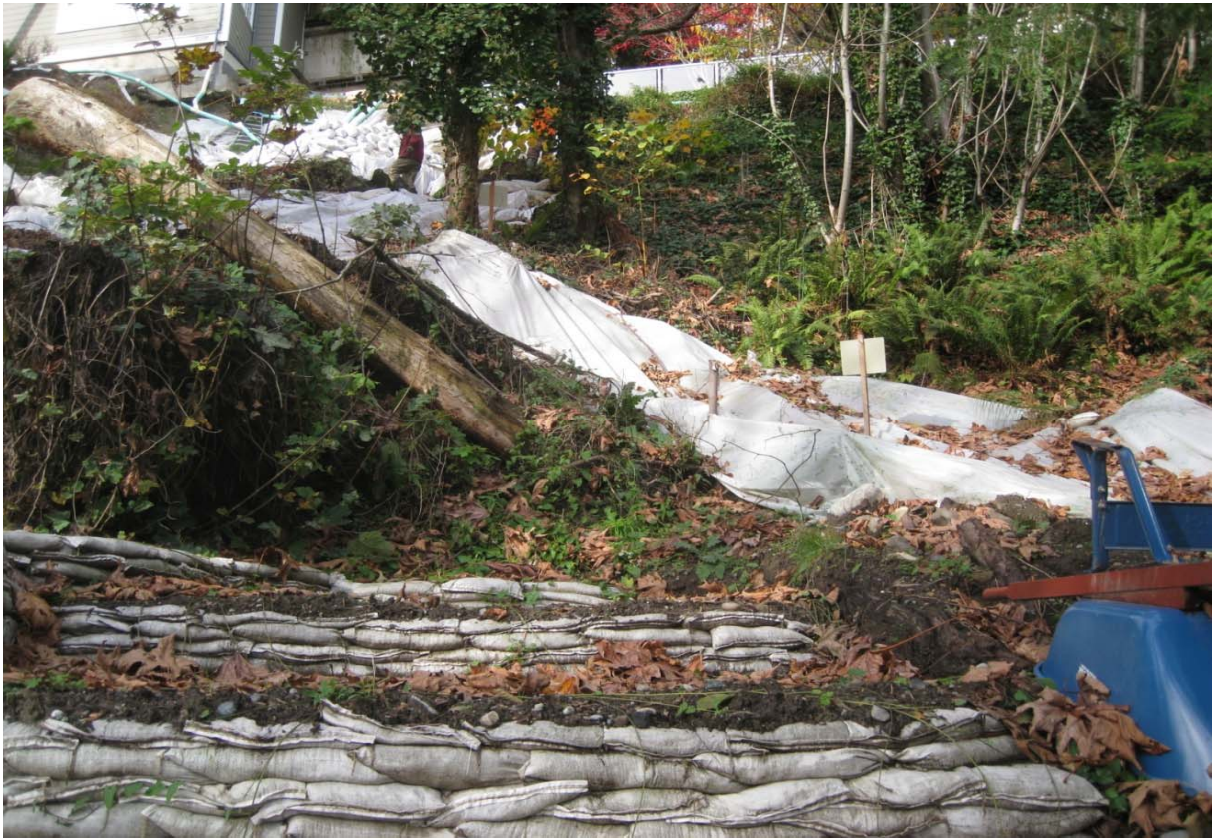
Photo #3: View of the upper part of the slope on the project site and adjacent upslope properties (Nov 7 2016).

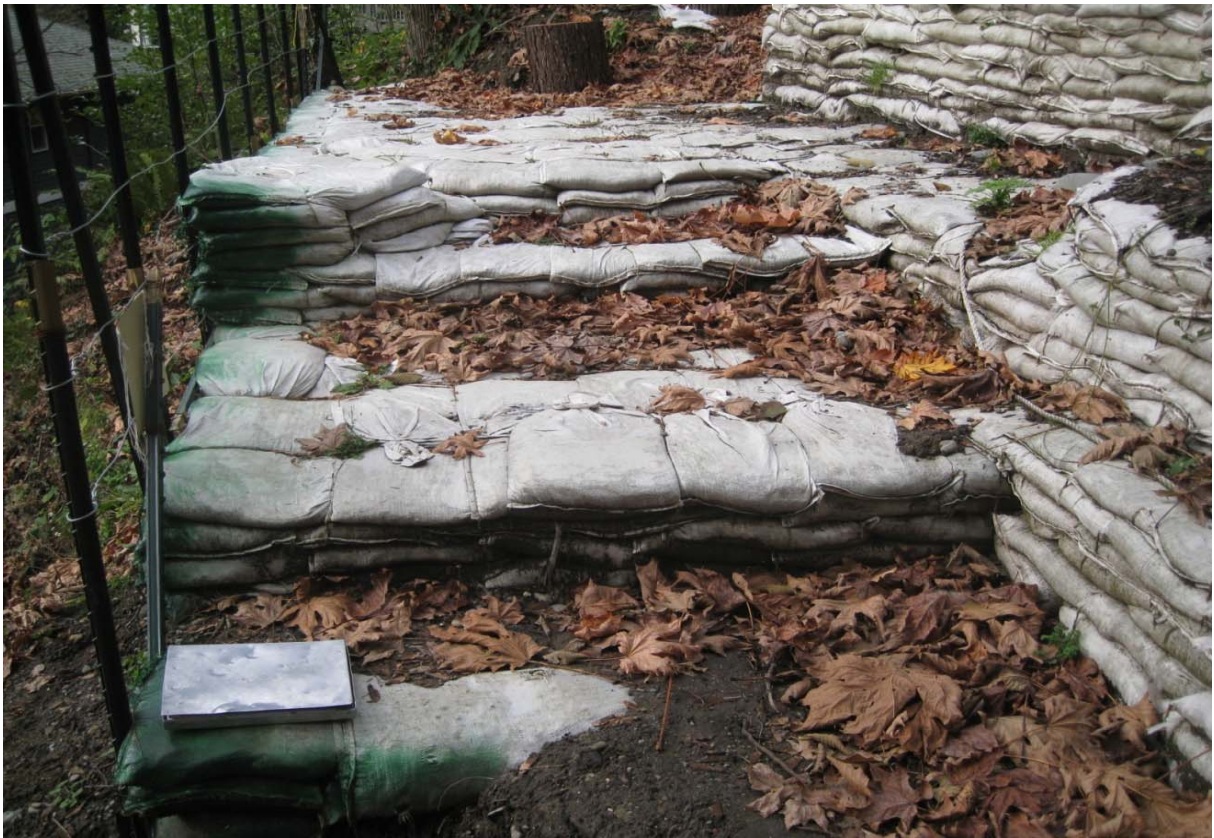
Photo #4: View of one of the sandbag retaining walls on the lower part of the slope (Nov 11 2016).

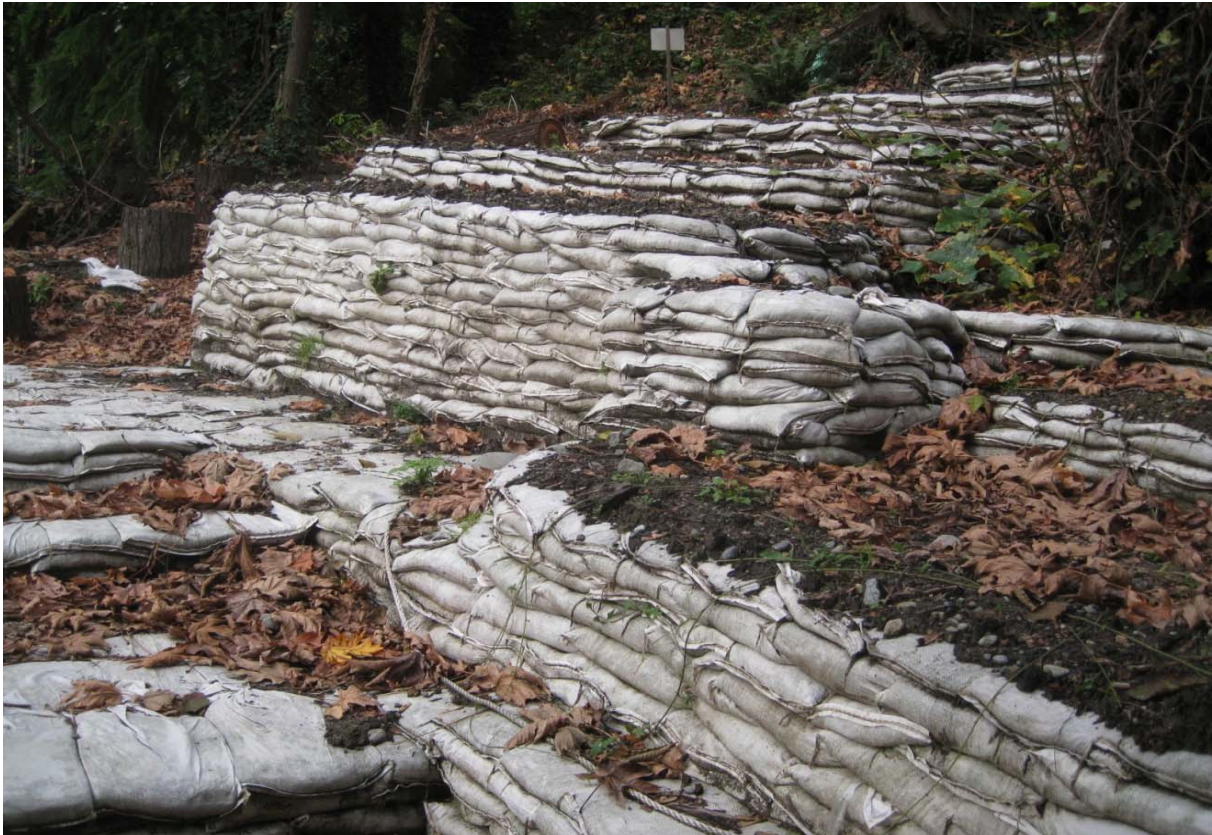
Photo #5: View of tiered sandbag walls on the project site (Nov 11 2016).

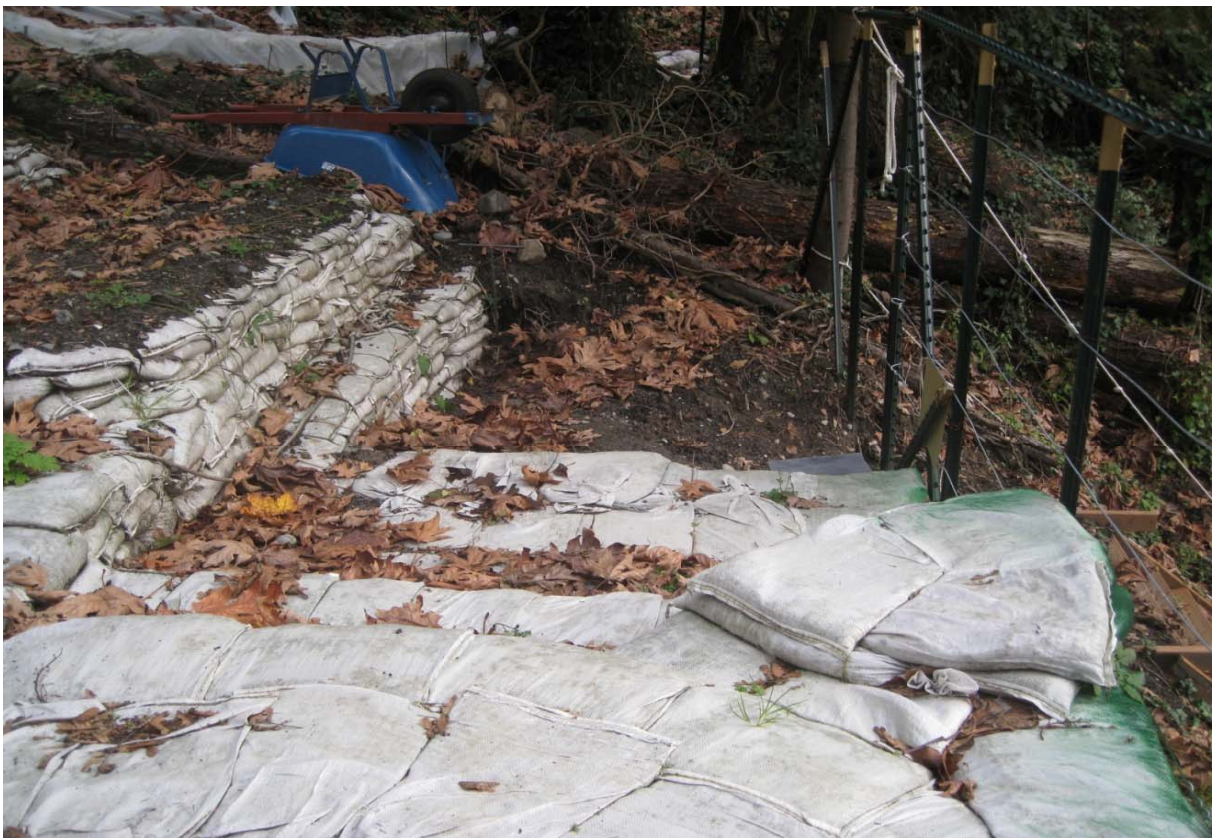
Photo #6: Eastward view of the lower sandbag walls (Nov 11 2016).

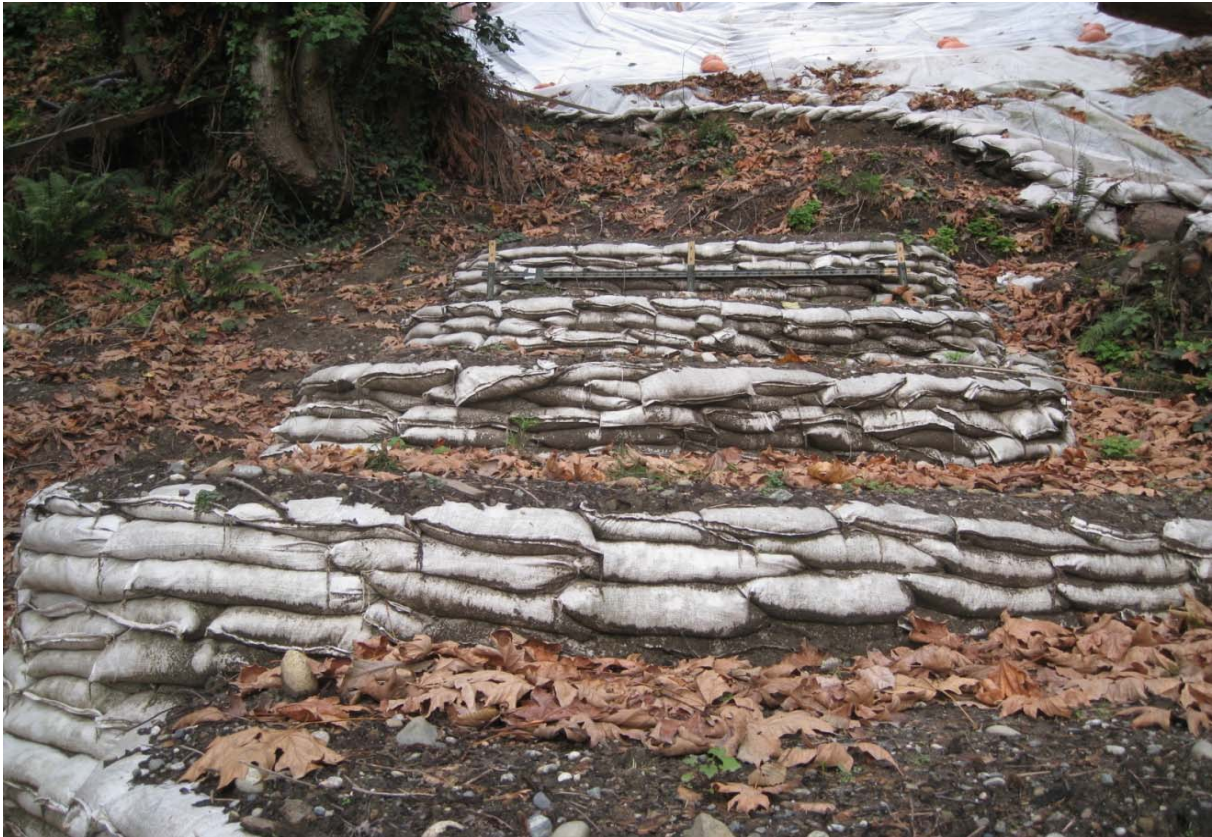
Photo #7: View of the upper tiered sandbag walls on the project site (Nov 11 2016).

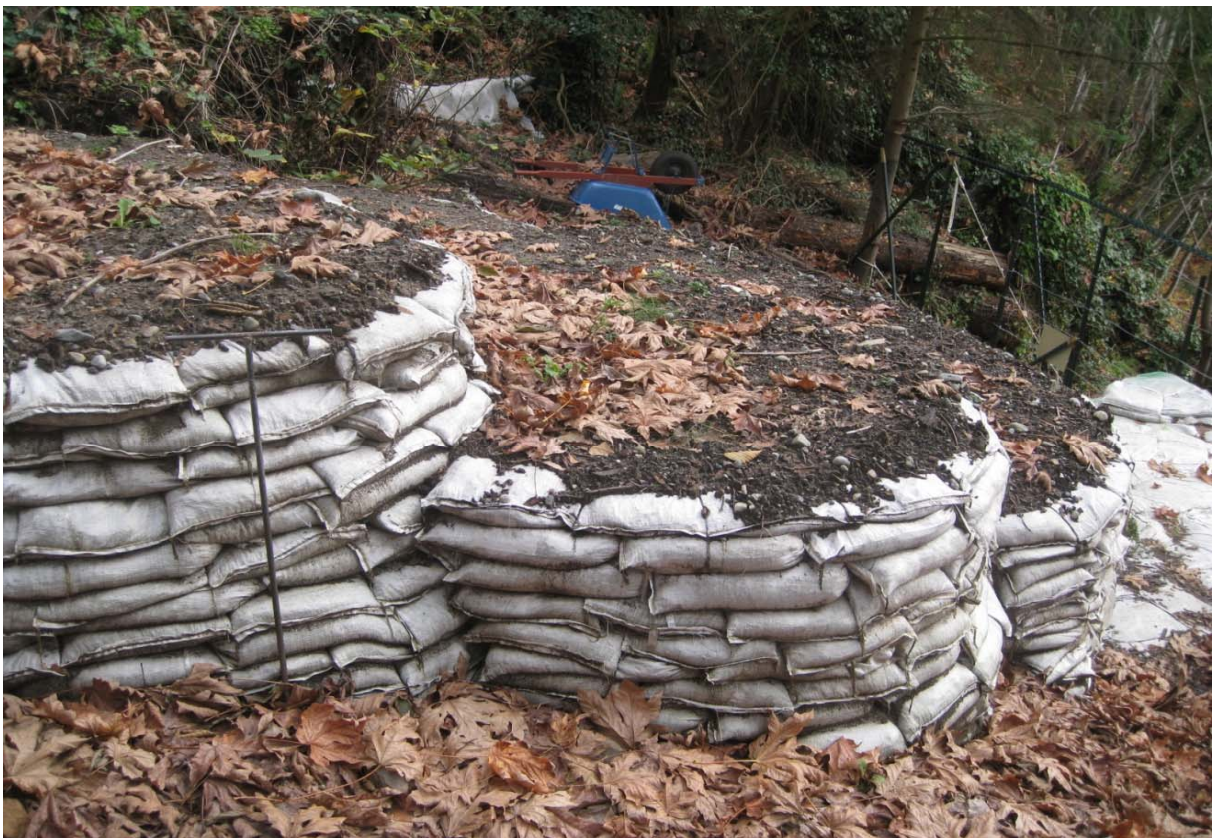
Photo #8: Downward and eastward view of the upper sandbag walls (Nov 11 2016).

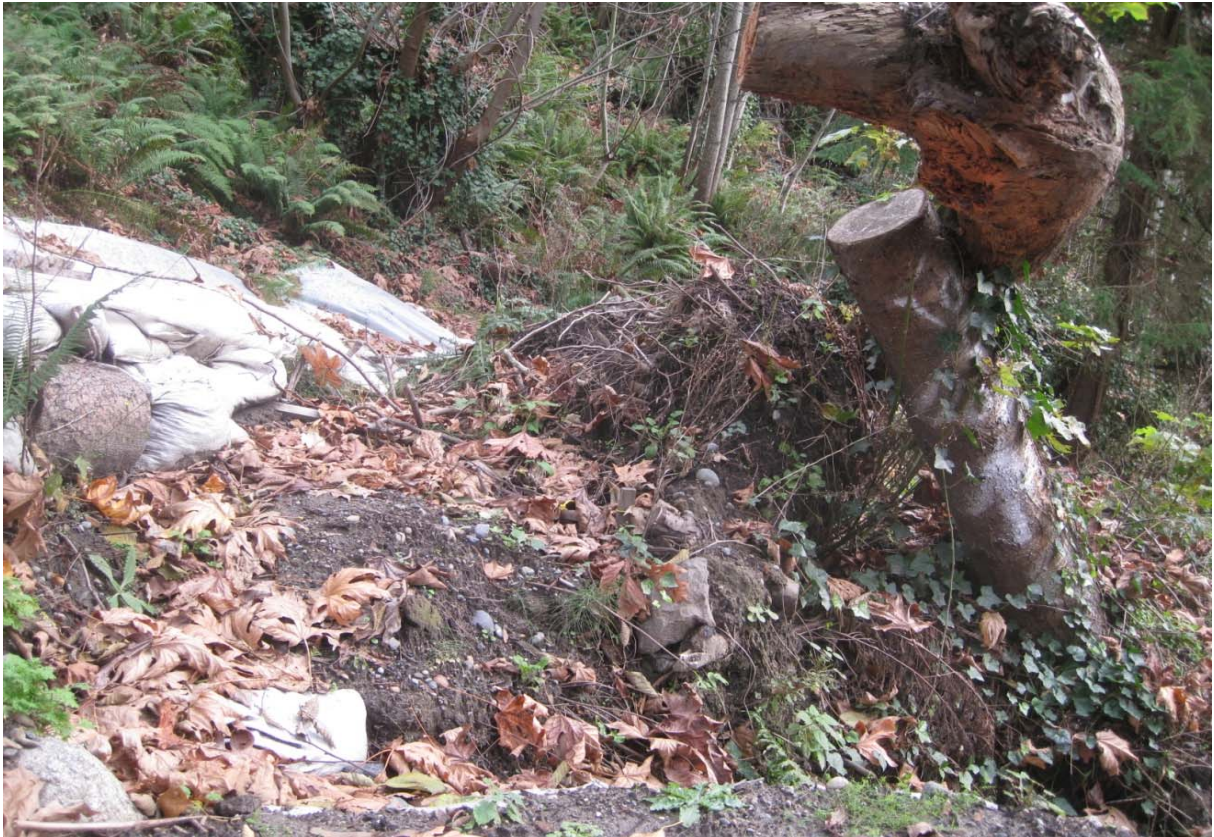
Photo #9: Eastward view across slope above tiered sandbag walls, north margin of project site (Nov 11 2016).

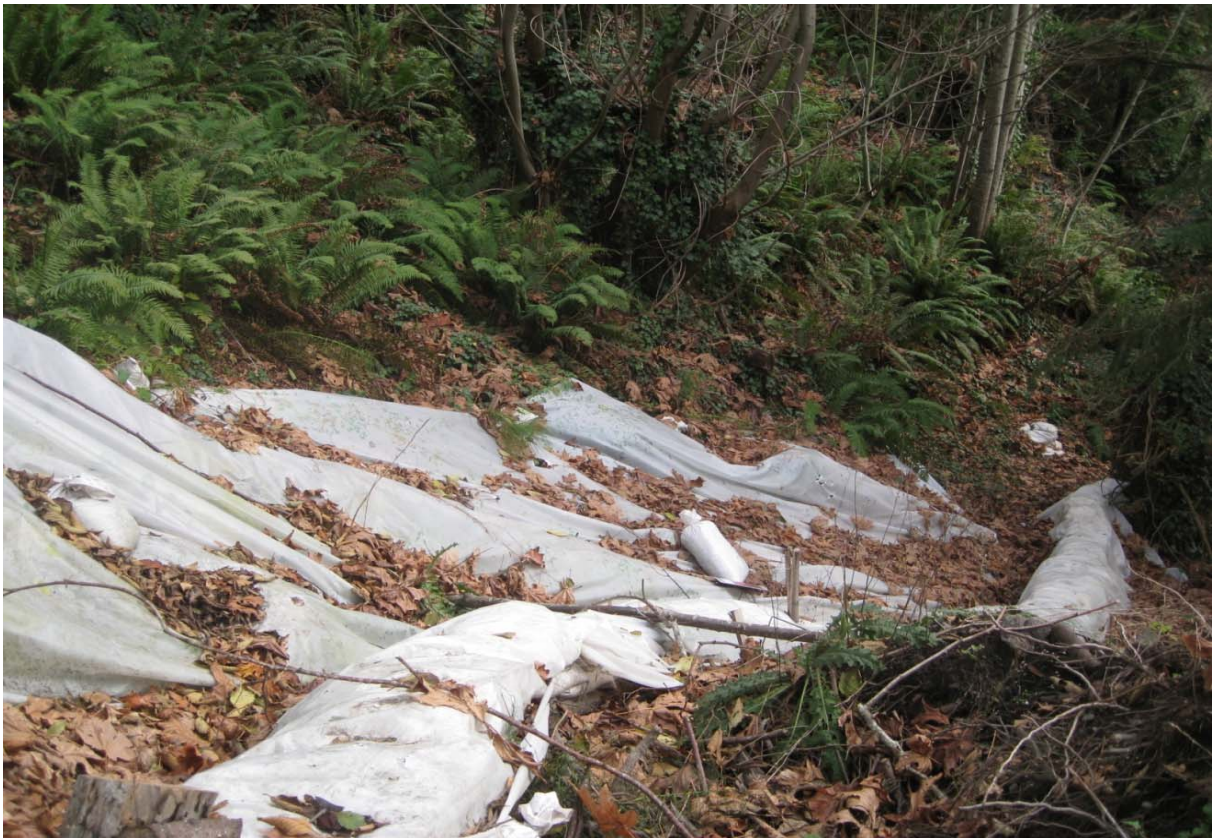
Photo #10: Eastward view of drainage berm and plastic sheeting on site property (Nov 11 2016).

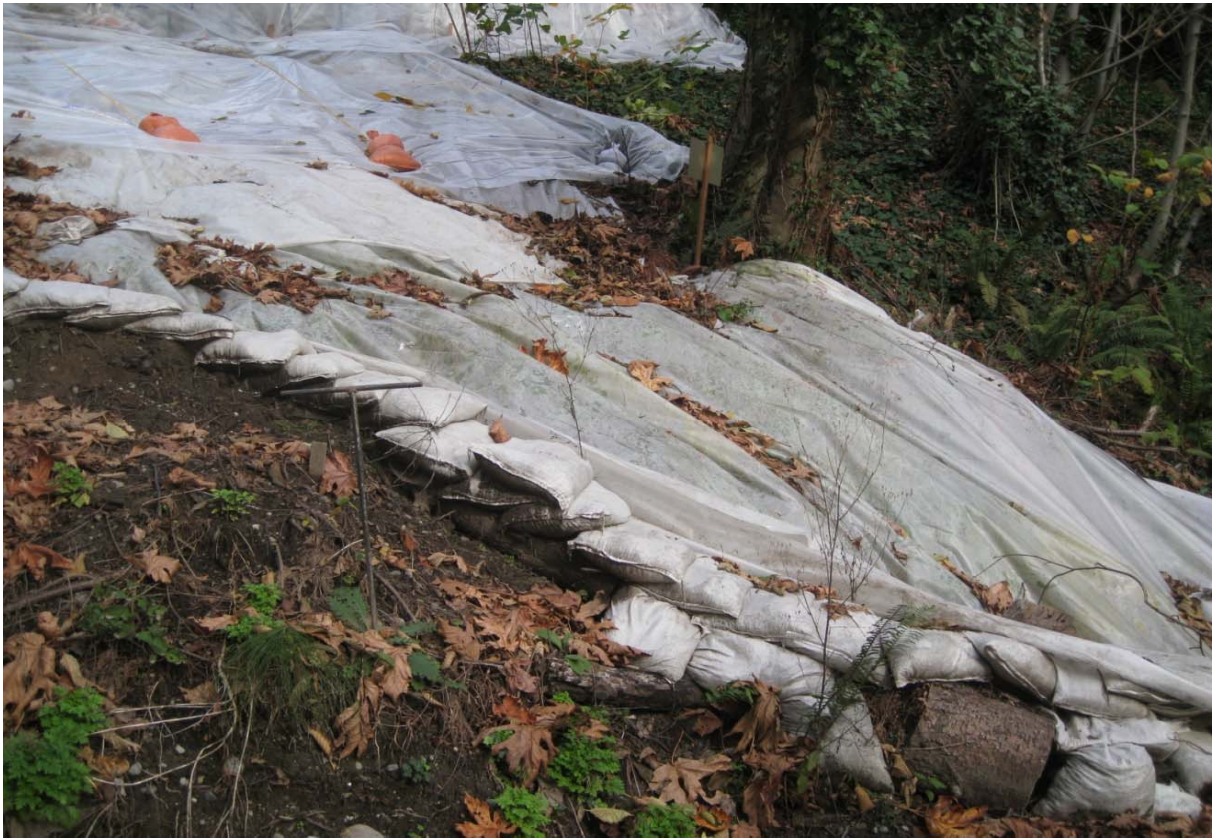
Photo #11: Eastward view of plastic sheeting and sandbags on adjacent north property (Nov 11 2016).

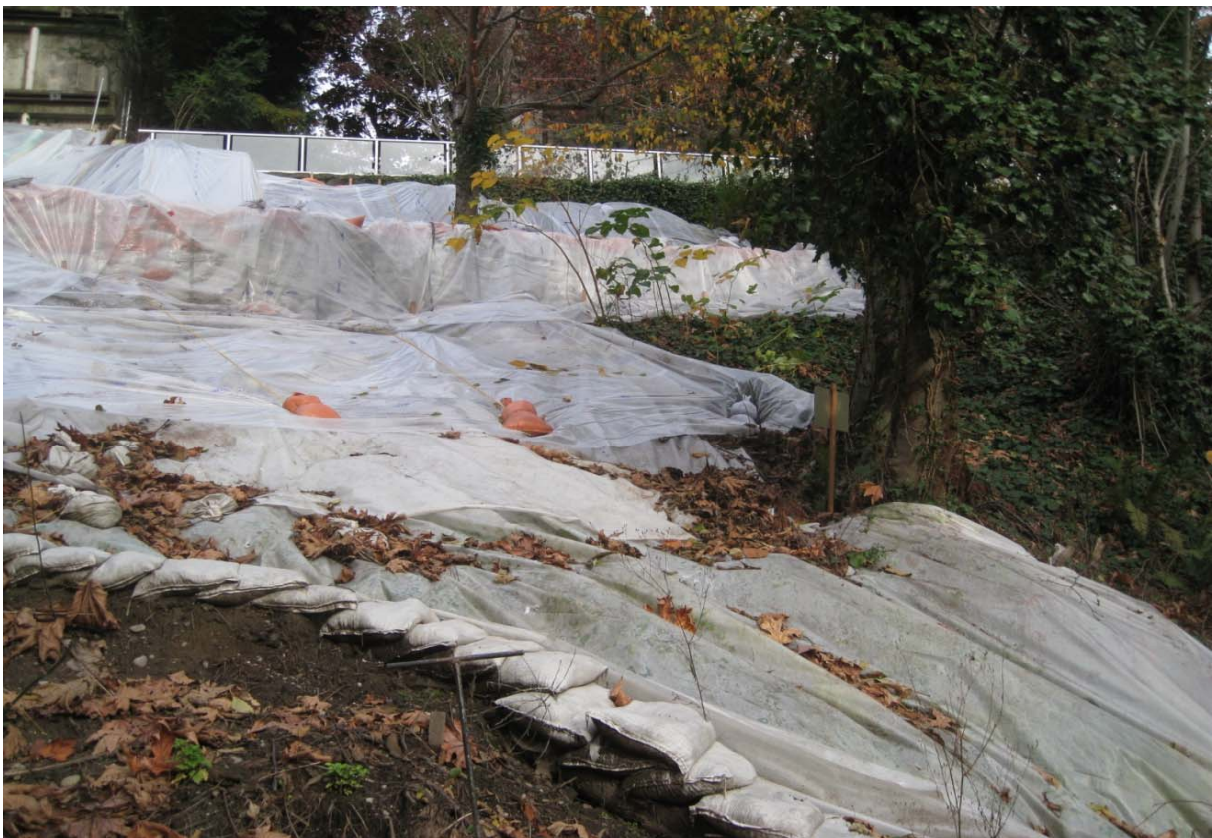
Photo #12: Sandbag berm and plastic sheeting on northern margin of site and adjacent properties (Nov 11 2016).

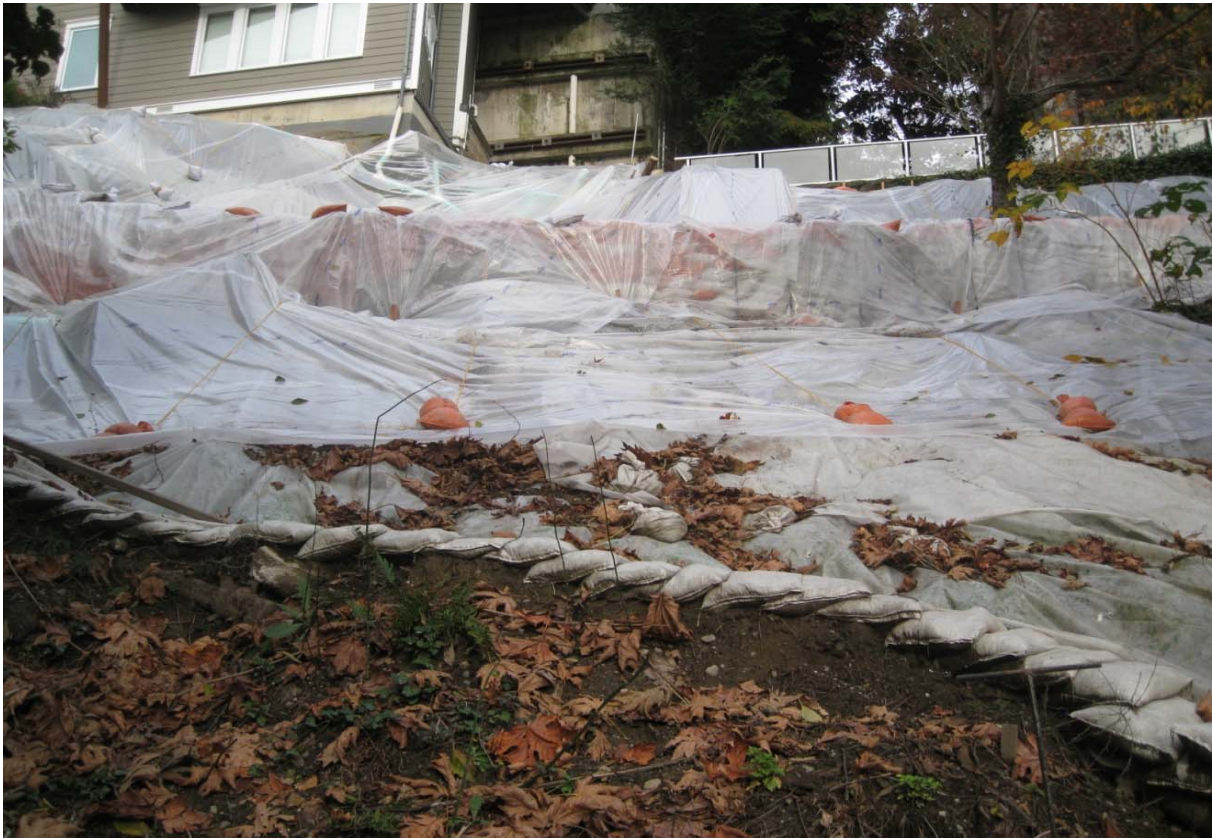
Photo #13: Sandbag berm and plastic sheeting on northern margin of site and adjacent properties (Nov 11 2016).

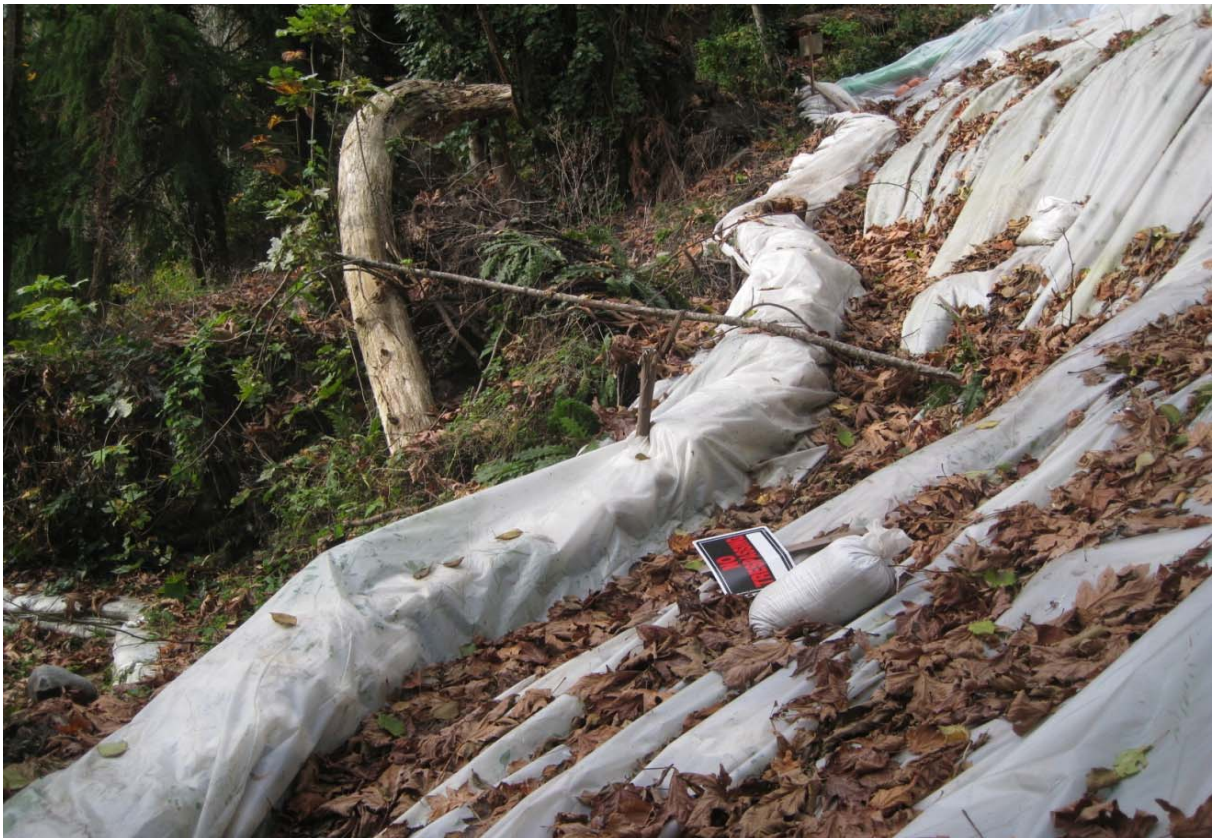
Photo #14: Westward view of sandbag berm and plastic sheeting (Nov 11 2016).

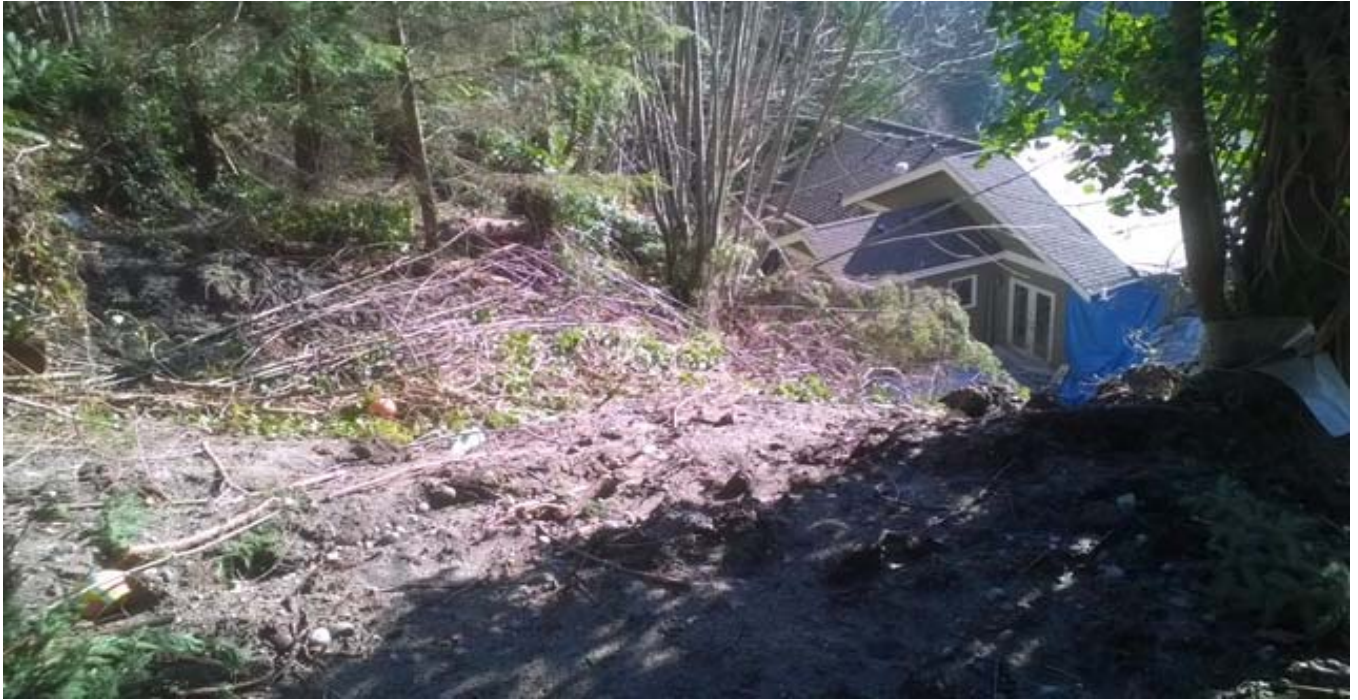
Photo #15: Downslope view of slide area on site property (Feb 2 2016).
