January 25, 2017

G-4149

Subject: Geotechnical Evaluation of Slope Stabilization Measures
9400 SE 47th Street, Mercer Island, Washington 98040

**SLOPE STABILIZATION EVALUATION
9400 SE 47TH STREET
MERCER ISLAND, WASHINGTON**

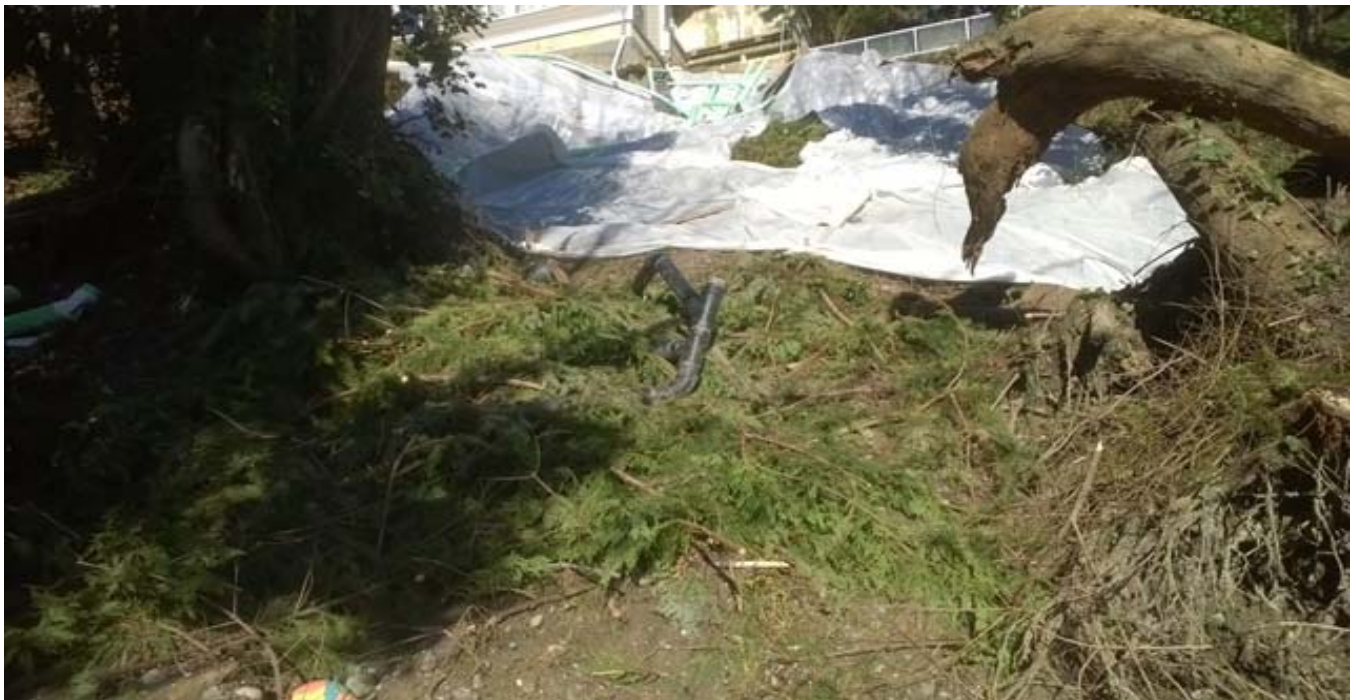
Photo #16: Upslope view of slide area on site and adjacent properties (Feb 9 2016).

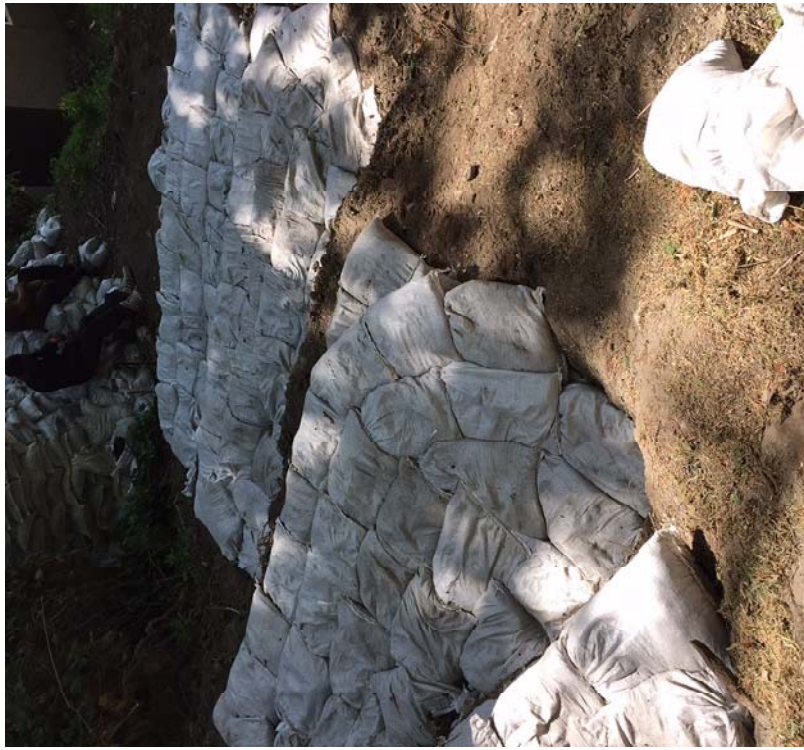
Photo #18: Construction of upper sandbag walls (May 13 2016).

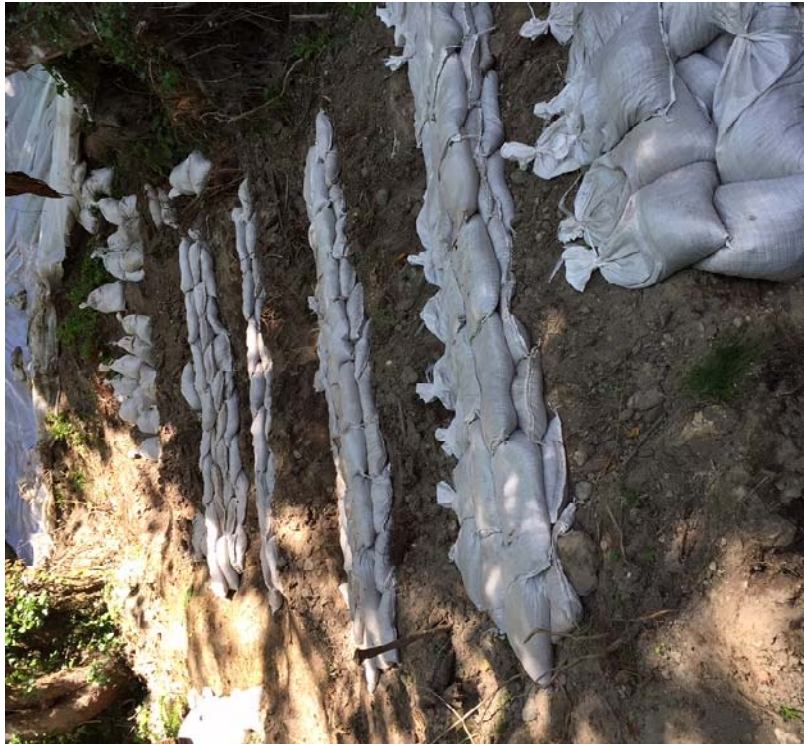
Photo #17: Construction of upper sandbag walls (May 13 2016).

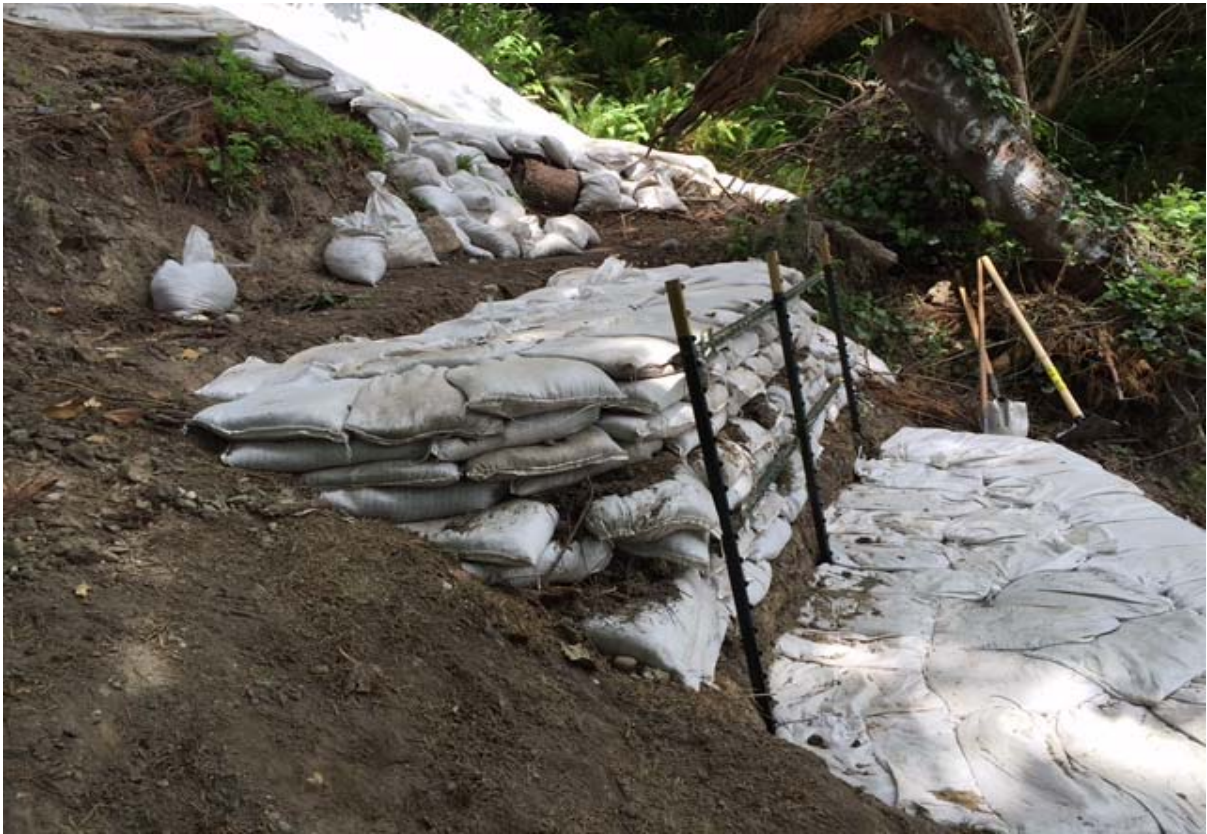
Photo #19: Continued construction of upper sandbag walls (May 17 2016).

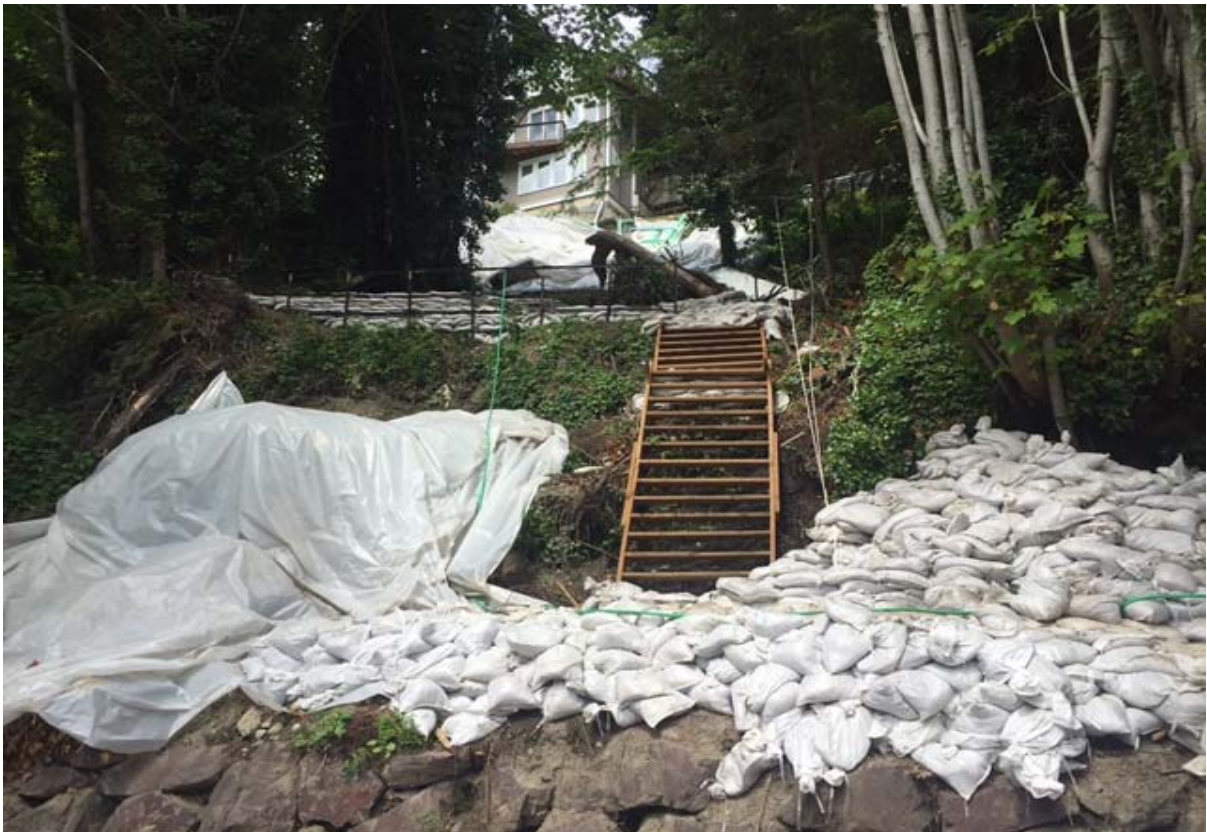
Photo #20: Construction of lower sandbag walls (May 25 2016).

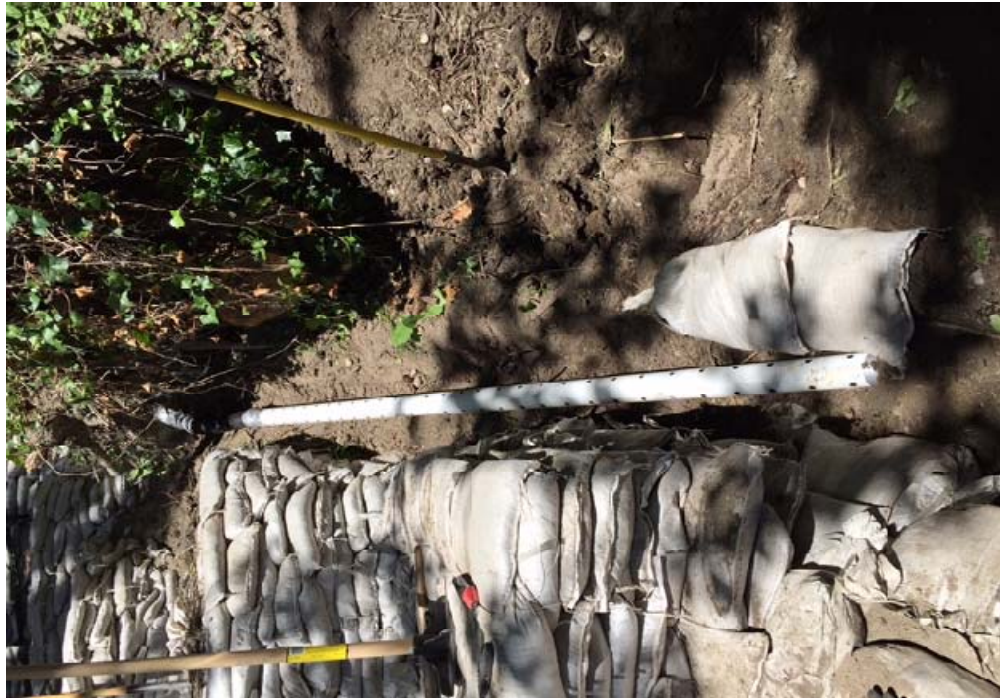
Photo #22: Subsurface drainage next to upper sandbag walls (Jun 6 2016).

We recommend that the subsurface drainage line that was installed along the eastern side of the upper sandbag walls (as noted in Photograph #22 in Attachment 1) should be tightlined to a discharge location at the bottom of the slope. We understand that no water has been observed to be discharging from the line to date, but recommend moving the discharge point downslope as a precaution against potential soil erosion if drainage flow develops in the future.

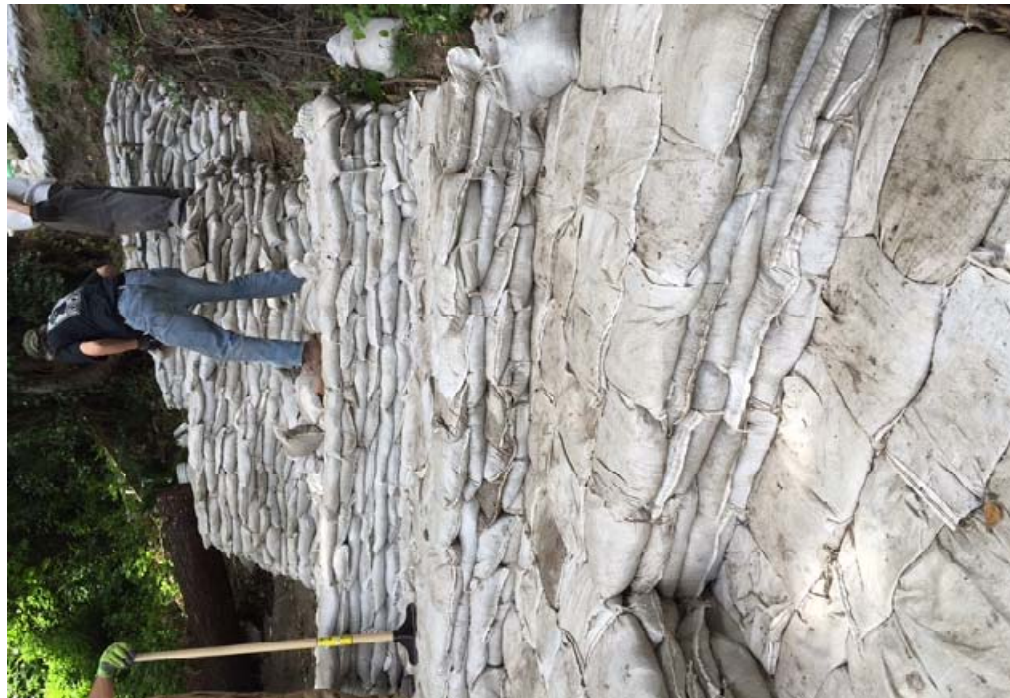
Photo #21: Construction of upper sandbag walls (Jun 2 2016).

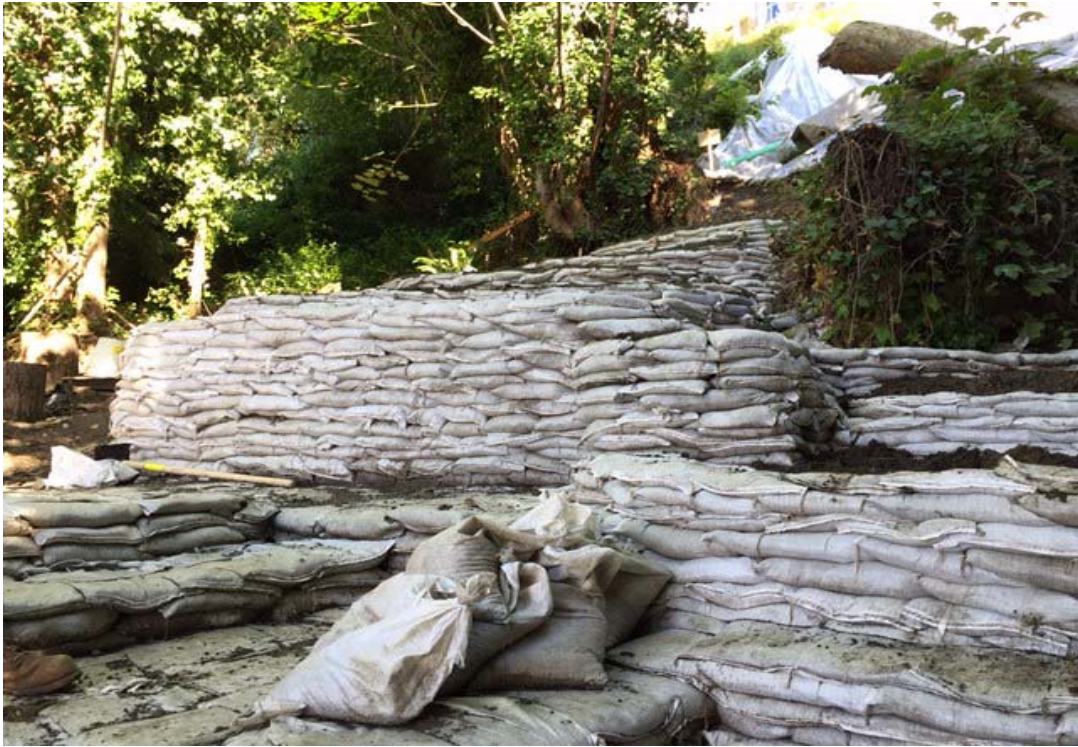
Photo #23: Completed upper sandbag walls (Jun 22 2016).

We recommend that the existing sand bag walls be protected from potential degradation by UV radiation from direct sunlight over the long term. Protection can be achieved by 1) placing a cover of at least 4 inches of topsoil or mulching on top of the sandbags, 2) placing a layer of UV-blocking durable material against the exposed faces of the walls, and 3) establishing a dense and permanent vegetation cover over the tops and faces of the walls. The UV-blocking material can consist of a durable shade cloth having at least 90% protection from UV radiation, or a shotcrete and wire mesh facing, or some other appropriate material.

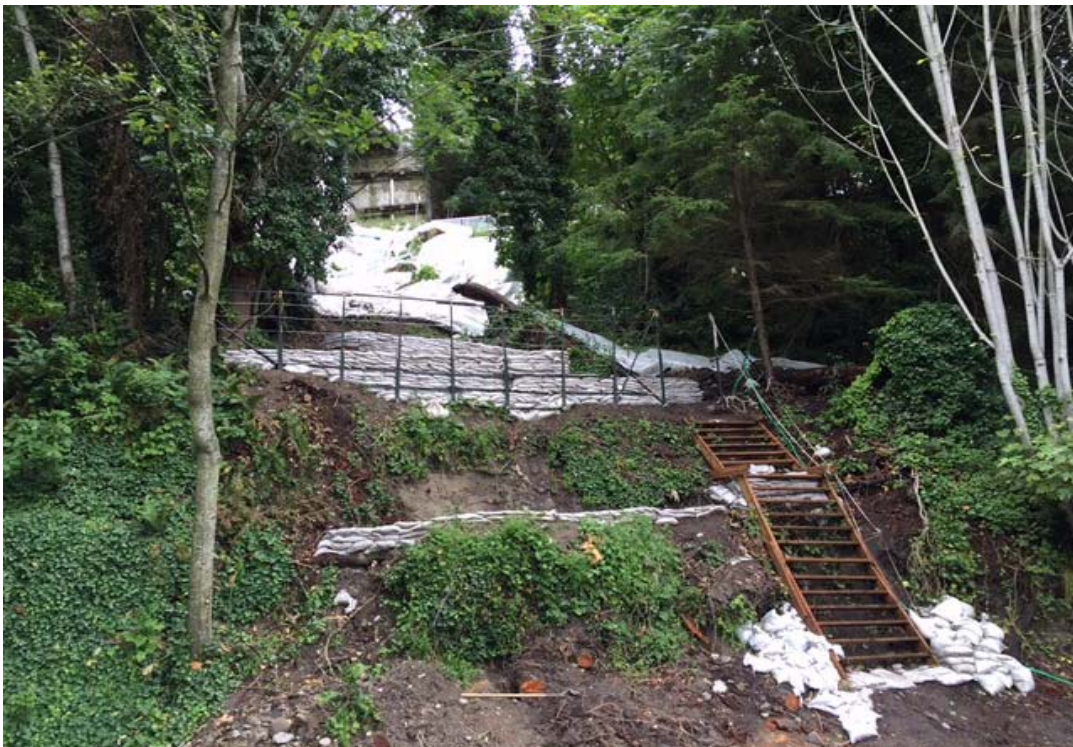
Photo #24: Completed lower sandbag walls (May 25 2016).
