LAYTON TREE CONSULTING, LLC

TREES & CONSTRUCTION MEMO

To: Paul Bosveld
From: Bob Layton
CC: Heather Crain, Matt Wittman
Date: March 31, 2022; Updated August 20, 2022
Re: Tree Protection at 7345 SE 38th Street, Project 2110-193

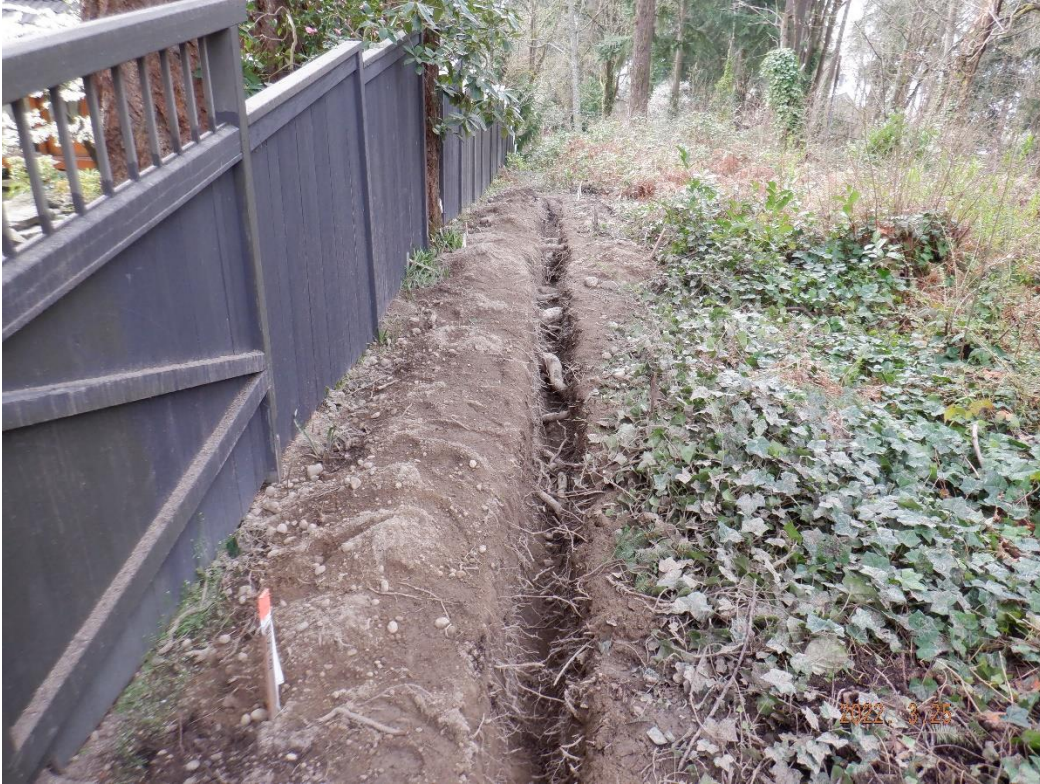
Trench air-excavated at excavation extent along east property line

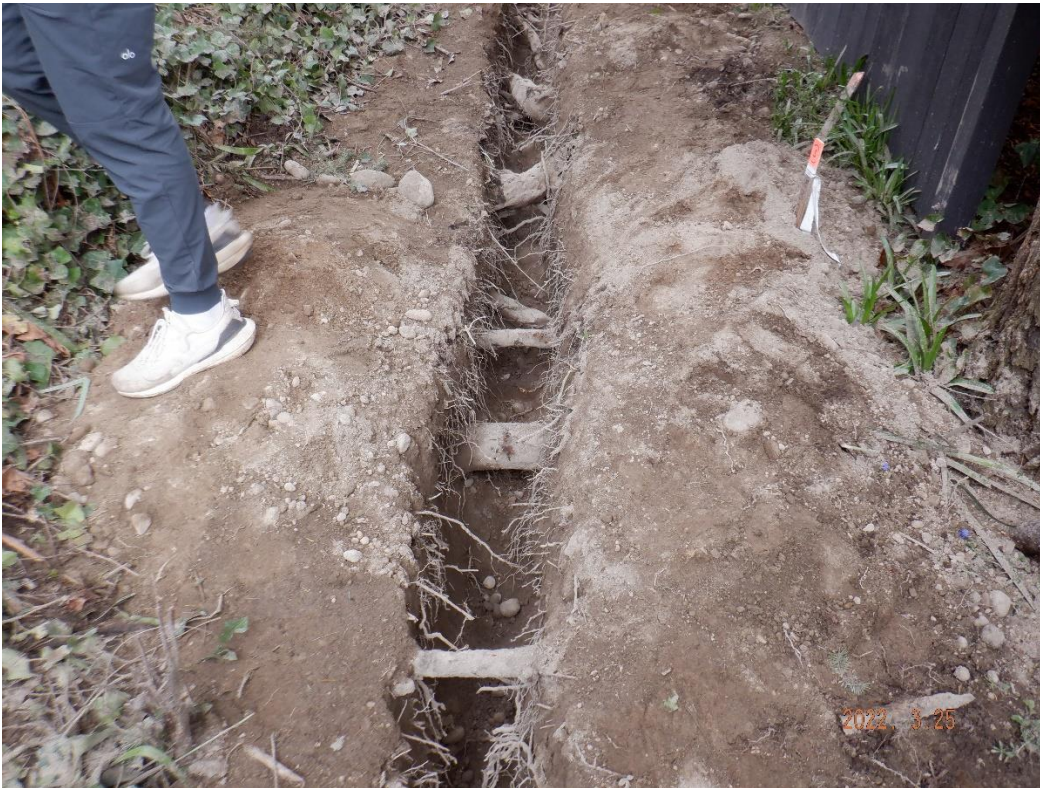
Another trench was air-excavated adjacent to the east property line at the proposed excavation extents. A cluster of +/- 5 structural roots exist directly west of Tree B. See the attached map. In order to protect roots, the proposed footing northwest of Tree D will be omitted and a cantilever system will be used to support the floating garage floor.

Cluster of structural roots exposed west of Trees C & D

All concrete footing locations will be hand-excavated and sited to avoid existing roots that have been exposed by air-excavation or encountered during hand-digging. All preparation work to be done by hand-labor. Concrete will be poured via a chute extending from a truck parked within the confined limits of the new proposed driveway. All concrete needed for this project will be delivered/poured in the same manner.

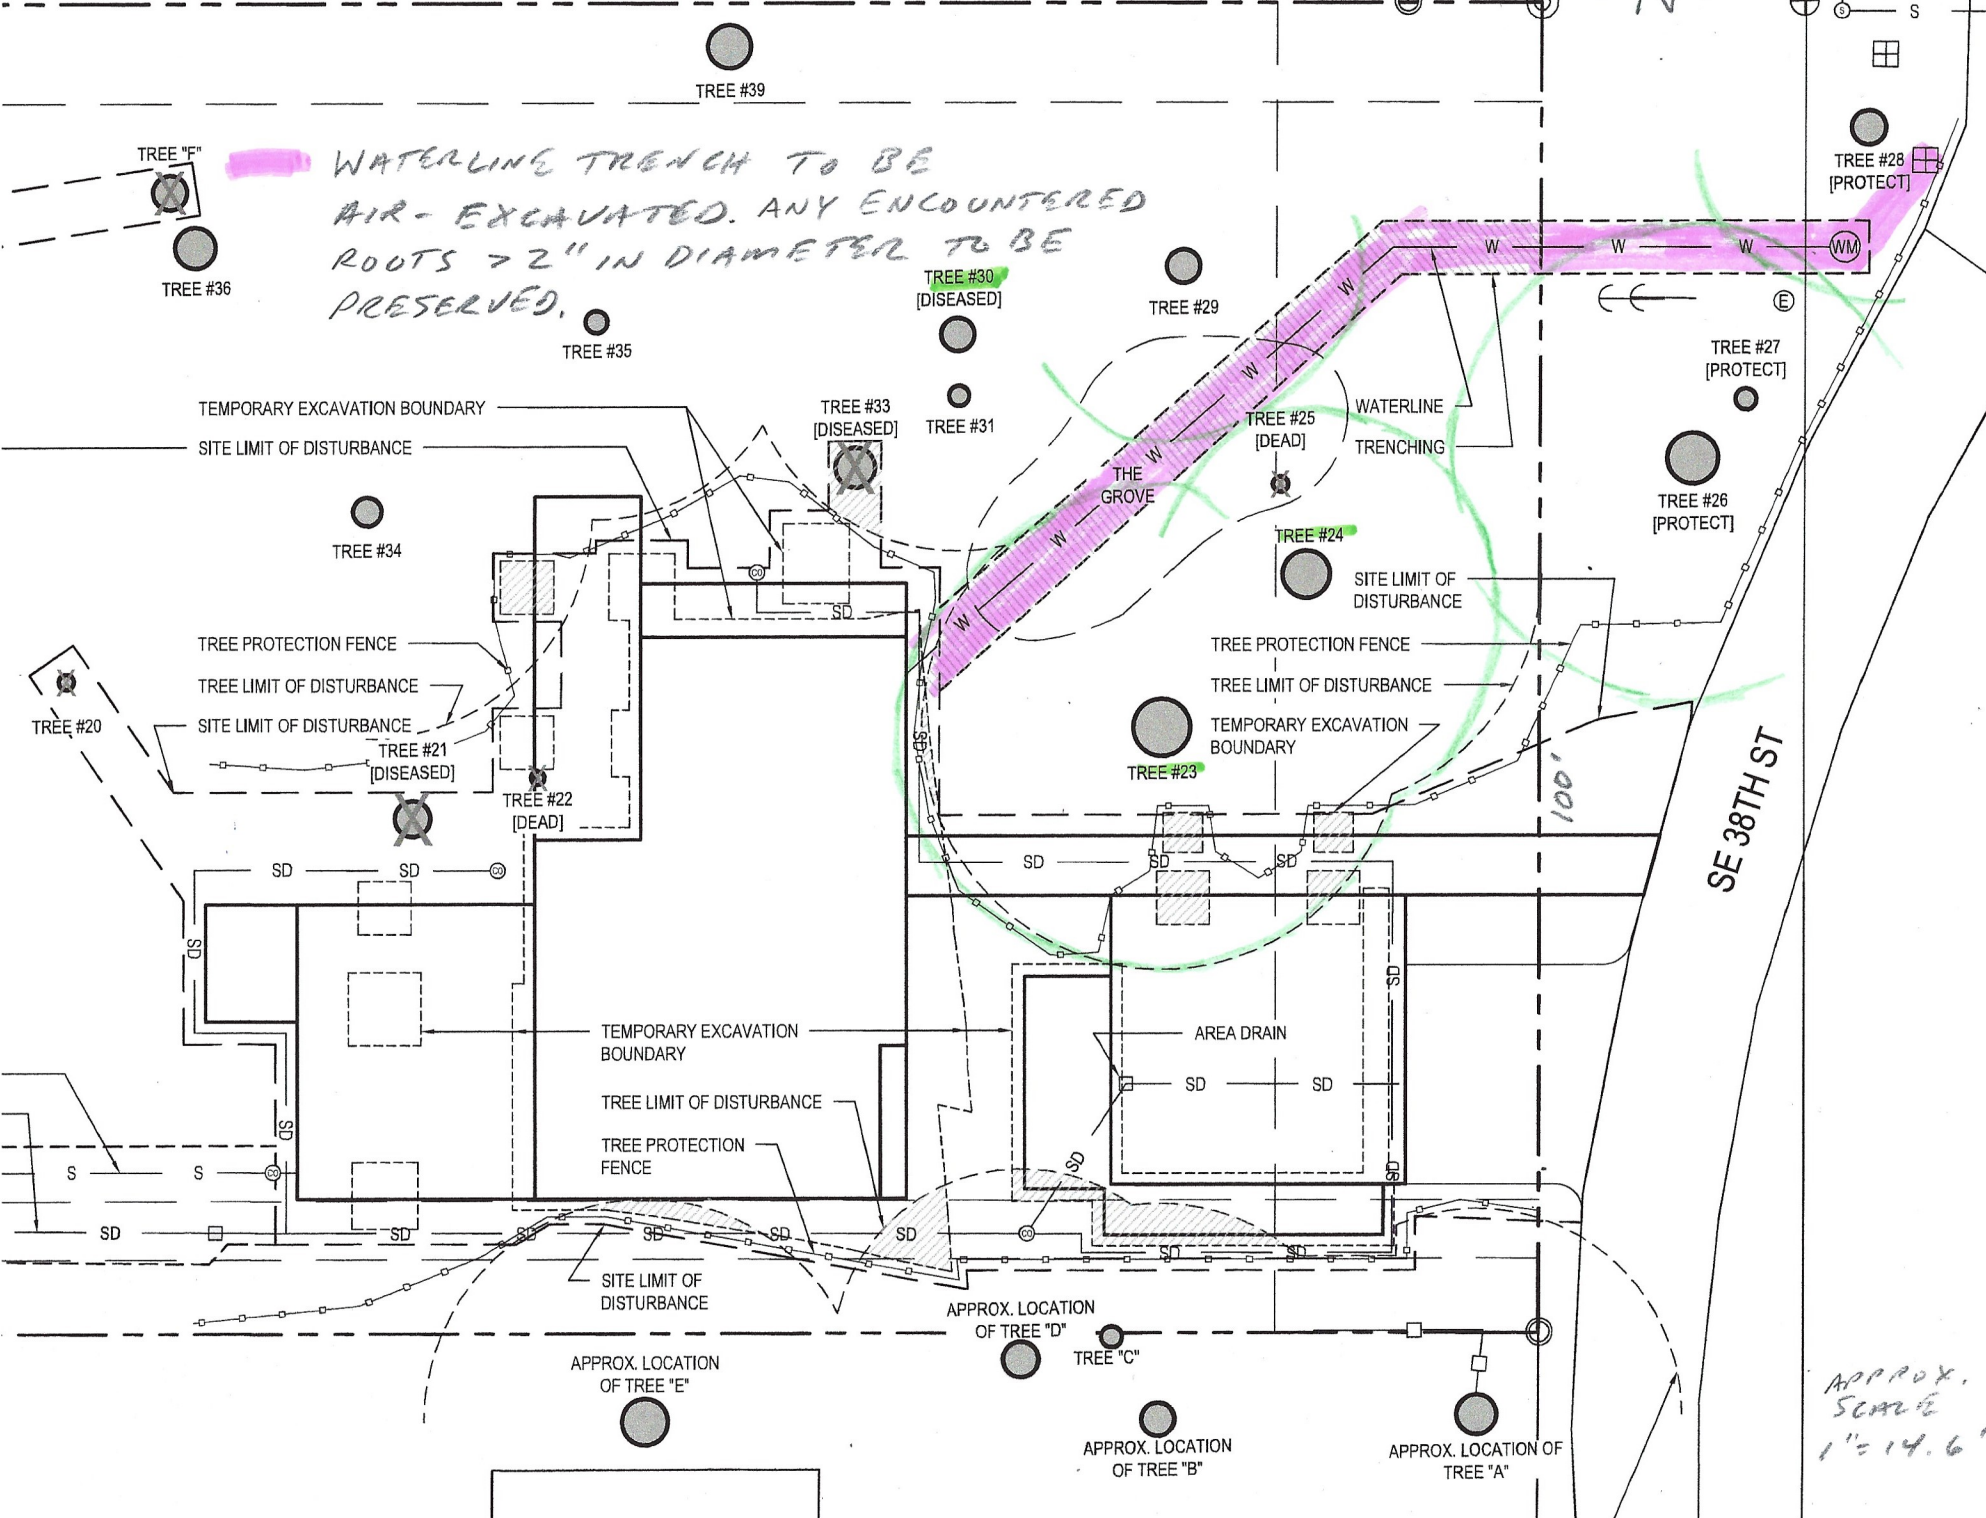
WATERLINE PLAN

Given the number of exceptional trees to be retained within the vicinity of the water line utility, it is not possible to stay at least 12-feet away from all exceptional trees. The location of the trench will ultimately be field-located to be as far from exceptional trees as possible. The entire length of the water line trench will be air-excavated. All roots greater than 2-inches in diameter will be preserved and the utility/pipe routed beneath them. The trench location on the

WATERLINE TRENCH TO BE AIR-EXCAVATED. ANY ENCOUNTERED ROOTS > 2" IN DIAMETER TO BE PRESERVED.

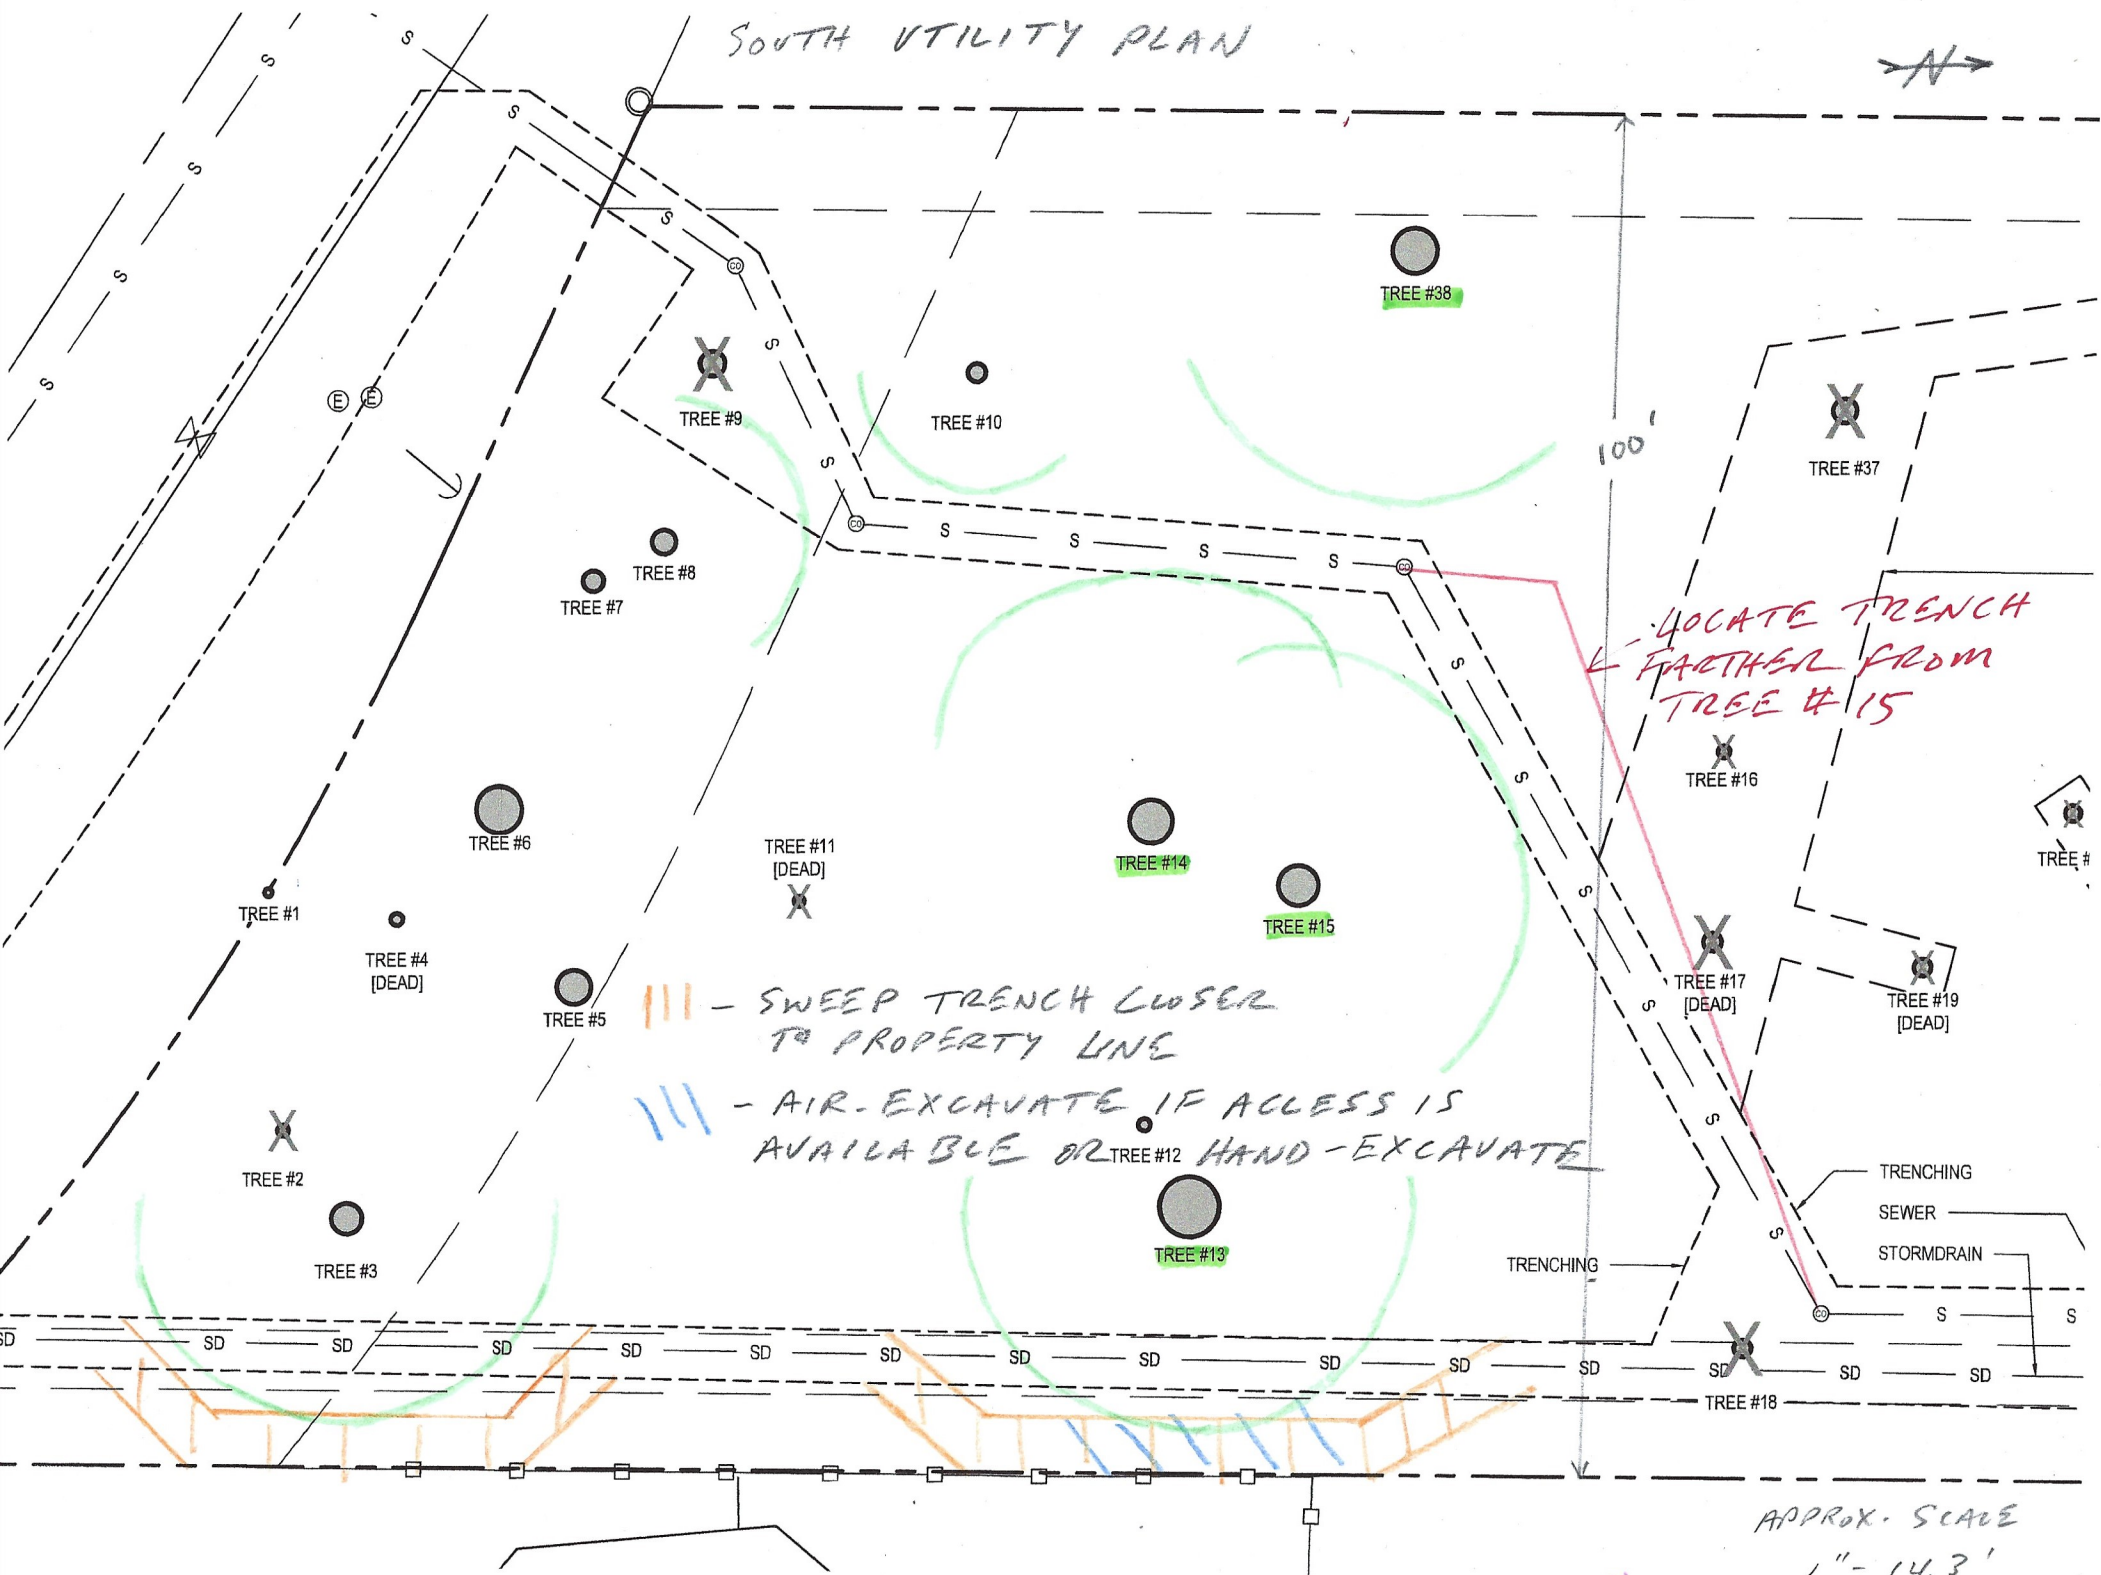
SOUTH UTILITY PLAN

The sewer utility has been designed to avoid the driplines of adjacent trees. The storm drain utility on the south perimeter shall be moved closer to the property line to the farthest extent allowable to reduce the impact to Tree #13 and Tree #3. See the attached copy of the site plan. Slightly move trench north away from Tree #15. The majority of trenching can be accomplished with a tracked mini-excavator. Air-excavate adjacent to Tree #13 if access available or hand-excavate to preserve any roots greater than 2-inches in diameter.

LOCATE TRENCH
1' FARTHER FROM
TREE #15

SWEEP TRENCH CLOSER
TO PROPERTY LINE

AIR-EXCAVATE IF ACCESS IS
AVAILABLE OR TREE #12 HAND-EXCAVATE
