# LAYTON TREE CONSULTING, LLC

## ARBORIST REPORT/TREE PLAN

73XX SE 38<sup>th</sup> Street  
Mercer Island, WA

**February 17, 2021**

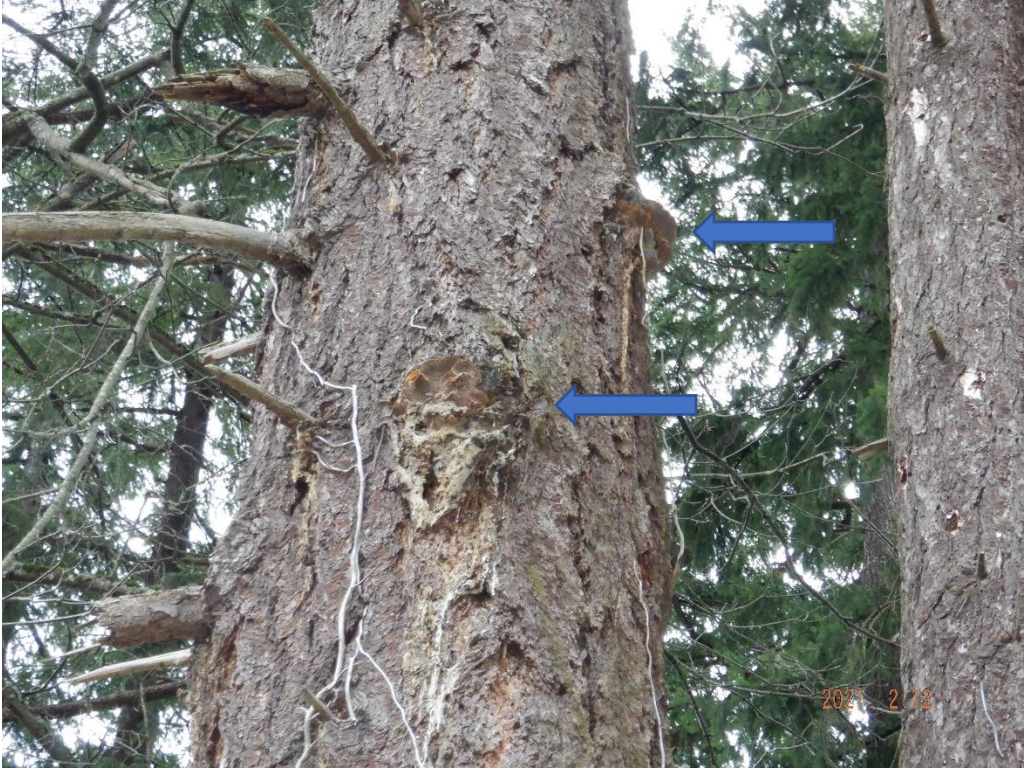
Tree #33, pini fruiting bodies on lower trunk (arrows)

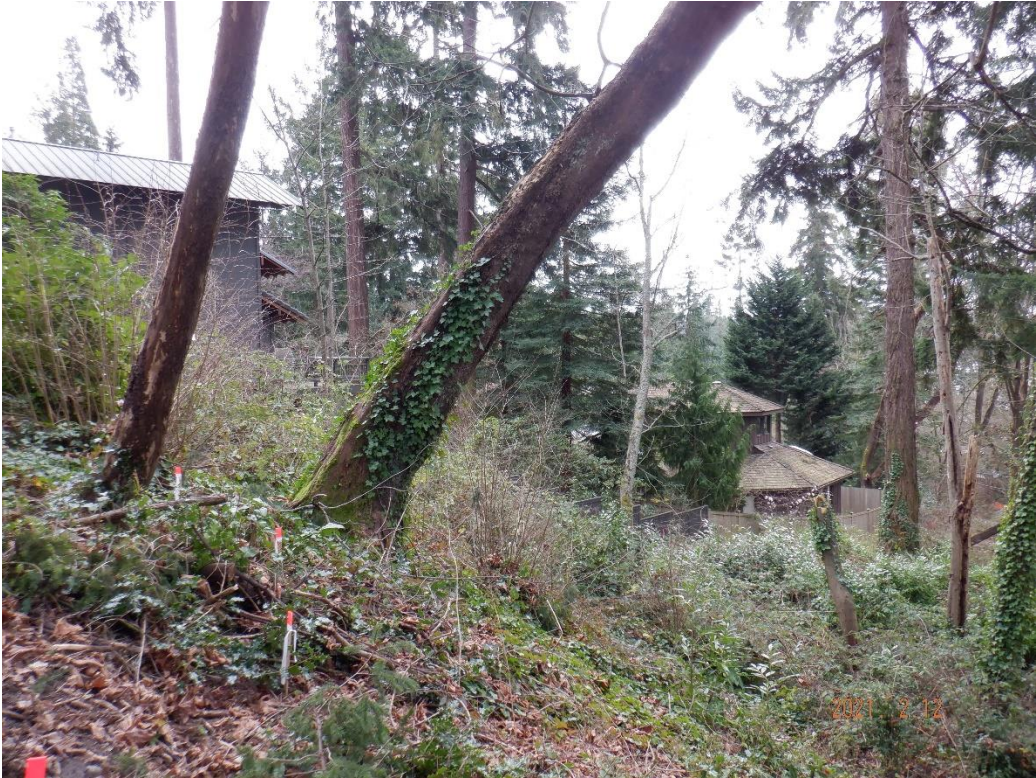
Tree #21 center, at edge of proposed building footprint, dead tree #22 on left

habitat. These are low risk trees. Dead trees #22, #25 and #32 will need to be removed for site improvements and to maintain risk at acceptable levels.

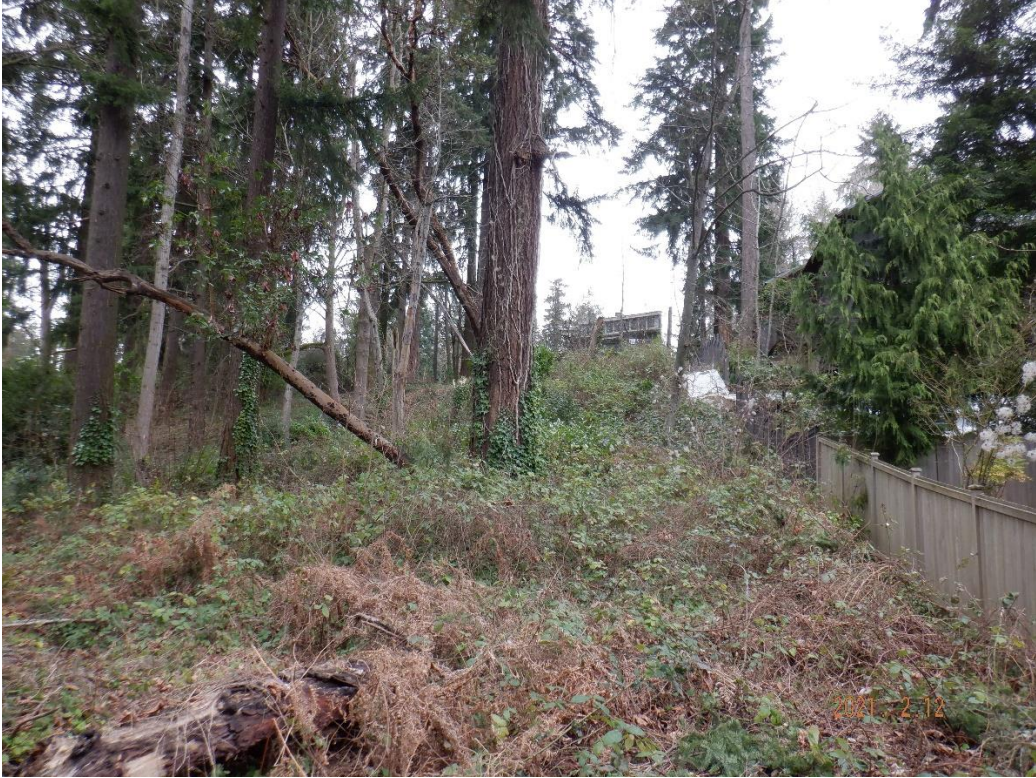
East property line, looking north, Trees #12 and #13 in foreground

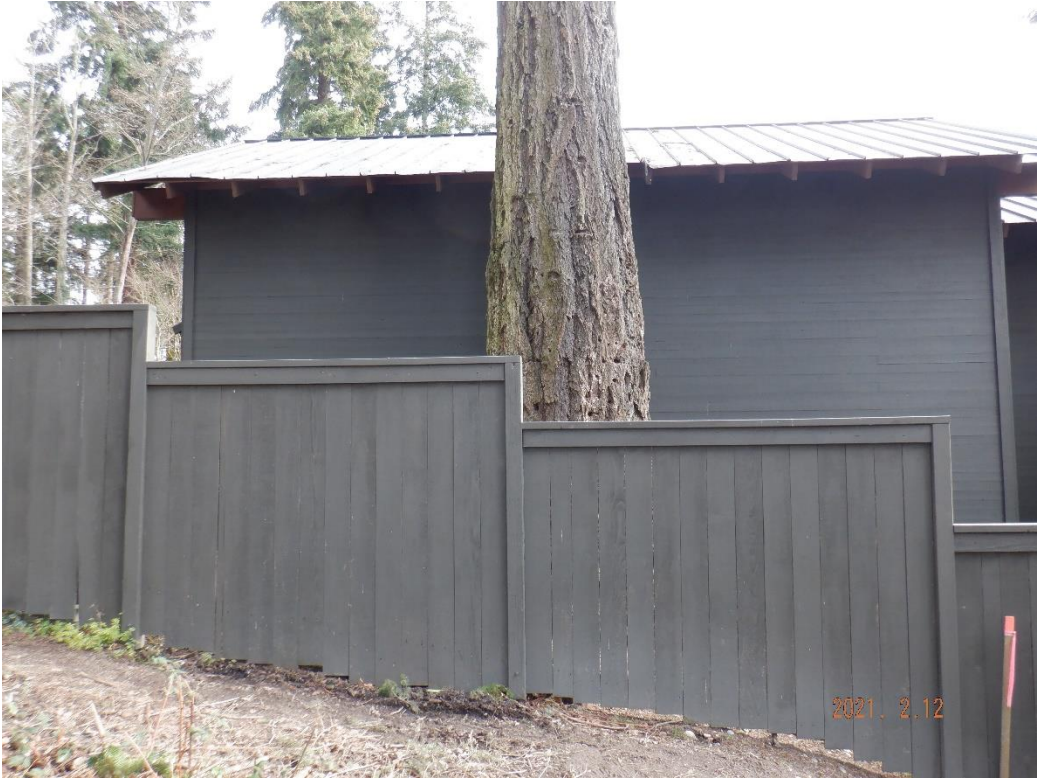
Off-site or neighboring trees are in fair to good condition. No overly concerning issues were observed from the street or from the subject property. Tree E has been impacted to some degree in the past. Foliage appears somewhat sparse. Overall condition is fair.

Neighboring Tree E

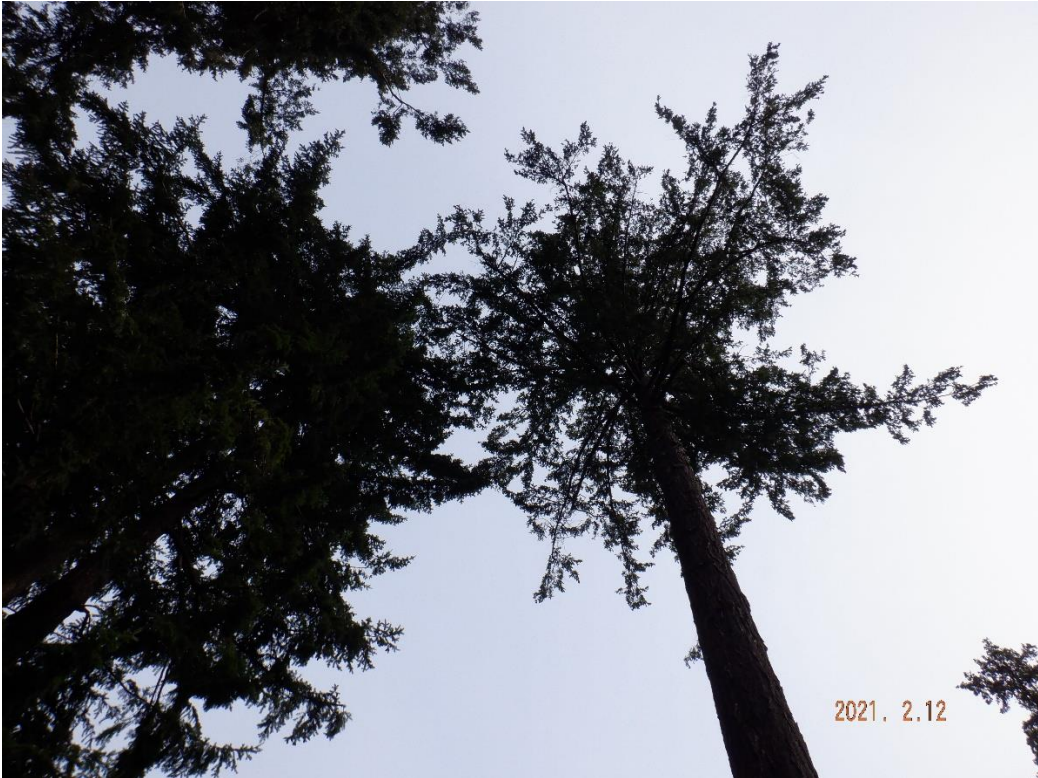
Neighboring Tree E – upper crown, foliage somewhat sparse

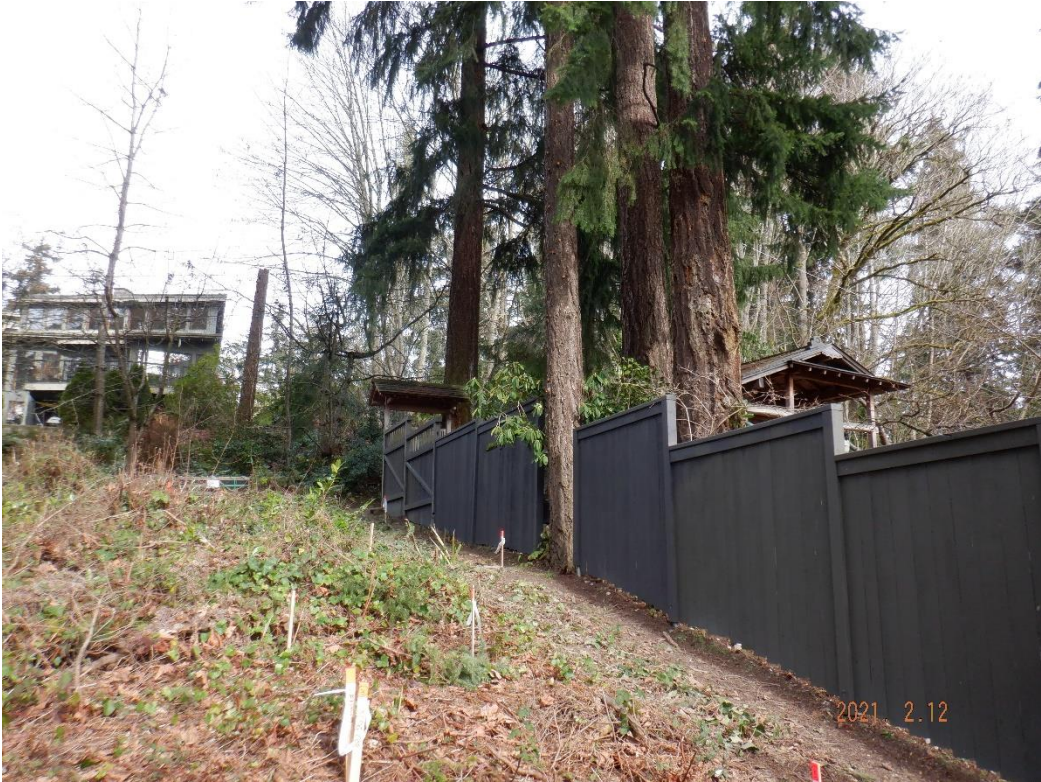
Neighboring Trees A > D
