Arborist Report

Site: Matthew Wiley Property
6838 96th Ave SE, Mercer Island

Re: Tree Inventory

Date: September 15, 2021

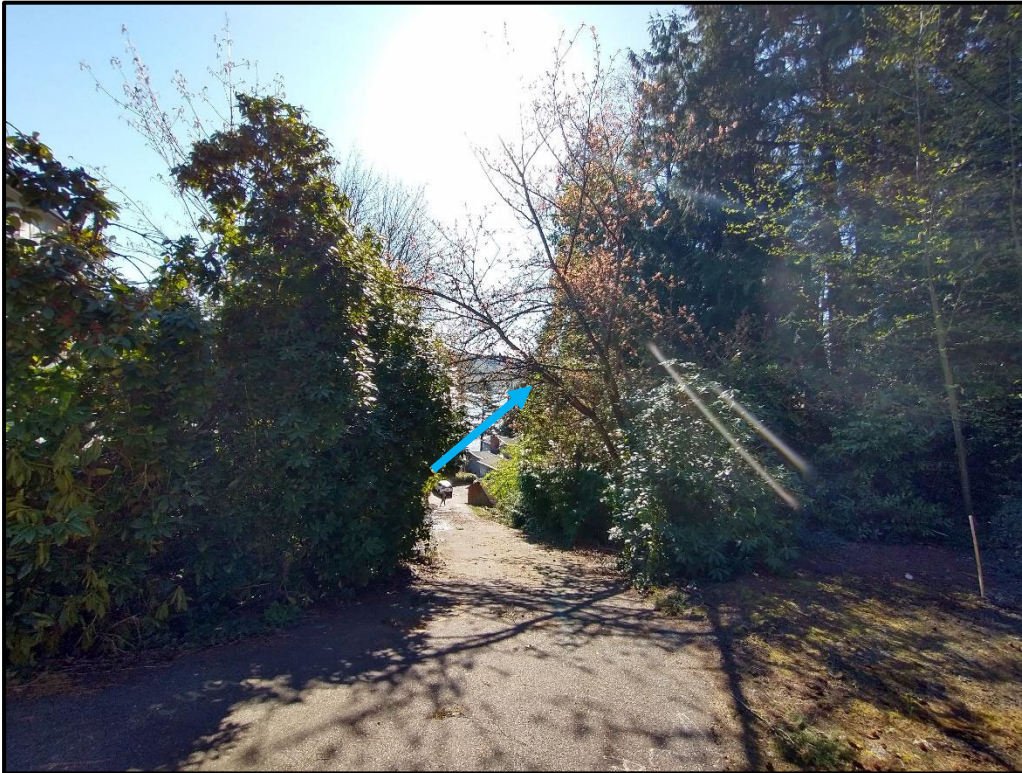
Photo 1. Looking to the southeast from the top of the driveway. Tree 331, a bitter cherry, will likely require some clearance pruning to accommodate construction access.

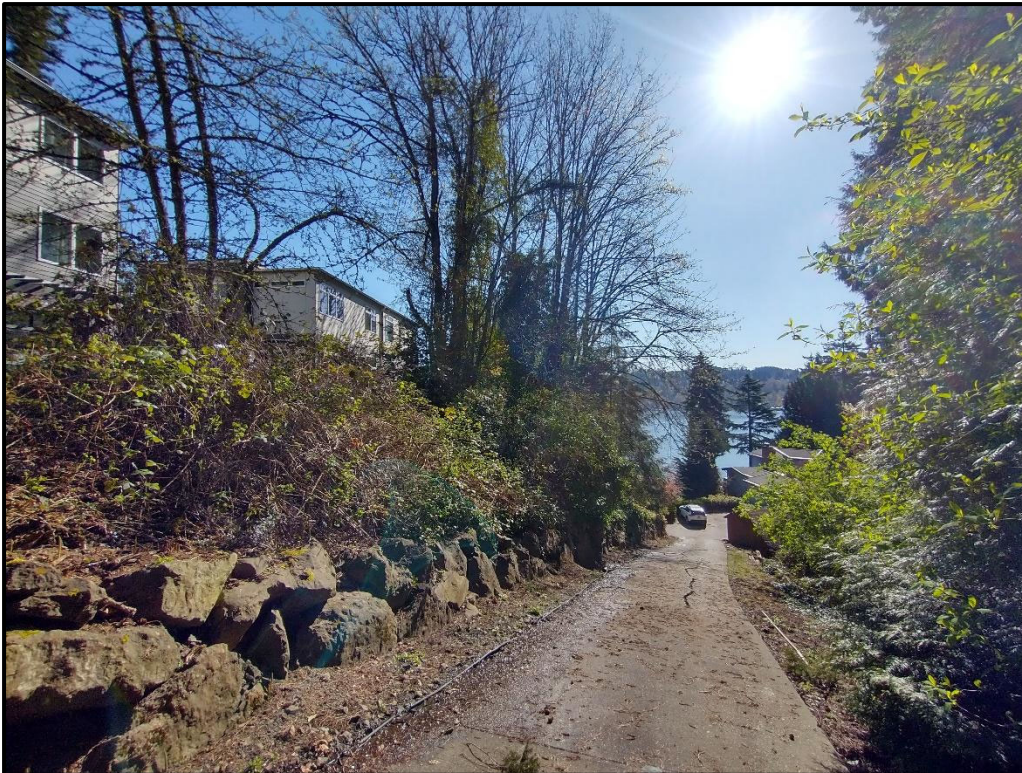
Photo 2. Looking east from near the top of the driveway. Rockery to the north is planned for retention.

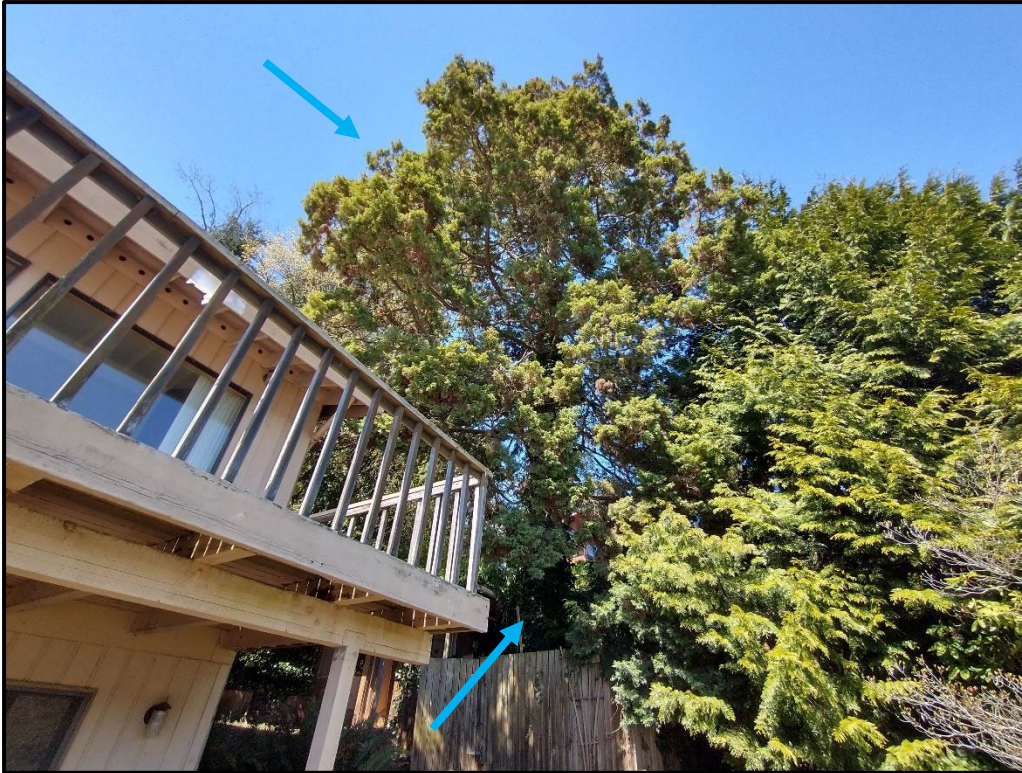
Tree 362 is a 31-inch DSH Sawara cypress (*Chamaecyparis pisifera*) in good health and structural condition located within a small, fenced area near the garden shed just north of the house.

Photo 3. Tree 362, a Sawara cypress, directly adjacent to the shed proposed for removal. Demolition and construction activities adjacent to this tree should be monitored by an ISA certified arborist. Some clearance pruning may be required to accommodate site work.

The storm line near 362 should be adjusted to follow the footprint of the house as closely as possible. While this is still within the RLOD, because of existing site conditions it is our opinion the impacts to the tree will be minor if the line location is adjusted.

To preserve the root system of tree 362 and the adjacent off-site trees, the shed should be demolished carefully with equipment staged outside the tree protection area. The project arborist should be on site to monitor this work and document any root impacts. The soil area exposed by the removal should be backfilled with native soil from the site or well-draining topsoil or prepped for new landscaping.

When installing the proposed prefabricated shed, install the foundation on a platform with sonotube footings. Exact footing locations should be finalized in the field and oriented to avoid impacting any structural roots of tree 362. Any excavation for footings must use excavation methods and specifications as indicated in the tree protection specifications provided in Appendix F.

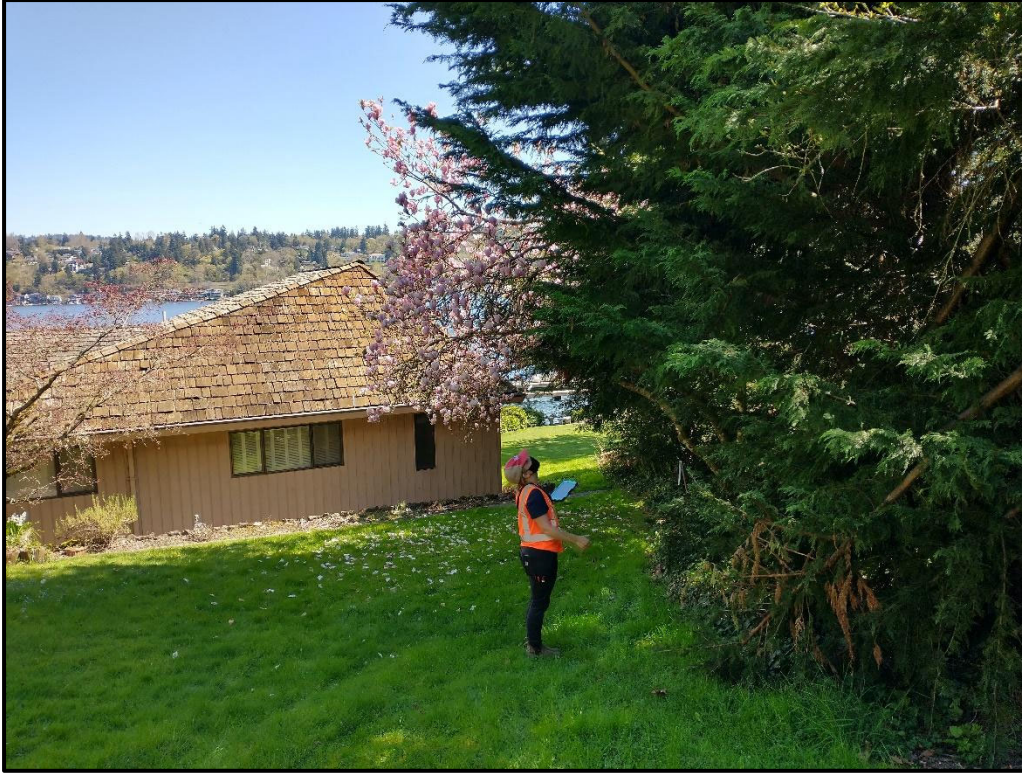
Tree 363 is a saucer magnolia (*Magnolia × soulangeana*) below regulated size. We included it in our inventory as it is likely to be impacted by proposed plans. The tree has an asymmetric, low-growing canopy. Depending on access requirements for demolition and construction, this tree may not be suitable for retention, as clearance pruning would remove an extensive amount of the canopy. This tree may be shared with the property to the south; we were not able to establish the exact location of the property line while on the site.

Trees F through K will require clearance pruning to accommodate the construction of the westward building overhang. Two of these adjacent trees, H and I, will require the most canopy management to provide construction clearance. To reduce canopy loss, use a combination of pruning and limb tying to achieve the required clearance. Pruning should be limited to the minimum required to meet access needs and must be performed by an ISA Certified Arborist.

Photo 4. Off-site trees on southern property line and tree 363, a phototropic saucer magnolia. Depending on clearance requirements, the magnolia may not be suitable for retention as clearance pruning would remove a significant portion of the canopy.

The storm line near F through K should be relocated north, outside the RLOD.

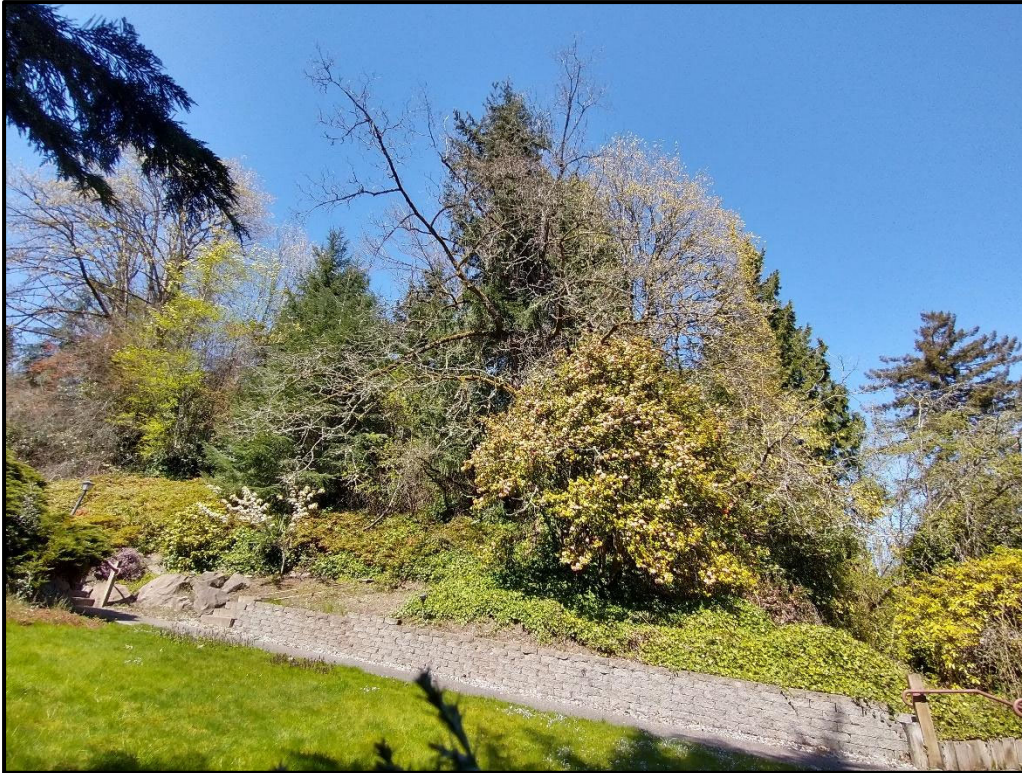
The understory is primarily invasive ivy (*Hedera helix*) with some areas vegetated with native sword fern (*Polystichum munitum*). The amount and density of the ivy will affect the tree and vegetation management. We recommend managing ivy on the site.

Photo 5. Trees north of the driveway. Stacked block retaining wall is proposed for replacement. Note extensive ivy understory.

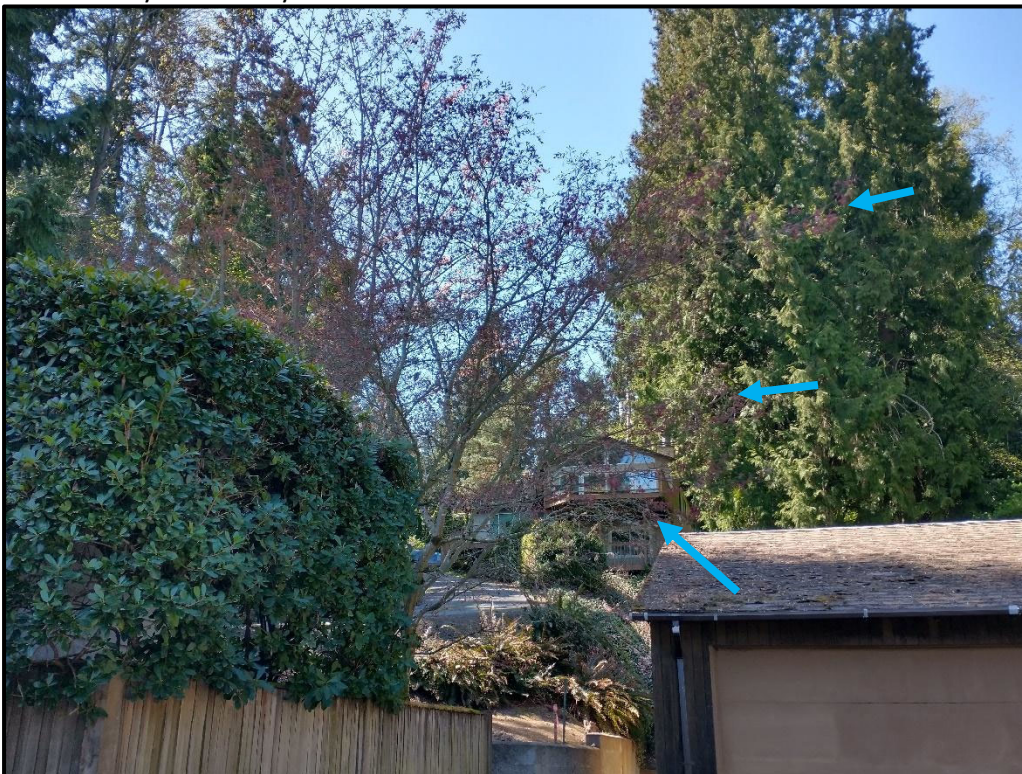
Photo 6. Off-site Japanese maple may require some clearance pruning to accommodate demolition and construction activities. Blue arrows identify overhanging branches that may need pruning management.

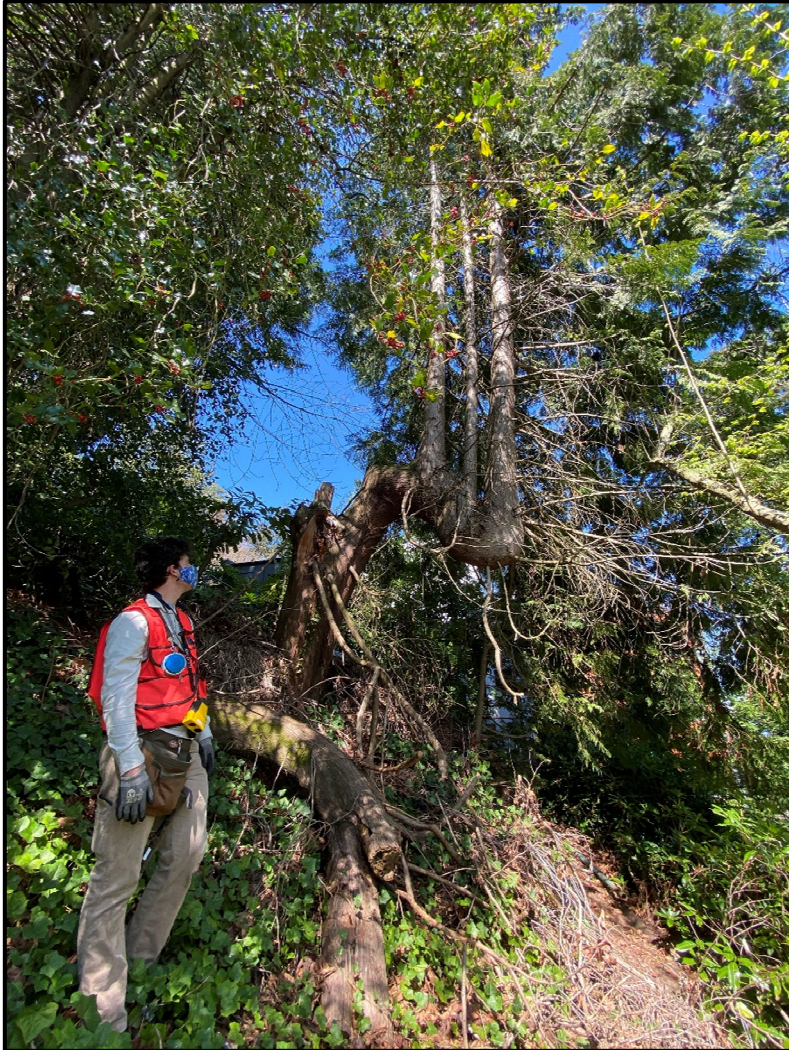
Off-site tree C is a large western redcedar that has a broken top and three codominant reiterated leaders growing asymmetrically to the east. We recommend a follow-up assessment of this tree, in coordination with the adjacent property owner, to assess structural stability and provide recommendations for long-term management.

Photo 6. Off-site tree C, a western redcedar with a broken primary leader and three reiterations. We recommend further assessment of this tree in coordination with the adjacent property owner.
