## GEOTECHNICAL ENGINEERING REPORT ADDENDUM Buttenwieser/Wiley Residence 6838 96th Avenue SE Mercer Island, Washington

Project No. 200631 • April 26, 2022

## GEOTECHNICAL ENGINEERING REPORT ADDENDUM

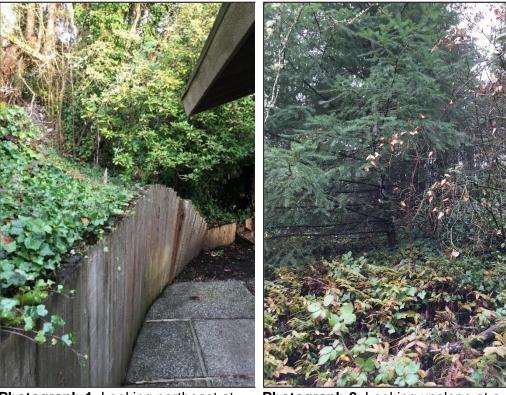
**Photograph 1**. Looking northeast at the existing yielding wall northwest of the existing residence.

**Photograph 2**. Looking upslope at a conifer with slightly curved trunk northwest of the existing residence.

We did not observe tension cracks or noticeable, well-delineated ground subsidence associated with the yielding condition of the wall, nor did the topographic survey performed for the Project capture any localized subsidence at this location. In our opinion, the cause of the yielding is localized surficial slope movement that reflects the age and decay of the railroad tie timbers and/or that the wall was not designed/engineered for the earth pressures it has been exposed to. In our opinion, the slope movement likely extends upslope a distance on the order of inches to a few feet.

• Proposed soldier pile wall alignments should be located, to the maximum extent practical, immediately upslope of the existing timber wall alignments to allow for drilling of shafts and placement of steel prior to demolition of the existing timber walls. Excavation in front of the proposed soldier pile walls and lagging installation should take place from the top down, concurrent with piece-wise demolition of the existing timber wall elements such that lateral support of the slope is maintained at all times.

Alternatively, soldier pile walls can be located directly in front of the existing walls, and the existing walls can be left in-place during backfill placement.

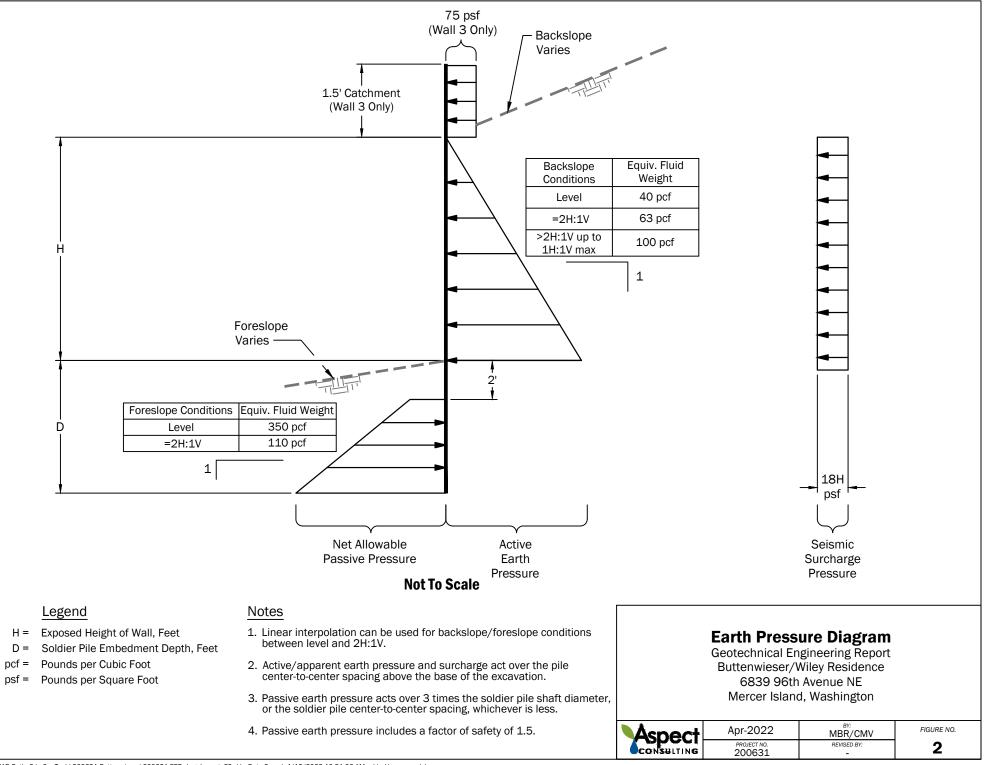
We included an earth pressure diagram for clarity as Figure 2 with this addendum.

Based on our interpretation of the failure surfaces and ranges in calculated factors of safety, it is our opinion that a unit volume of slide debris expected to mobilize during a characteristic shallow slide is approximately 55 cubic feet per foot of slope width. Assuming the slide debris will come to rest at the base of the slope with a residual backslope of approximately 20 degrees, we recommend a minimum extra stick-up height for debris catchment of 1.5 feet above existing grade at the top back of the wall. These calculations are represented graphically in Appendix D. We recommend the wall be designed to resist lateral forces exerted by the shallow landslide debris. In our opinion, a uniform lateral load of 75 pounds per square foot, distributed uniformly over the stick-up height, can be used for design. This is presented graphically in the earth pressure diagram on Figure 2.
