December 2, 2021

Site Address: 8005 SE 34th Pl Mercer Island 98040
King County Parcel No: 445830-0240

DOWNSTREAM ANALYSIS REPORT

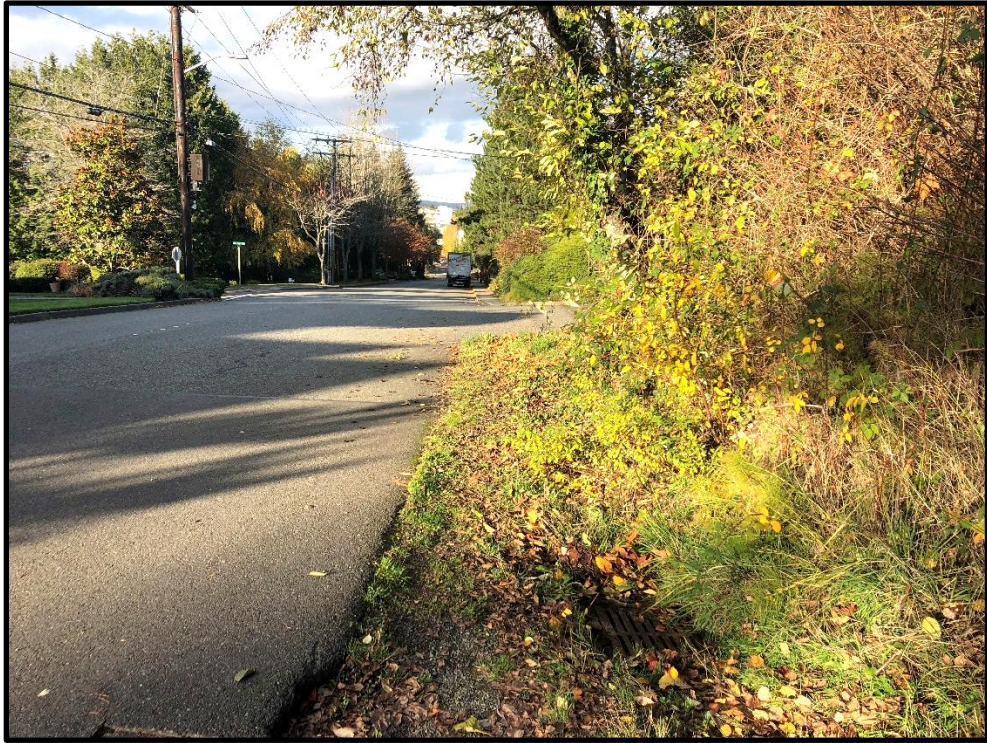
Element 1: Type 1 CB along western project frontage on 80th Ave SE

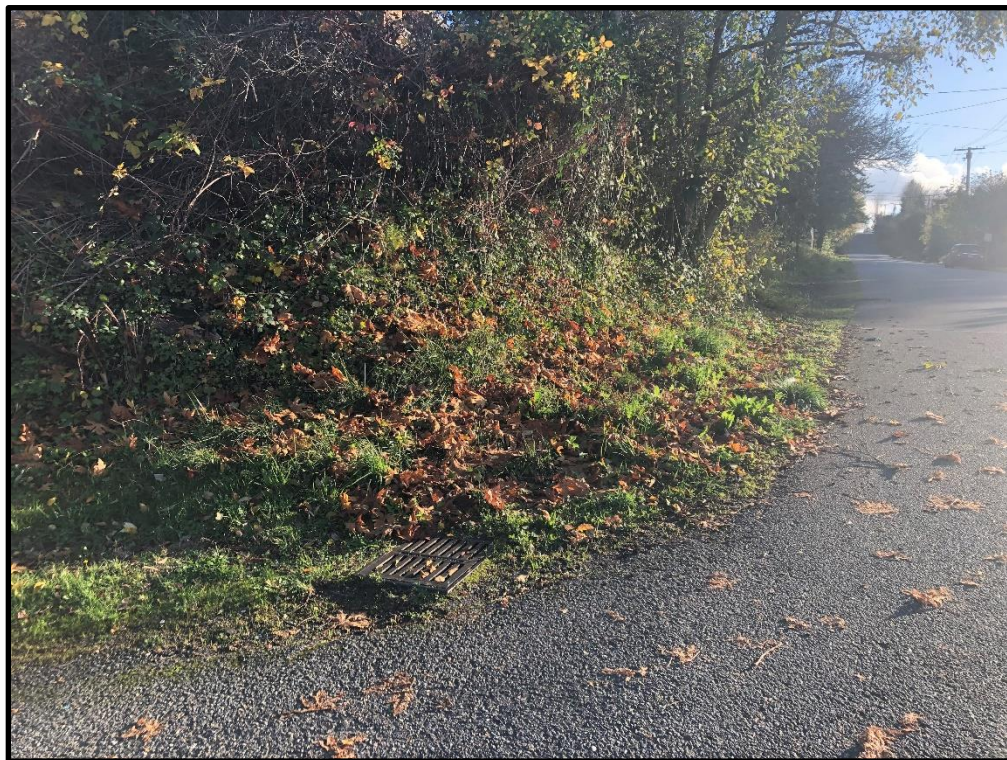
Element 2: Type 1 CB at project frontage at 80th Ave SE & SE 34 PI intersection

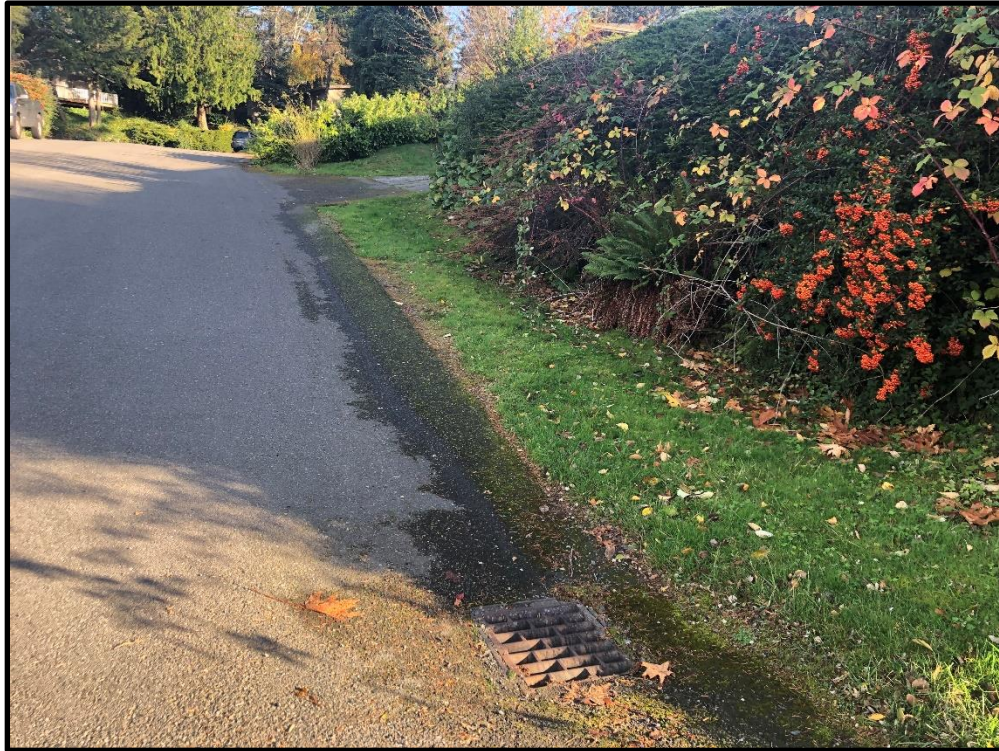
Mercer Island storm system in a Type 1 CB (Element 3). From here, the stormwater flows west via a 12" concrete pipe and combines with the stormwater from NDA A. The combined stormwater flows to the north on 80th Ave SE through a series of Type 1 CBs (Elements 4-10) located on the eastern side of the road. After Element 5, the storm pipes increase to 15" concrete. At the intersection of SE 32nd St and 80th Ave SE, stormwater crosses to the north side of SE 32nd St and passes through a Type 1 CB (Element 11), a Type 2 CB (Element 12), and into a Type 1 CB (Element 13) on the north side of SE 32nd St. Stormwater continues west on the north side of SE 32nd St and passes through two Type 2 CBs (Elements 14 & 15) via 20" concrete pipes and passes through the intersection of SE 32nd St and 8th Ave SE, and enters a Type 1 CB (Element 16) at the northwest corner of the intersection. Stormwater continues west along the north side of SE 32nd St and passes through two Type 2 CBs (Elements 17 & 18) before entering a Type 1 CB (Element 19) at the corner of SE 32nd St and 77th Ave SE. This is approximately ¼ mile downstream of the site, and is where the downstream analysis was concluded. No problems or capacity constraints in the downstream storm system were identified. See Figure 1 below for a detailed Downstream Map.

Element 3: Type 1 CB at project frontage on SE 34th PI

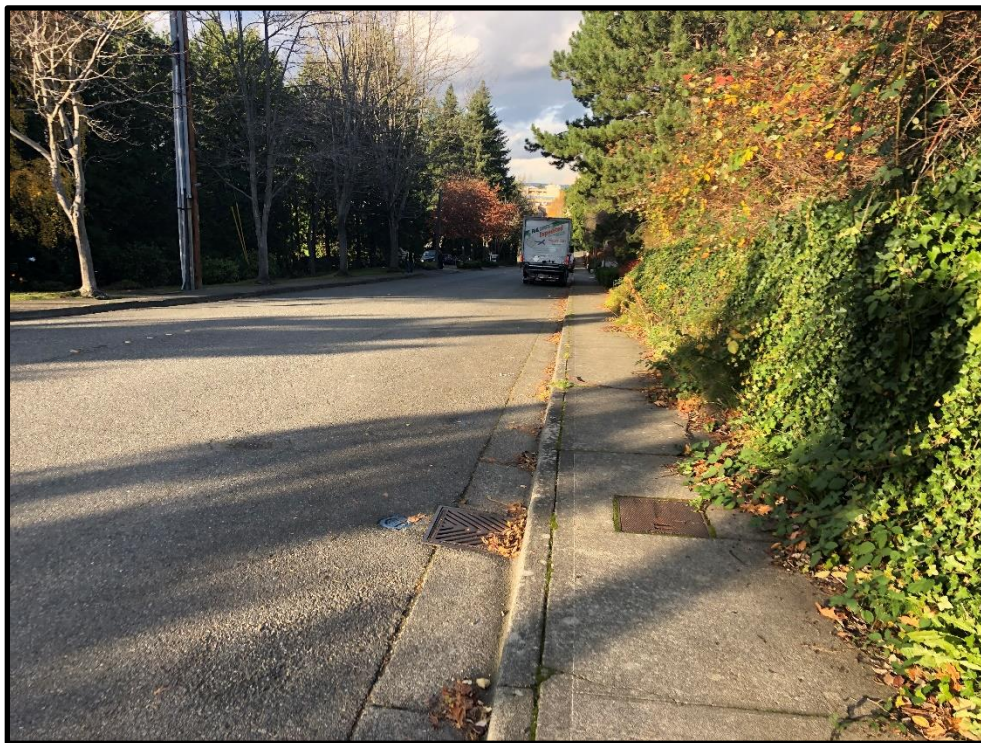
Element 4: Type 1 CB on 80th Ave SE

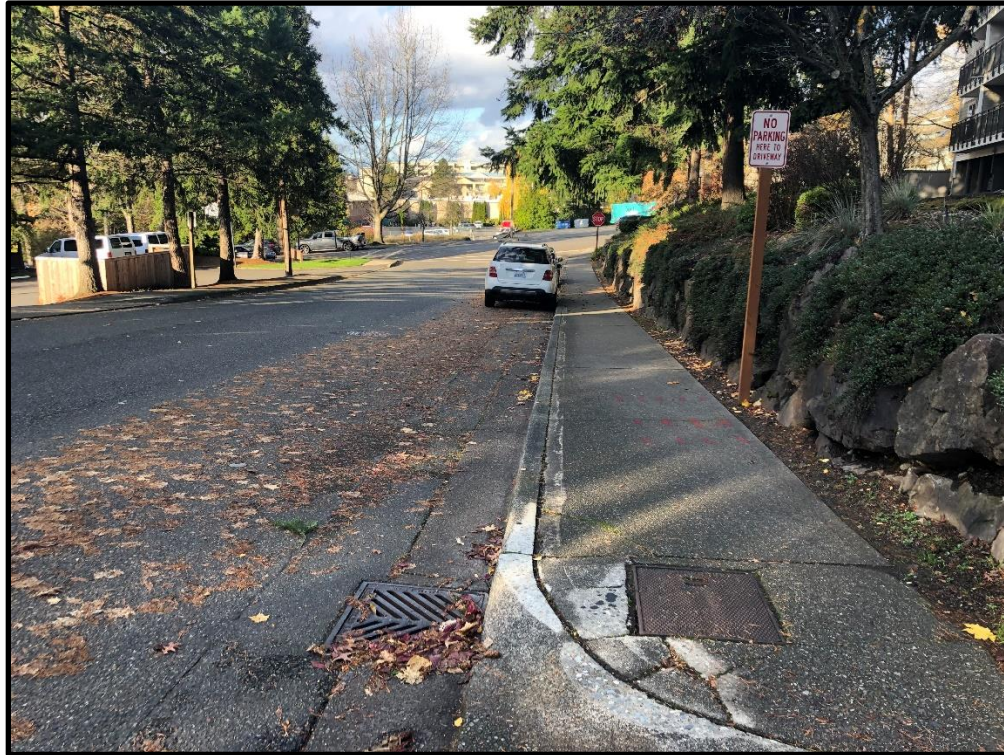
Element 6: Type 1 CB on 80th Ave SE

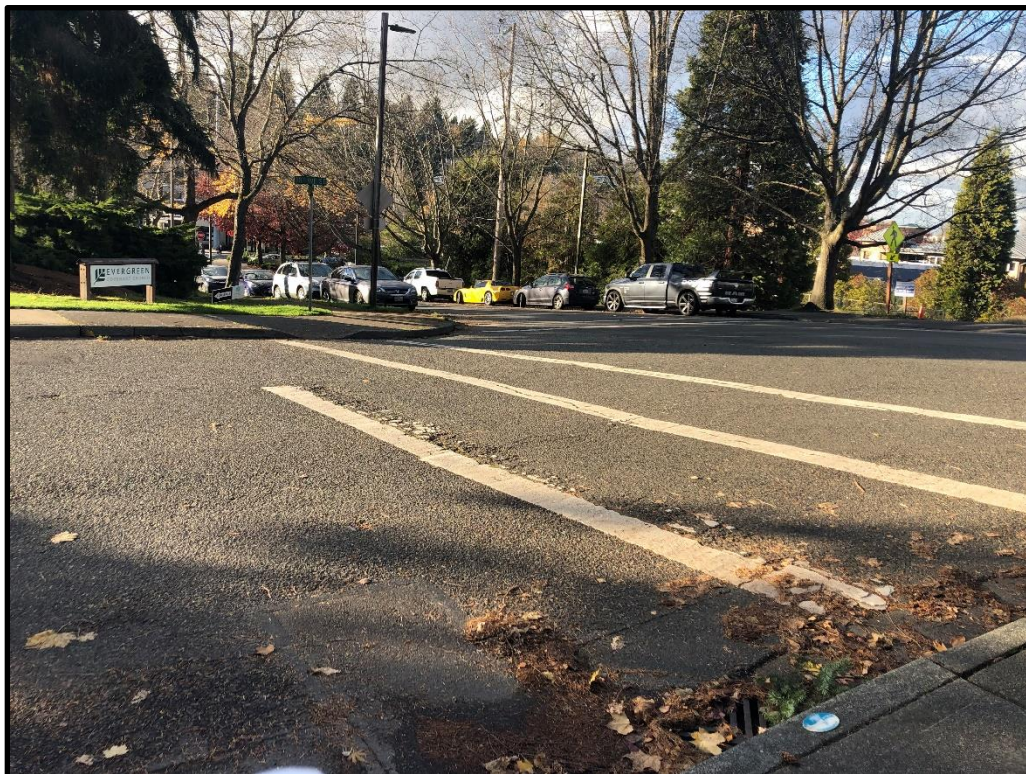
Element 10: Type 1 CB at intersection of 80th Ave SE and SE 32nd St

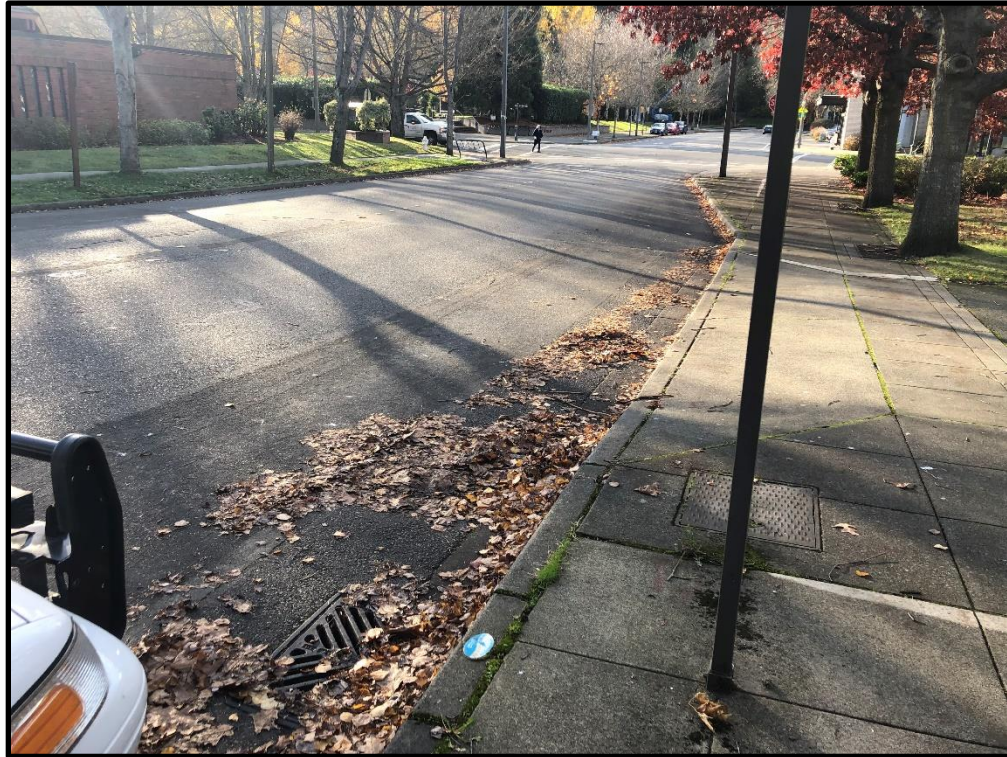
Element 13: Type 1 CB on SE 32nd St

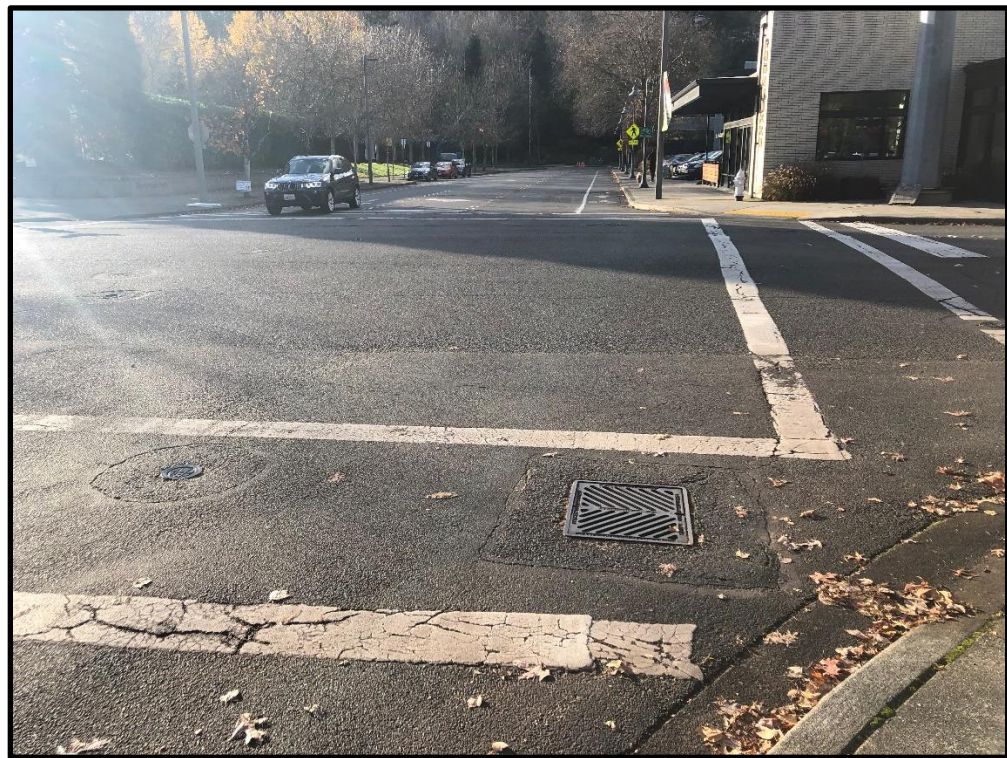
Element 15: Type 2 CB (per Mercer Island Records) at intersection of SE 32nd St and 8th Ave SE

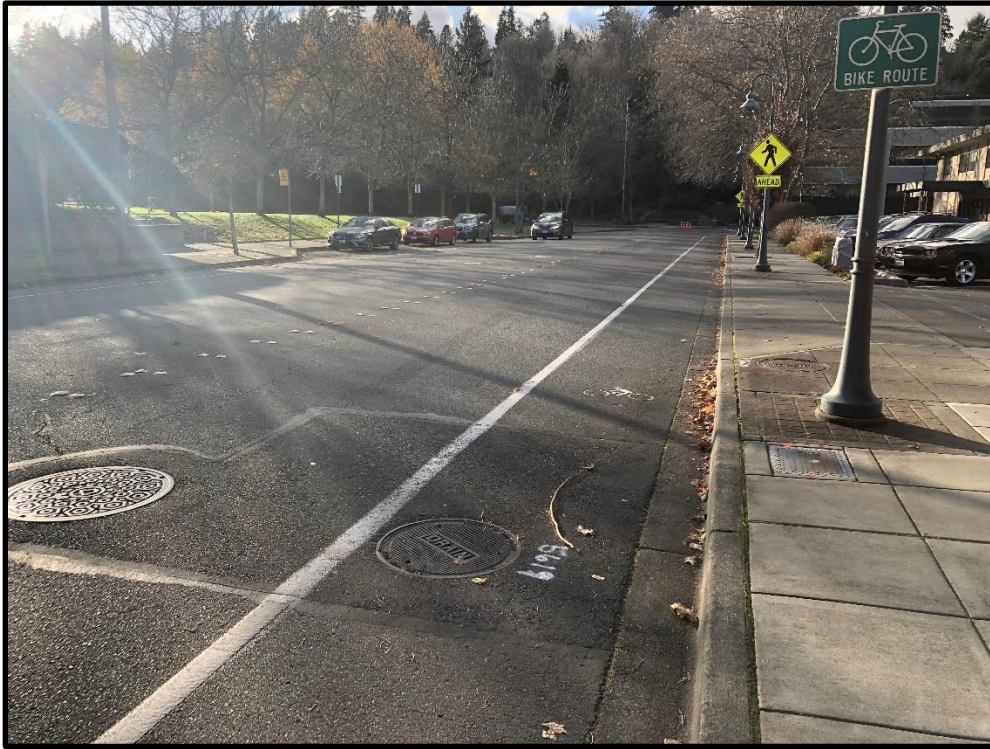
Element 17 & 18: Two Type 2 CBs on SE 32nd St

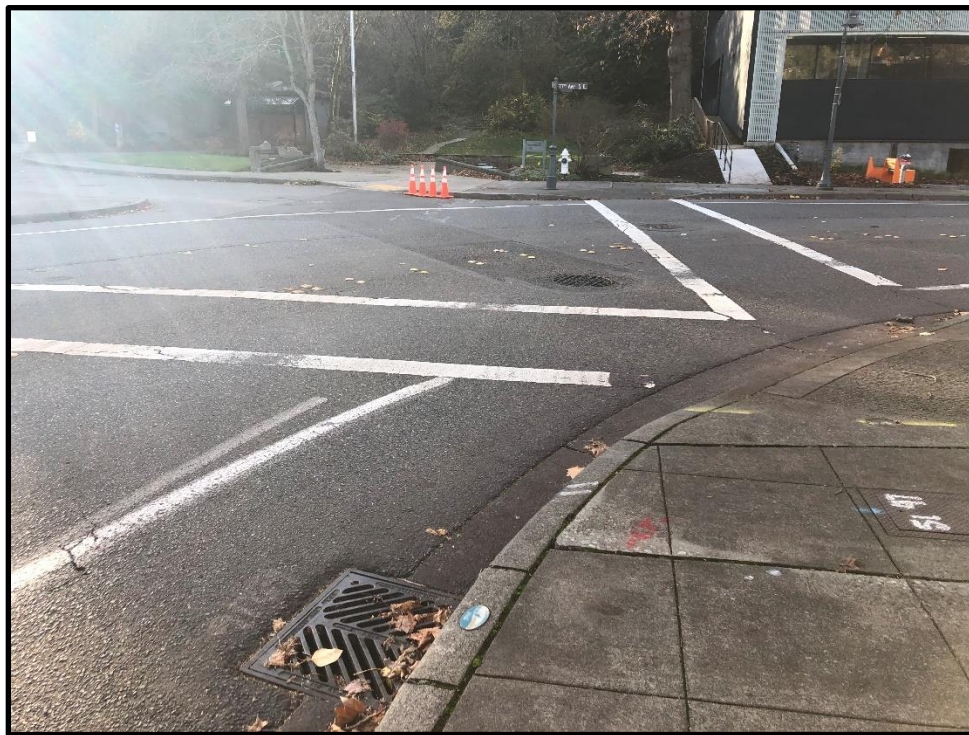
Element 19: Type 1 CB at intersection of 77th Ave SE and SE 32nd St at ¼ mile downstream of the site
