Arborist Report

To: Catherine Moran
Site: 5000 West Mercer Way, Mercer Island, WA 98040
Re: Tree Inventory
Date: September 24, 2021
Project Arborist: Josh Petter
ISA Board Certified Master Arborist #PN- 8406B
ISA Qualified Tree Risk Assessor
Reviewed By: Andrea Starbird, Environmental Scientist
Attached: Table of Trees
Tree Site Map

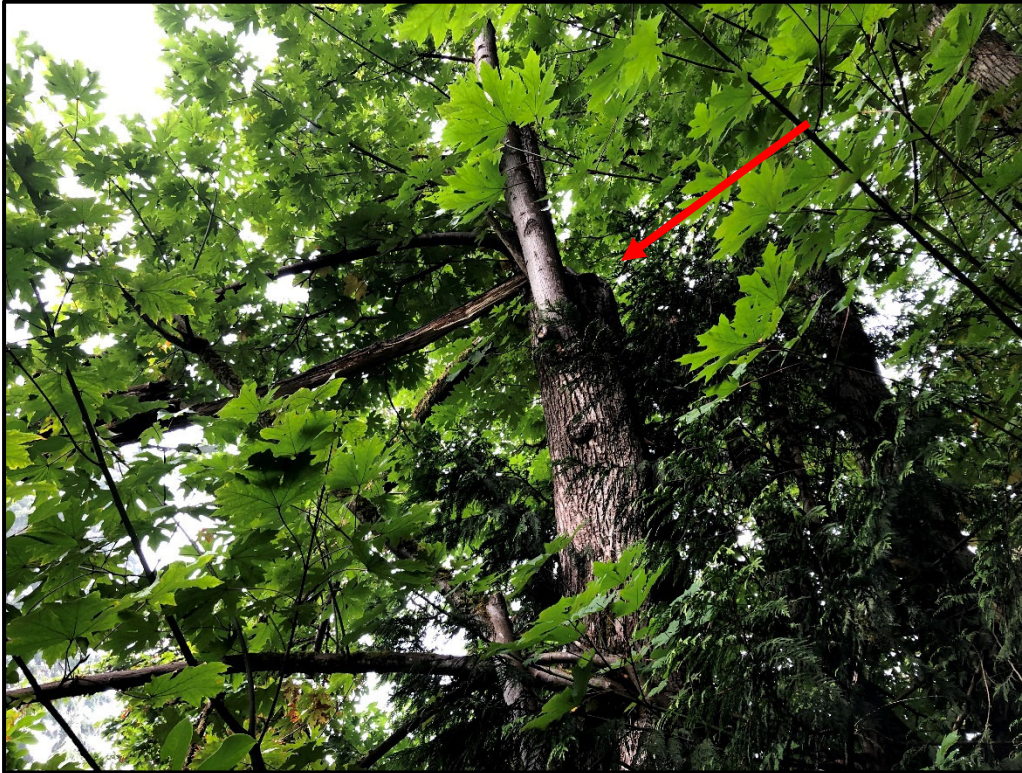
Photo 1. Looking up at the previously broken top (red arrow) of tree number 40. If retained, some reduction pruning should be done on the limb extending out over the road. Additionally, an aerial assessment should be conducted to determine the condition of the branch attachments.

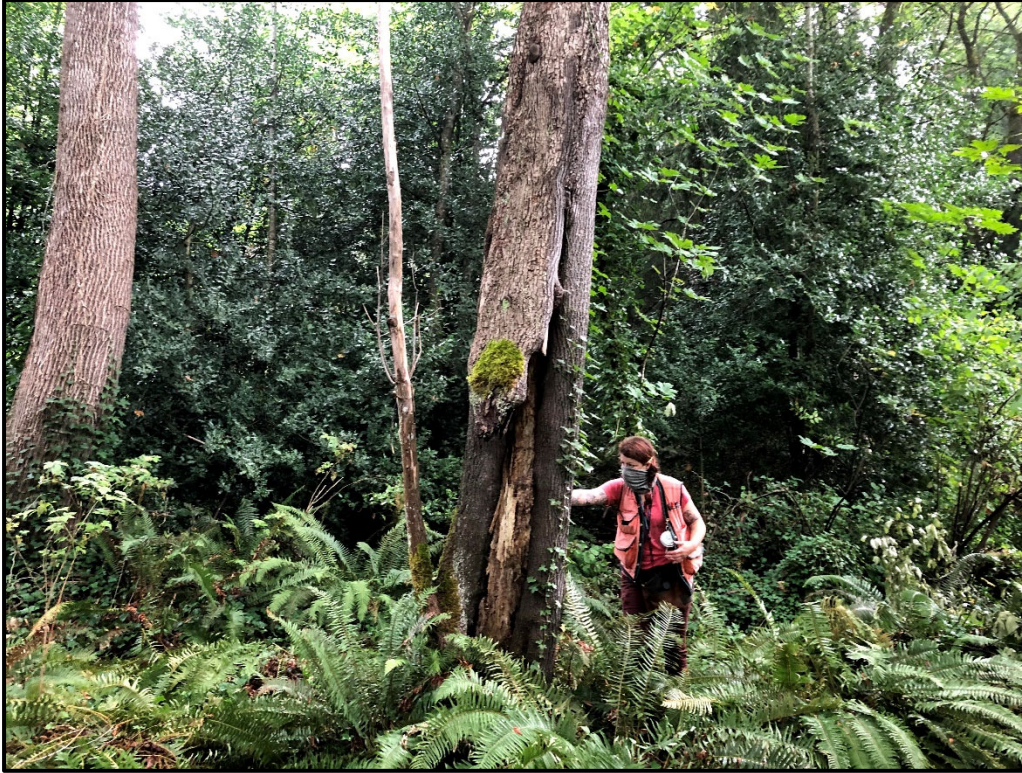
Photo 2. Tree 46 has a large wound that initiates at the base, this tree has a low retention value.
