INITIAL ARBORIST REPORT

6221 83rd Place SE
Mercer Island, WA

January 3, 2022

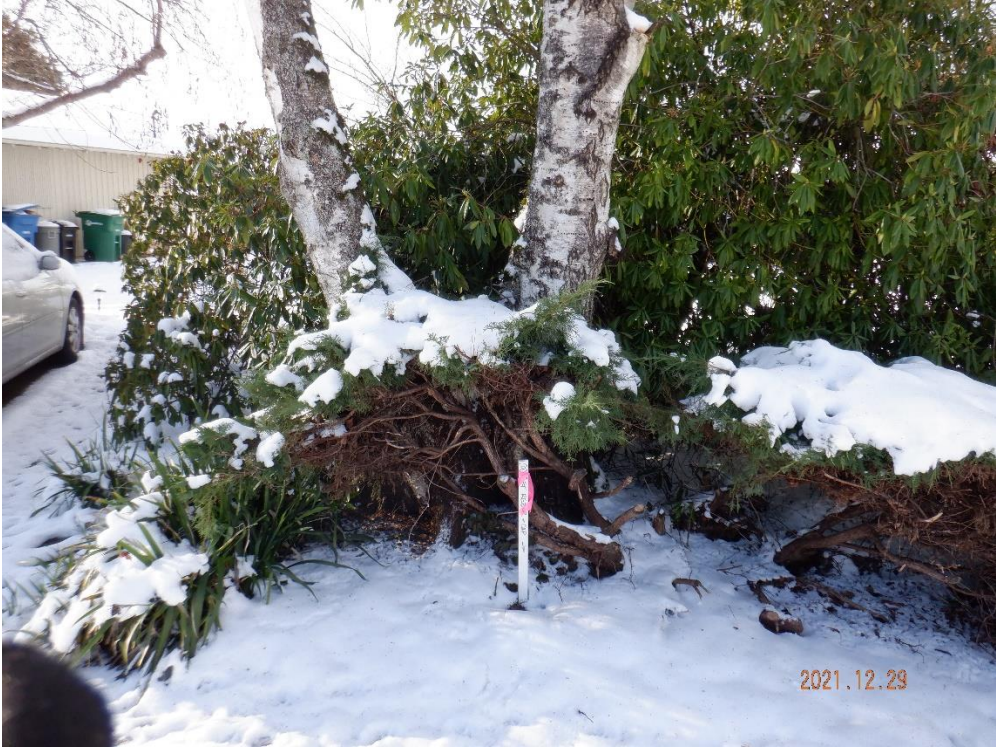
Tree #1 is a semi-mature cluster of European white birch, located close to the southeast property corner. It appears to be a boundary line tree. Vigor appears good for age. There are no signs of any top decline. It has developed fairly good structural form. Overall condition is rated ‘fair-to-good’.

Tree #1 – lower trunks

Trees #1 and #5 appear to be boundary line trees. It is assumed both of these are to be retained. Tree #1 is located in the front corner of the property and not likely to be impacted. Tree #5 is located within a proximity of the existing house. The new house can likely be sited in the same location as the existing house foundation without having any significant impact on the tree, so long as work is carried out diligently. The canopy may need to be pruned to provide adequate construction clearance depending on the house design.

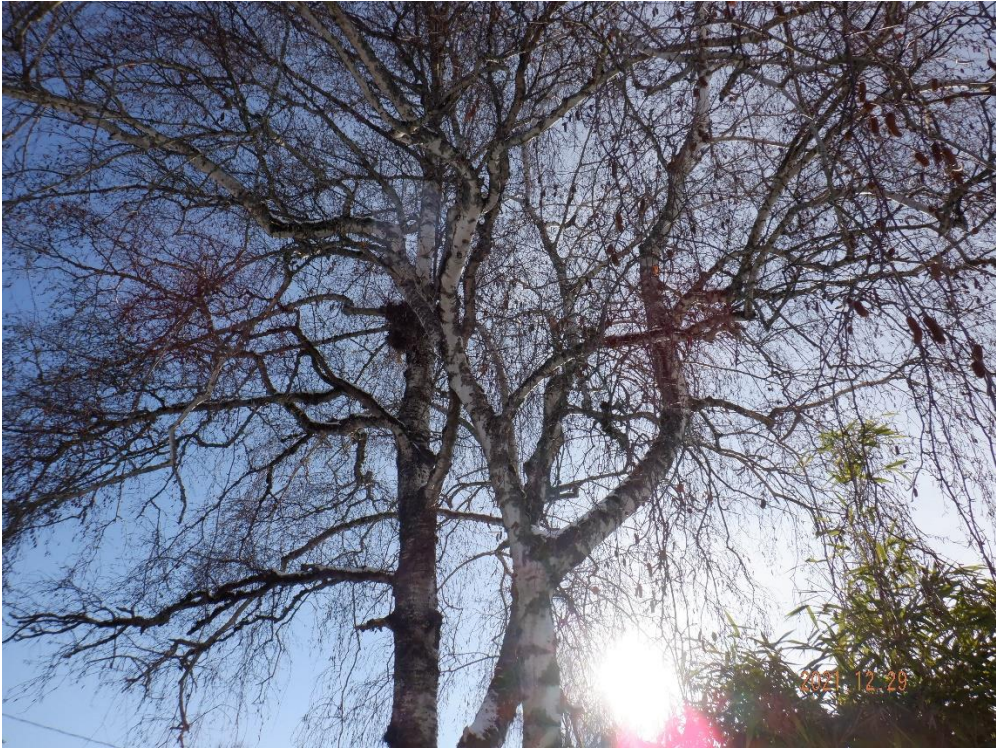
Tree #1 – upper crowns

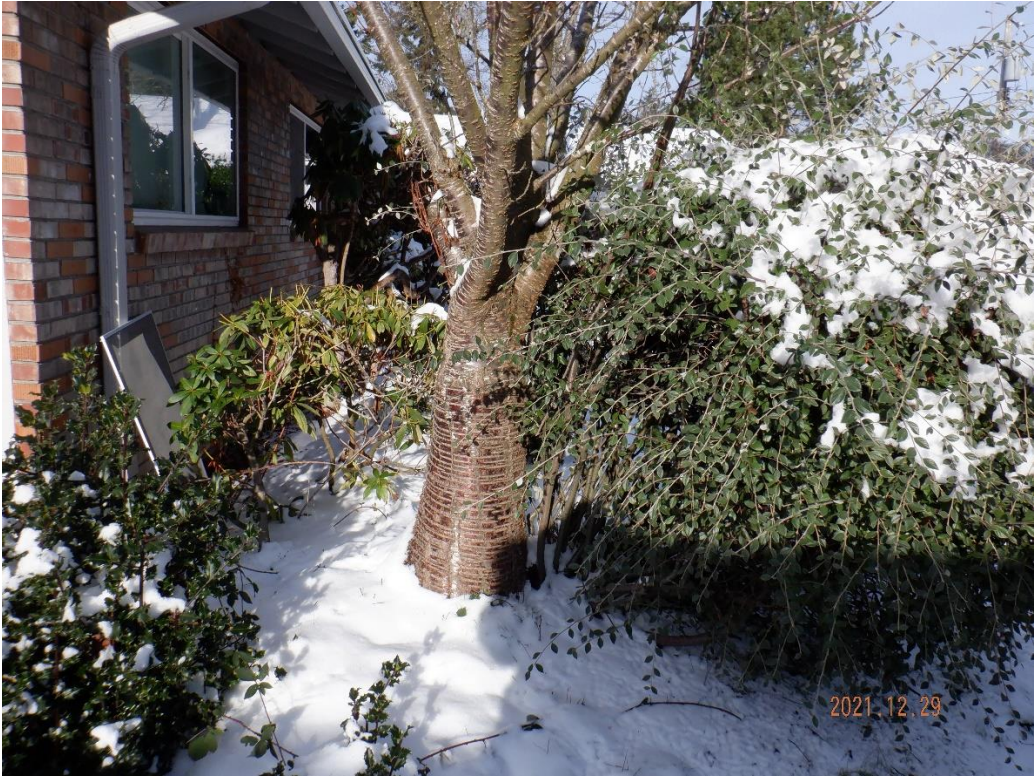
Tree #2 is a young flowering cherry variety located close to the existing house corner. It is believed to be the Mt. Fuji cultivar. No concerning issues were observed. It is in ‘good’ condition.

Trees #2 and #3 are proposed for removal. These will be compromised by the demolition of the existing house and new construction. The removal of the proposed trees from the subject property will not have any adverse impacts on trees to remain at the site.

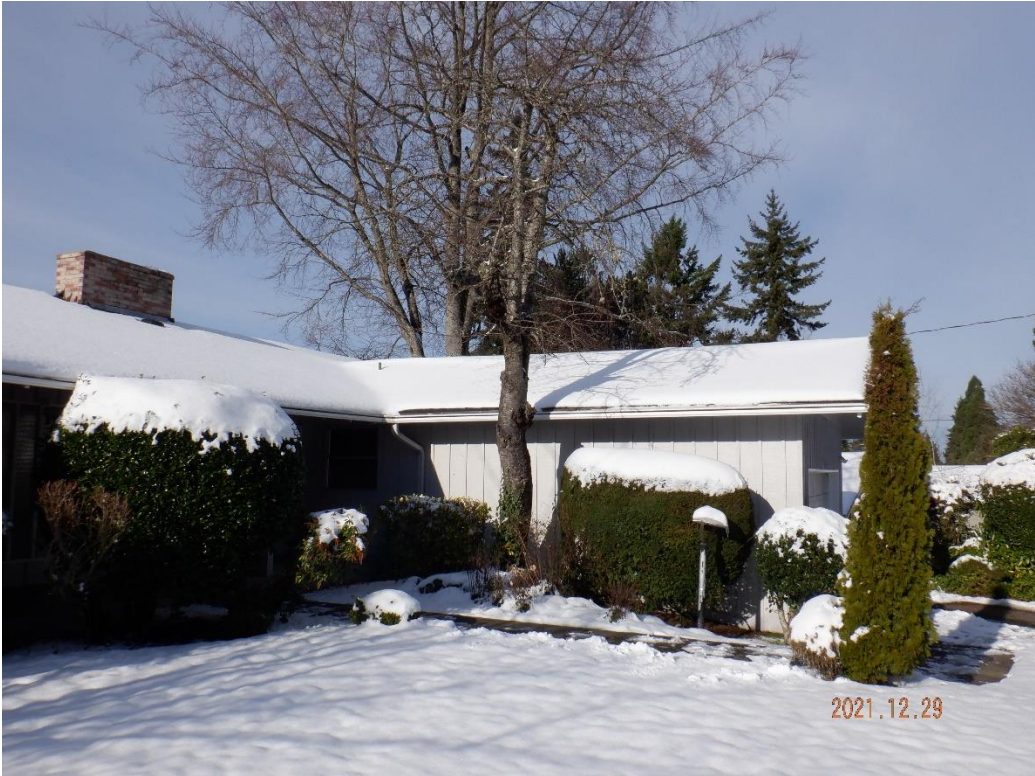
Tree #3 in foreground, #5 in background

Tree #3 is a semi-mature flowering cherry, also located close to the existing house. It is believed to be the ‘Kwanzan’ variety. It has been topped in the past. Condition is ‘fair’.

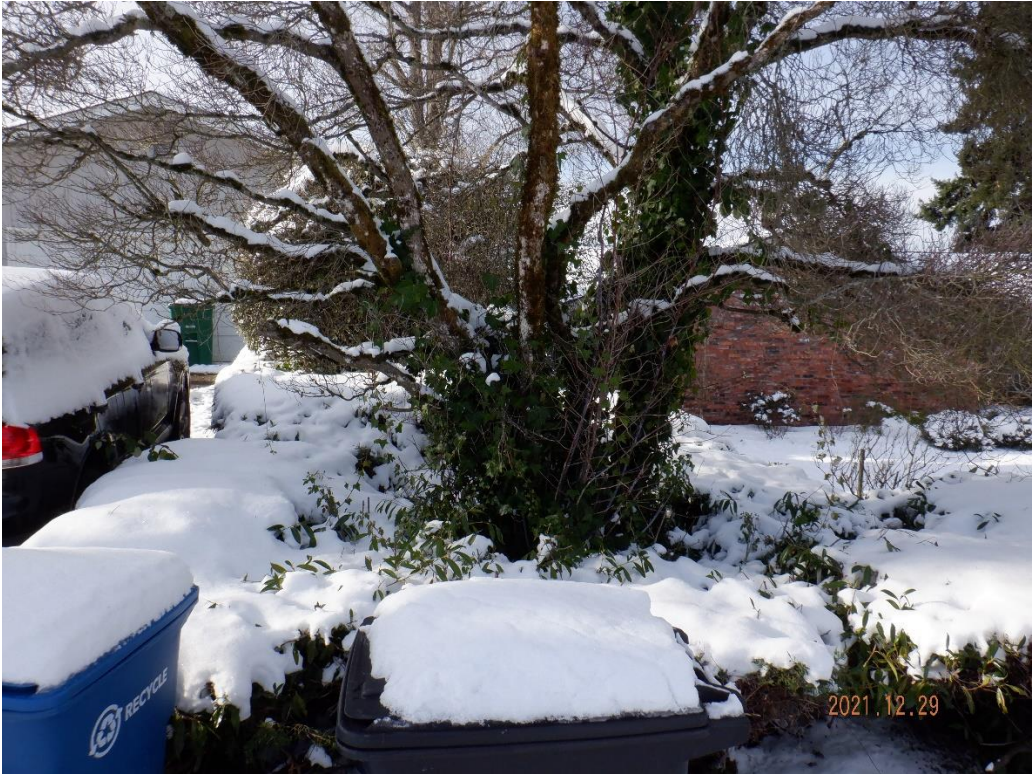
Tree #4 is a young cluster of flowering dogwood, located close to the northeast property corner. It is comprised of four small stems or trunks. It appears to be of good vigor. It was partially topped in the past, likely to provide roadside clearance. It is in 'good' condition.

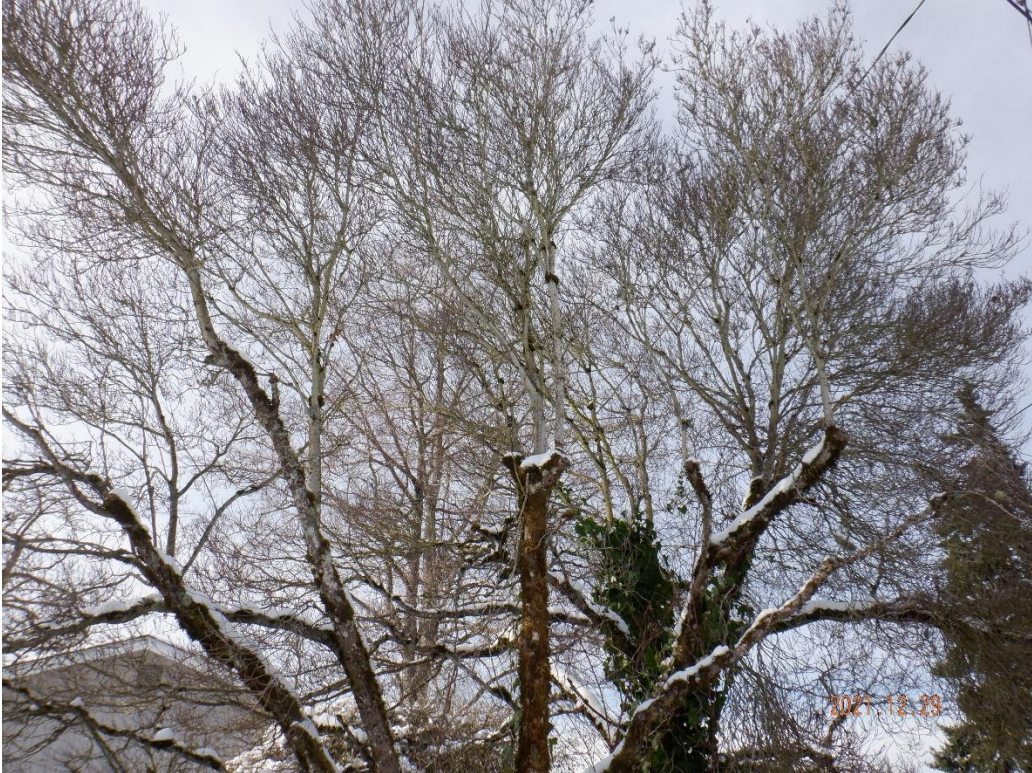
Tree #4 – upper crown

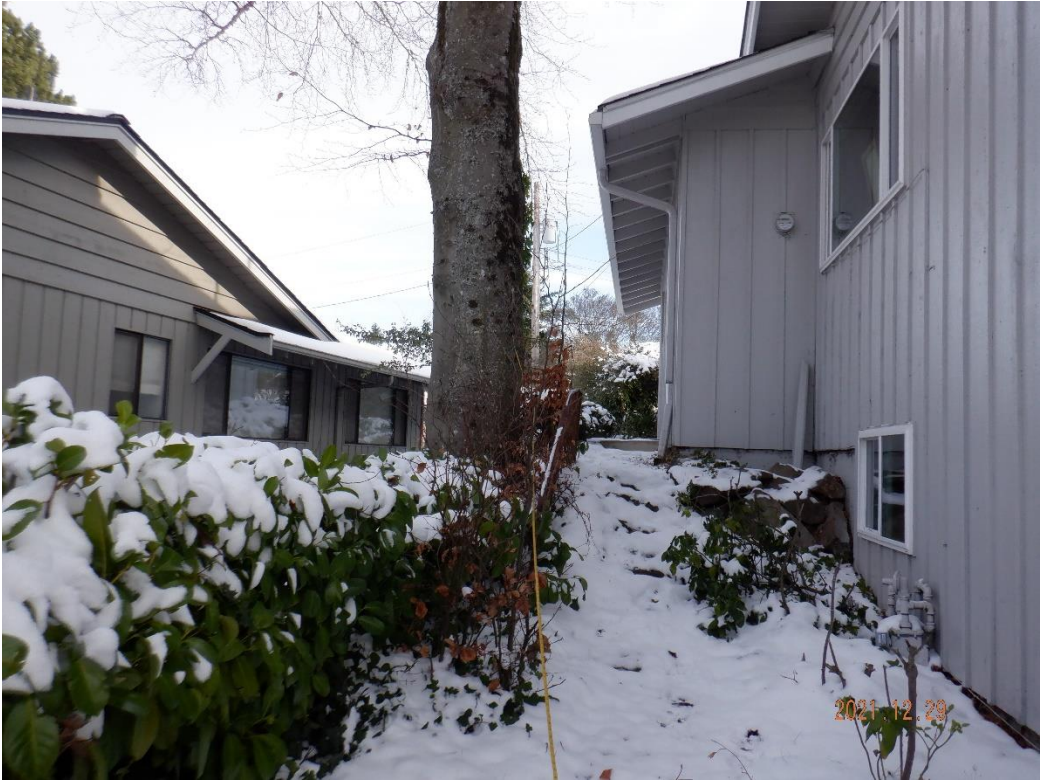
Tree #5 is a semi-mature European beech, possibly the purple leaf form or variety. The tree diameter was measured with a Spiegel Relaskop. In order to get a tape around the tree, access onto the neighboring property is needed. The tree has developed good structural form and appears to be of good vigor. It appears to be a boundary line tree. It is located close to the existing house, there is roughly 6-feet between the house wall and trunk face. The crown or canopy extends several of feet over the house.

Tree #5 – lower trunk

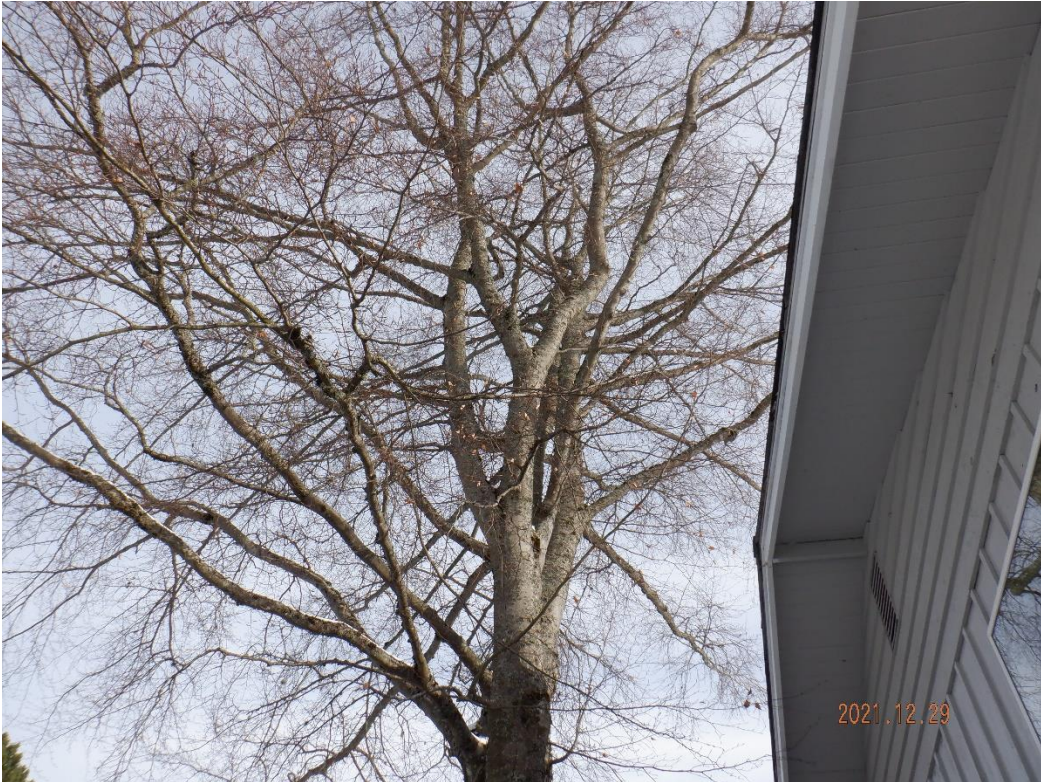
Tree #5 – upper crown

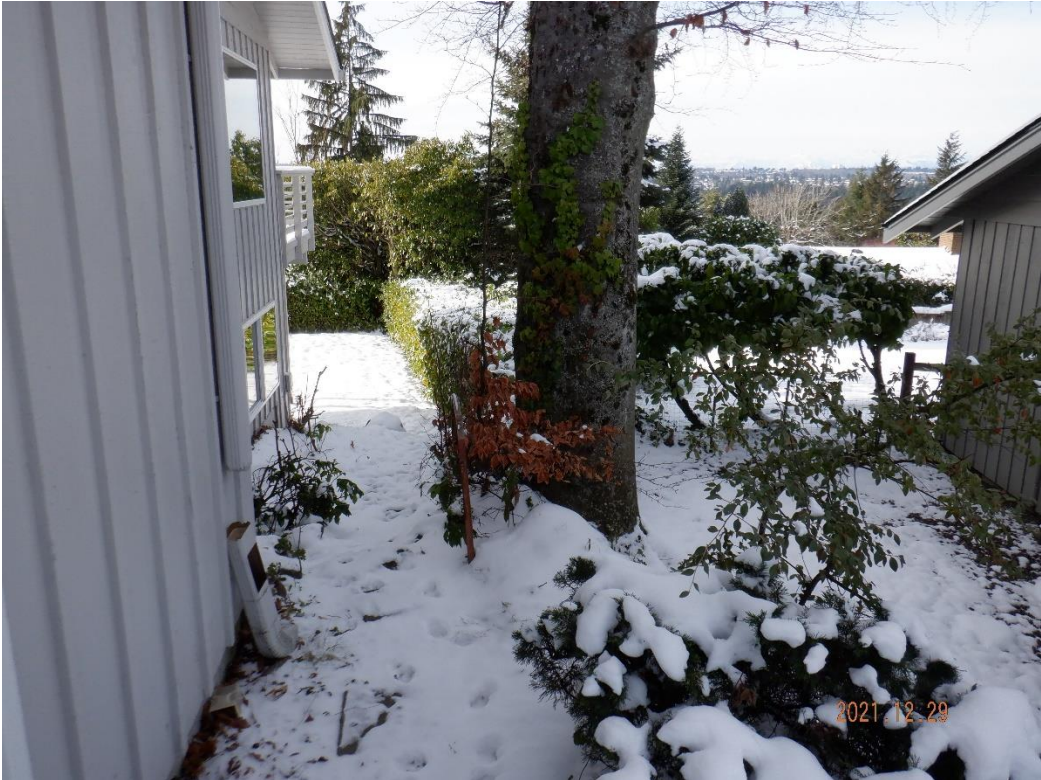
Tree #5 – lower trunk
