## Re: Arborist Report

The Watershed Company Reference Number: 201107

We are pleased to present to you the findings of our tree inventory for the Houtchens Residence at 6024 SE 22<sup>nd</sup> Street in Mercer Island, WA (parcel #2439700110). ISA-Certified Arborists® Jake Robertson and Alexis Ochoa visited the property on March 25<sup>th</sup>, 2021 to inventory and assess trees located on the subject parcel and on adjacent parcels with driplines overhanging the subject parcel.

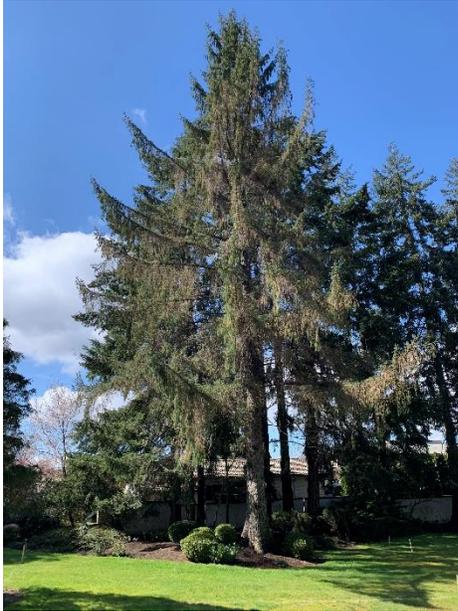
Tree #521 is a large, 28-inch in diameter Norway spruce (*Picea abies*, Figure 2). Multiple design iterations explored the retention of this tree while minimizing design impacts within the drip line. However, this tree presently is infested with the spruce adelgid and exhibits extensive chlorotic foliage. If this tree were to be retained, the development stress in tandem with the existing known pathogen would likely result in this tree failing within 10 years post-construction. As a result, the proposed site plan has the main footprint of the new home at the location of this tree. This tree is part of the grove that runs along the western border of the property and is therefore classified as exceptional. Given its exceptional tree status, six replacement trees are required.

Figure 2. Norway spruce with discoloration and dieback within the canopy that will need to be removed prior to construction.

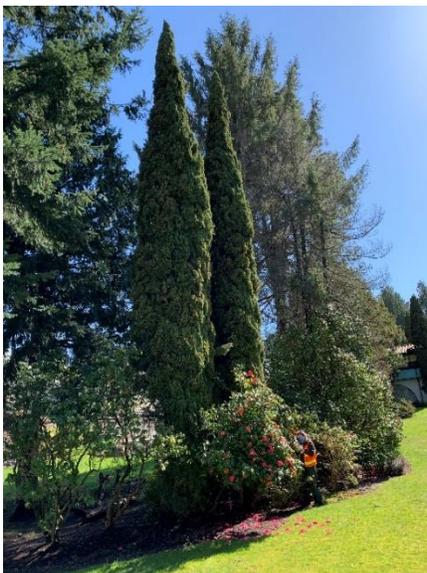
Trees #525 & 526 are a medium diameter Italian cypress (*Cupressus sempervirens*, Figure 3) trees. These trees are rooted within the main footprint of the new home design. These trees are in Fair condition with a canopy radius of two feet. This tree is not part of any grove nor classified as exceptional given its size. Four replacement trees are required following the removal of these two trees.

Figure 3. Italian cypress trees that are rooted within design footprint of the home.

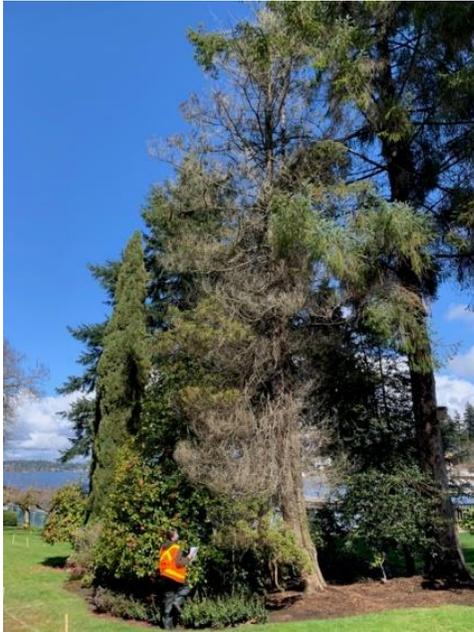
Tree #527 is a medium, 19-inch in diameter Japanese cedar (*Cryptomeria japonica*, Figure 4). This tree is in Very Poor condition and would have minor impacts to its critical root zone when the footprint of the new home is excavated. Since the tree is already in such poor condition, it is likely that the impacts derived from construction would result in tree death which would then become a hazard for the new home. This tree is part of the grove that runs along the eastern border of the property and is therefore classified as exceptional. Given its exceptional tree status, six replacement trees are required.

Figure 4. Japanese cedar that is in declining health that would likely not survive the construction process.

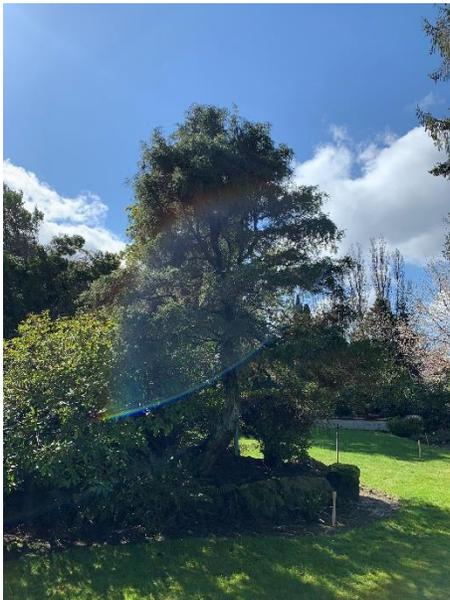
Tree #536 is a small, 10-inch in diameter Excelsa western red cedar (*Thuja plicata* 'Excelsa', Figure 5). The trunk of this tree is rooted within the footprint of the new home design. This tree is not part of any grove nor classified as exceptional given its size. Two replacement trees are required following the removal of this tree.

Figure 5. Tree #536 is a small Excelsa western red cedar that will need to be removed prior to construction.

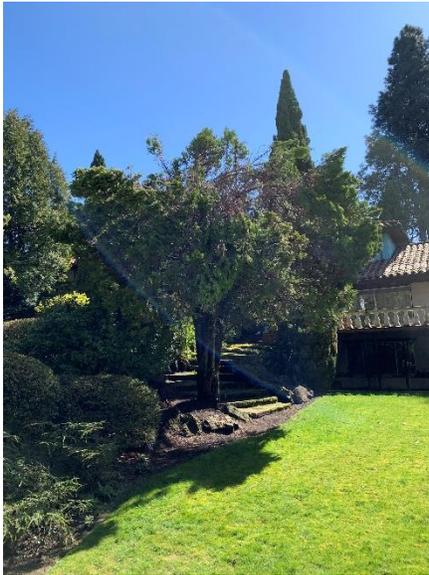
Tree #537 is a medium, 18-inch in diameter Hinoki falsecypress (*Chamaecyparis obtusa*, Figure 6). The entire tree is rooted within the footprint of the new home design. The tree is in Poor health with a canopy radius of 11-feet. This tree is not part of any grove nor classified as exceptional given its size. Two replacement trees are required following the removal of this tree.

Figure 6. This Hinoki falsecypress tree is rooted within the footprint of the new home design that would need to be removed.

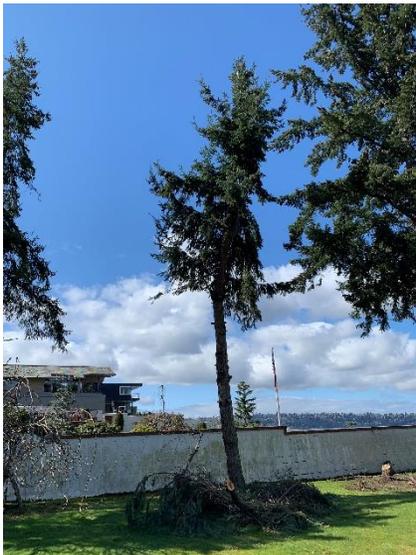
Trees #'s 524 (*Prunus sp.*) & 502 (*P. menziesii*, Figure 7) are not going to be impacted by the construction of the home; however, they are in poor enough condition that warrants their removal. Tree #502 has been greatly affected by windstorms and many of the limbs have broken off and has left the remaining stem in poor structure. #524 is as cherry tree that only has one living leader within its canopy. Tree #502 is part of the western border tree grove and would require six replacement trees and Tree #524 is only a regulated tree and requires two replacement trees.

Figure 7. Tree #502 with severe storm damage.
