October 13th 2022

G-5776

Subject: Geotechnical Engineering Investigation
Proposed New Deck and Stairs
9405 SE 47th St
Mercer Island, Washington

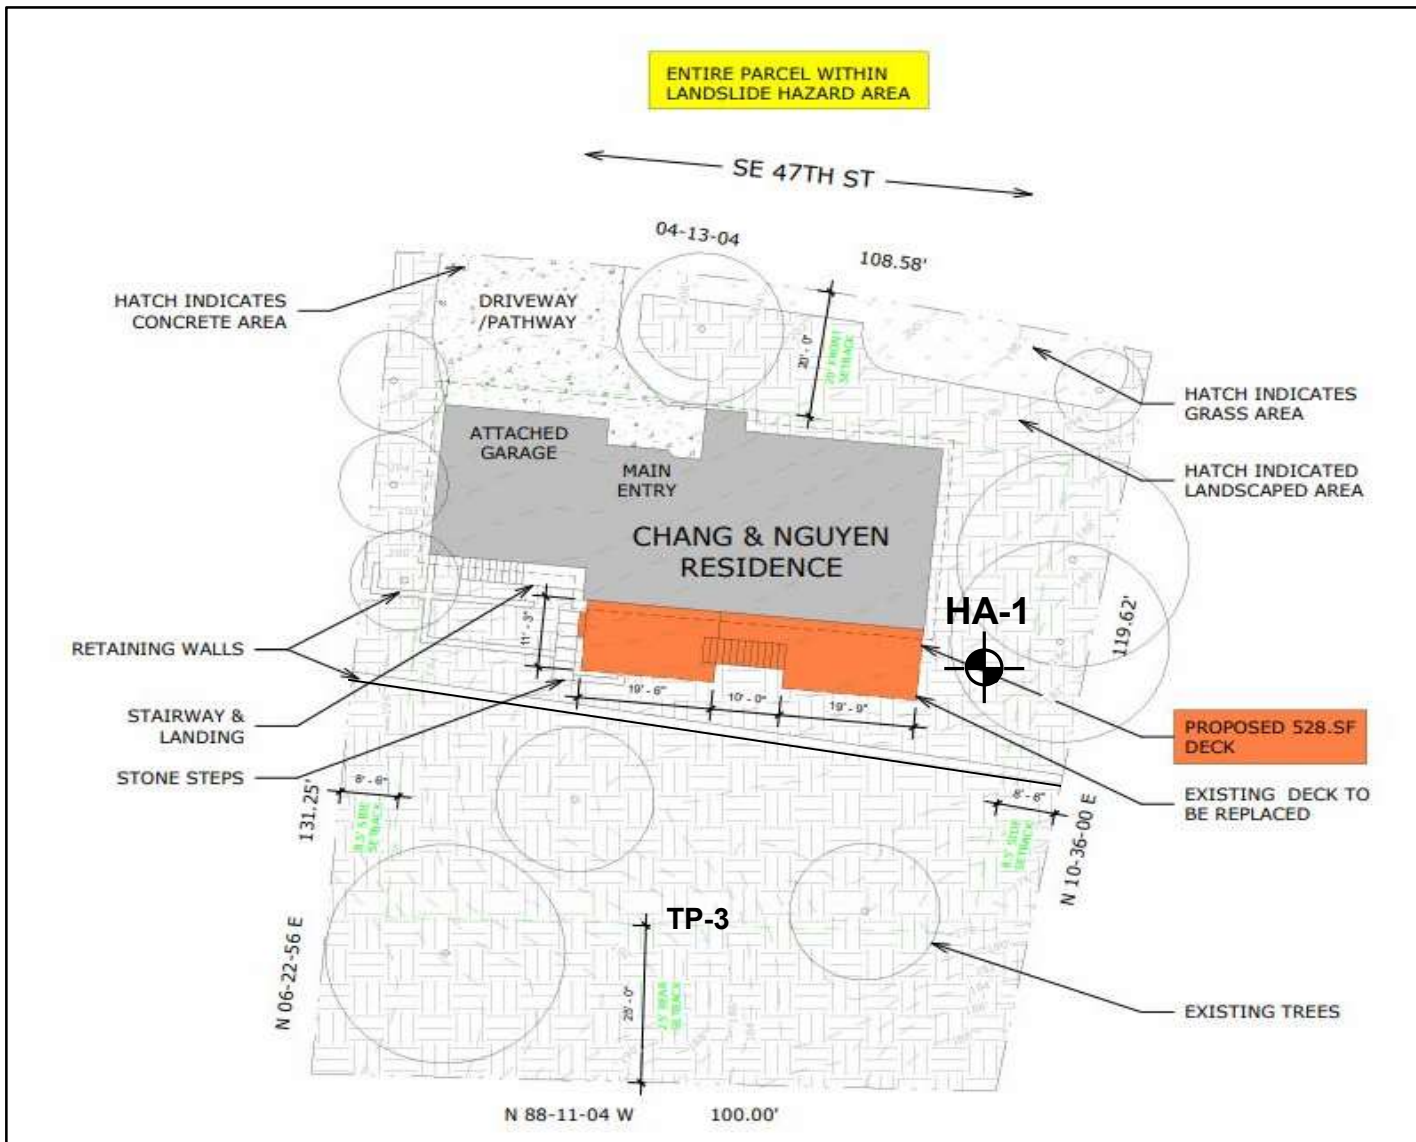
SCALE:	NO SCALE	DRAWN:	SH	CHECKED:	WC	DATE:	10/13/2022	PROJECT NO.:	G-5776	PLATE	2
--------	----------	--------	----	----------	----	-------	------------	--------------	--------	-------	---

Hand Auger 1 (HA-1) was dug to the south-east side of the existing deck, dense, dry silty sand with gravel and silt were observed 1 foot to 1.5 feet below the ground surface. The area below the existing deck, by the footings and under the west side of the existing deck was probed and found to be dense. In our opinion, dense native soils will be encountered at similar depths approximately 1-2 feet below ground surface. We interpret these dense soils to be dense, native Lawton Clay. No groundwater was observed onsite. For a more detailed description of the soils encountered, please refer to the boring logs in *Appendix A*.

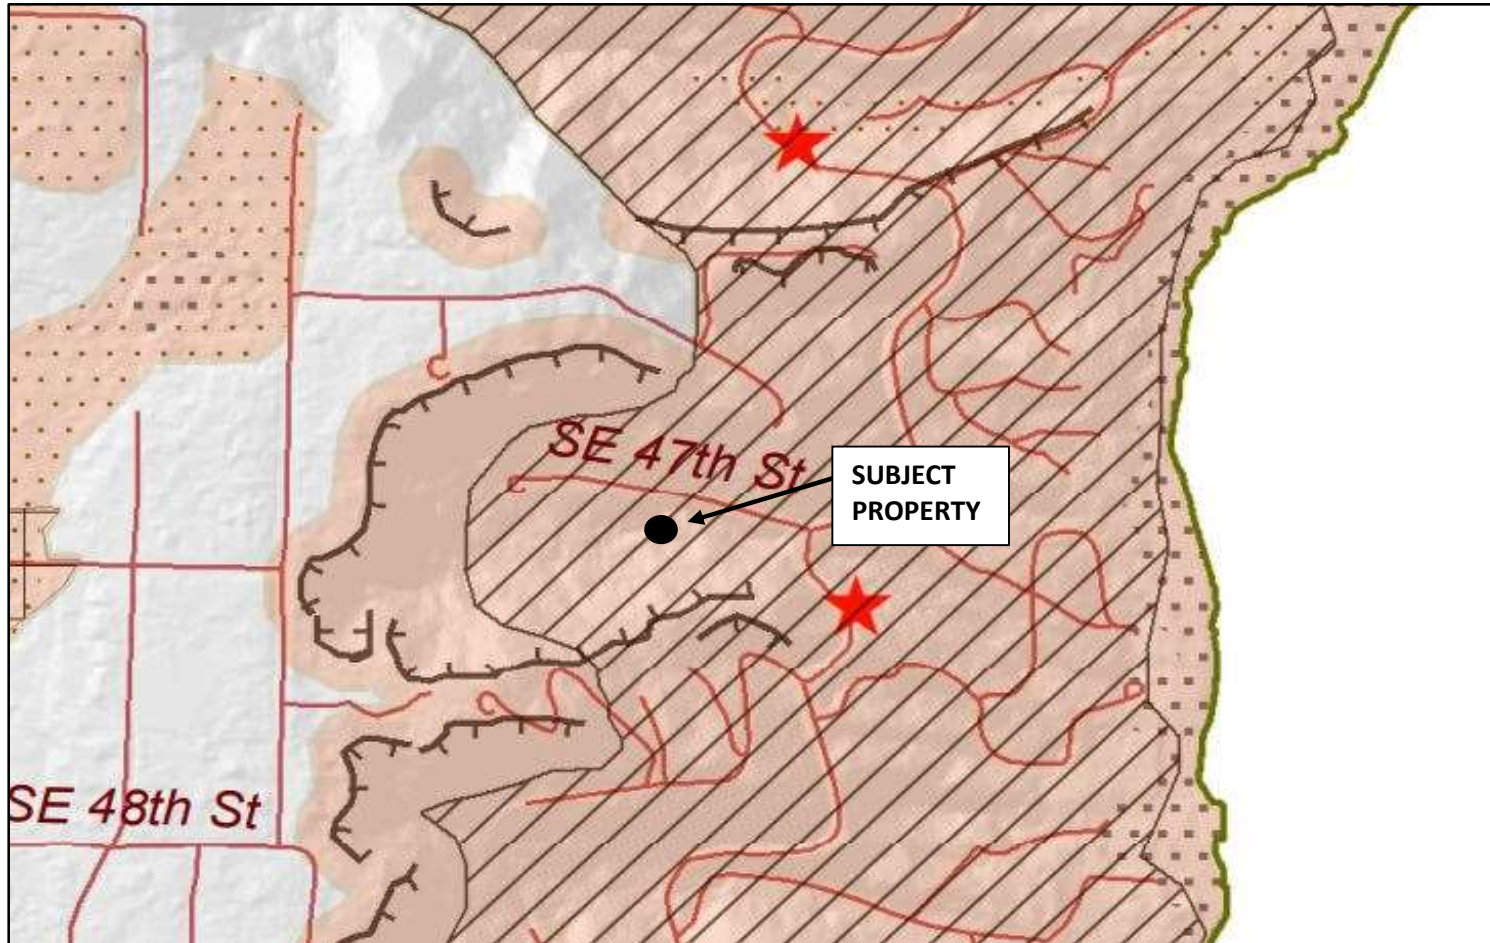
SCALE:	NO SCALE	DRAWN:	SH	CHECKED:	WC	DATE:	10/13/2022	PROJECT NO.:	G-5776	PLATE	3
--------	----------	--------	----	----------	----	-------	------------	--------------	--------	-------	---

According to the City of Mercer Island, a seismic hazard area is an area that has potential for seismically induced ground failures including settlement, cracking, lateral spreading and liquefaction due to ground shaking. The site is also mapped as a potential slide area, as having a scarp upslope to the west of the site, and as having a landslide deposit beneath the site and several surrounding properties. Landslide deposits are typically loose to medium dense and massively bedded, however onsite we observed dense native soils in the location of the proposed addition. In our professional opinion, because of the dense native soils observed onsite, the risk of a potential slide or seismically induced settlement or failure is low.

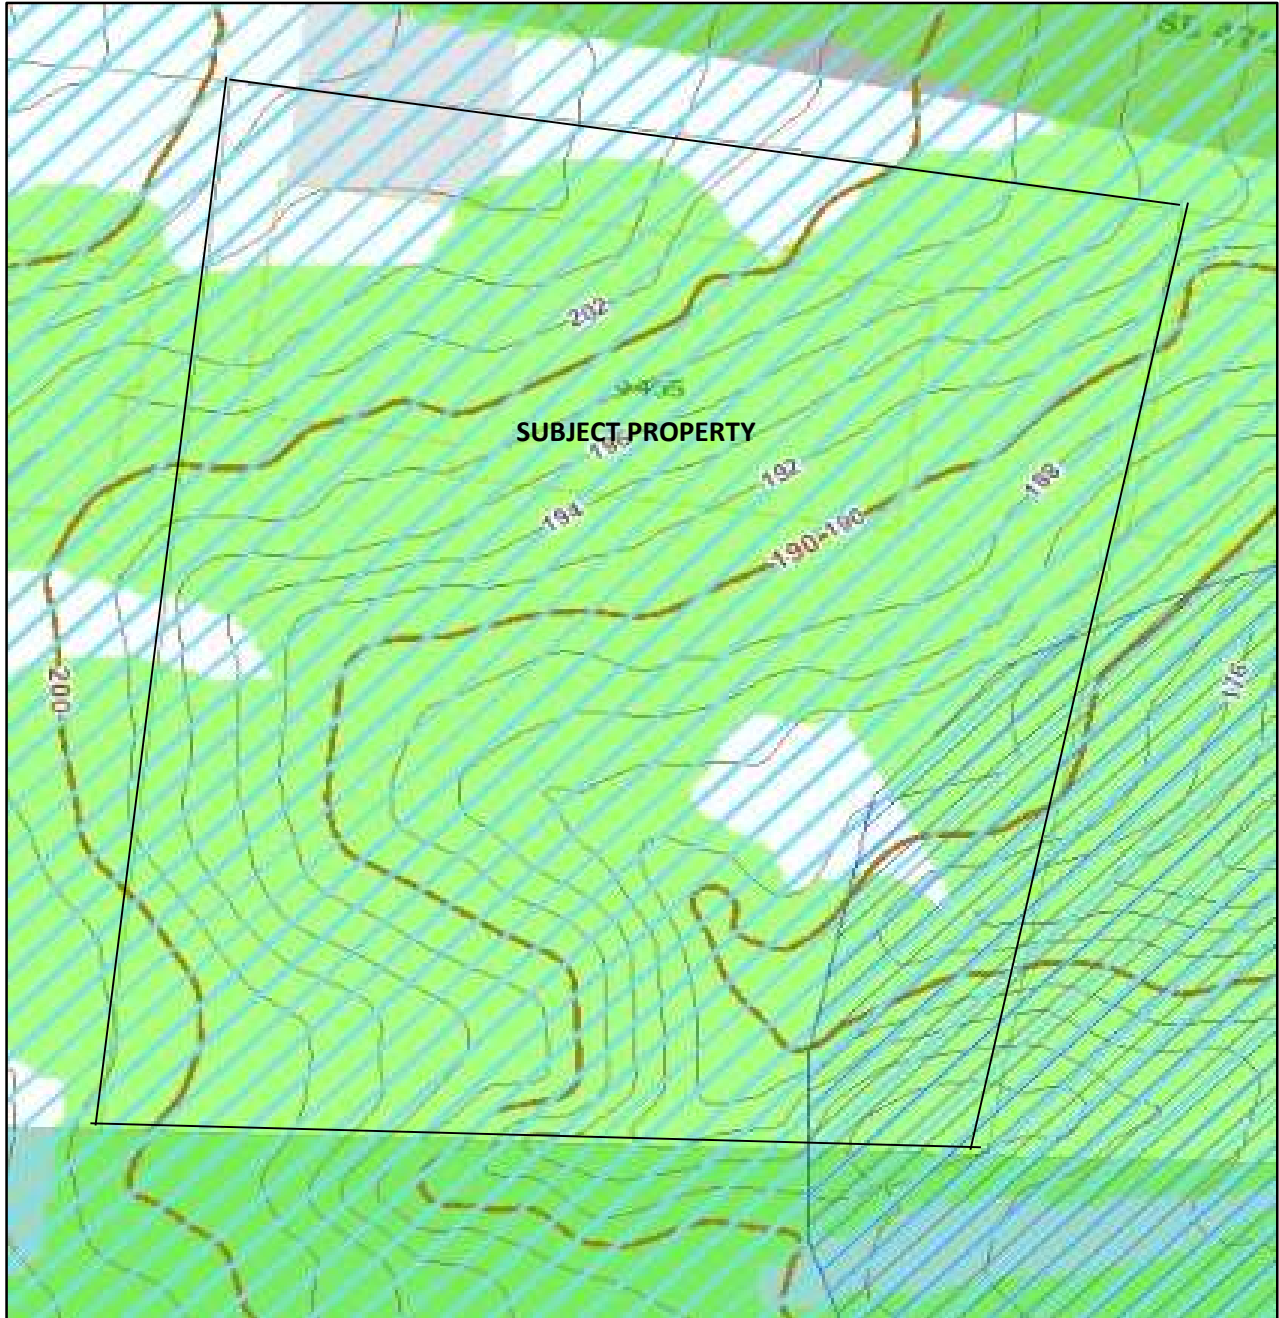
SCALE	NONE	DATE	10/13/2022	MADE	SH	CHKD	WC	JOB NO.	G-5776	PLATE	4
-------	------	------	------------	------	----	------	----	---------	--------	-------	---

The Project site is mapped to overly a City of Mercer Island Seismic, Potential Slide and Erosion Hazard area. As part of our scope of work we evaluate the hazard with respect to the project scope of work. Please see *Plate 3 and 4 – Hazardous Areas Map*.

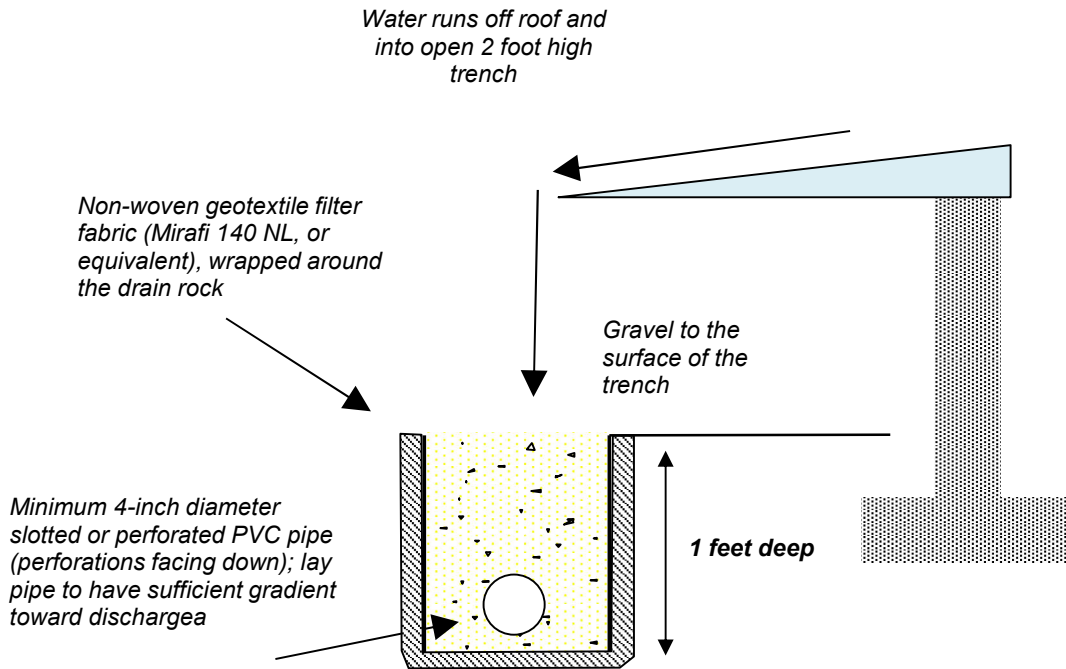
SCALE: NONE	DATE: 10/13/2022	MADE: SH	CHKD: WC	JOB NO. G-5776	PLATE 5
-------------	------------------	----------	----------	----------------	---------

The site is also mapped as an erosion hazard area, and onsite we observed signs of erosion around the existing footings. We also observed erosion and deposited soft soils on the south-west corner of the house to the side of the existing deck. Water from the deck should be re-routed away from the footings and to the other side of the retaining wall. Please see the recommendations outlined below for details.

Some erosion was observed onsite beneath the deck and around the footings. To mitigate future erosion, we recommend a 4-inch layer of clean crushed rock overlying non-woven geotextile filter fabric (Miraf 140 NL or equivalent), be placed below the deck to route water to a perimeter trench. An approximately 1-foot-deep trench consisting of filter fabric and crushed rock should be placed around the perimeter of the deck to catch stormwater. A perforated or slotted rigid PVC pipe should be tight jointed and laid with perforations or slots down. Do not replace rigid

PVC pipe with flexible corrugated plastic pipe. Please see *Plate 4 – Drainage Trench for Runoff*. This water should then be routed to the footing drain on the south-east corner of the house and piped into the recharge area beyond the retaining wall.

- 1.) Runoff trench is to be placed around the perimeter of the structure to route water to pipes leading to the footing drain. A four-inch slotted pipe should be at the base of the trench. Perforated or slotted rigid PVC pipe should be tight jointed and laid with perforations or slots down. Do not replace rigid PVC pipe with flexible corrugated plastic pipe.
- 2.) Trench should be 1 foot deep
- 3.) The geotextile filter fabric should be placed around the drain rock as shown, and not wrapped directly around the pipe. The surface of the trench should be open, and then be filled with gravel to the surface.
- 4.) Water from the perimeter trench should be routed to a pipe to south-east footing drain
