ARBORIST REPORT

October 14, 2022

3036 67th Avenue SE
Mercer Island, WA

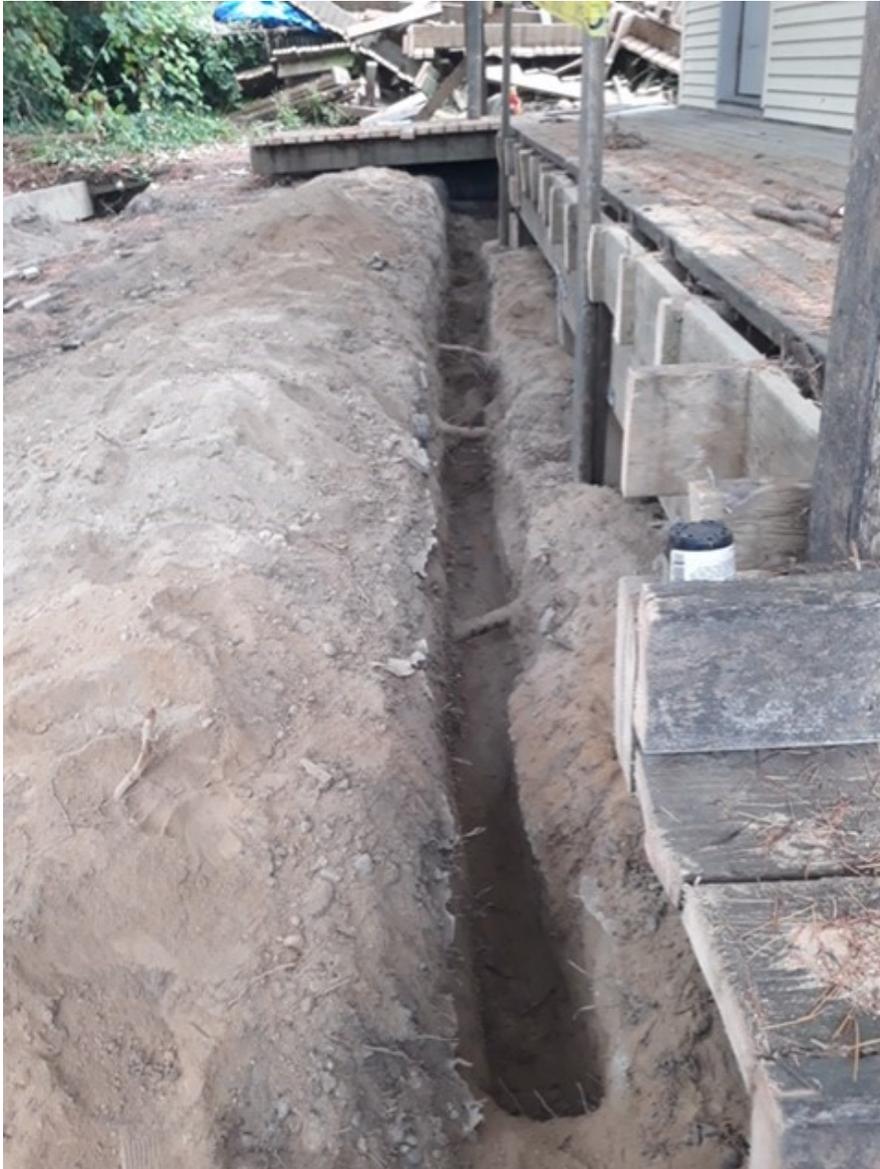
Your initial plans were to retain Tree #1. Those plans would have involved excavation within 15' – 17' of the tree trunk. An exploratory trench was hand excavated 14' away from the trunk. The trench was dug to a depth of 18" to 24" where dense hardpan soils were encountered. In the top profile of soil, we found several roots larger than 2" in diameter. In my opinion, severing the roots found within the trench would significantly increase the likelihood that Tree #1 might fail from lack of structural roots. The tree is located within a few feet of the residential structure located immediately north of the subject property. While the tree may be of Exceptional size, its planting location is far less than exceptional. It is planted on, or very near the property line, within a few feet of the neighboring structure.

Photo #1 – Exploratory trench dug by hand 14’ from the tree trunk, measured 4.5’ above grade
This view is from the west, looking east.
