**Tree Assessment  
For  
Seascape Homes  
At  
Lot 2, 5214 Forest Ave SE  
Mercer Island, Washington**

**Date  
11/21/2022**

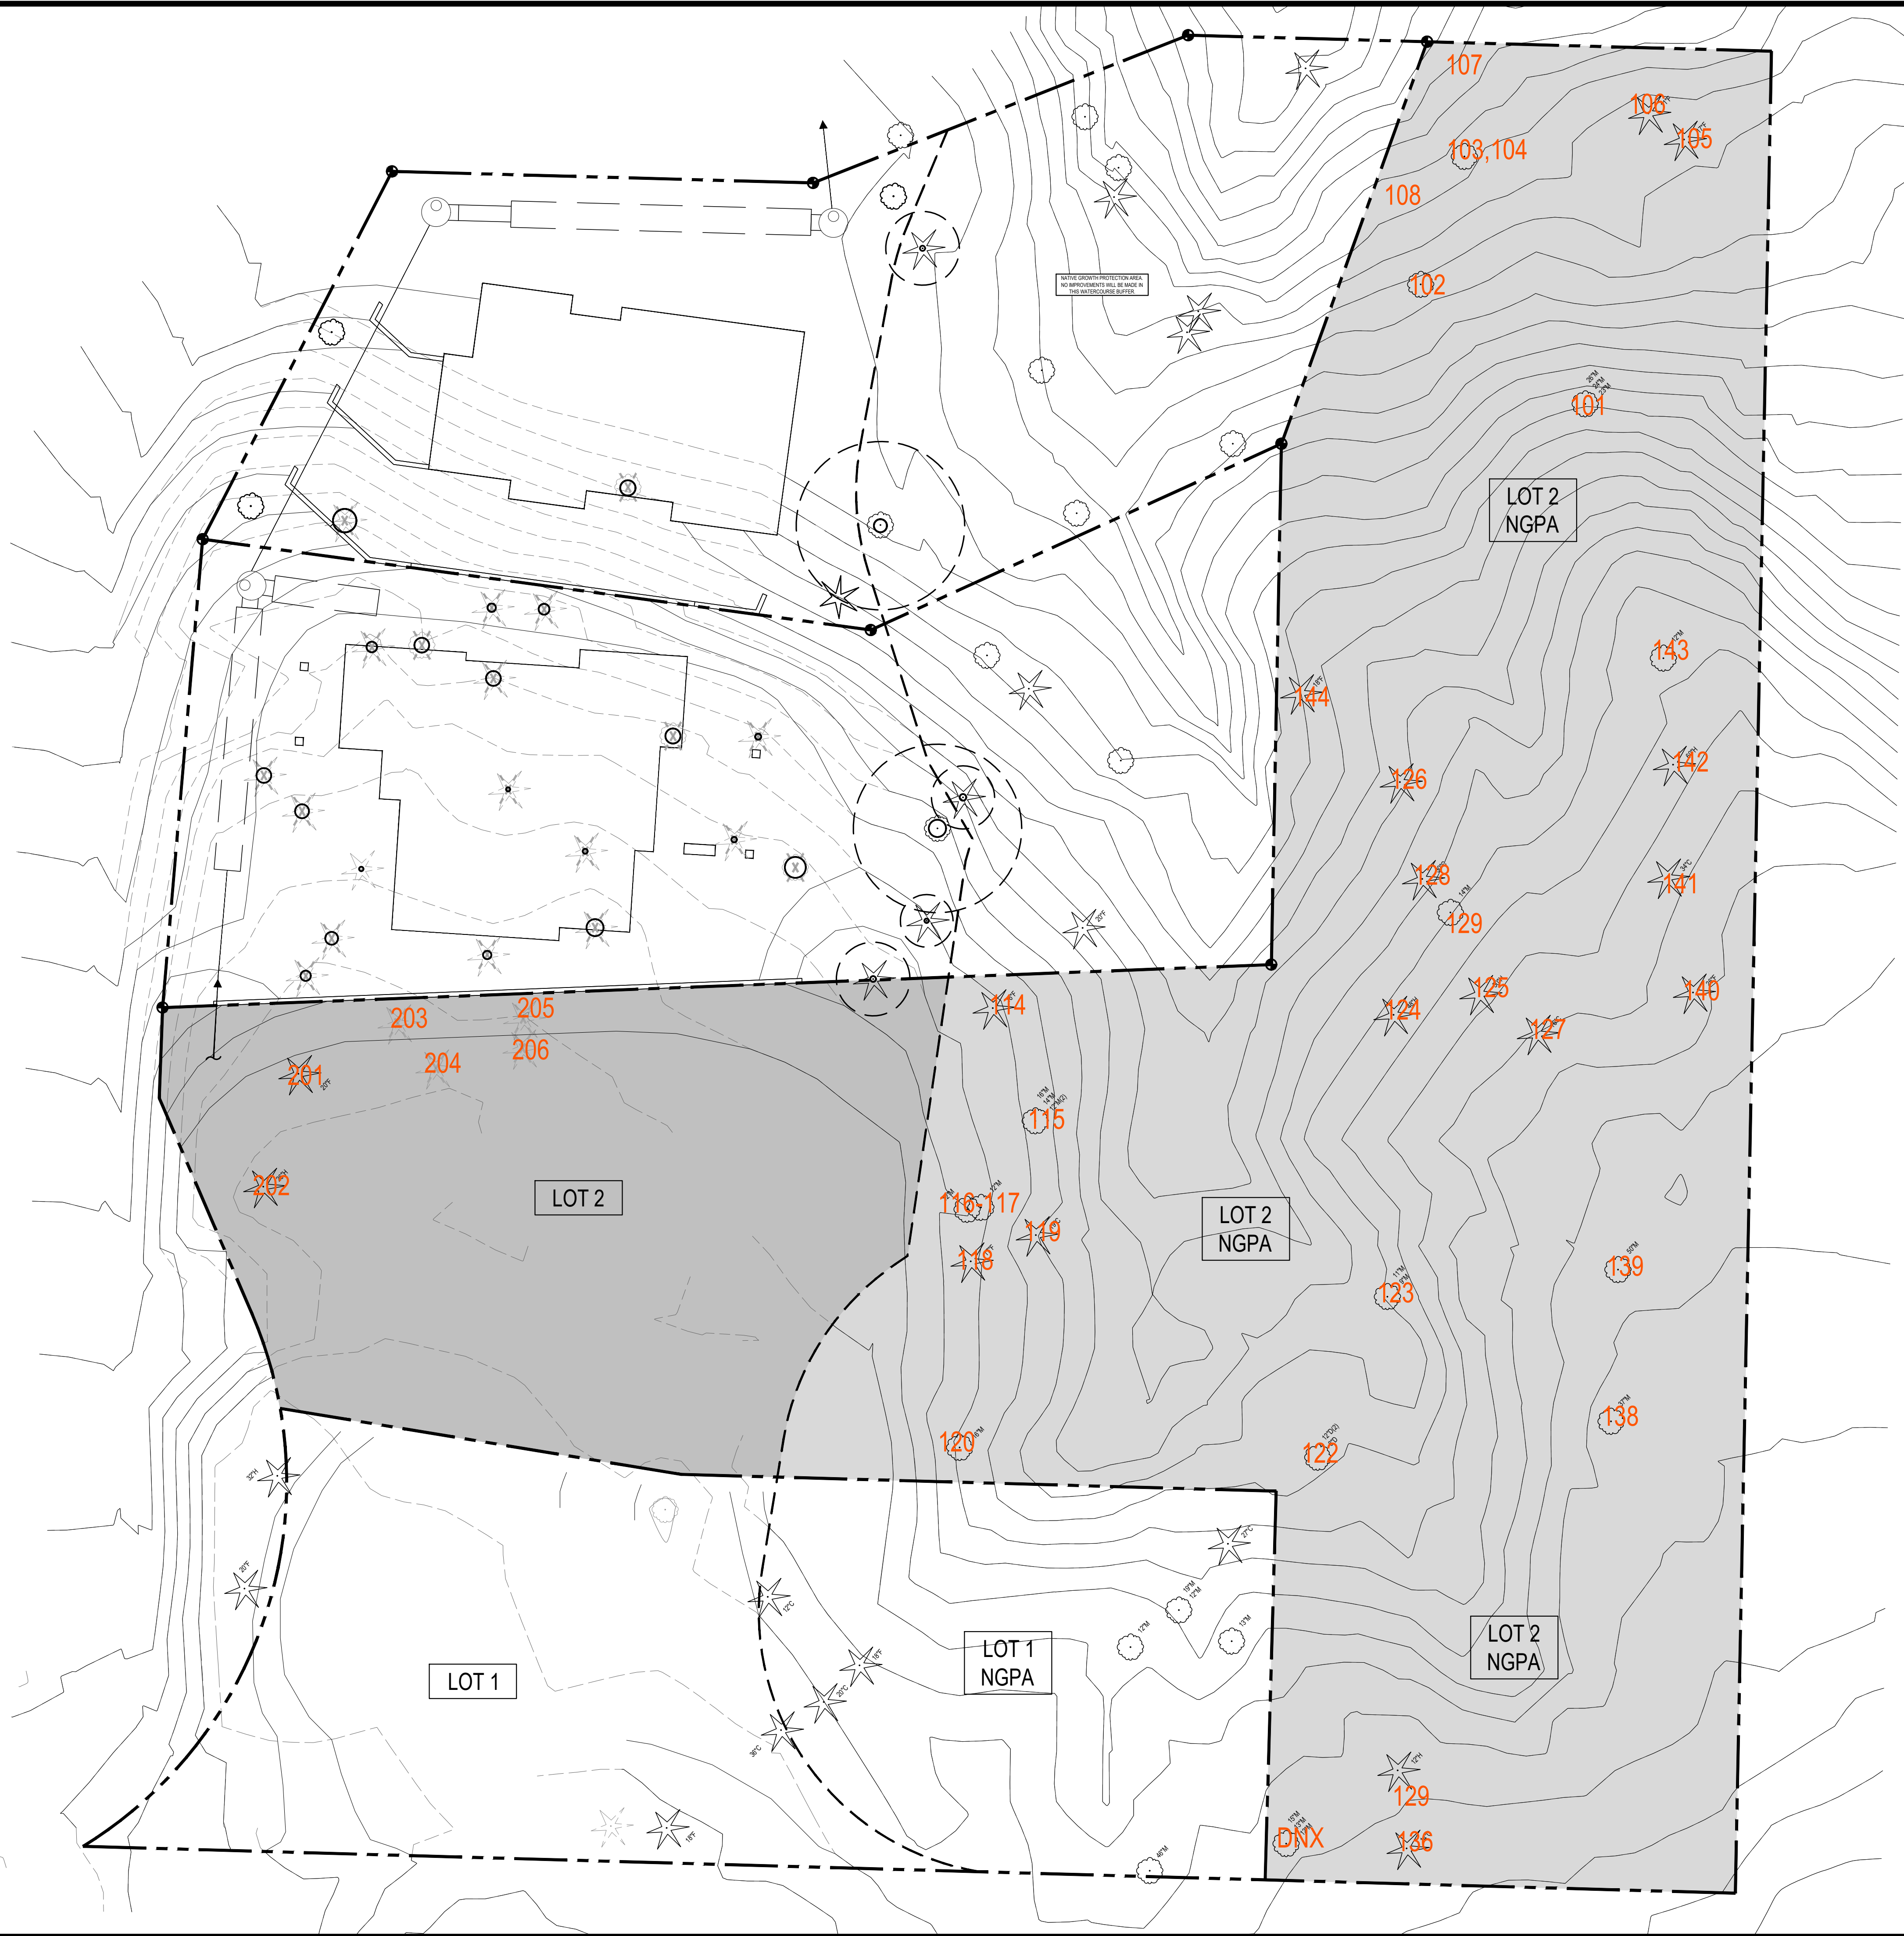
**2** LOT 2 FULL TREE PLAN  
 SCALE: 1/16" = 1'-0"

Tree Locations
