ARBORIST REPORT

Immediate Action Required

June 7, 2023

3036 67th Avenue SE
Mercer Island, WA

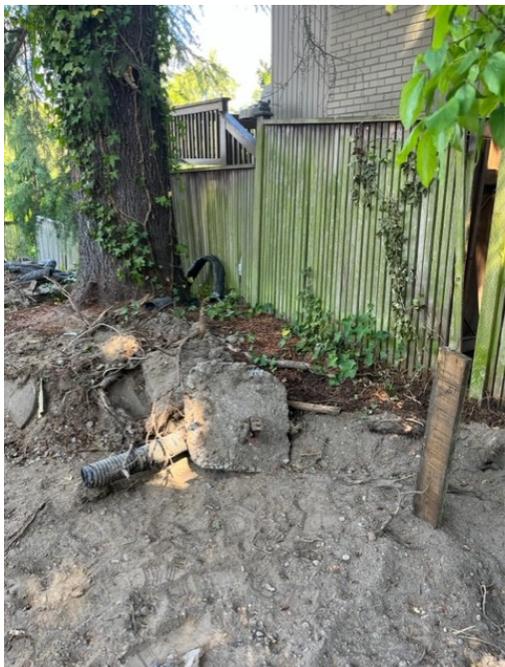
Tree #1 has had significant root impact from excavation inside the dripline radius of the tree, significantly close to the tree trunk. The exact extent of root damage is not completely known as the excavation was backfilled prior to my site visit. As shown in the photo included in the report dated October 11, 2022, significant roots were located in an exploratory trench that was opened 14' from the tree trunk, as detailed in said report. As shown in the photo below, much of the southern half of the tree's dripline radius has been impacted by site work. There is a marker placed in the ground by the excavation contractor that indicates an excavation cut of five feet (5').

In my professional experience, it would not be possible to undertake the extent of apparent excavation work without significantly impacting structural roots. If anyone had any doubt about the exact extent of damage, a pneumatic spade could be used to excavate a new exploratory trench along the existing excavation edge closest to the tree trunk in order to reveal any roots that were encountered. I am quite confident that significant roots were impacted and that the sum total of all roots impacted would far exceed any reasonable level of tolerance for such impacts. While the tree may have sufficient remaining roots to keep it standing, the seemingly apparent level of soil disruption and associated root system impacts would indicate the opposite.

I have completed an ISA Tree Risk Assessment Form for this tree. I considered the 'Likelihood of Failure' to be Imminent. The damage is hidden below grade; if we were to see an equal level of structural damage above ground, an assessment of Imminent failure is understandable. Tree that have their roots severed, often fail in the opposite direction from the severed roots. The Likelihood of this tree striking the residential structure located just a few feet from the tree is High. The consequences of a failure and strike could be severe as the home is occupied full-time.

Wood marker to right of photo indicates 5' deep excavation, about 10' from tree.

I believe there is an obligation to notify the homeowner of the target residence. The tree should be removed as soon as possible and should be considered priority one.

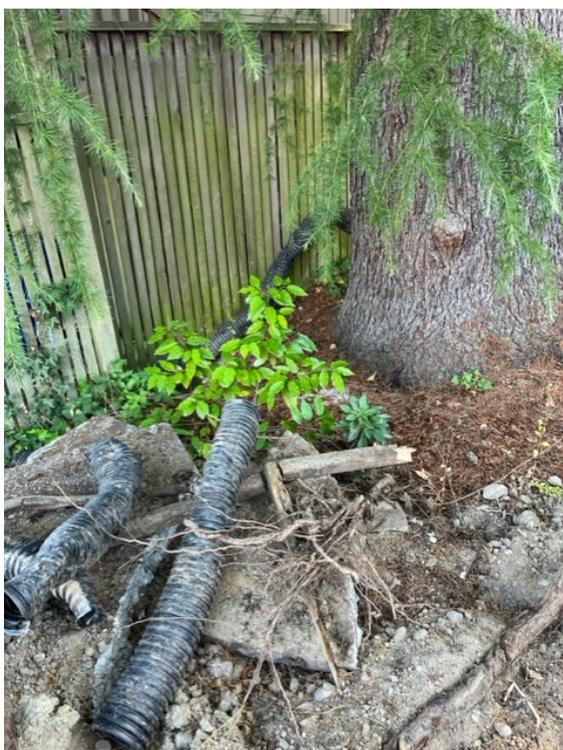
Debris piled next to tree. Edge of excavation shown in bottom right of photo.
