ARBORIST REPORT

October 11, 2022

3036 67th Avenue SE
Mercer Island, WA

Tom Quigley
ISA Certified Arborist, PN-655A
Tree Risk Assessment Qualified (TRAQ)

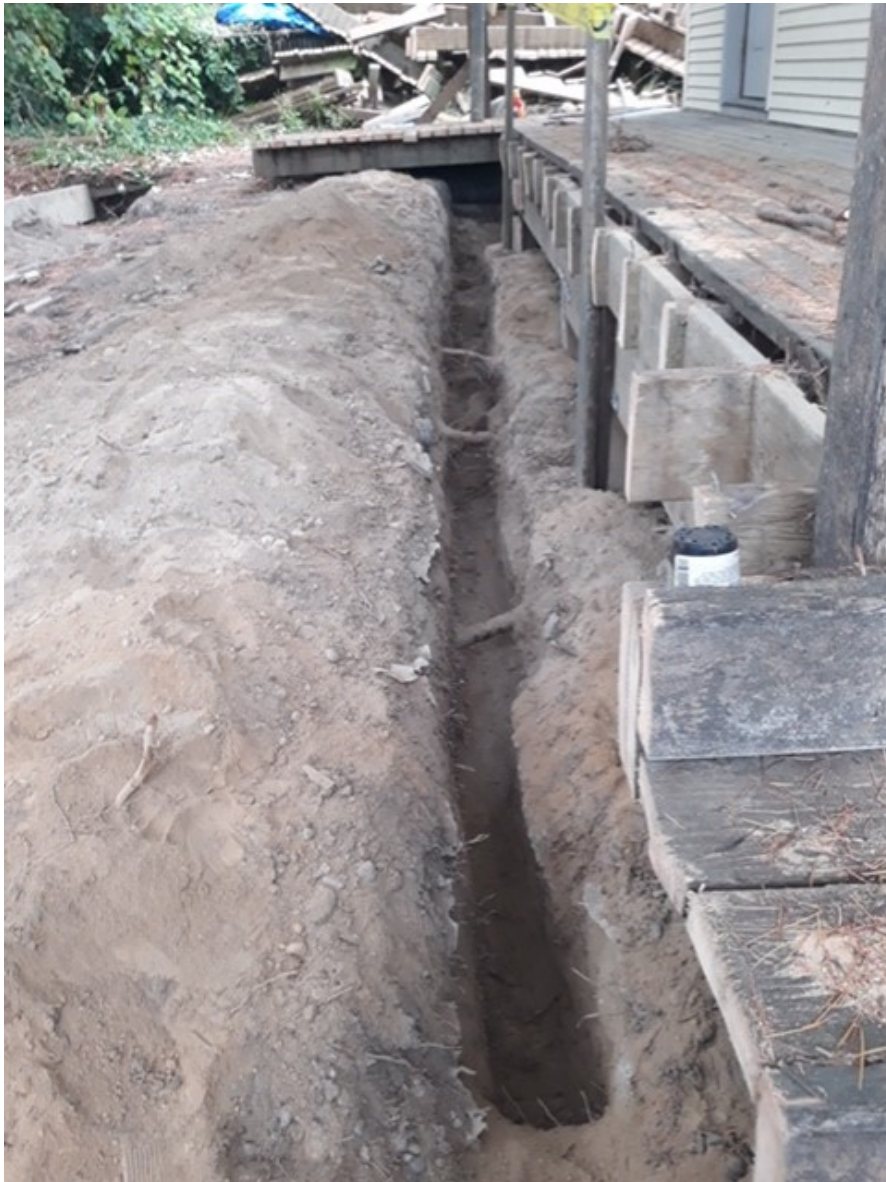
Your initial plans were to retain Tree #1. Those plans would have involved excavation within 15' – 17' of the tree trunk. An exploratory trench was hand excavated 14' away from the trunk. The trench was dug to a depth of 18" to 24" where dense hardpan soils were encountered. In the top profile of soil, we found several roots larger than 2" in diameter. In my opinion, severing the roots found within the trench would significantly increase the likelihood that Tree #1 might fail from lack of structural roots. The tree is located within a few feet of the residential structure located immediately north of the subject property.

Photo #1 – Exploratory trench dug by hand 14’ from the tree trunk, measured 4.5’ above grade
This view is from the west, looking east.
