DOWNSTREAM ANALYSIS
FOR
SINGLE FAMILY RESIDENCE
6175 SE 27TH ST
MERCER ISLAND, WA 98040

December 28, 2023

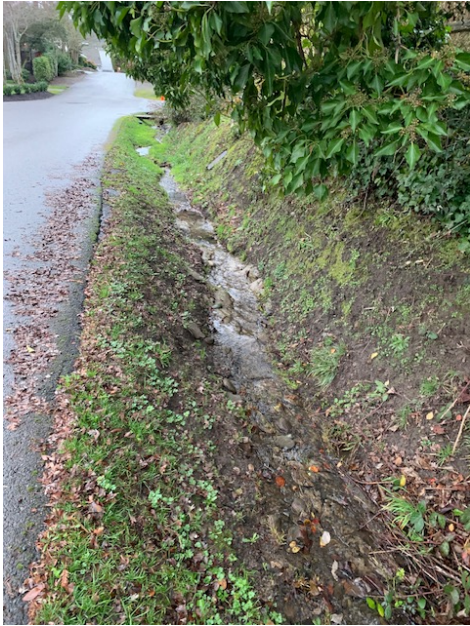
Open Ditch Across the site - Looking Downstream

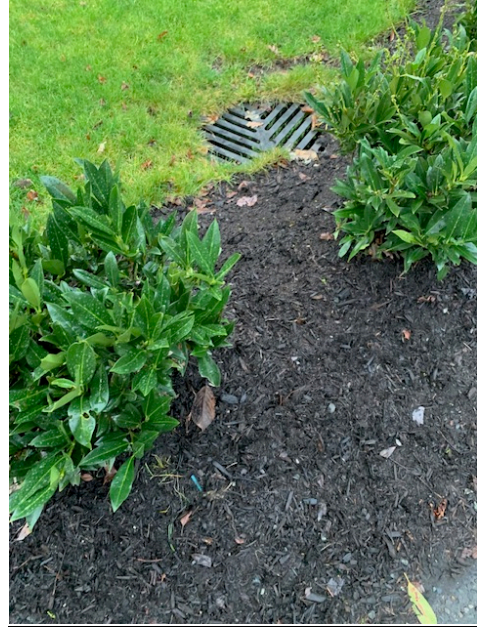
Catch Basin – At Point C

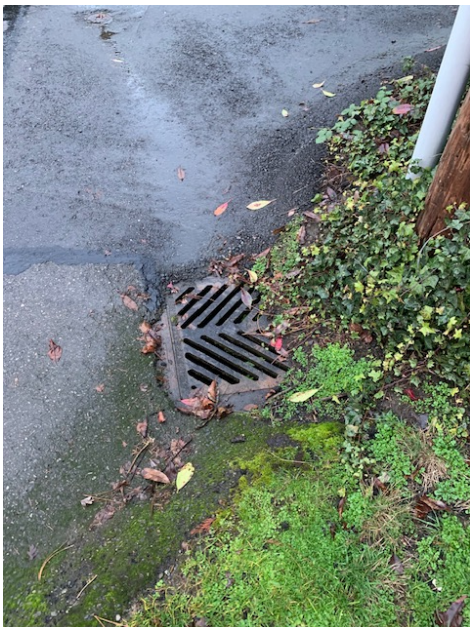
Catch Basin – At Point B

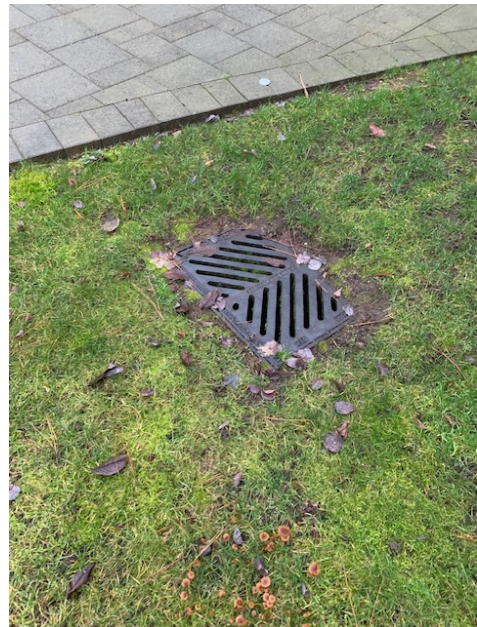
SE 27th St. South Edge Catch Basin – Point D

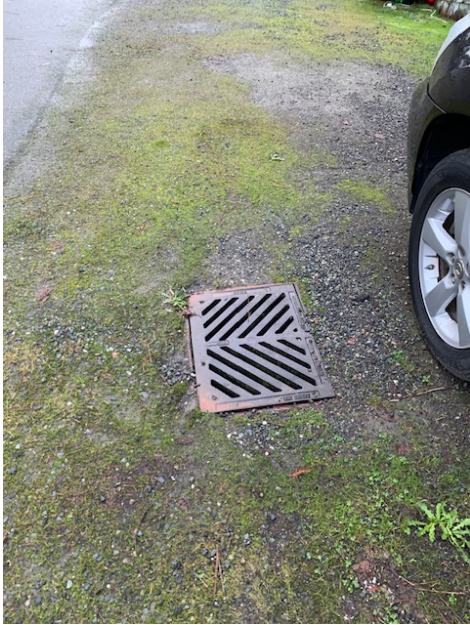
SE 27th St. North Edge Catch Basin –
Point E

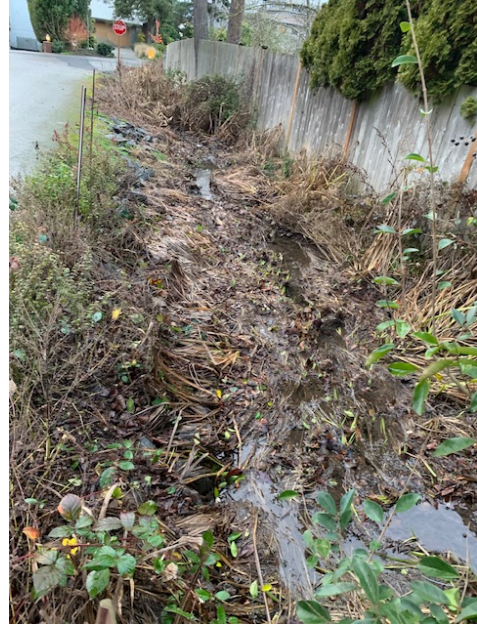
Open Channel Looking Downstream
Point F

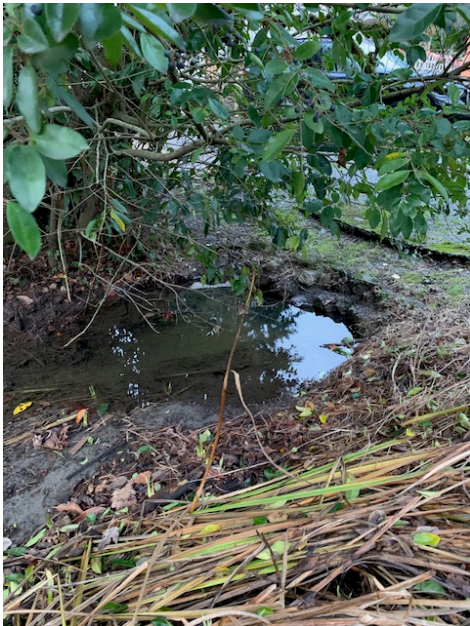
2. No existing or potential constraint or lack of capacity in the existing drainage system was apparent. Some ponding existed in the open ditch where culvert discharges but it will not prevent runoff from flowing in the ditch. There was no other standing water in the open ditch.

Culvert Discharge to open Ditch Point F

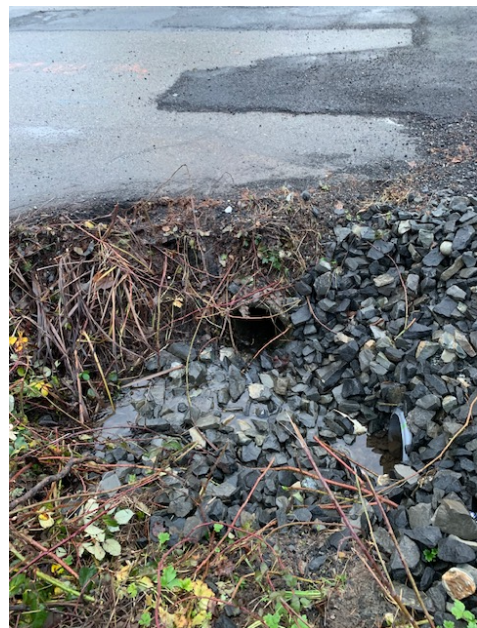
End of open channel – Culvert entrance
Point G

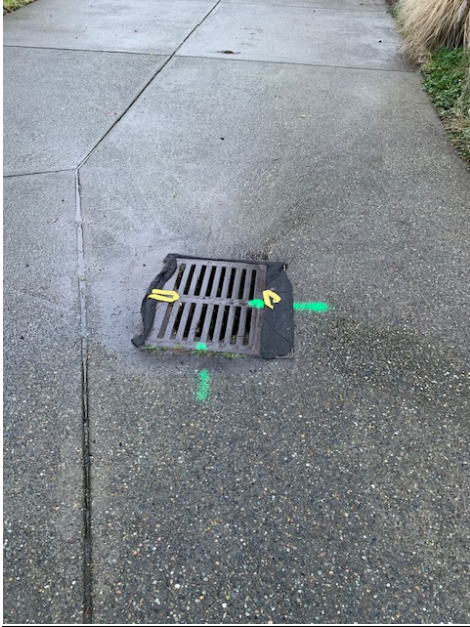
Catch Basin Point H driveway - West of
60th Ave SE - Looking West
