Arborist Report

To: Anne James Landscape Architecture LLC
Site: 6236 SE 22nd St, Mercer Island, WA 98040
Re: Tree Inventory
Date: January 25, 2024
Project Arborist: George White,
ISA Certified Arborist #PN-8908A
ISA Qualified Tree Risk Assessor
Reviewed By: Katherine Taylor
ISA Certified Arborist #PN-8022A
ISA Qualified Tree Risk Assessor
Referenced Documents: Overall Landscape Plan L-1.0 (Anne James Landscape Architecture LLC,
1.18.2024)
Attached: Table of Trees
Tree Site Map

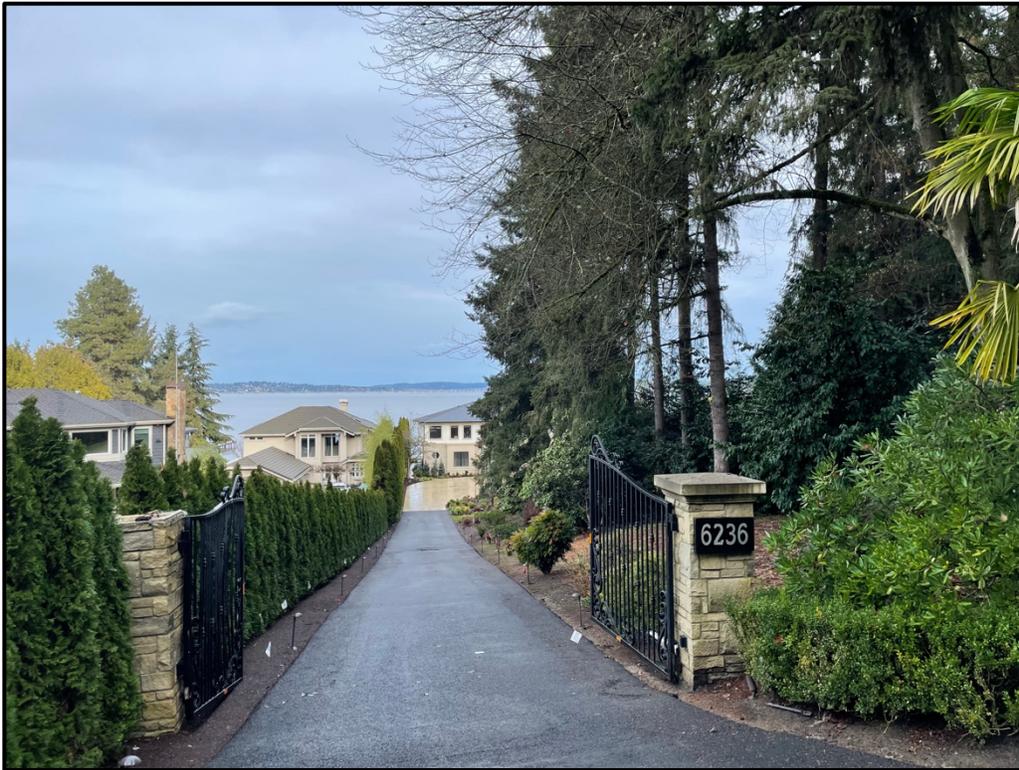
Photo 1. A view looking north along the existing driveway. Most tree impacts will occur on the east (right) side of this driveway.

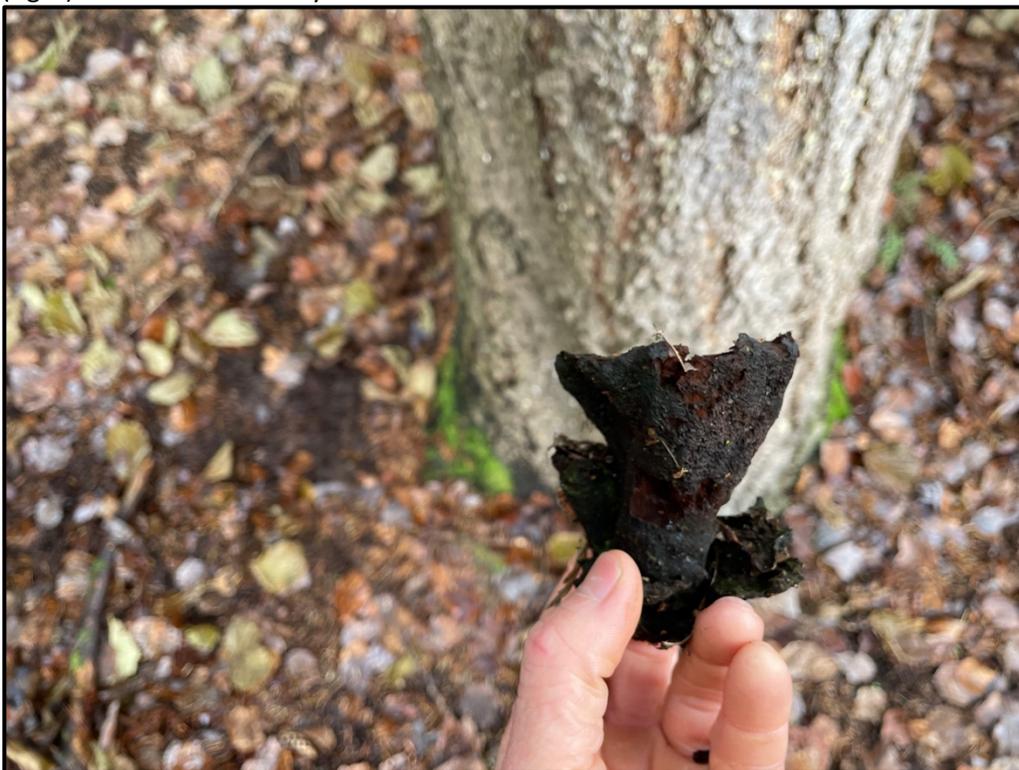
Tree 401 is a 19.6-inch Douglas-fir located near the southern property line. A small dyer's polypore (*Phaeolus schweinitzii*) fruiting body was found at the base of this tree. Dyer's polypore is a native pathogen that commonly associates with Douglas-fir. This fungus causes basal heartwood and root decay in affected trees. While this has little impact on tree health, trees with hollowed bases are more susceptible to windthrow. This tree is currently proposed for removal.

Photo 2. A small Phaeolus fruiting body found near the base of tree 401.

Trees 401 and 405 are proposed for removal because they conflict with the proposed driveway grading and the installation of the proposed gate. Trees 421, and 422 are currently proposed for removal

because they conflict with the installation of stone steps as part of the proposed bark-mulch pathway. All removed trees should be felled directionally or should be removed in pieces to avoid damaging the adjacent trees. Stumps of removed trees located within the recommended limits of disturbance (see RLOD and MLOD below) of a retained tree should be ground in place rather than be ripped out to avoid damaging the adjacent root systems.

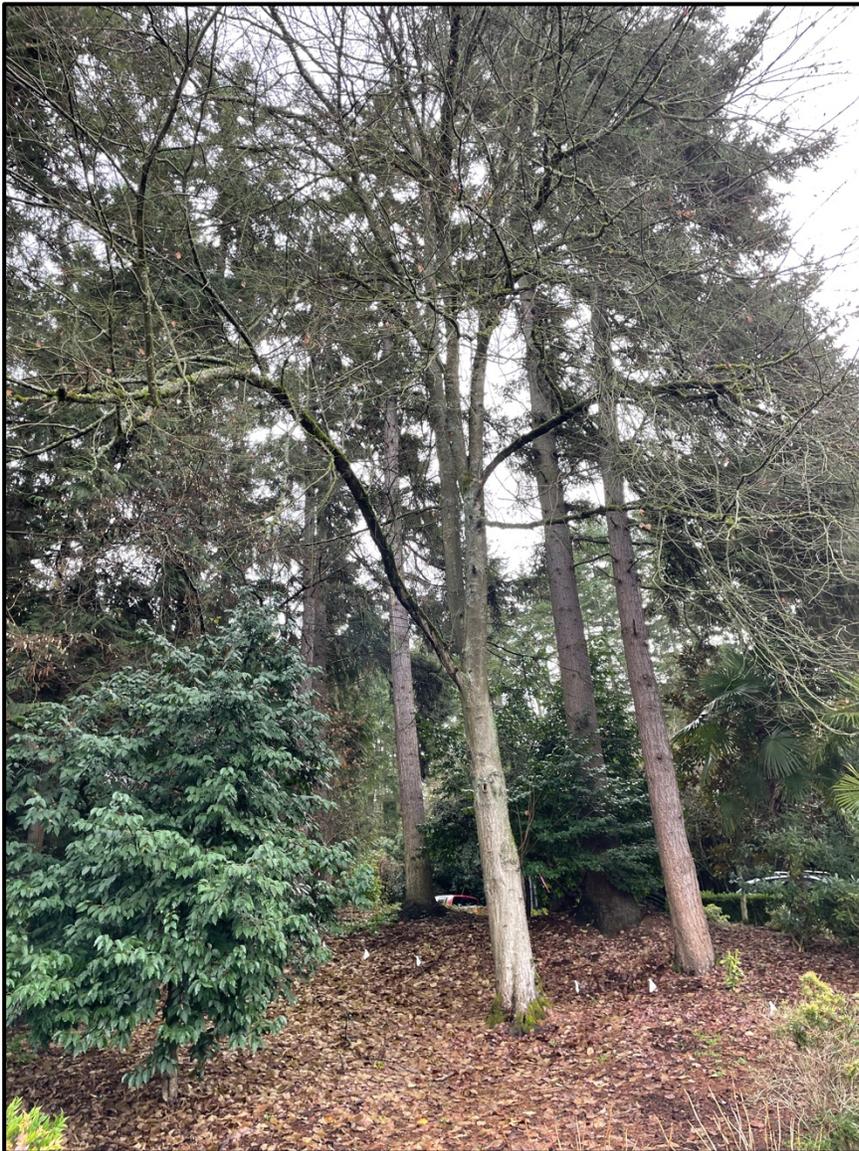
Tree 405 is an 18.7-inch red maple that is in fair health and structural condition. This tree has a narrow, codominant union at approximately 20 feet above grade with included bark. Brittle cinder fungus (*Kretschmeria deusta*), a root rot, was also found at the base of this tree. This tree is currently proposed for removal.

Photo 3. Tree 405, a red maple I fair health/fair structural condition that is currently proposed for removal.

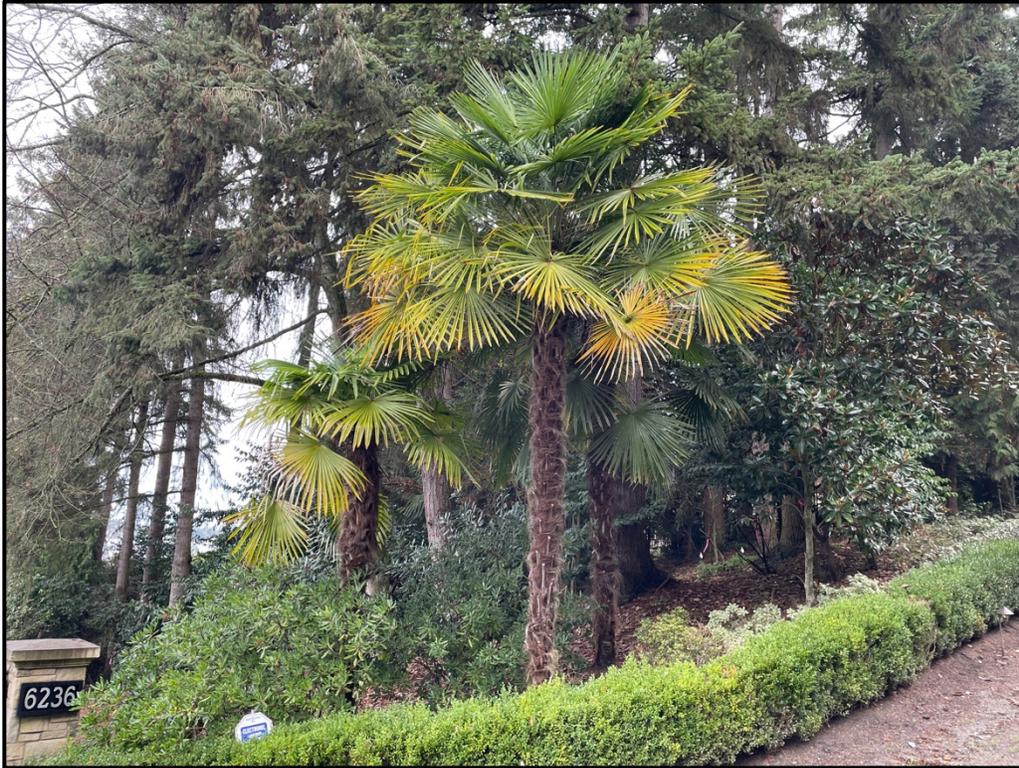
We observed three Chinese windmill palms (*Trachycarpus fortunei*) on-site near the southern property line. Palm trees are taxonomically distinct from woody trees and are therefore not regulated as trees under most municipal code unless explicitly stated. All three palms are proposed for removal.

Photo 4. Chinese windmill palms near the driveway entrance. These plants are not regulated and are proposed for removal

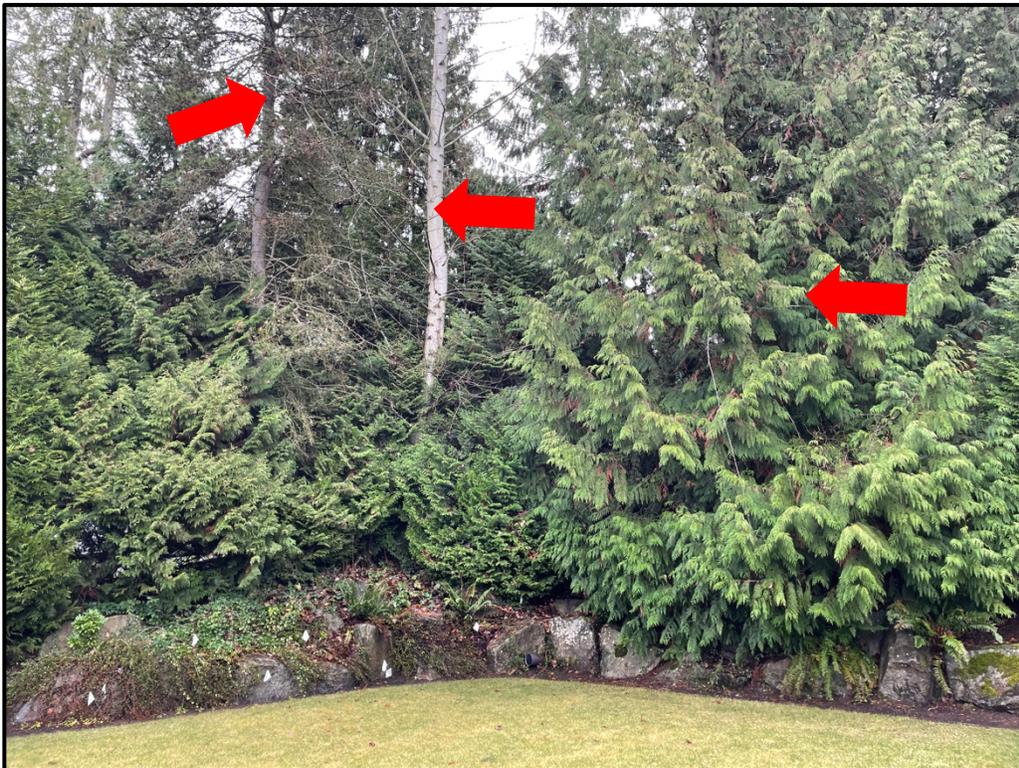
Trees 418-420 are growing above an existing rockery southeast of the proposed pickle-ball court. The rockery and associated grade change are sufficient to contain the root systems of these trees from extending into the footprint of the proposed court. No changes are proposed to the existing rockery; therefore, these trees will be protected adequately if tree protection fencing is placed at the rockery edge.

Photo 5. Trees 418-420 (Red arrows) growing above an existing rockery.

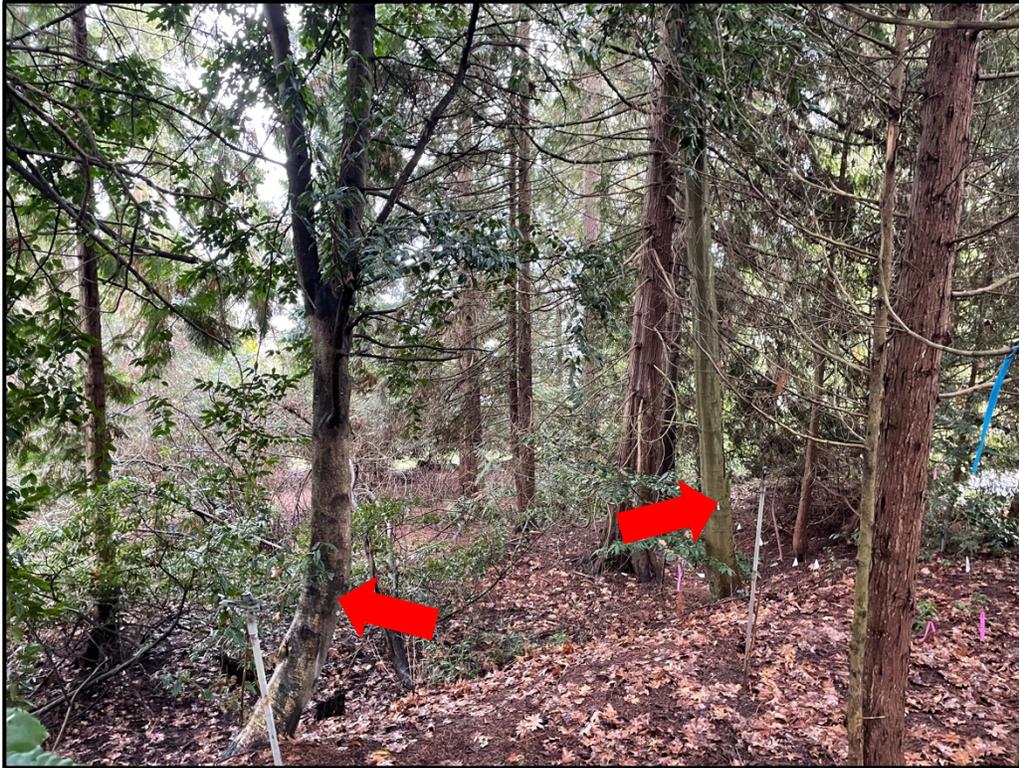
Photo 5. Trees 421 and 422 (red arrows), two Portuguese laurels currently proposed for removal.
