Arborist Report

To: Johnathon Spare
Site: 8265 SE 61st St, Mercer Island, WA 98040
Re: Tree Inventory
Date: March 20, 2024
Project Arborist: George White,
ISA Certified Arborist PN-8908A
ISA Qualified Tree Risk Assessor
Reviewed By: Connor McDermott,
ISA Certified Arborist PN- 8704A
ISA Qualified Tree Risk Assessor
Referenced Documents: Preliminary Site Plan A1.1 (Ectypos Architecture, 3.9.2024)
Attached: Table of Trees
Tree Site Map

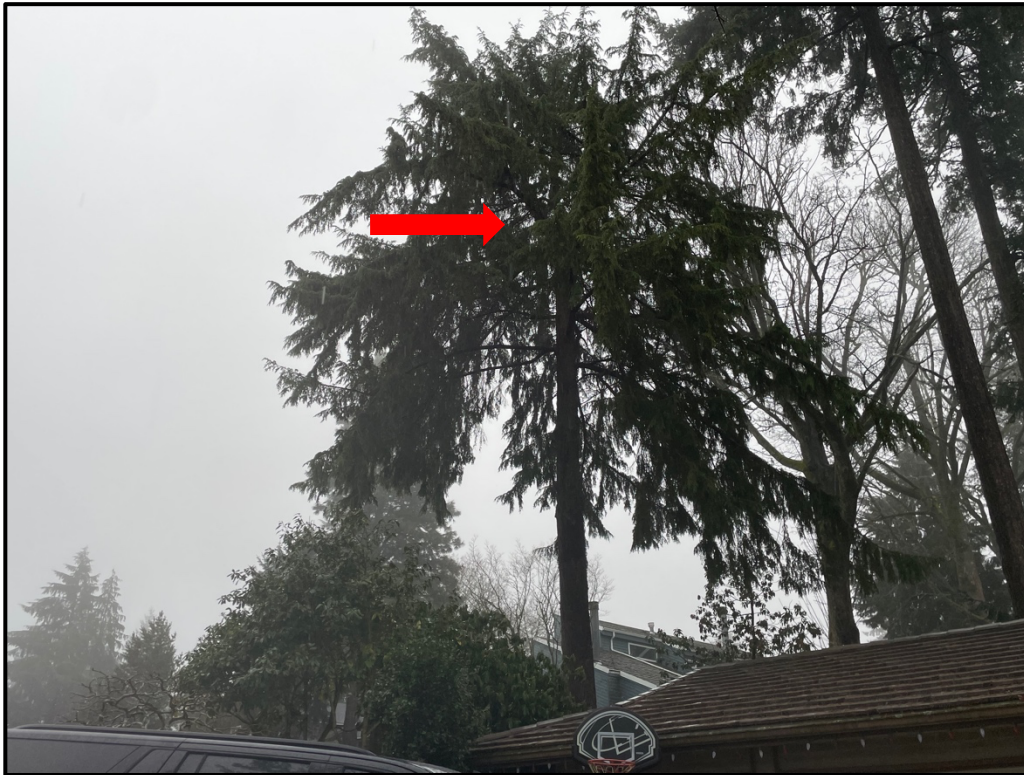
Tree 166 is a 23.8-inch western hemlock located east of the existing garage. This tree has been topped and has two reiterated leaders growing above the site of the old topping wound. I also noted wounds from climbing gaffs on the trunk of the tree. I recommend hiring a competent ISA certified arborist to perform structural pruning of the reiterative growth and inspect the site of the old topping cut for decay.

Photograph 1. Tree 166, a western hemlock that had been topped at the point indicated by the red arrow. This tree is currently proposed for removal.

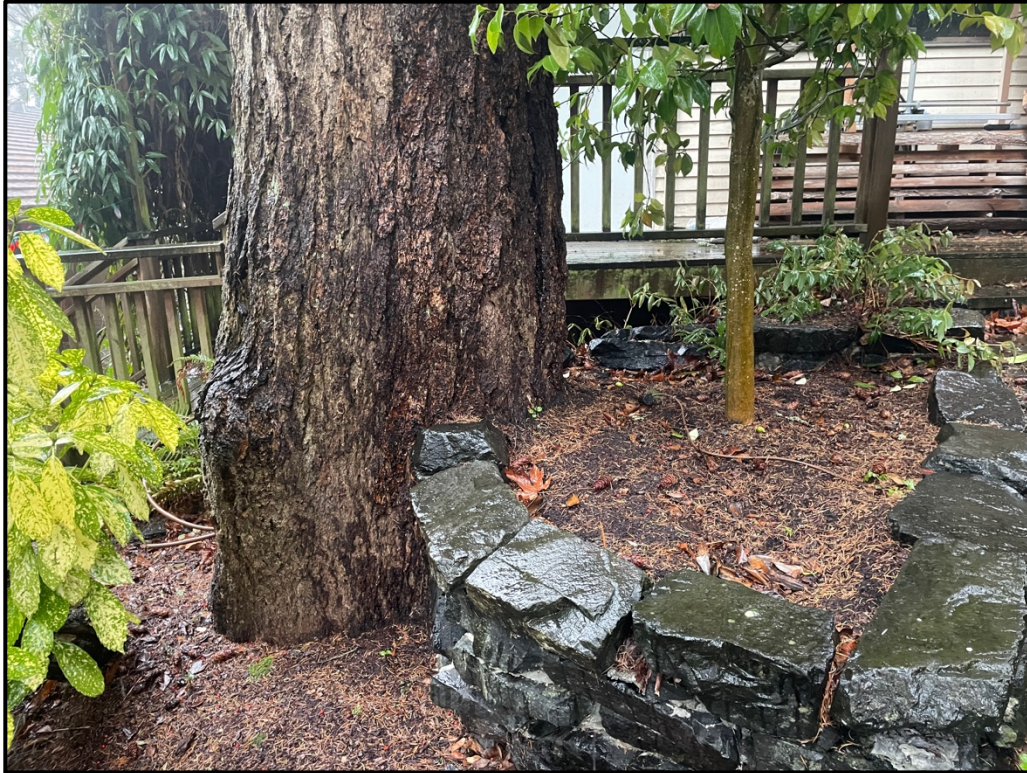
Trees 168 and 169 are two exceptional Douglas-fir trees in good health/structure growing in the terraced area southeast of the existing residence. The base of tree 168 appears to be partially buried as a result of terracing. I recommend renovating the terrace at the base of this tree to expose the entire root flair.

Photograph 2. The base of tree 168 has been partially buried during the yard-terracing. The root flare of this tree should be exposed to prevent disease.

- Renovate retaining wall adjacent to tree 168 to expose entire root flare.

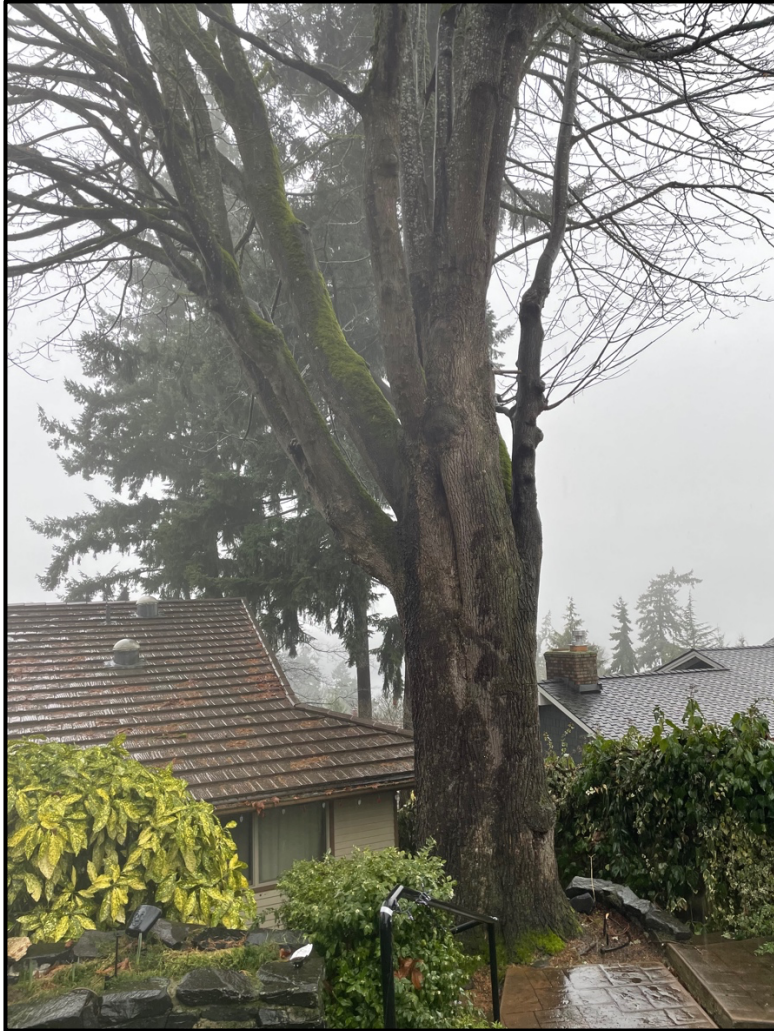
Tree 170 is an exceptional, 44.2-inch, bigleaf maple growing northeast of the existing residence. This tree is growing above a rock retaining wall and therefore has somewhat limited rooting area. In some

places confined roots have caused minor damage to an adjacent retaining wall, steps, and hardscape. This tree has considerable overhang of the existing residence.

This tree is of great concern to Mr. Spare as its crown overhangs his children's bedroom. He often moves his children into the basement during wind events because he is worried that a large branch or trunk will fail and impact their bedroom with severe consequence.

One exceptional tree in excess of 24 inches (Tree 170) is currently proposed for removal. This removal is permitted under MMIC 19.20.060.3.a, because its retention would prevent the replacement, or lasting repair, of the existing steps that have been damaged by the tree's root system. This limits safe egress/access from the front of the house and thereby creates an unavoidable hazardous situation. In addition, the only feasible avenue to access the west, and north sides of the existing structure is via the north side-yard. Tree 170 would conflict directly with this avenue if retained.

Photograph 3. Tree 170, an exceptional bigleaf maple currently proposed for removal.

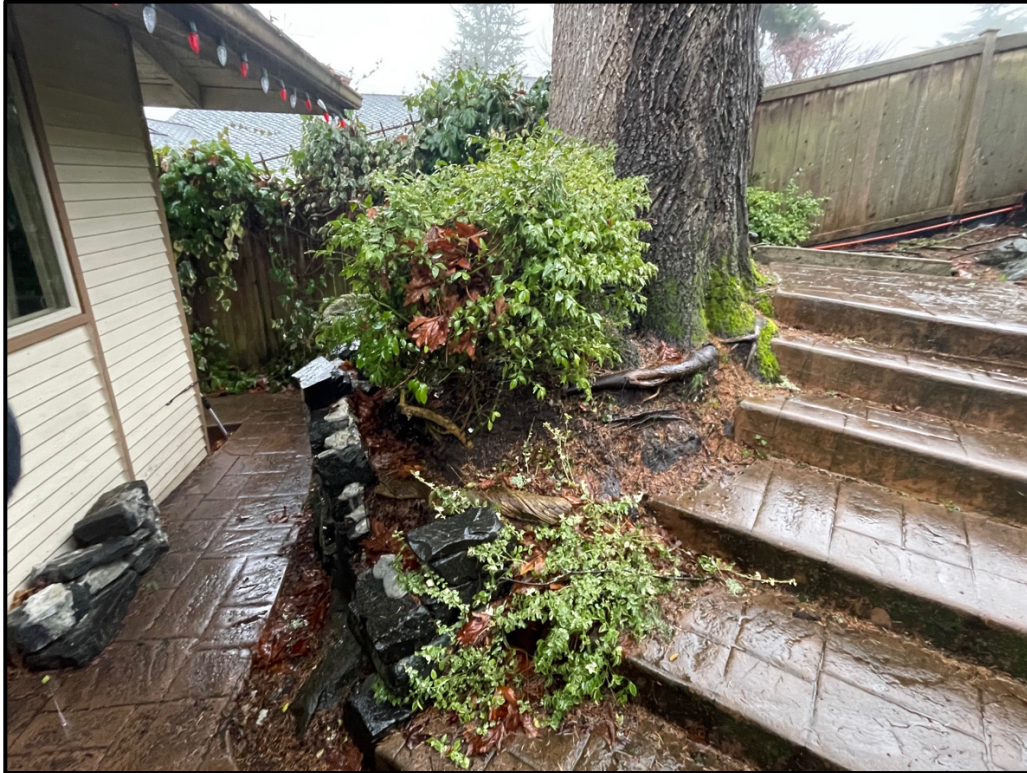
Photograph 4. Limited rooting area at the base of tree 170 causing uplift of the adjacent steps and damage to the existing retaining wall.

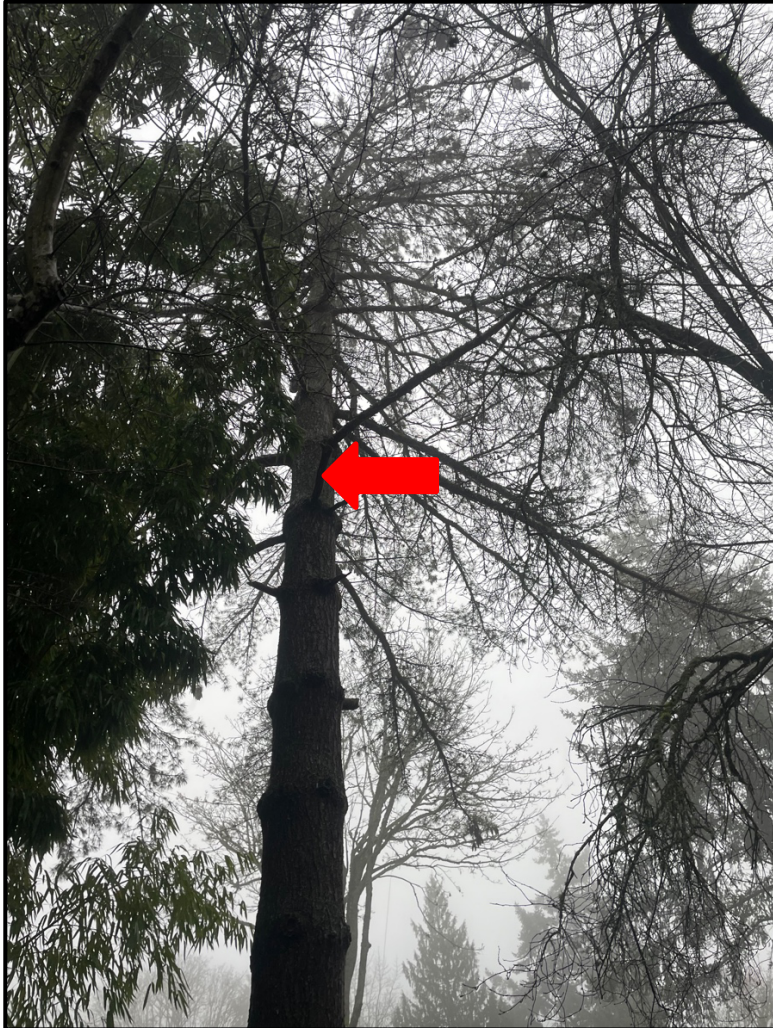
Tree 171 is a 22.2-inch, western white pine growing southwest of the existing house. This tree is in poor health as evidenced by thinning foliage, limited dieback, and a stress cone-crop.

I predict that this tree is tree will continue to decline in health.

Photograph 5. Tree 171, a western white pine in poor health (red arrow) exemplified by a very thin crown.

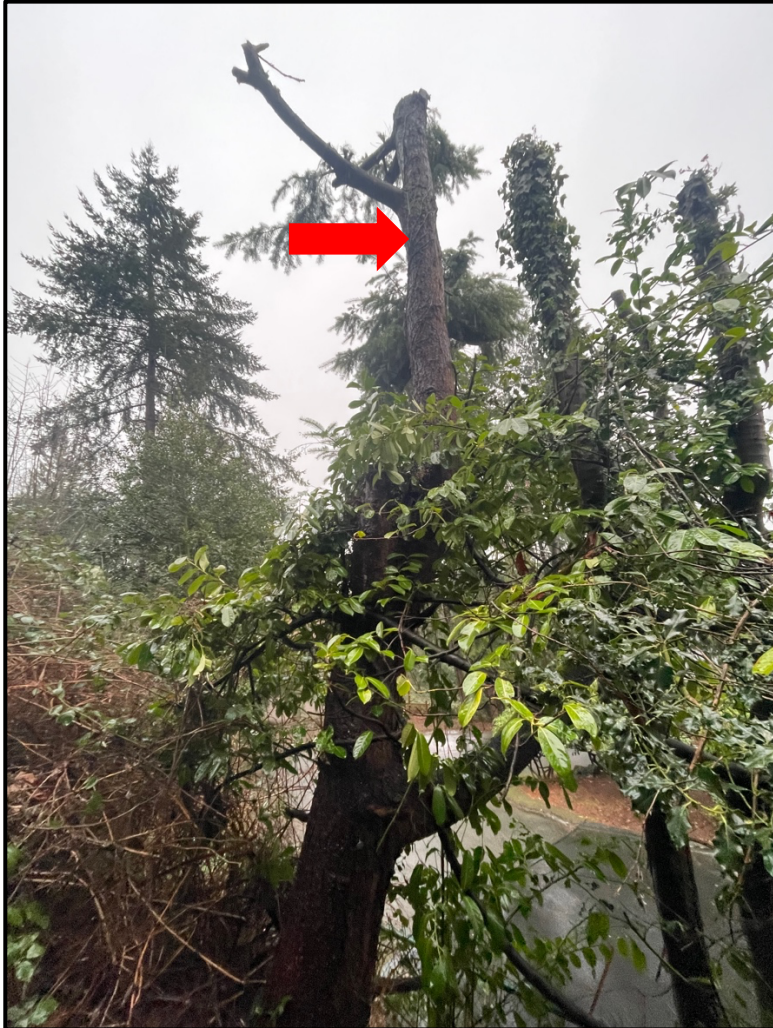
Trees 173-175 are growing in the steep slope ECA near the western property edge. All of these trees are in fair health and are exhibiting poor structure because they have been repeatedly topped/mal pruned.

Photograph 6. Tree 174 (red arrow), a Douglas-fir in poor health/structure that has been repeatedly topped. Several invasive plant species that should be managed are also shown in this photo.

I observed moderate levels of invasive plant species including Himalayan blackberry (*Rubus bifrons*), English ivy (*Hedera helix*), cherry laurel (*Prunus laurocerasus*) English holly (*Ilex aquifolium*) and invasive bamboo (*Phyllostachys aurea*). Pressure from invasive plants is most concentrated on the easternmost portion of the site across the steep slope ECA. Invasive plant species should be managed prior to construction.
