**RE: Limiting impact to site trees during wall reconstruction at 3655 73rd Avenue SE.
PN-2837700125**

A post-construction impact assessment was prepared and submitted in February of 2023 for this site. A follow up report documenting the first stage of mitigation for the retained trees was completed in July of 2023.

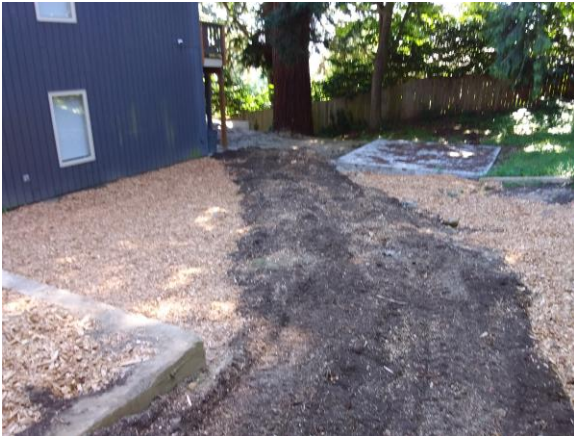
An 18” deep mulch access path was created for the light equipment necessary to aid in the mitigation work. It was carefully laid out to thread between the retained trees as to provide the most protection as possible for their Critical Root Zones. This path was left in place in expectation of its usage during the larger project of removing and replacing the rear retaining walls (Figures 1-3).

Figure 1. West end of the mulch access path. Figure 2. East end of the access path.

It is recommended that additional mulch be overlaid on the existing to ensure there is a full depth of 18” before it usage during the next phase of the project. Steel plate or 5/4” plywood will have to be placed over the mulch bed between Wall 3 and the street entry in order to fully protect the roots.

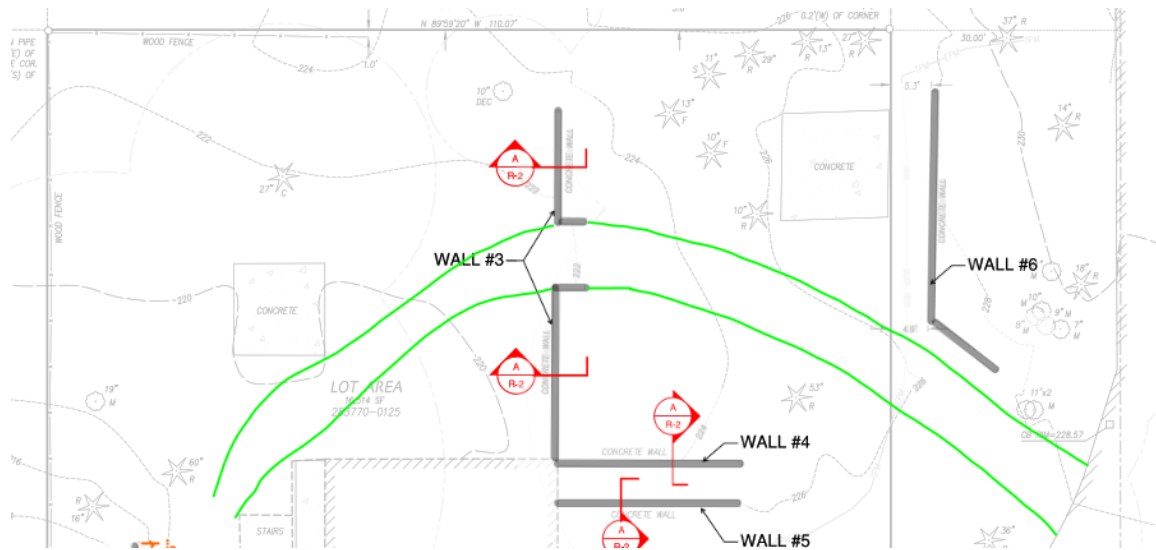
Figure 3. Design of the mulch access path necessary to reach the west side work space.

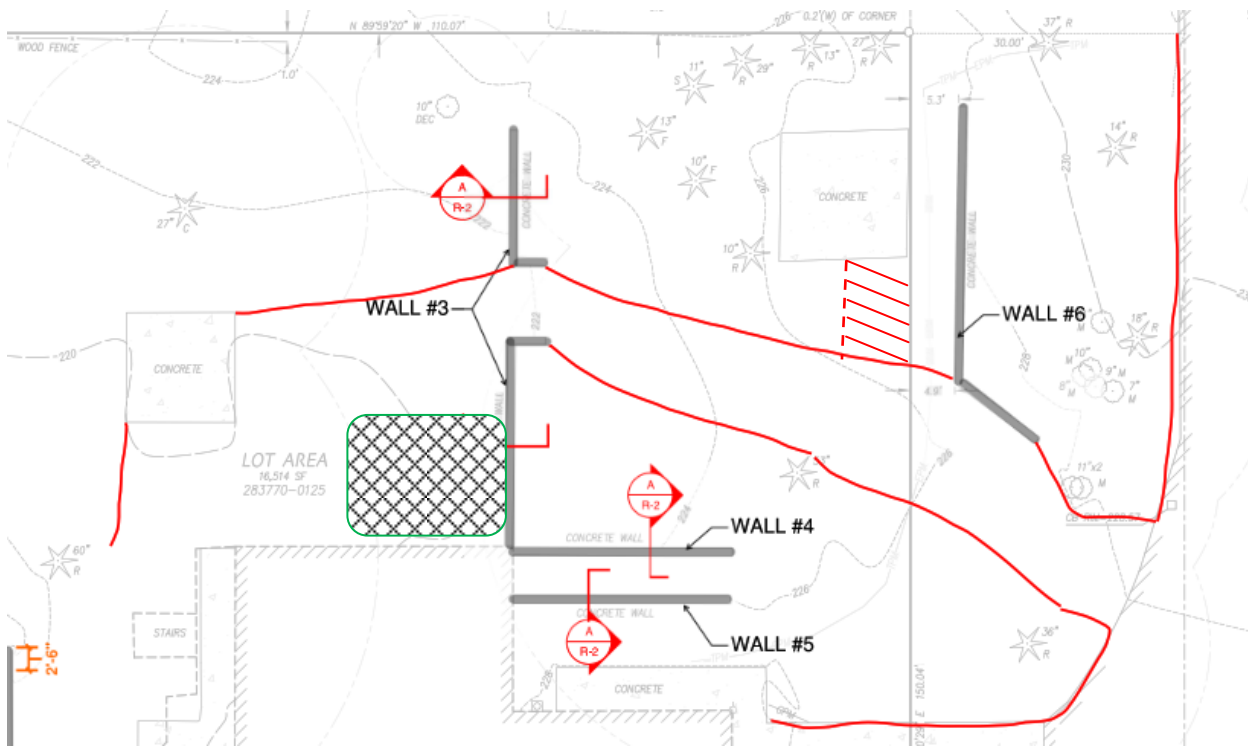
Figure 4. Rough outline of the where the tree protection fencing should be installed. The red striped area is where safe entrance to the concrete pad can be made. The cross-hatched area is good space for stockpiling.

To ensure that the site trees experience no further impact fencing will have to be erected as shown in Figure 4 below. Absolutely no work may occur within this space, no materials can be stored within it, and no vehicles can park in it. Mulch has already been laid in the areas as part of the initial mitigation. The two existing concrete pads can be used as stockpile areas without affecting the trees. If the NW corner one is to be used it can be accessed via the corridor shown in the illustration. A section of fencing would be set between the pad and construction entry path at 10' radial distance from tree at its corner.

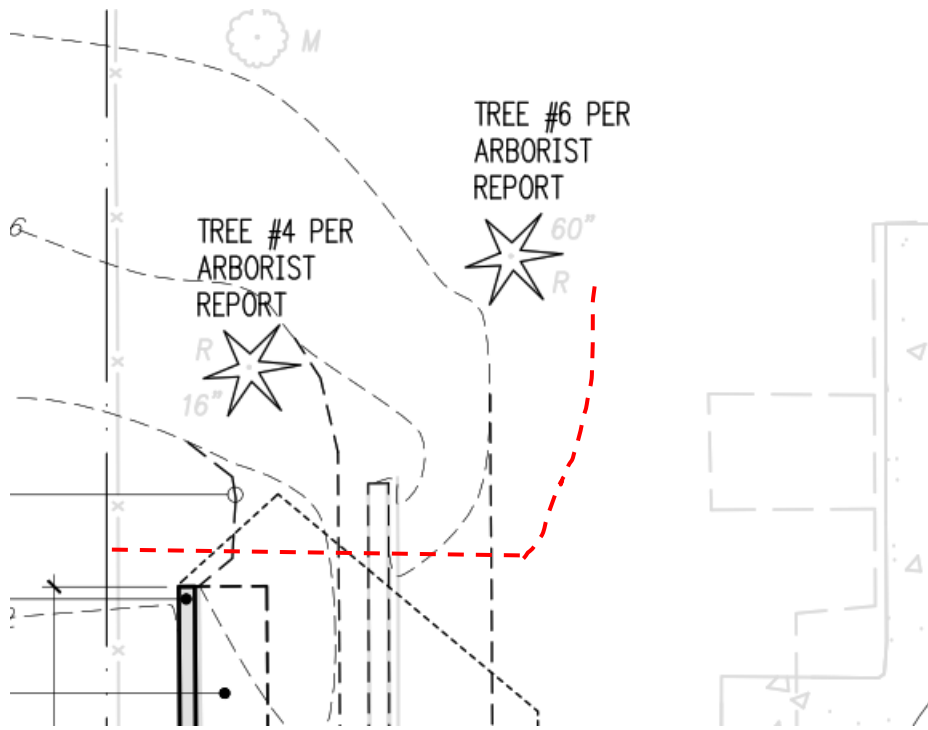
Figure 5. The red dashed line shows approximated location of protection fencing for the #4 and #6 trees. The north/south section will be set in accordance to the width of the construction entry path but should be placed as far as possible from the east side of the #6 tree. The section coming down from the concrete pad shown in Figure 4 will tie into this one.

The area immediately around the #6 tree will have to be carefully excavated of the fill material that was pushed around it during the initial wall construction. This work will have to be done under arborist oversight. Once the original grade is exposed and the north ends of Walls 1 and 2 are removed a protection fence should be set from the existing west fence to the edge of the construction access drive and then along the drive's west side as possible (Figure 5).
