May 23, 2024

JN 24185

Subject: **Foundation Considerations and Critical Area Report**  
Proposed Covered Entryway Addition  
4226 – 85<sup>th</sup> Avenue Southeast  
Mercer Island, Washington

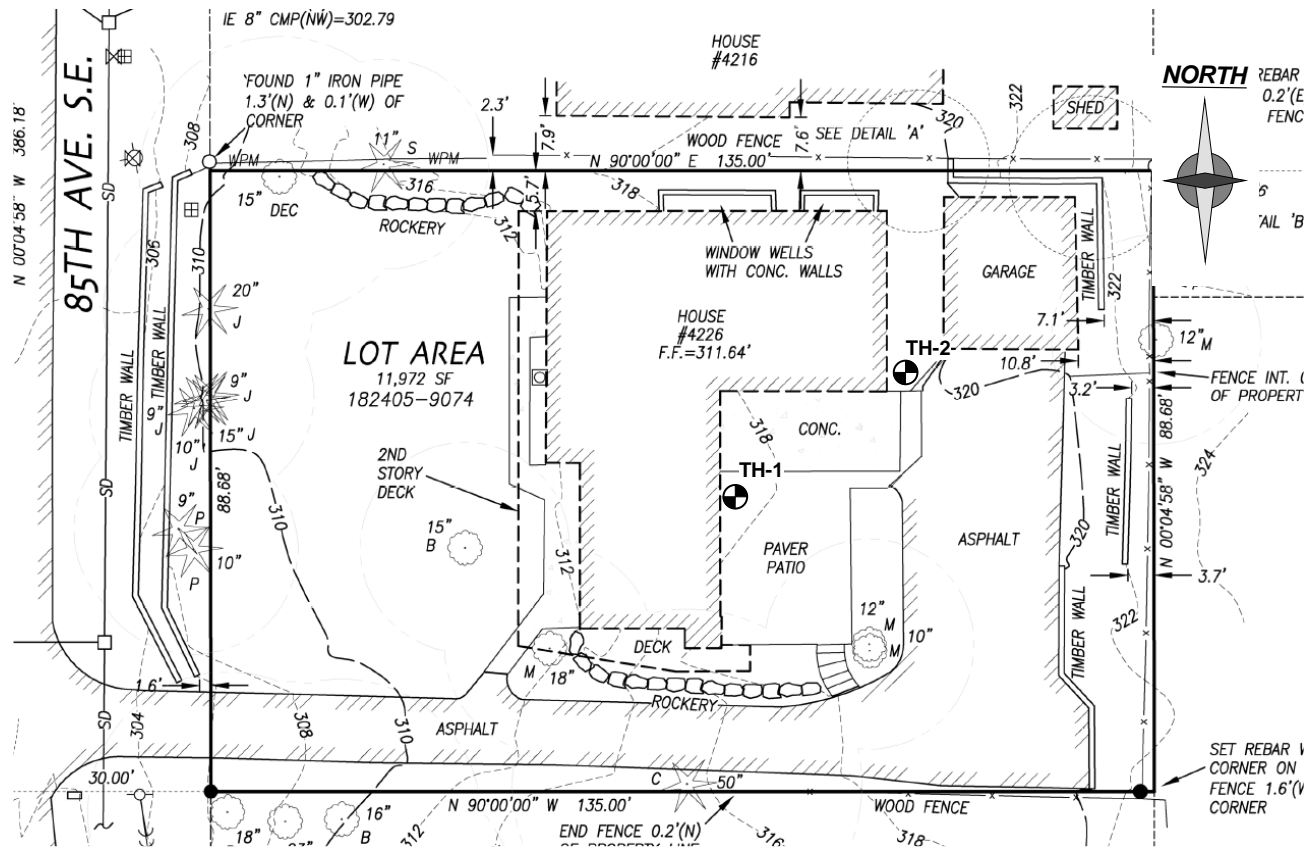
During our site visit, two test holes were excavated near the proposed addition area. The undersigned staff geotechnical engineer from our firm excavated and logged the test holes. The location and logs of both test holes are presented below.

**TEST HOLE 1**

Depth (feet)	Soil Description
0.0 – 7.5+	Brown and dark-brown, gravelly, very silty SAND with roots and decayed organics, fine-grained, moist, jumbled, loose to medium-dense [FILL]

Test Hole was terminated at 7.5 feet May 21, 2024 due to auger refusal on gravels. No groundwater seepage was encountered in the test hole.

**TEST HOLE 2**

Depth (feet)	Soil Description
0.0 – 9.0	Brown and dark-brown, gravelly, very silty SAND with roots and decayed organics, fine-grained, moist, jumbled, loose to medium-dense [FILL]
9.0 – 9.5	Gray, slightly gravelly, silty SAND, fine-grained, moist, medium-dense to dense [SM]

Test Hole was terminated at 9.5 feet on May 21, 2024. No groundwater seepage was encountered in the test hole.
