Arborist Report

~ Tree Inventory & Protection Zones ~

October 20, 2020

Tree133 LLC was hired to perform a pre-construction tree inventory and recommend appropriate tree protection for street trees adjacent to the Mercer Island Shell Station, 7833 SE 28th St. The site visit for this project was completed on October 12, 2020.

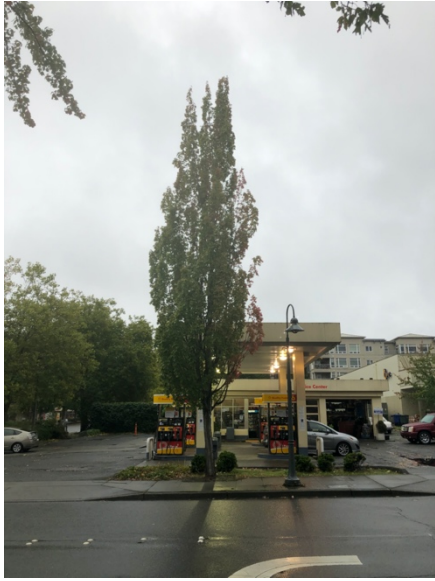
Tree 1 - North View

**Tree 1: Red maple (*Acer rubrum*)
10.4" dsh, 42 ft height, canopy spread 10x10 ft**

This street tree is located at the north end of the property along SE 28th St, near the canopy structure. Overall, the tree is in fair condition with visible mechanical damage along with minor canopy dieback on the west aspect of the trunk.

Considering all input received, it appears that tree removal and replacement will be necessary. Therefore, site plans should include appropriate space for appropriate replacement as directed by the City of Mercer Island.

If the tree will be retained, tree protection fencing should be installed in accordance with City of Mercer Island guidelines. Please note the defined tree protection zone includes paved areas on the site, and they should be fenced appropriately. Excavation within the tree's dripline area will require supervision by a Qualified Arborist, per city code.

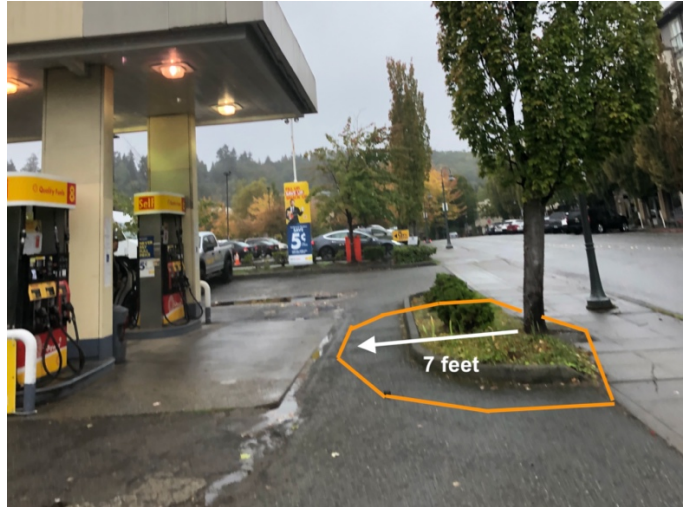
*Tree 1 - Recommended Protection Zone
(East View)*

Based on species, size and condition, the recommended tree protection zone (TPZ) radius for this tree is 8x trunk diameter (ie. 83" or approx. 7 ft). As described by Brad Kaul, project architect, the client anticipates excavation will extend to the property line adjacent to/including this tree. If significant excavation (greater than 15% of protected area) is required within the TPZ, proactive removal and replacement is recommended due to anticipated severe impacts to health and/or stability.

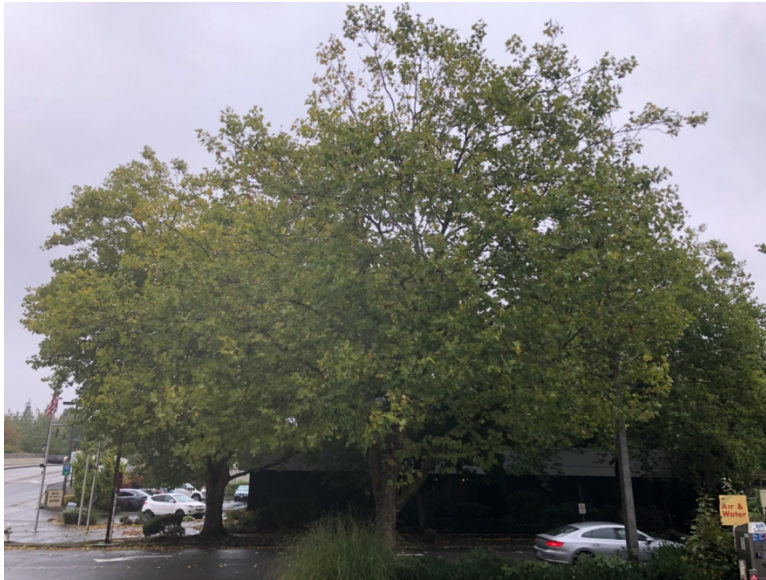
Tree 2 - West View

**Tree 2: American sycamore (*Platanus occidentalis*)
17.8" dsh, 46 ft height, canopy spread 45x39 ft**

This street tree is located at the east edge of the property, along 80th Ave SE. The tree appears to be in excellent condition with no visible defects.

Considering the input received, it appears that removal and replacement will be necessary for this tree. Therefore, site plans should include appropriate space for appropriate replacement as directed by the City of Mercer Island.

If the tree will be retained, tree protection fencing should be installed in accordance with City of Mercer Island guidelines, including paved areas. Excavation within the tree's dripline area will require supervision by a Qualified Arborist.

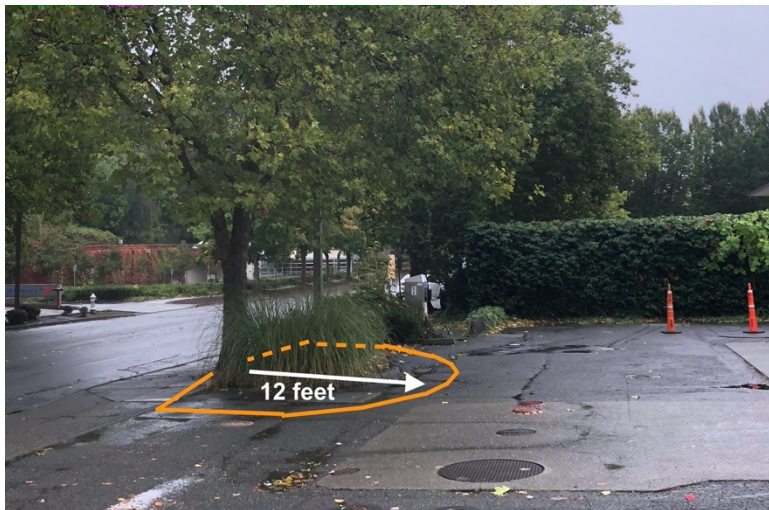
*Tree 2 - Recommended Protection Zone
(North View)*

Based on species, size and condition, the recommended TPZ radius for this tree is 8x trunk diameter (ie. 142" or approx 12 ft). Similar to Tree 1 (above), the client anticipates excavation will extend to the property line adjacent to/including Tree 2. Several access points for underground fuel infrastructure are located approximately 9 ft northwest of the trunk. We understand these structures will be removed and replaced during the project.

If significant excavation (greater than 15% of protected area) is required within the TPZ, proactive removal and replacement is recommended due to anticipated severe impacts to health and/or stability.

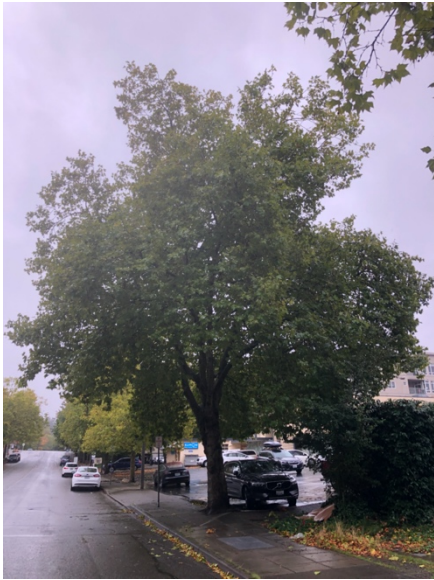
Tree 3 - Northeast View

**Tree 3: American sycamore (*Platanus occidentalis*)
27.0" dsh, 55 ft height, canopy spread 63x51 ft**

This street tree along 80th Ave SE overhangs the southeast corner of property. The tree appears to be in excellent condition with no visible defects. The trunk is located approximately 15 feet from the property corner.

Tree protection fencing should be installed in accordance with City of Mercer Island guidelines. Excavation within the tree's dripline area will require supervision by a Qualified Arborist.

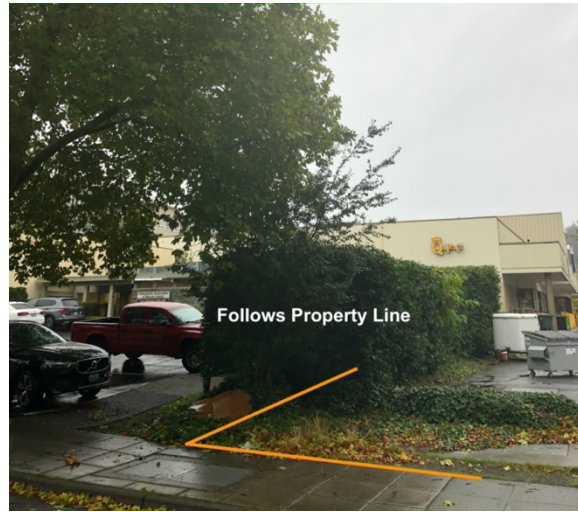
*Tree 3 - Recommended Protection Zone
(Northeast View)*

Based on species, size and condition, the recommended TPZ radius for this tree is 8x diameter (ie. 216" or approx 18 ft). Due to the limited canopy overhang, it is recommended to establish the TPZ at the property boundary.

Based on available information, and the understanding that excavation is limited to within the property boundary, no significant impact to health or stability are anticipated for this tree.
