Arborist Report

February 7th, 2022

Imani Homes
2900 78th Ave Se
Mercer Island, Wa

Arborist report for Imani Homes. 2900 78th Ave SE, Mercer Island Washington. Currently the site of Baskin-Robbins. February 1, 2022. 1 PM.

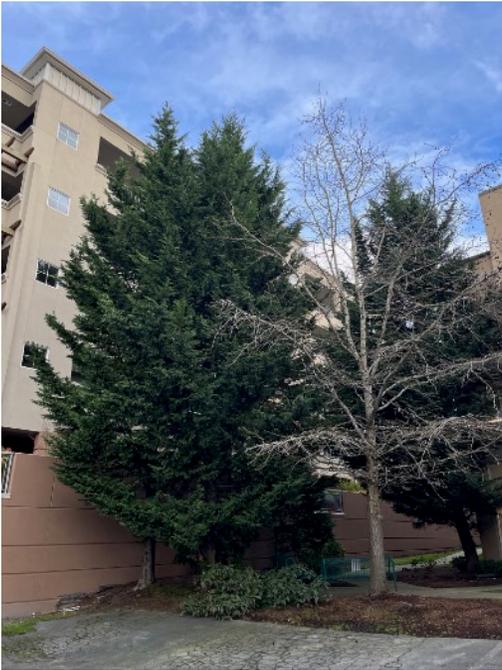
Trees #1-4 above

Close to the northeast corner of the site there are three Leyland Cypress (*Cupressus x Lelandii*) trees and one Sweetgum (*Liquidambar styraciflua*) that belong to the adjacent apartment complex.

1. Leyland Cypress (*Cupressus x Lelandii*). 12" DSH. Condition 1. 12' CRZ radius.
2. Leyland Cypress (*Cupressus x Lelandii*). 10" DSH. Condition 1. 12' CRZ radius.

3. Leyland Cypress (*Cupressus x Lelandii*). 19" DSH. Condition 1. 19' CRZ radius.
4. Sweetgum (*Liquidambar styraciflua*). 12" DSH. Condition 1. 13' DLR. 12' CRZ radius.

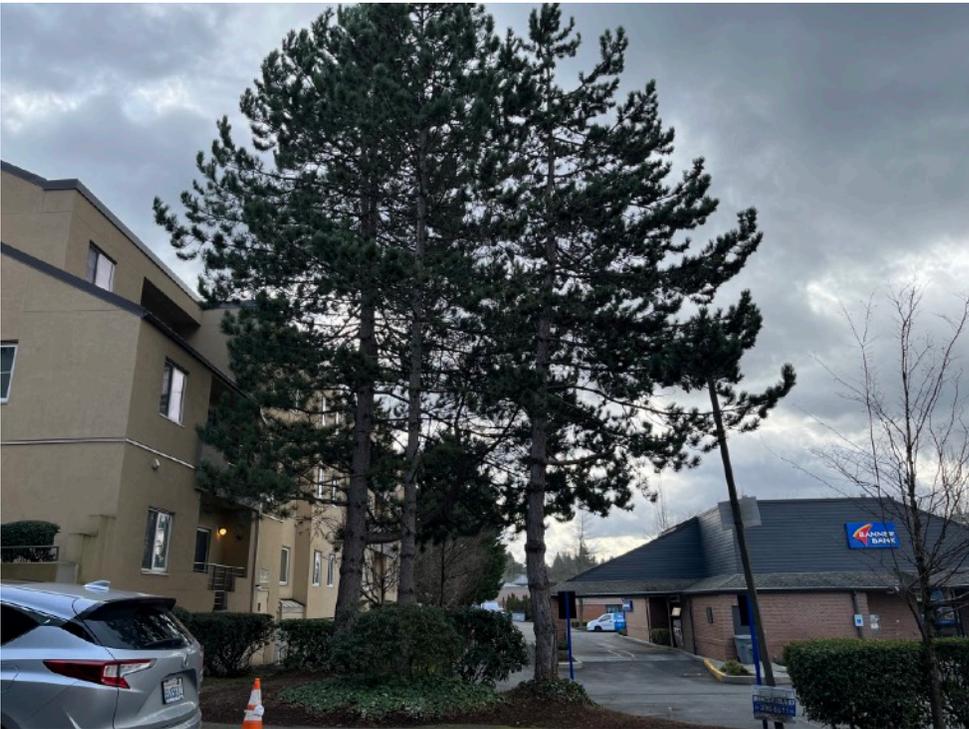
Trees #5-7 above

Close to the southeast corner of the site there are three Austrian Black Pines (*Pinus nigra*).

5. Austrian Black Pine (*Pinus nigra*). 20" DSH. Condition 1. 20' CRZ radius.
6. Austrian Black Pine. (*Pinus nigra*). 10" DSH. Condition 1. 10' CRZ radius.

7. Austrian Black Pine. (*Pinus nigra*). 20" DSH. Condition 1. 20' CRZ radius.
8. Sawleaf Zelkova (*Ulmus serrulata*). 4" DSH. Insignificant tree.
9. Sawleaf Zelkova (*Ulmus serrulata*). 5" DSH. Insignificant tree.

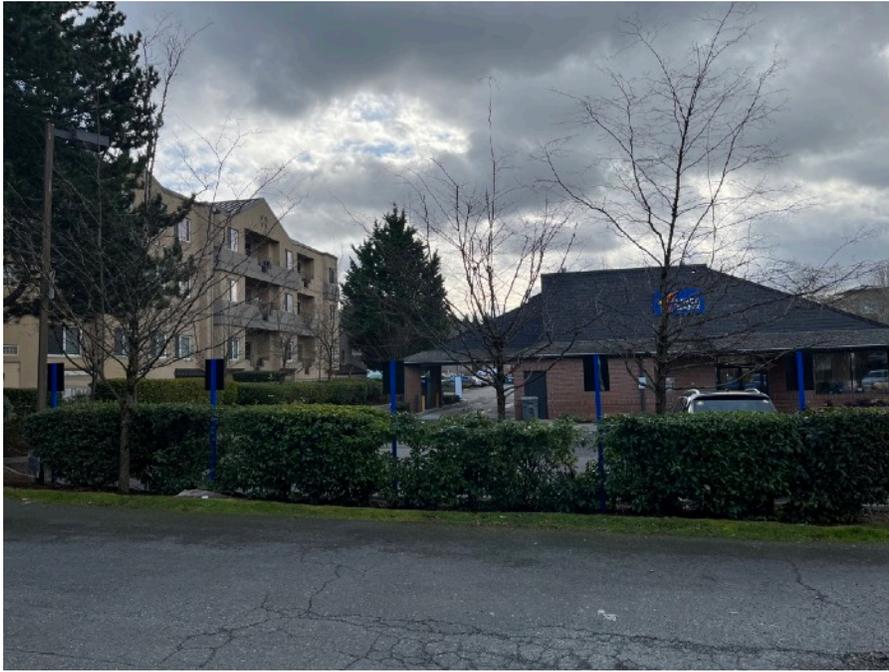
Trees #8-10

Along the southern edge of the site there are three Sawleaf Zelkova (*Ulmus serrulata*) that are too small to be considered significant.

10. Sawleaf Zelkova (*Ulmus serrulata*). 4" DSH. Insignificant tree.
11. Red Maple (*Acer rubrum*). 13" DSH. Condition 1. 14' DLR. 13' CRZ radius.
12. Red Maple (*Acer rubrum*). 13" DSH. Condition 1. 14' DLR. 13' CRZ radius.

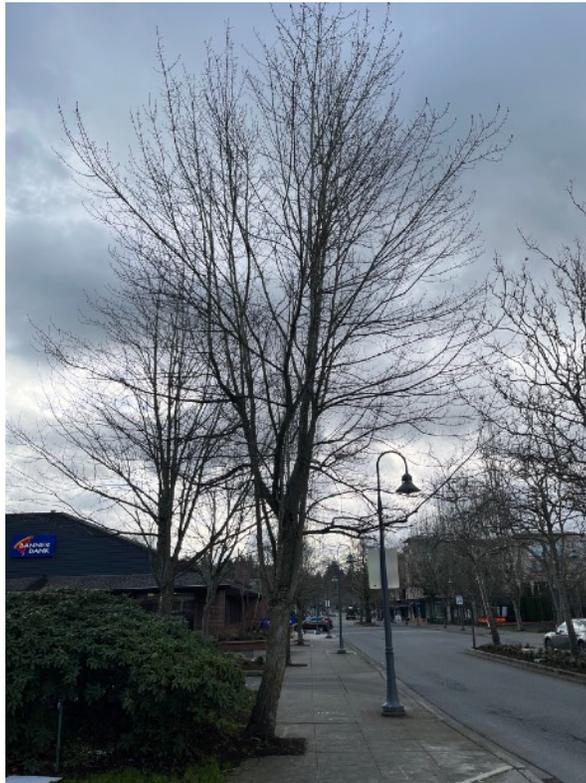
Tree #11

The Red Maples (*Acer rubrum*) along the Western frontage are likely part of The City of Mercer Island's purview.
