# LAYTON TREE CONSULTING, LLC

## ARBORIST REPORT

3003 77<sup>th</sup> Avenue SE  
Mercer Island, WA

July 18, 2023

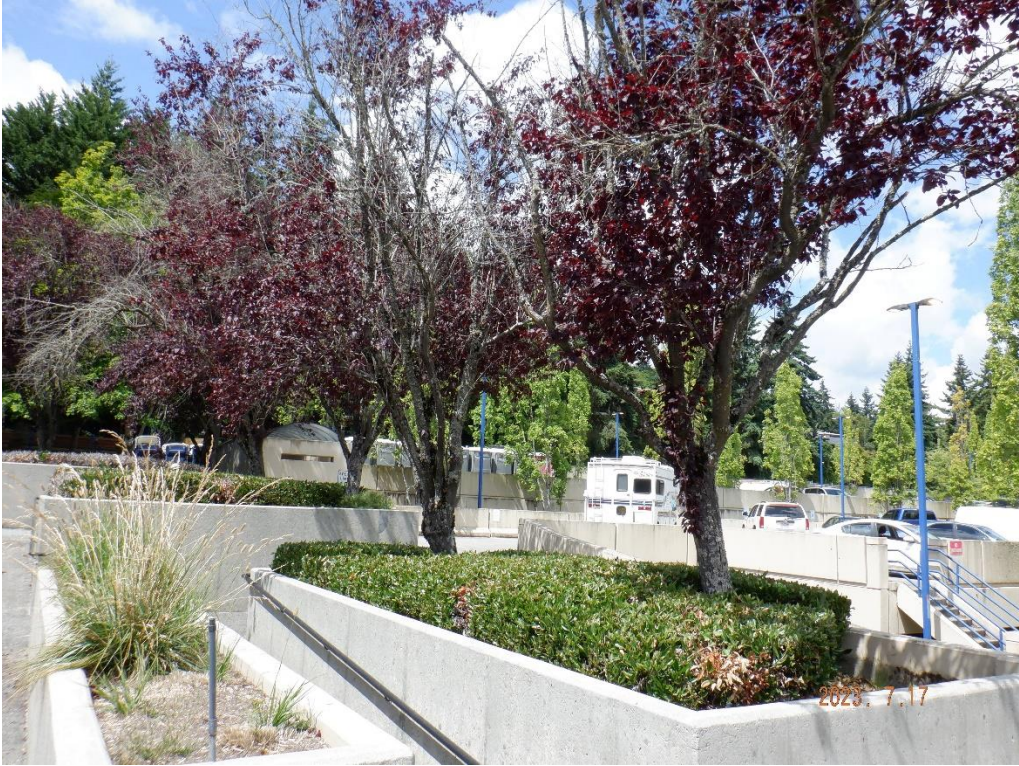
Trees #205 and #206

Nine of the subject trees are a cultivated variety of cherry plum or purple-leaf plum, *Prunus cerasifera*. These exist in large concrete planters. They were likely planted around the time the building was constructed in 1982, making them roughly 40 years of age. All have significant dieback of upper crown components. See pictures below. Some have major dieback and are in an ultimate state of decline. It appears the irrigation inside the concrete planters has been turned off or is not working.

The subject cherry plum trees are in varying stages of decline, some more advanced than others. These trees have a limited productive lifespan in the landscape. They can be expected to continue to decline. Considering long-term sustainable tree canopy cover, replacement with new trees suitable for these concrete planter locations is prudent.

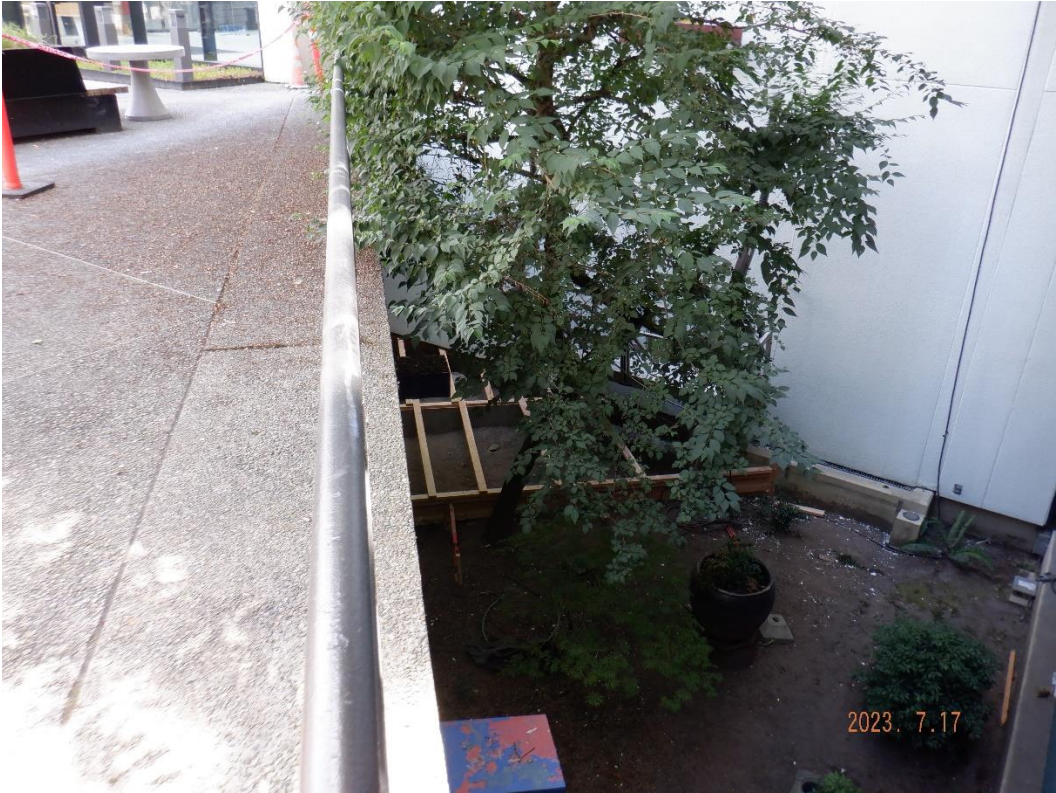
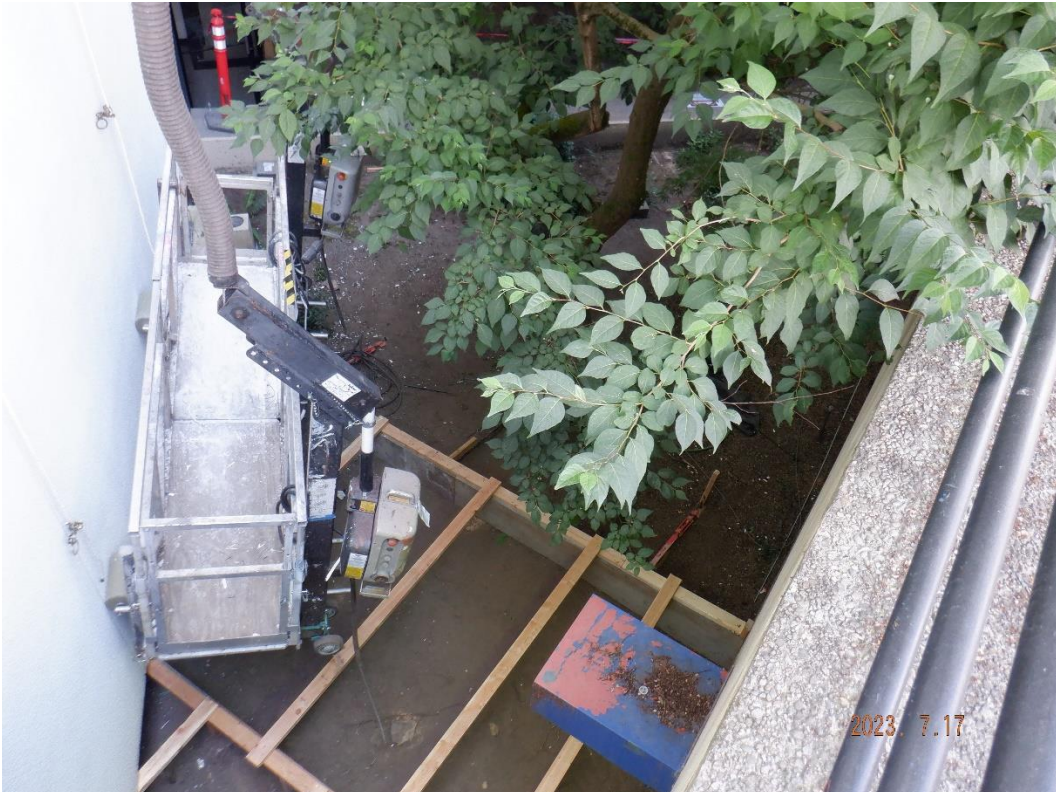
The other subject tree is a semi-mature Japanese snowbell, *Styrax japonicus*. It is located on the existing grade at the base of the building. Access to the base of the tree was not possible. It appears to be in good condition with no concerning defects. Unfortunately, there is a large new generator pad to be constructed directly next to the tree, covering roughly half of its root zone.

The long-term health of the Japanese snowbell is expected to be compromised by work within a vicinity of it. Removal and replacement are recommended.

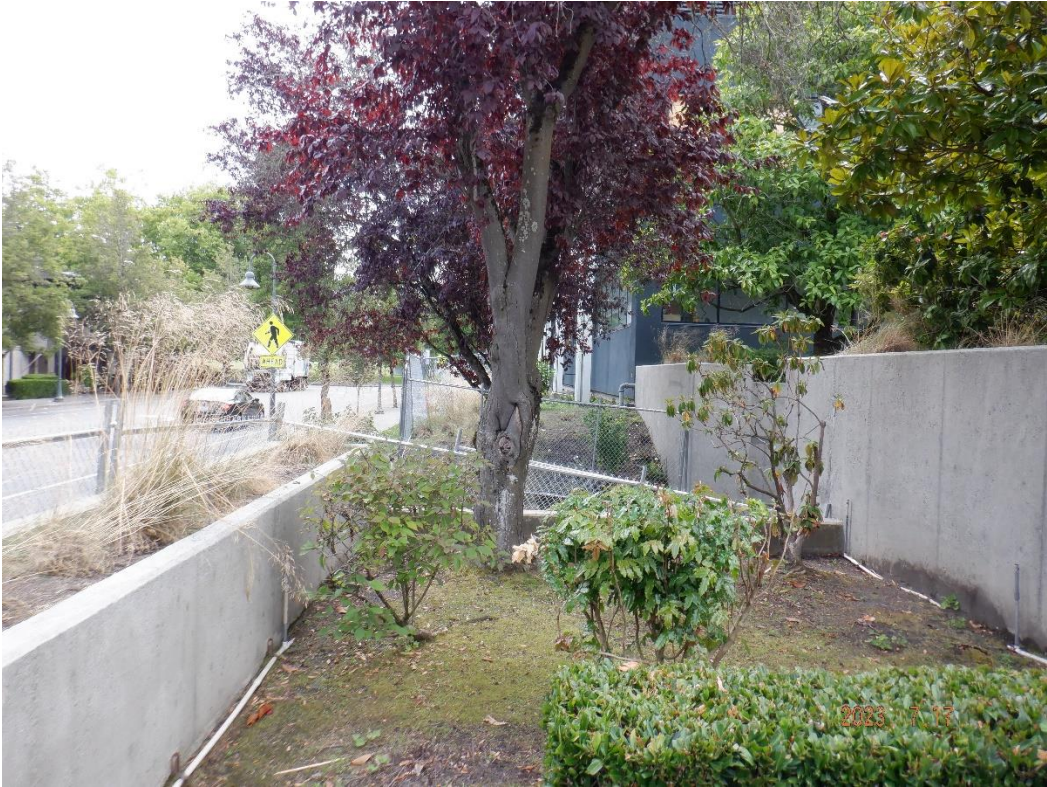
Tree #203

203	cherry plum cv.	<i>Prunus cerasifera</i>	15	23	Poor	Yes	No	major decline, trunk decay	remove and replace
200	cherry plum cv.	<i>Prunus cerasifera</i>	12	22	Fair-Poor	Yes	No	stressed, noteworthy decline	remove and replace

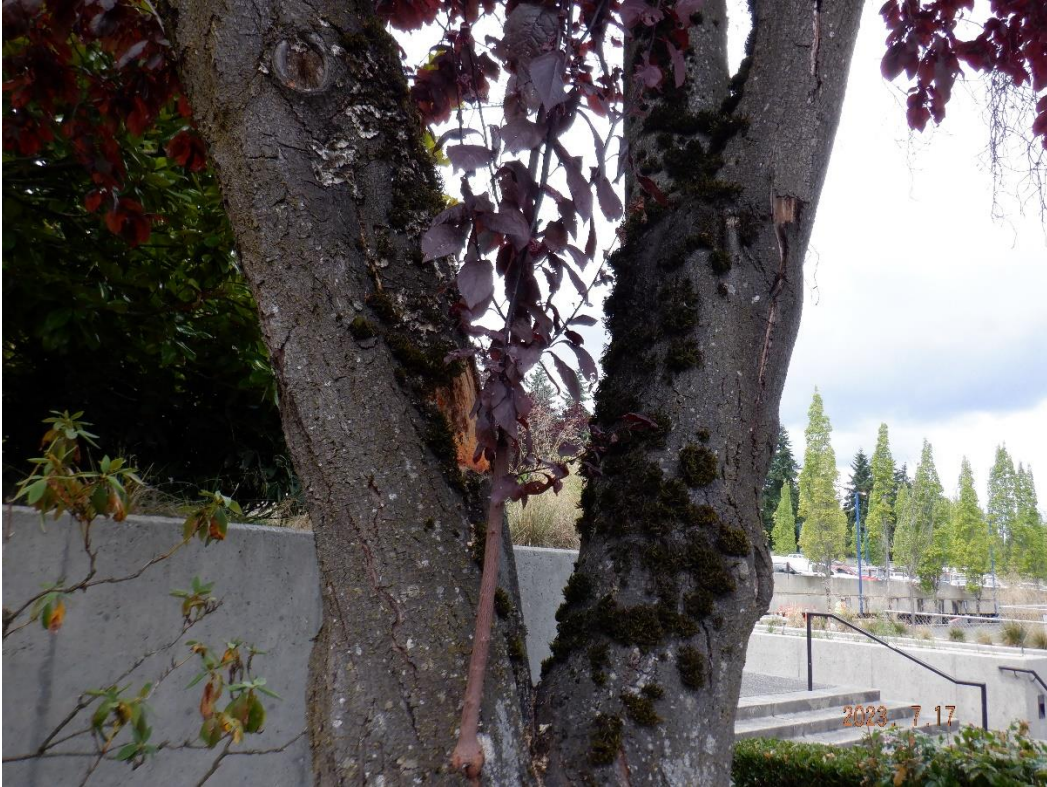
Tree #203, significant cambium dieback/decay

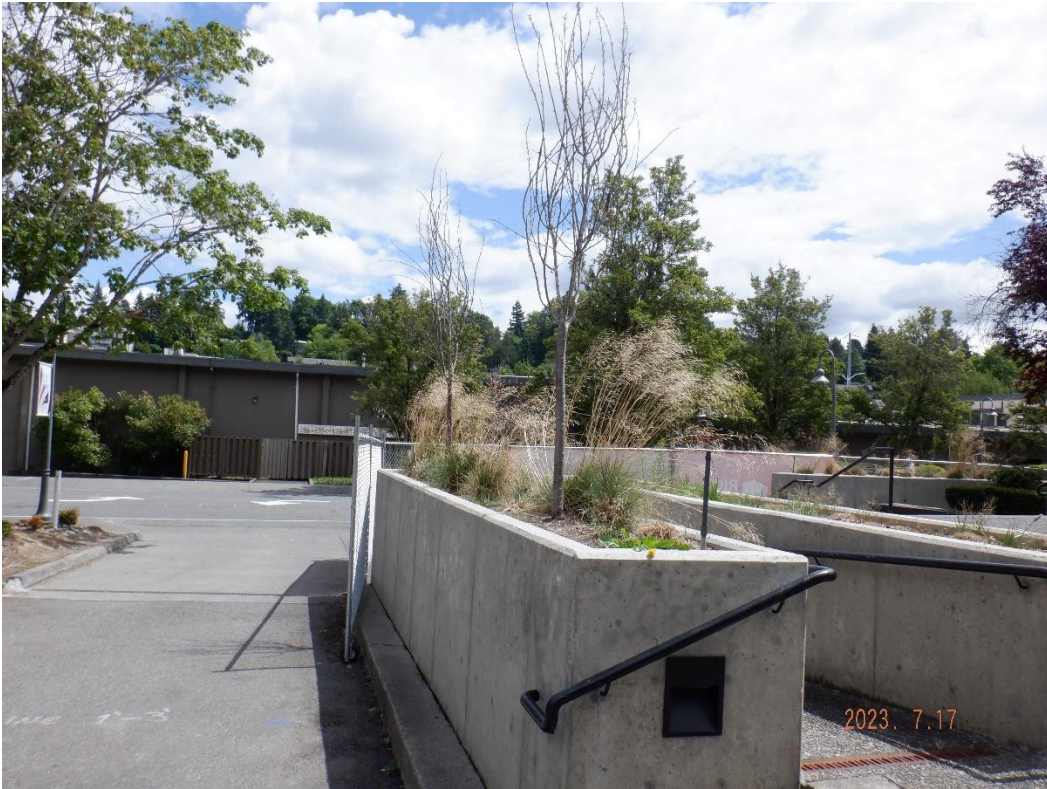
Dead 2-inch flowering cherry variety

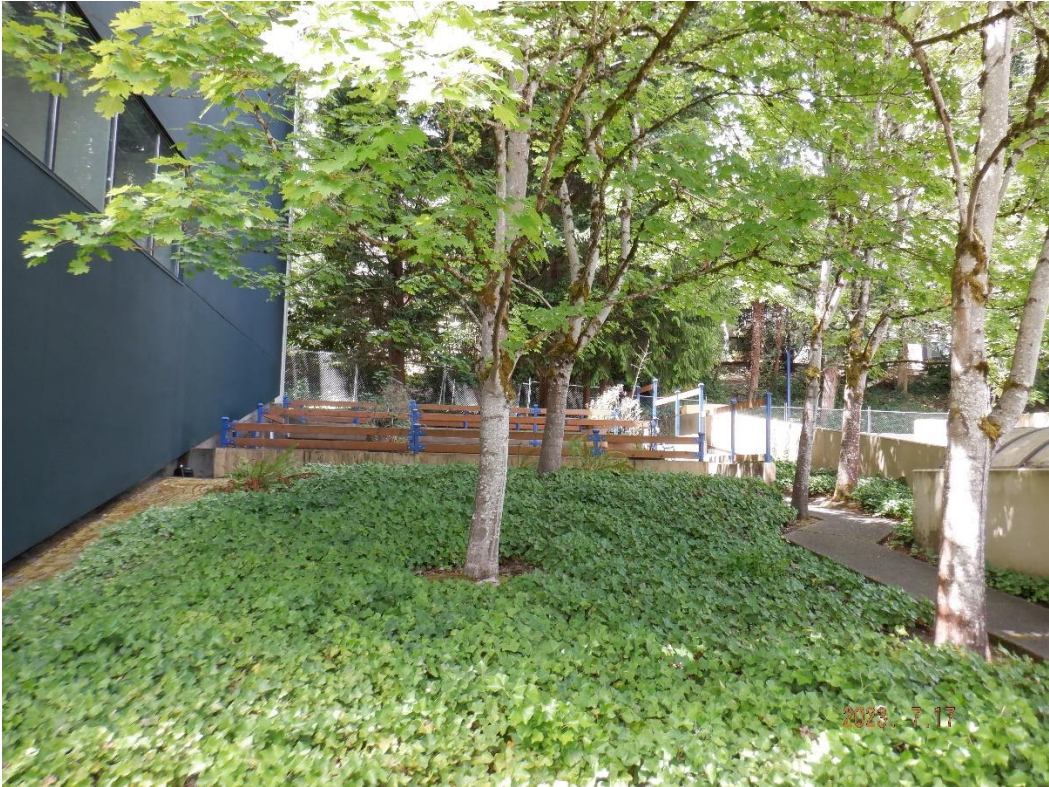
Norway maples on northwest side of building to be maintained

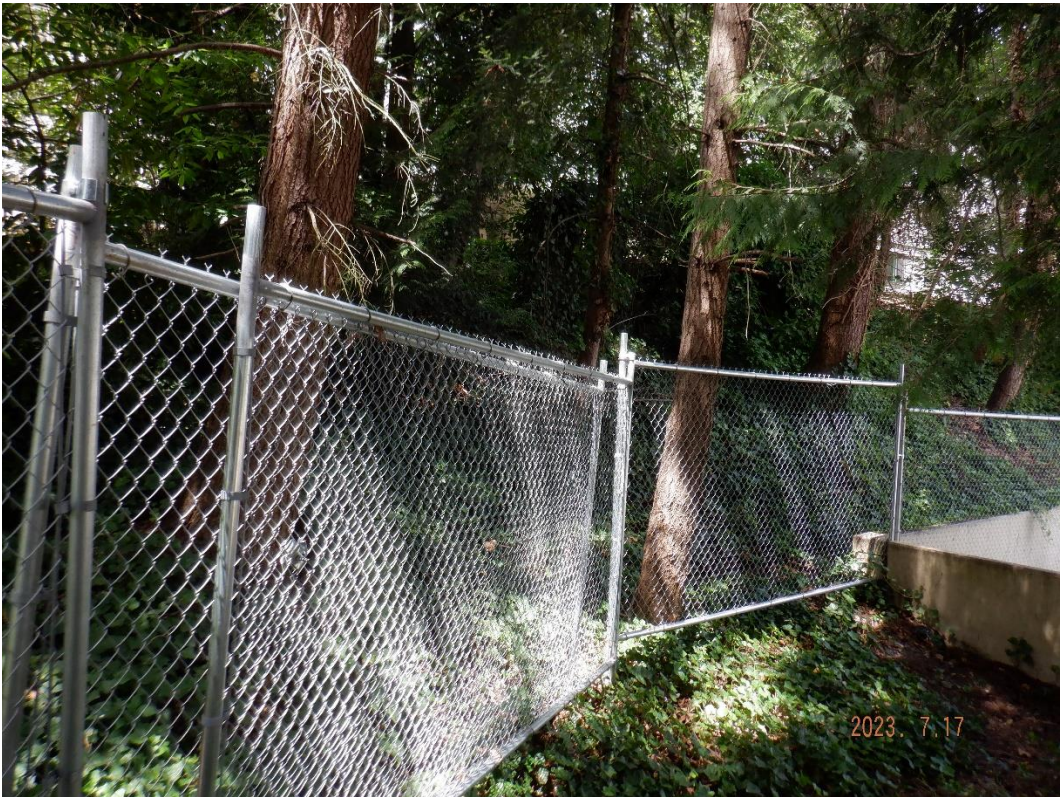
Trees on northwest side of building to be maintained
