EVALUATION OF SELECTED TREES AT

5637 E Mercer Way
Mercer Island, WA 98040

July 14, 2015

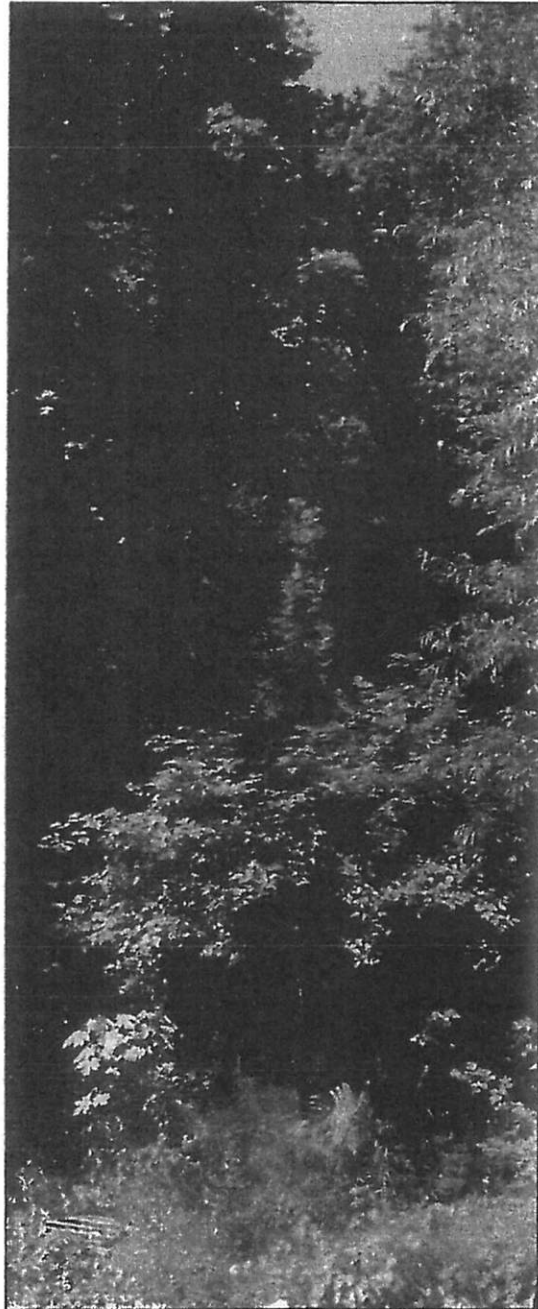
Photo # 2: A view from the shoulder of E Mercer Way looking up into the wooded lot that is 5637.

Note the storm drain cover in the lower left of the photo at the bottom of the ditch.

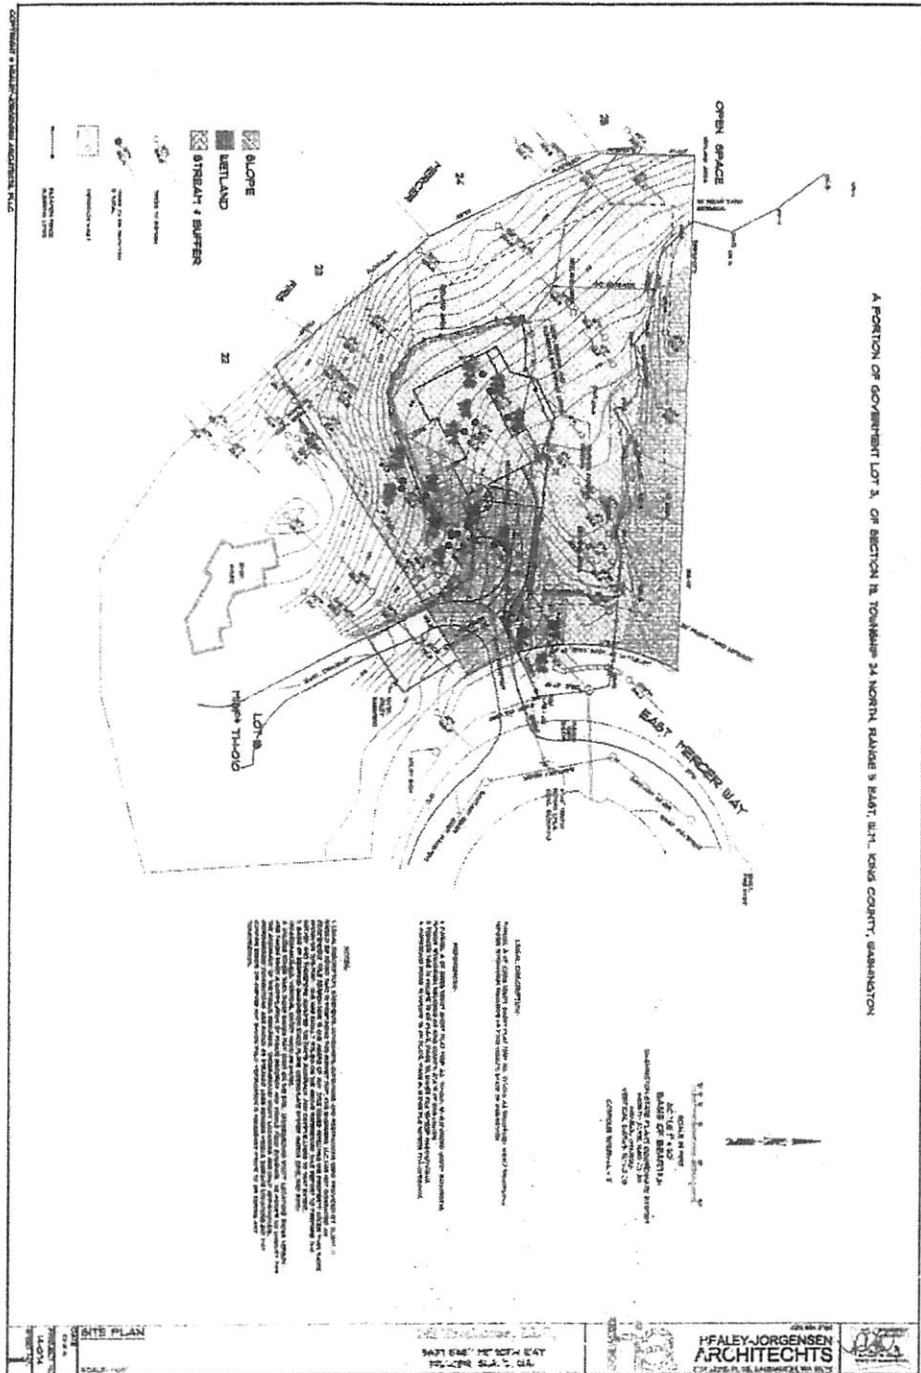
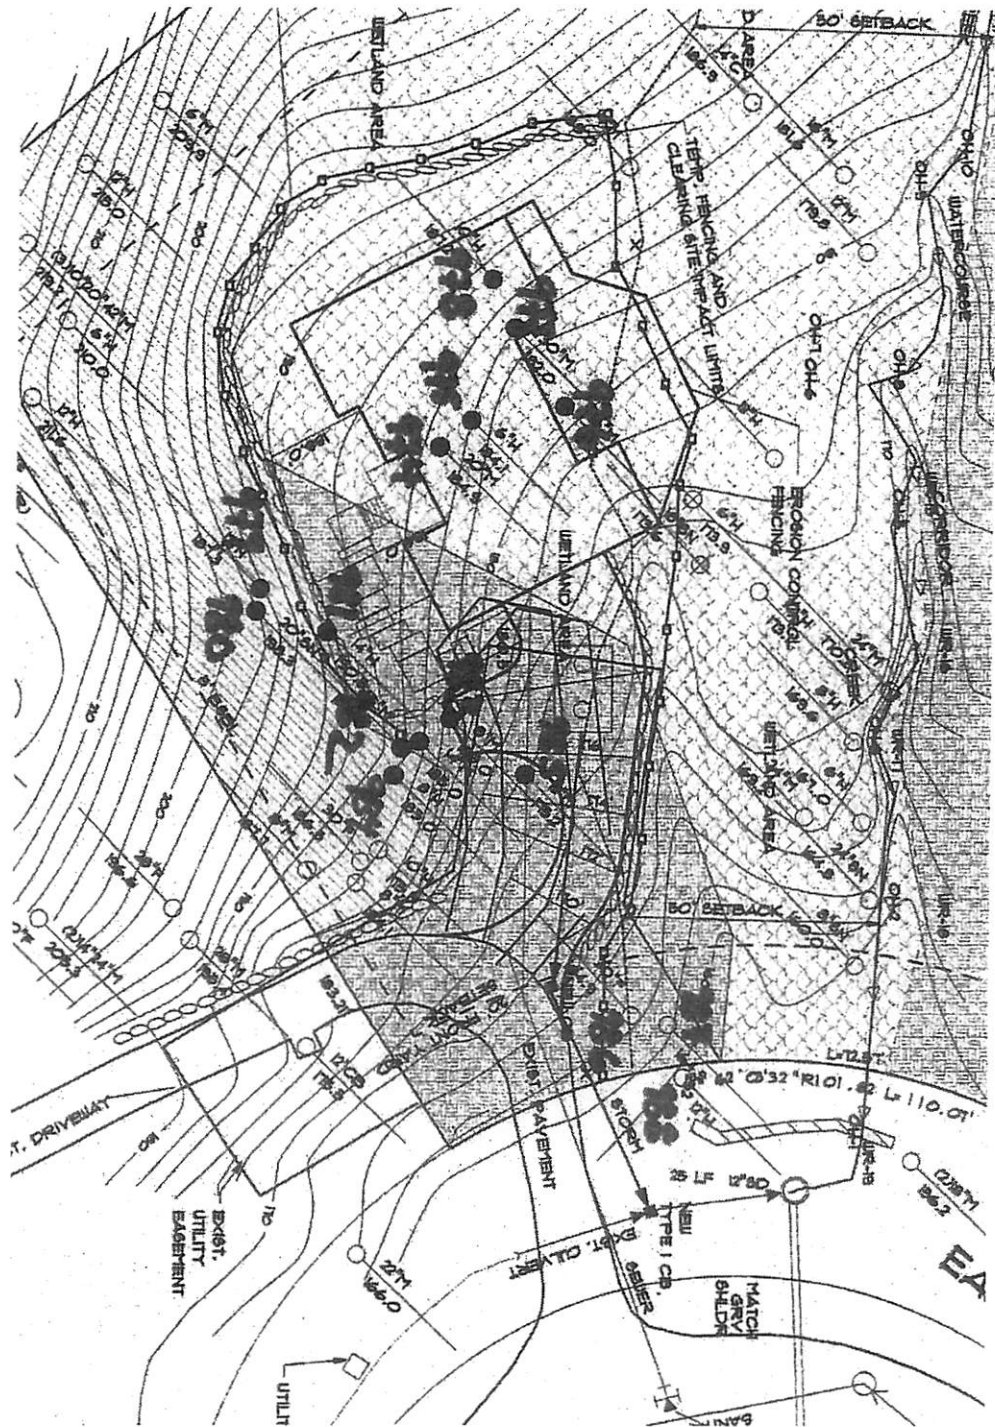
ATTACHMENT 1 - SITE PLAN WITH TREE NUMBERS

Trees within the building footprint include trees # 974, 975, 976, 977, and 978. They are recommended for removal. Trees impacted by the grading and detention vault excavation include trees # 979, 980, 981, 982, 983, 984, and 985. Trees # 986 and 987 are north of the existing driveway and north of the proposed "*Limits-of-Disturbance*" fence. This fence should adequately protect them. They can remain. Please note that trees # 974, 975, and 980 are either Dying or in Poor Condition. They are already recommended for removal for safety. Tree # 987 is the large Maple tree immediately south of the existing driveway. It has considerable decay in the lower trunks and base. Left as it is, and with the removal of the other 11 trees, this tree could be vulnerable to stronger storm forces and could fail. However, the tree may not need to be completely removed. It is my judgment that if the tree was severely reduce, say by 35% to 40%, it could remain at an acceptable level of risk. It will be important to inform the new homeowners to have the tree re-pruned once every seven to ten years for safety.

I agree that trees 974 through 985 should be removed for safety and for the construction of the new home. I recommend extending the "*Limits-of-Disturbance*" fencing to protect tree # 988 in the East Mercer Way right-of-way. The remaining trees will be adequately protected by the "*Limits-of-Disturbance*" fencing.

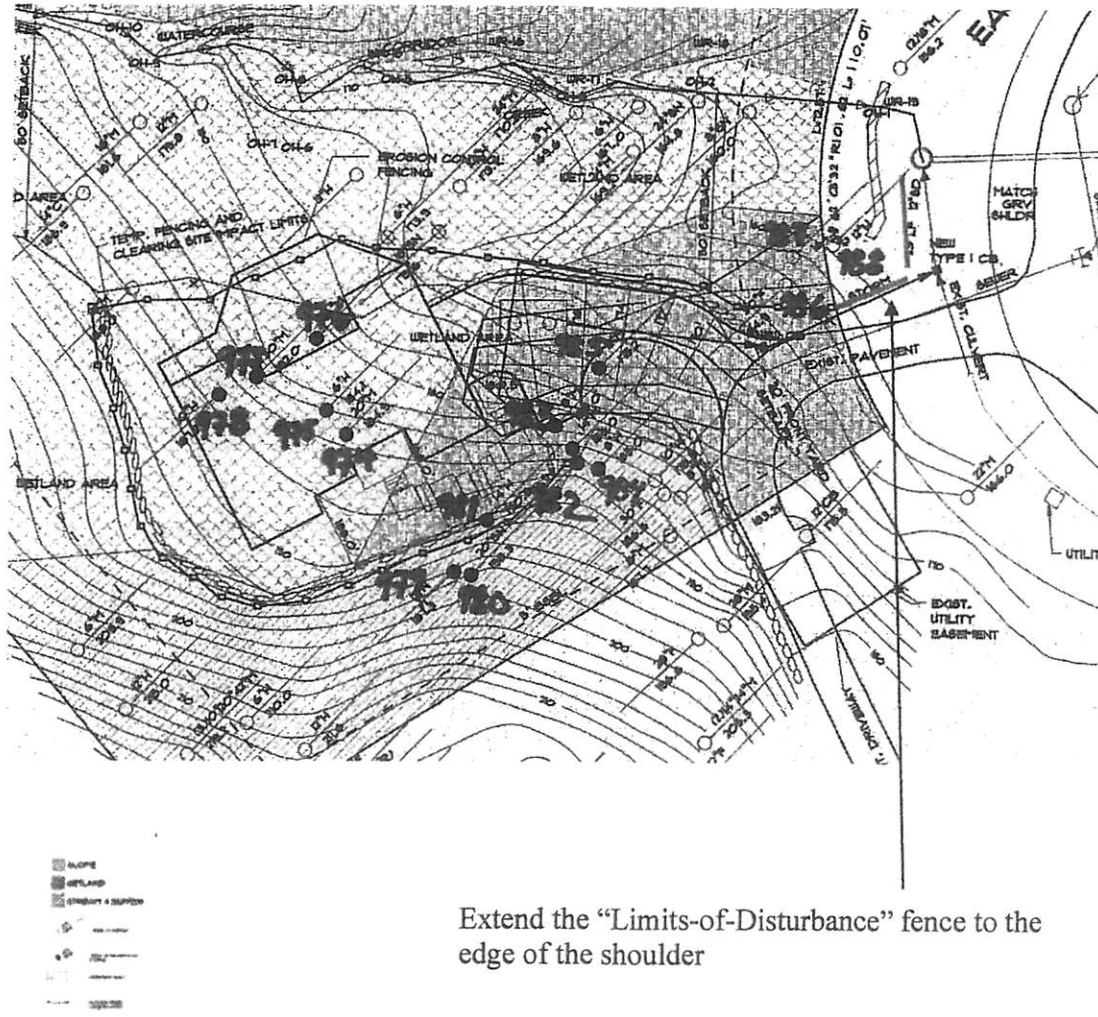
There is one right-of-way tree impacted by the project. It is tree # 988. It is a 15.4-inch Diameter Western Hemlock in Good Condition. It can be adequately protected by having the "Limits-of-Disturbance" fence extend east from the property line to the road shoulder and extend slightly north above the Storm drain inflow device.

Extend the "Limits-of-Disturbance" fence to the edge of the shoulder
