REVISED TREE REPORT AT

**5637 E Mercer Way
Mercer Island, WA 98040**

April 7, 2021

**Bill Summers
P.O. Box 261
Medina, WA 98039**

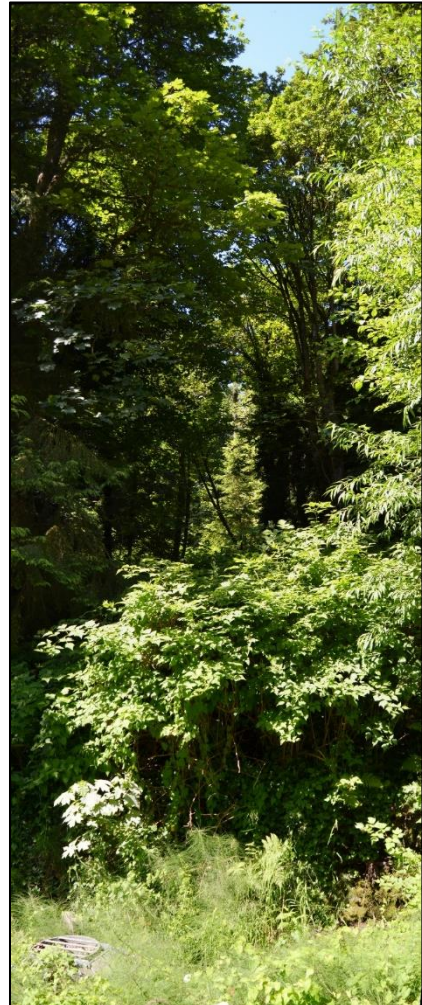
Photo # 3: A view from the shoulder of E Mercer Way looking up into the wooded lot that is 5637.

Note the storm drain cover in the lower left of the photo at the bottom of the ditch.

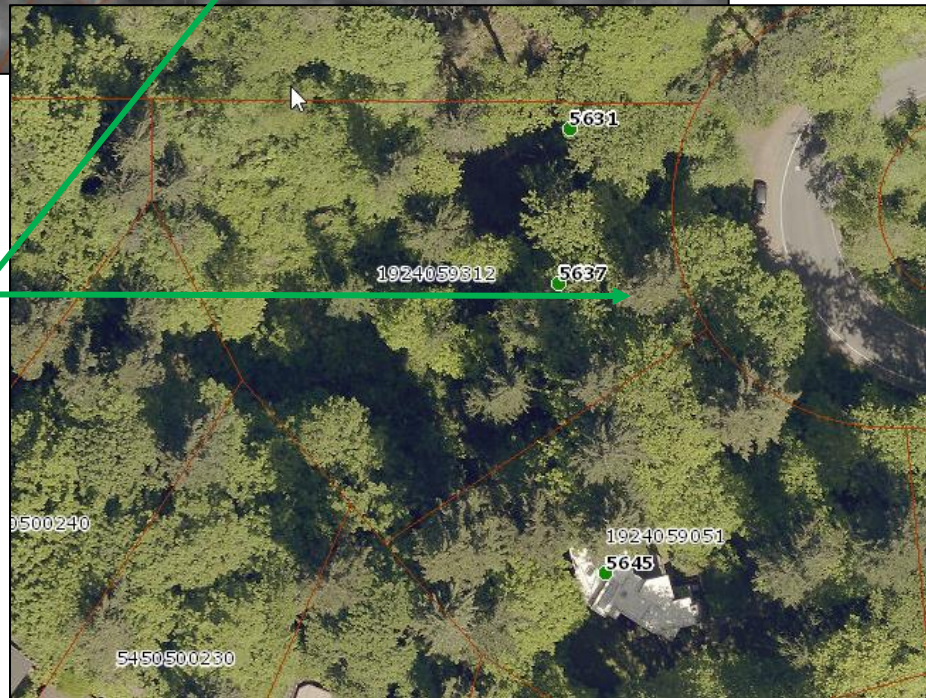
Tree # 986 is a special condition tree. It is a 40.7-inch diameter Douglas Fir tree in Fair Condition. This is the tree that was required to be retained in the 1977 short plat process.

It is also reasonable then to surmise that tree # 986 has adapted very well to the presence of the existing driveway. It is reasonable to conclude that the tree has adapted to the driveway and its pattern of runoff. It is also reasonable to surmise that the existing driveway has hindered root growth and development underneath it. Therefore, it is reasonable to conclude that placing some stormwater facilities under the new driveway addition can be done with minimal impact on the tree—if strict adherence to the *Tree Protection Measures*, that are outlined below. That is, the tree appears to have the current health, vigor, internal stored reserves, and wind-firmness, to tolerate some

Tree # 986 appears to be this tree.

The proposed driveway to access the proposed new house at 5637 is within a small portion of the dripline of this tree.

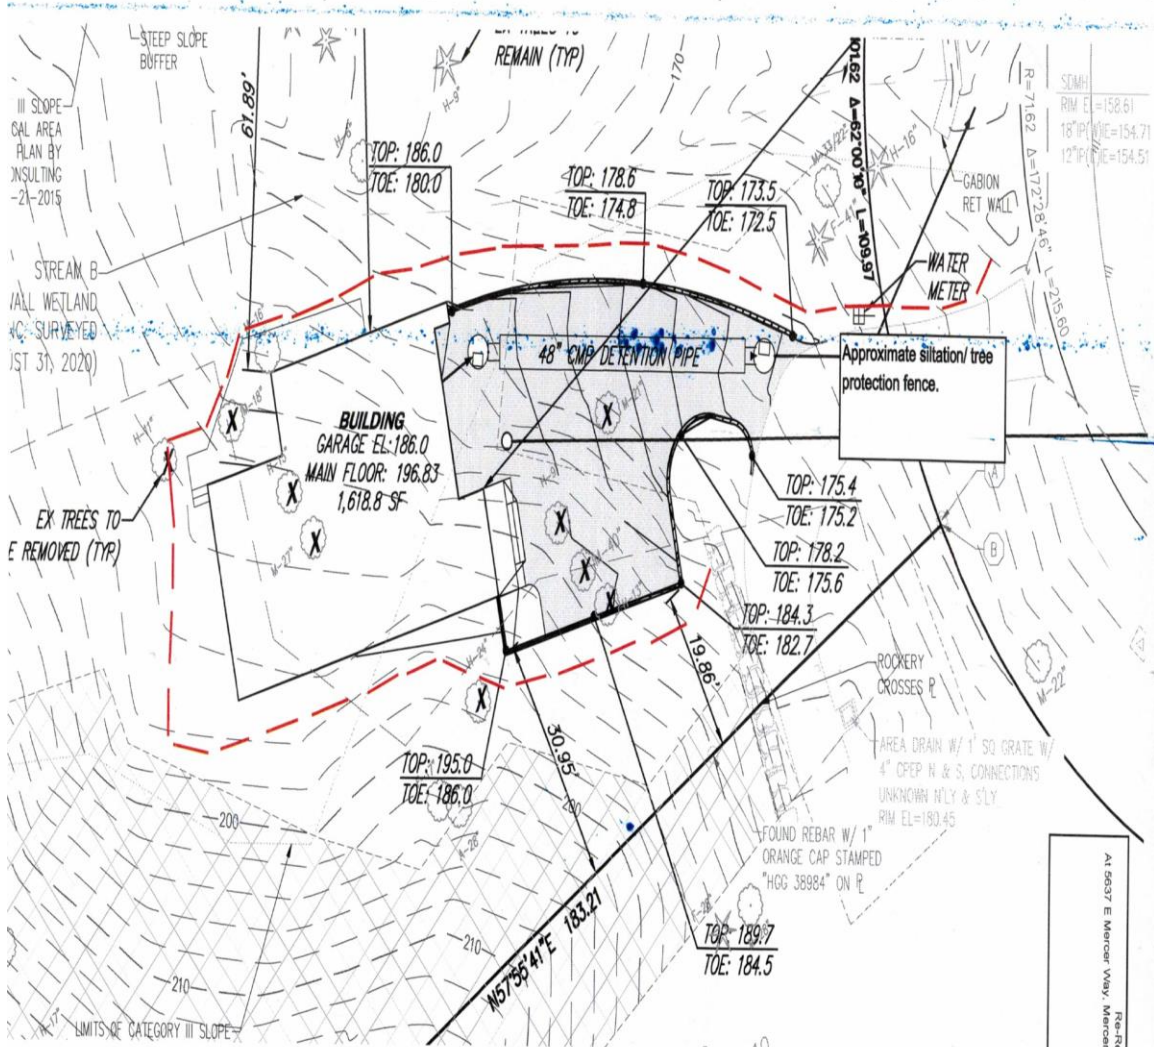
Approximate Tree Protection Fence locations: - - - - -

I recommend that Trees # 974 through 985 should be removed for safety and for the construction of the new home. I recommend extending the “*Limits-of-Disturbance*” fencing to protect tree # 988 in the East Mercer Way right-of-way. The remaining trees will be adequately protected by the “*Limits-of-Disturbance*” fencing. Indicated in *Attachment 4, Tree Protection Measures* below.
