EVALUATION OF SELECTED TREES

5637 E Mercer Way
Mercer Island, WA 98040

July 14, 2015

GILLES CONSULTING

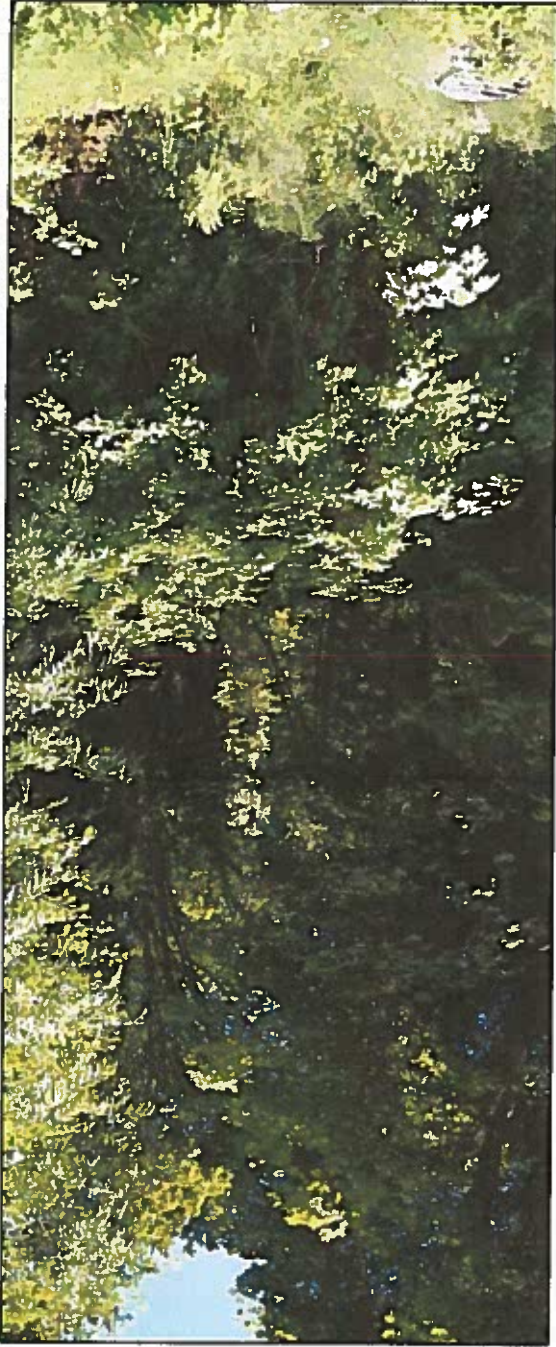
Photo # 2: A view from the shoulder of E Mercer Way looking up into the wooded lot that is 5637.

Note the storm drain cover in the lower left of the photo at the bottom of the ditch.

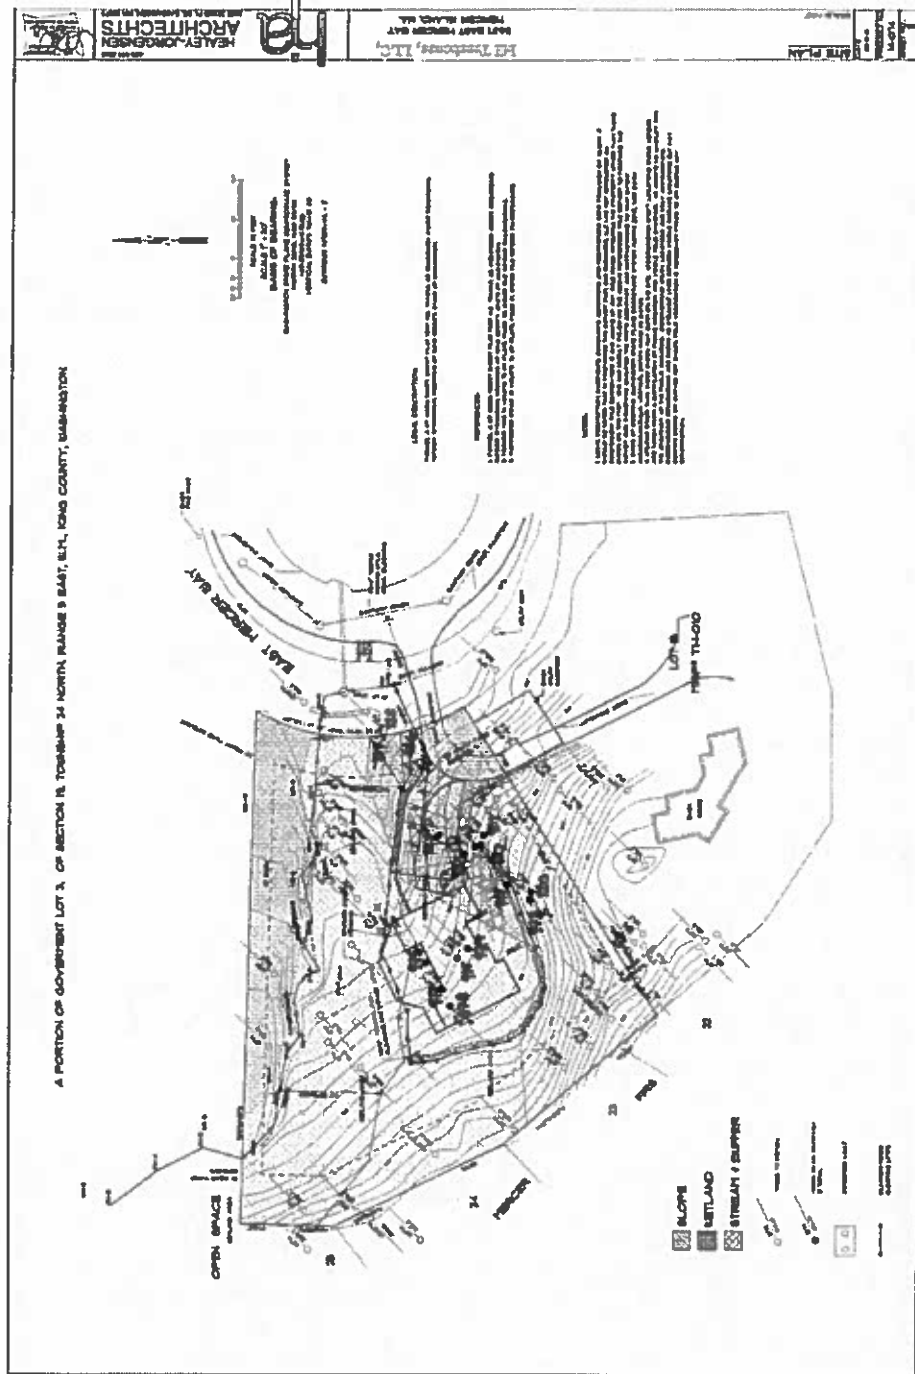
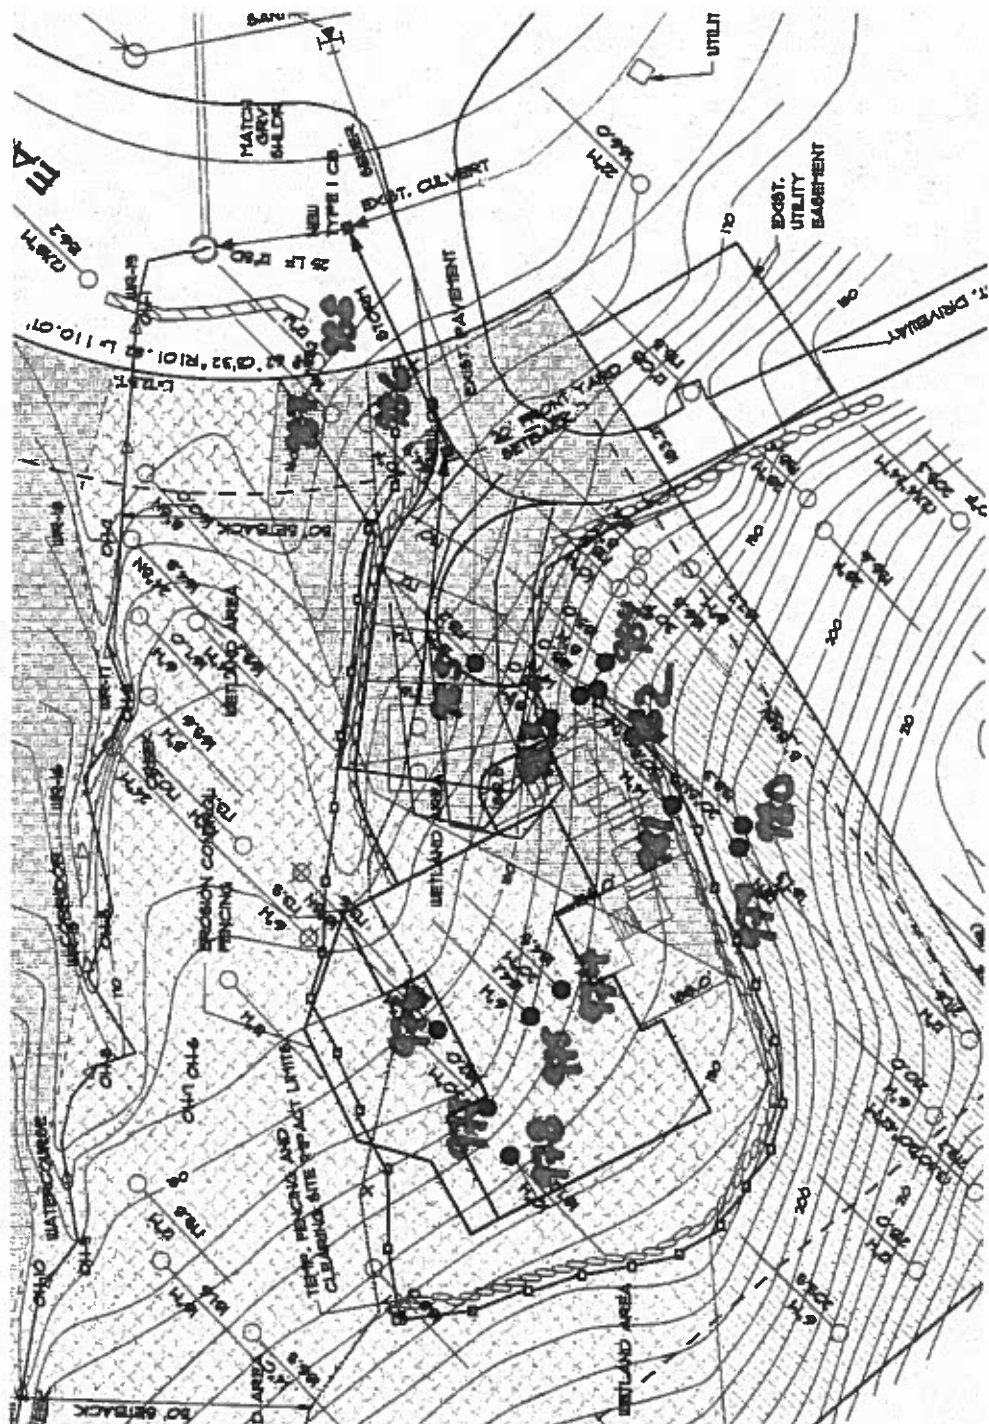
ATTACHMENT 1 - SITE PLAN WITH TREE NUMBERS

Trees within the building footprint include trees # 974, 975, 976, 977, and 978. They are recommended for removal. Trees impacted by the grading and detention vault excavation include trees # 979, 980, 981, 982, 983, 984, and 985. Trees # 986 and 987 are north of the existing driveway and north of the proposed "Limits-of-Disturbance" fence. This fence should adequately protect them. They can remain. Please note that trees # 974, 975, and 980 are either Dying or in Poor Condition. They are already recommended for removal for safety. Tree # 987 is the large Maple tree immediately south of the existing driveway. It has considerable decay in the lower trunks and base. Left as it is, and with the removal of the other 11 trees, this tree could be vulnerable to stronger storm forces and could fail. However, the tree may not need to be completely removed. It is my judgment that if the tree was severely reduced, say by 35% to 40%, it could remain at an acceptable level of risk. It will be important to inform the new homeowners to have the tree re-pruned once every seven to ten years for safety.

I agree that trees 974 through 985 should be removed for safety and for the construction of the new home. I recommend extending the "Limits-of-Disturbance" fencing to protect tree # 988 in the East Mercer Way right-of-way. The remaining trees will be adequately protected by the "Limits-of-Disturbance" fencing.

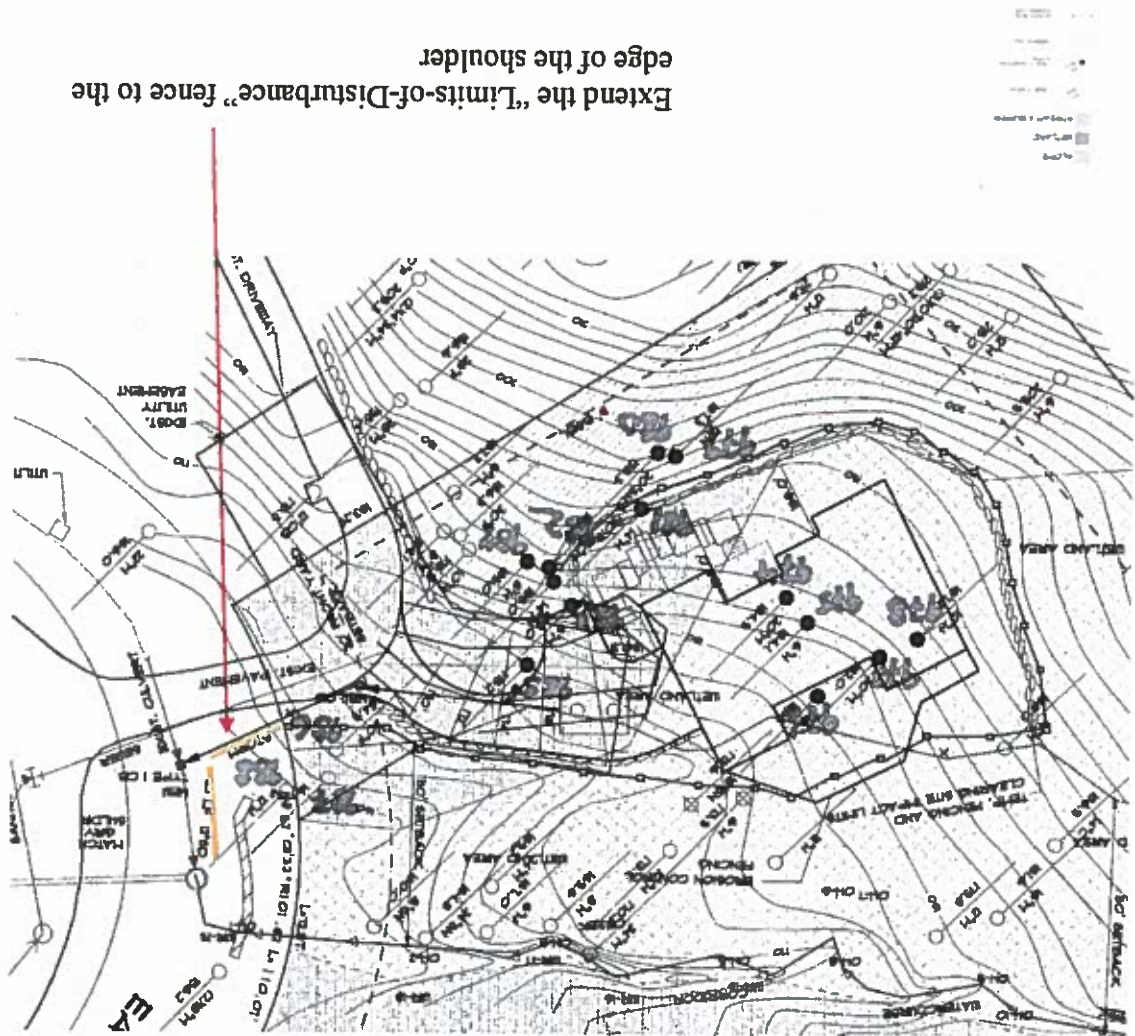
There is one right-of-way tree impacted by the project. It is tree # 988. It is a 1.54-inch Diameter Western Hemlock in Good Condition. It can be adequately protected by having the "Limits-of-Disturbance" fence extend east from the property line to the road shoulder and extend slightly north above the Storm drain inflow device.

Extend the "Limits-of-Disturbance" fence to the edge of the shoulder
