**ARBORIST REPORT
FOR
3675 W Mercer Way
Mercer Island, WA**

August 16th, 2016

Date of Field Examination: August 2nd, 2016

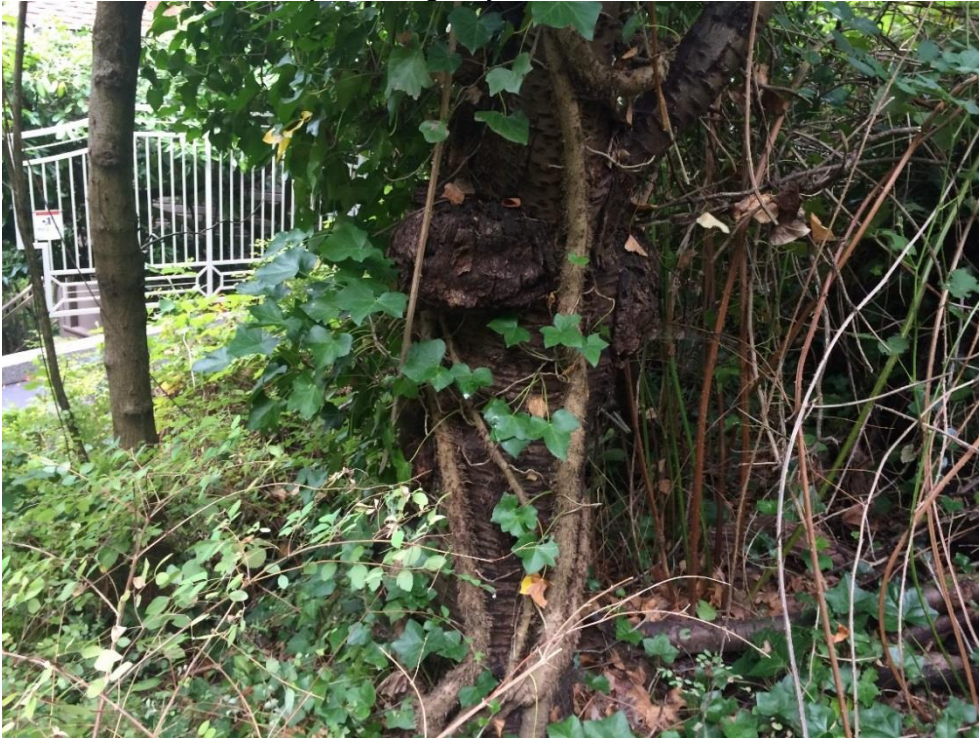
Tree #102 – bitter cherry with large ivy stems and burls

Tree/ Tag #	Species	DBH (inches)	Height (feet)	Drip-Line/Limits of Disturbance (feet)				Condition	Viability	Comments
				N	S	E	W			
101	white ash	11	38	8 / 6	15 / 2	10 / 6	14 / 2	fair	viable	slight lean s
102	bitter cherry	13	18					poor	non-viable	large ivy stems covering trunk, burls
103	big leaf maple	8, 5	26	9				poor	non-viable	broken top, growing on steep slope, small live crown, trunk forks at base
104	white ash	7, 5	42	4 / 6	5 / 6	0 / 6		fair	viable	on steep slope, some decay
105	cherry laurel	8, 5, 5, 4	25	18 / 10	16 / 5	0 / 10	14 / 5	fair	viable	
106	cherry laurel	5, 6, 5, 10	26	12 / 8	15 / 5		18 / 8	fair	viable	
107	big leaf maple	34	88	25 / 10	30 / 15	16 / 15	25 / 8	fair	viable	trunk forks at 5', u-shaped attachment
108	big leaf maple	15, 11, 8	80	12 / 12	10 / 12	9 / 15	7 / 5	fair	viable	2' from ground, fork is an ok attachment
109	big leaf maple	10, 5, 5, 3	21	2 / 10	15 / 10	2 / 10	17 / 8	fair	viable	self corrected lean, forks at base

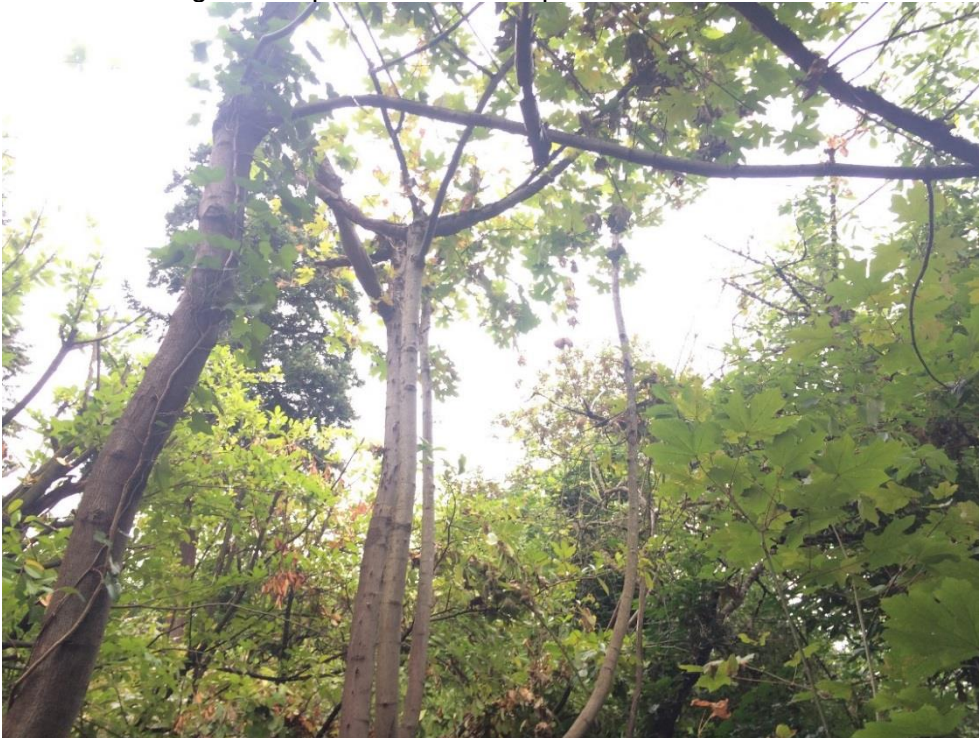
Big leaf maple trees are dispersed throughout the steep slope above the home. The big leaf maple range in age and condition. One big leaf maple, #103 has a broken top and is in poor condition. This is the only significant, non-viable big leaf maple on the subject property. Common defects include forked trunks, self-corrected leans.

Tree #103 – big leaf maple with broken top

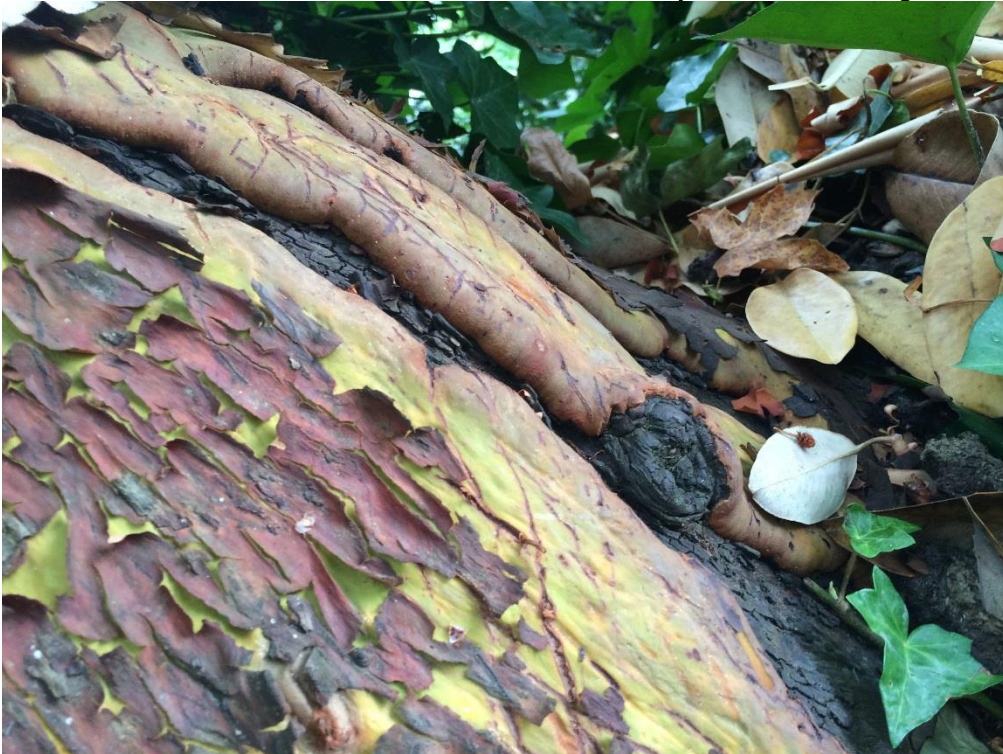
Tree #121 – Pacific madrone with cankers caused by *Nattrassia mangiferae*

121	Pacific madrone	28, 32	58	14 / 20	15 / 20	0 / 20	34 / 25	good	viable	some cankers, forks 4' from the ground
122	red alder	9	45	3	12	5	15	fair	viable	leans west, broken top
123	paper birch	8	30	12	8	5	12	fair	viable	leans west
124	western hemlock	10	49	6	7	9	6	fair	viable	self corrected lean N, some soil plate lifting
125	horse chestnut	21	82	8 / 10		15 / 10		fair	viable	ivy covering trunk
126	horse chestnut	12	80	5 / 6		12 / 6		fair	viable	poor taper
127	horse chestnut	16, 10, 5	84	8 / 10	10 / 10	5 / 10	15 / 10	fair	viable	ivy covering trunk, leans west
128	horse chestnut	8, 4	25	9 / 6	4 / 6	6 / 6	5 / 6	fair	viable	covered in ivy, leans north
129	Lombardy poplar	33, 20	83	16	14	7	20	fair	viable	
130	yellow wood	7, 5, 5, 4	63	16 / 5	4 / 5	0 / 5	13 / 5	good	viable	forks at the base
131	western red cedar	11	64	9 / 6			7 / 6	good	viable

It is important to consider species ability to withstand construction damage. Pacific madrone trees are intolerant of site damage and any work within the dripline could severely compromise long term viability. If any of the Pacific madrones will be retained, no work may occur within the dripline of these trees.

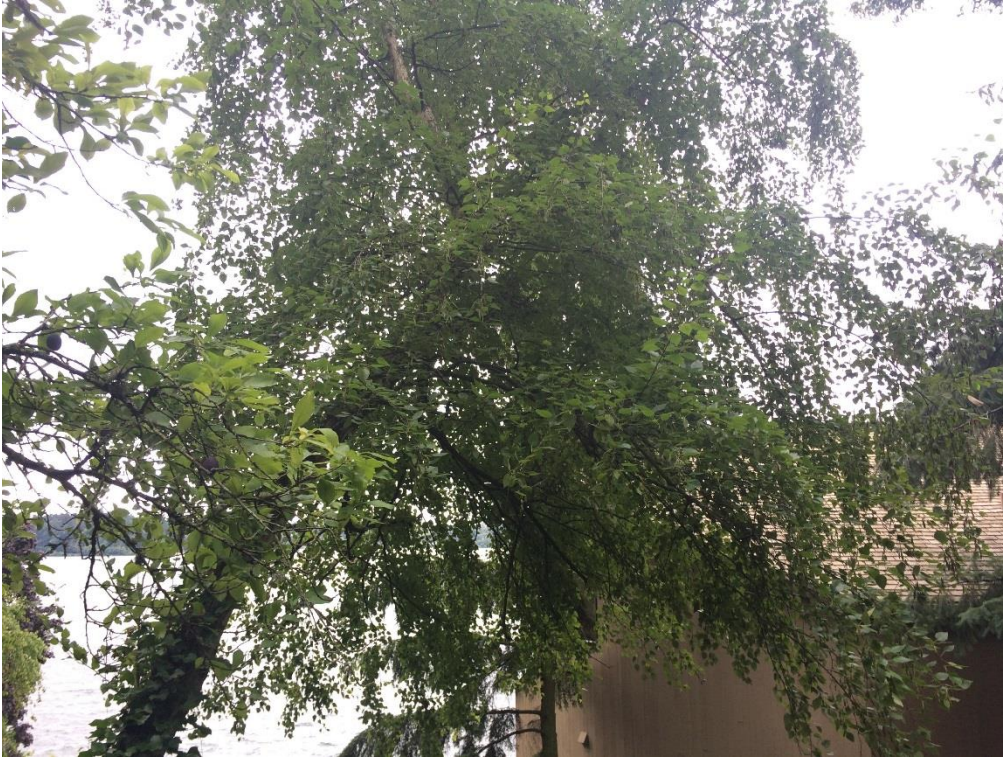
Tree #123 – paper birch leaning west, ivy on the trunk

For the majority of the property, ivy was killed and removed from trees. There is still ivy covering the trunks of many trees. This threatens the long term health and viability of the trees. It also impeded visual assessments of tree trunks. The remaining ivy should be killed and removed from trees.

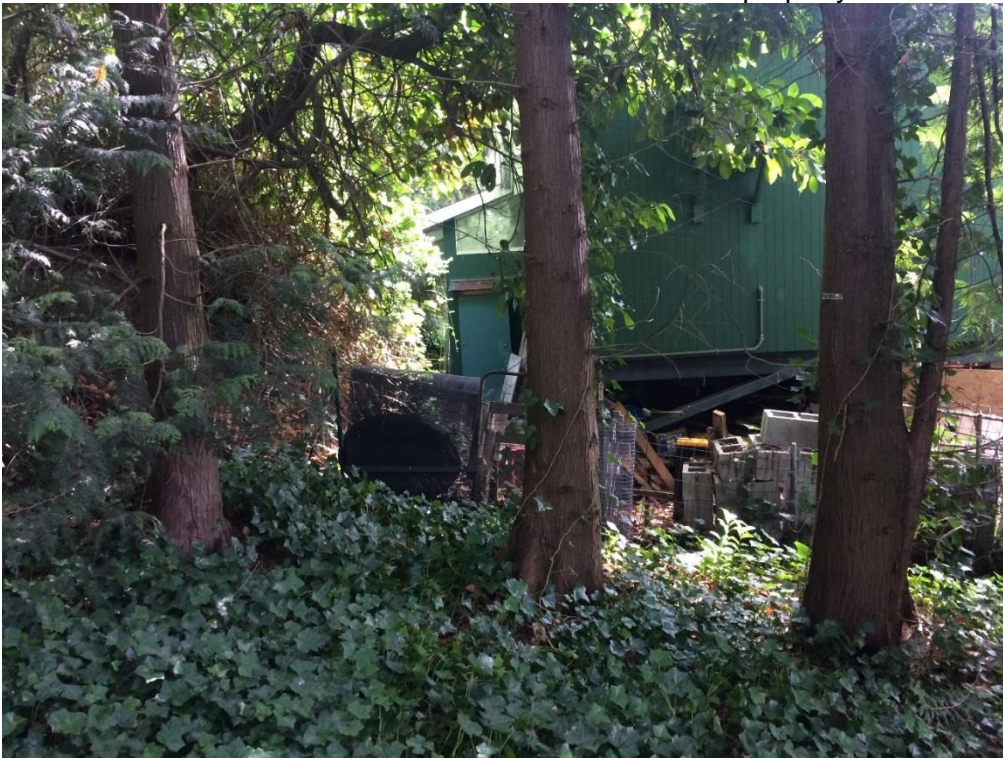
Tree #131 - #133 – western red cedars on the southeast property line

The cluster of western red cedar trees on the south property line are close to the preliminary new home and deck location. Western red cedar trees are intolerant of root damage and fill. Changes in water table and soil moisture can severely impact their viability. Careful tree protection measures will be necessary to protect these trees. Retaining all eight trees (#131 – 138) as a group, would be best to minimize wind impacts.

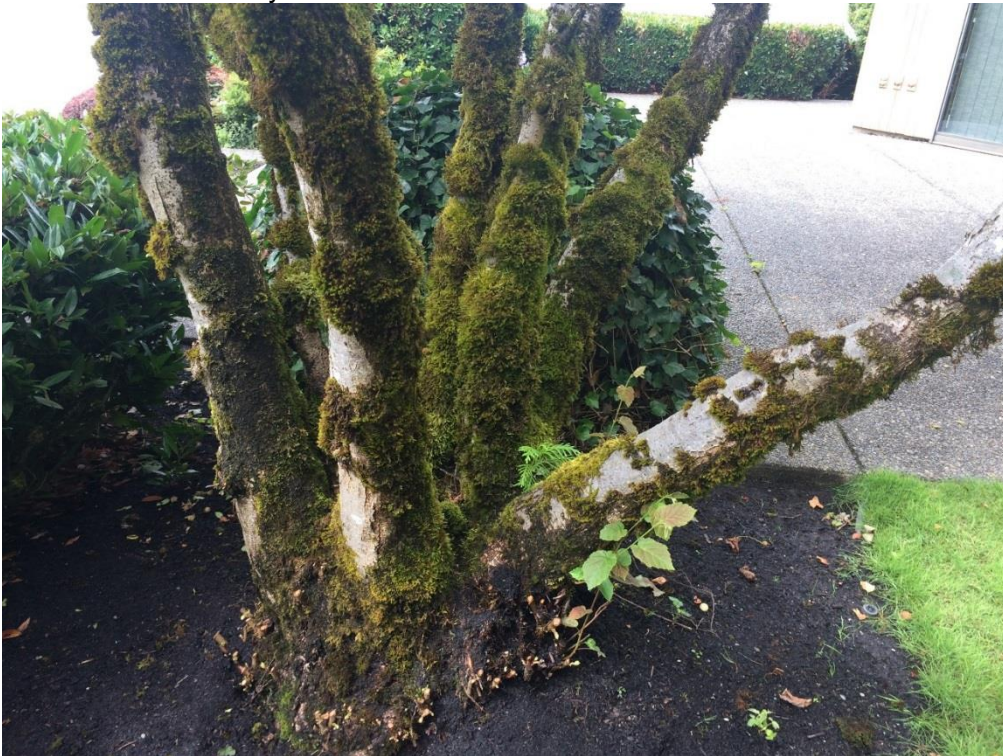
Tree #140 – mulberry tree with co-dominant stems

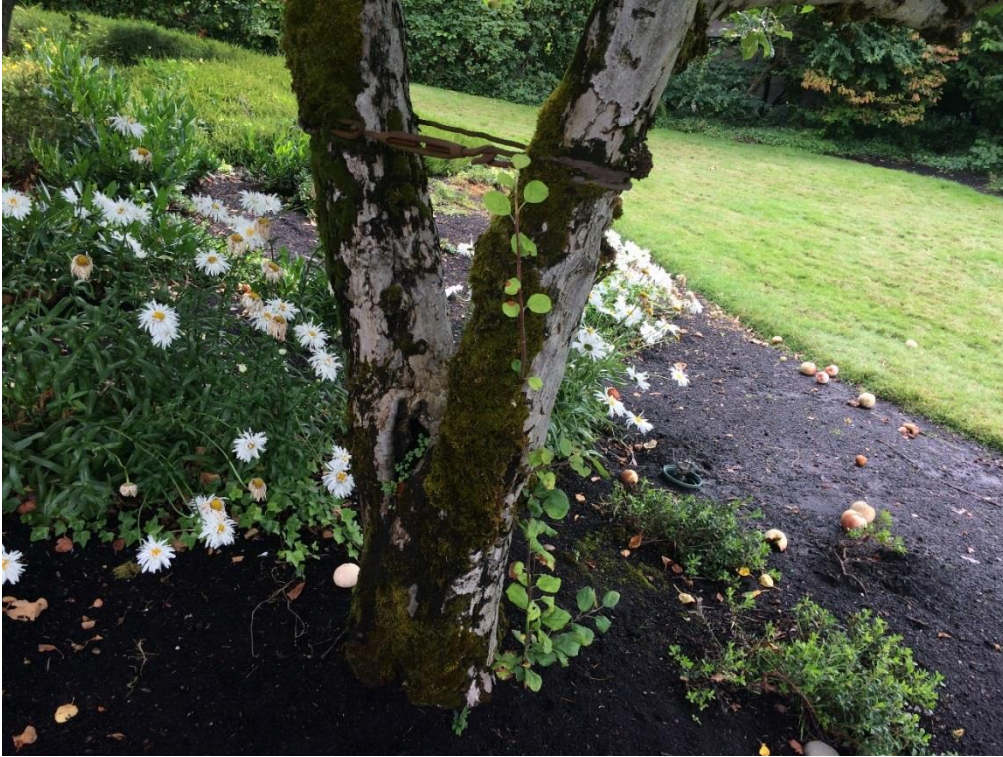
Tree #141 – apple tree with old cabling

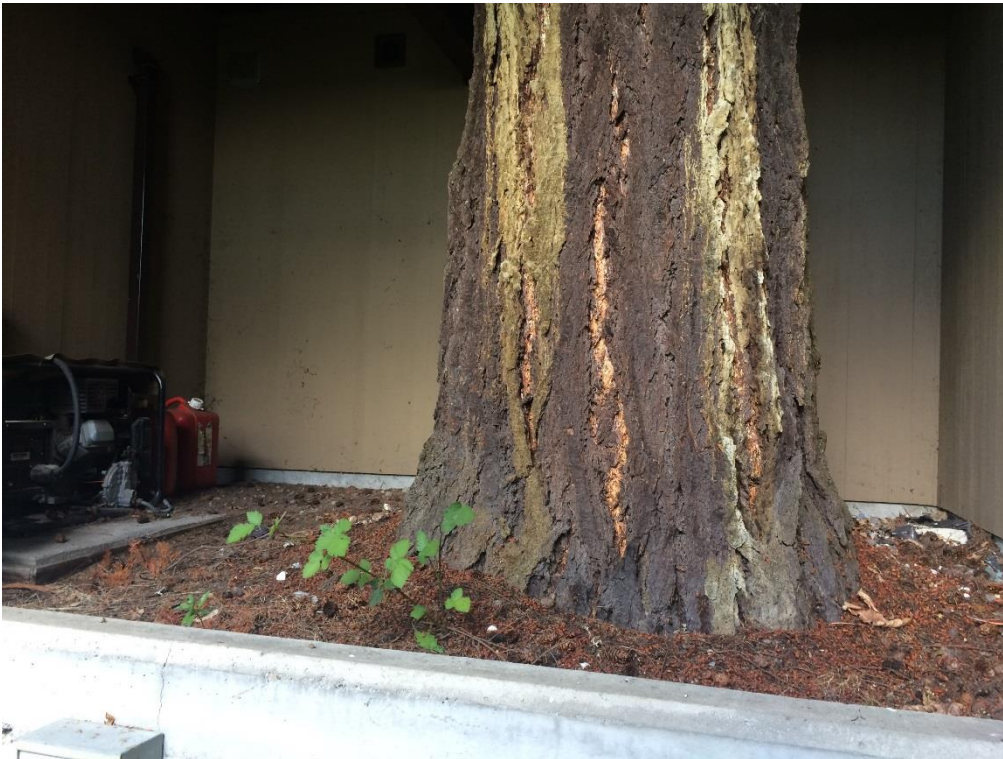
The Douglas-fir trees on the subject property are generally healthy, mature trees. Many of the Douglas-fir trees are adjacent to the home and in small planters. Common defects include butt swell, and structural defects such as forked tops. All of the Douglas-fir trees are viable.

Tree #162 – mature Douglas-fir in small planter box adjacent to home, cambium ruptures on the trunk

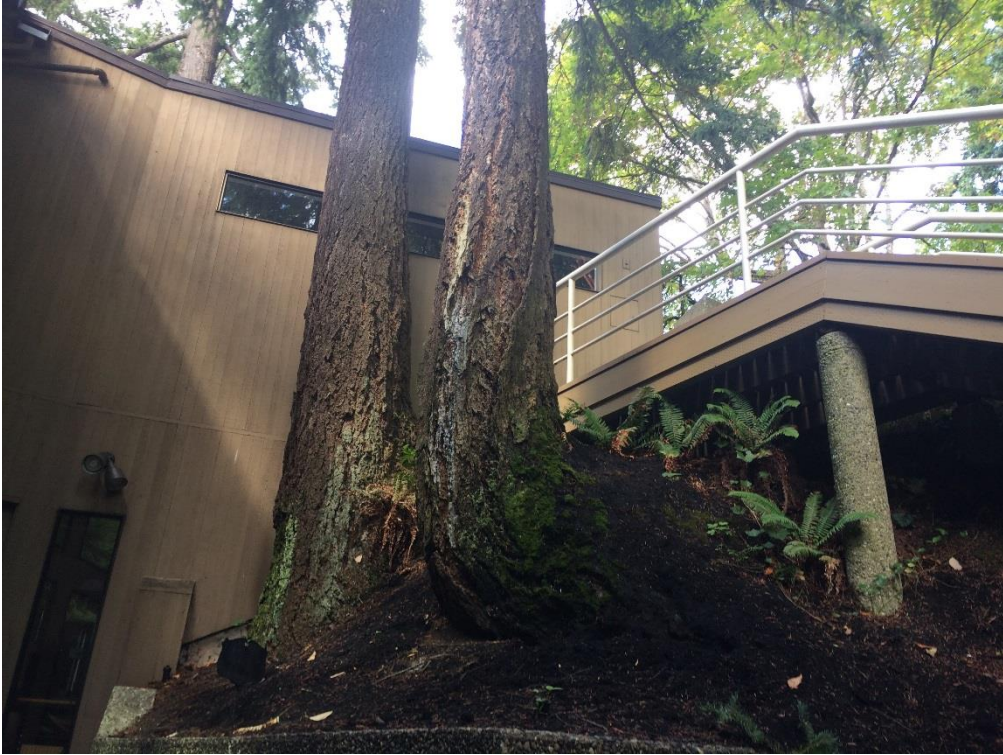
Tree #163 and #164 – Douglas-fir trees adjacent to the home in a small planter box

Tree/ Tag #	Species	DBH (inches)	Height (feet)	Drip-Line/Limits of Disturbance (feet)				Condition	Viability	Comments
				N	S	E	W			
163	Douglas-fir	36	131	25	15	20	17	fair	viable	some butt swell, small planter
164	Douglas-fir	28	85	11	16	20	7	fair	viable	j-shaped trunk, small planter
Neighboring Trees										
201	bitter cherry	7	42	16	0	0	22	fair	viable	leans west, cherry gummosis
202	Crimson King maple	28	80	6				good	viable
