**ARBORIST REPORT
FOR
3675 W Mercer Way
Mercer Island, WA**

**August 16th, 2016
Revised January 12th, 2018**

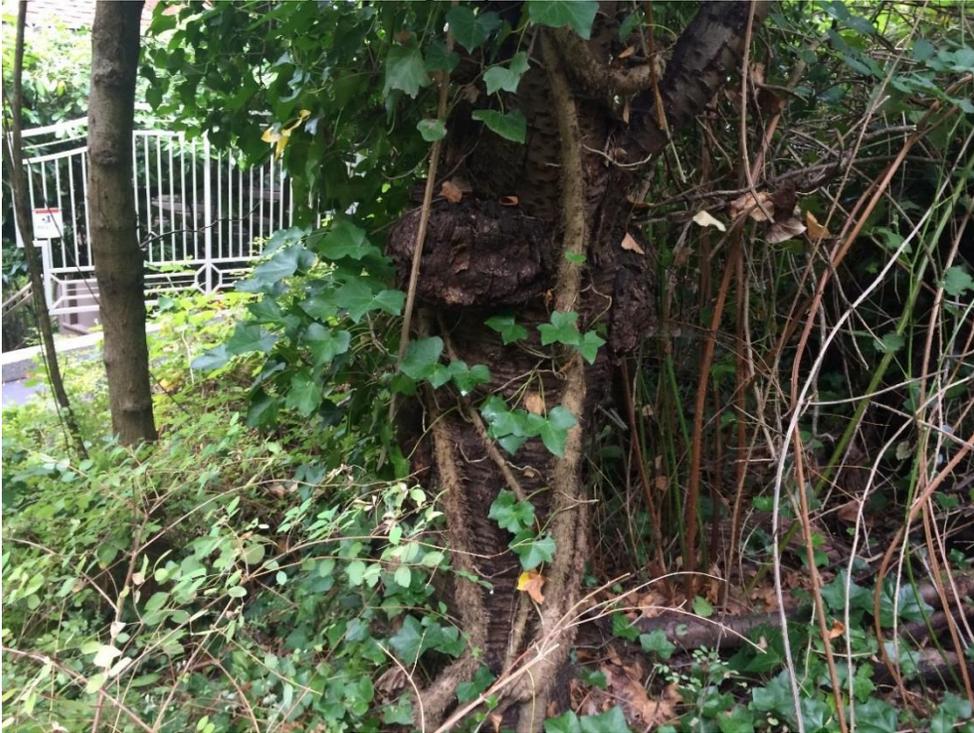
Tree #102 – bitter cherry with large ivy stems and burls

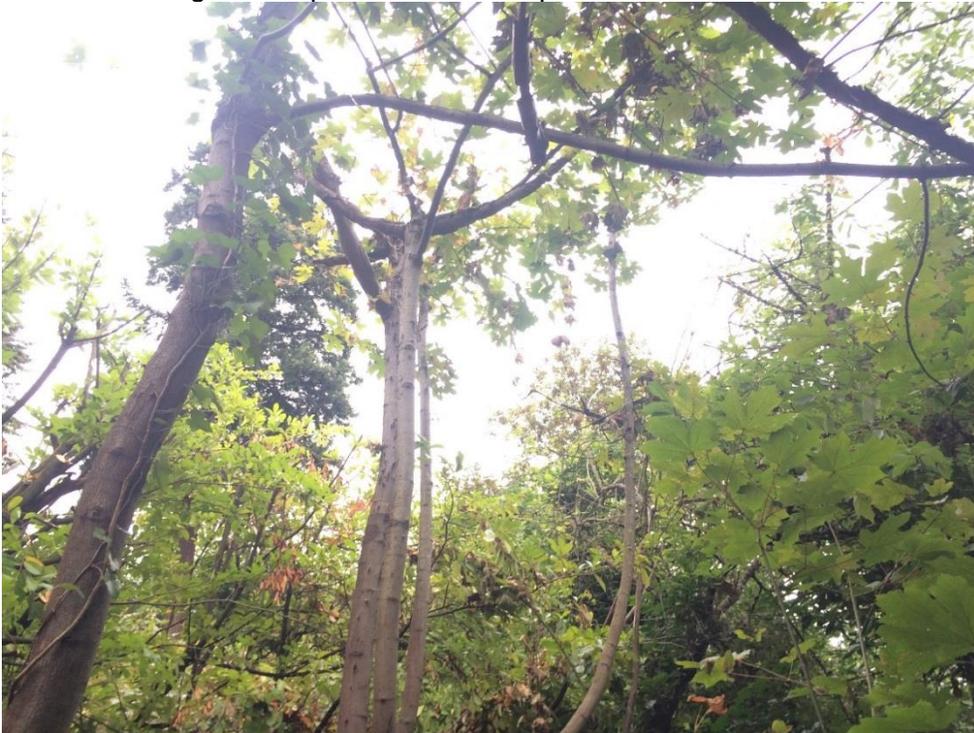
Big leaf maple trees are dispersed throughout the steep slope above the home. The big leaf maple range in age and condition. One big leaf maple, #103 has a broken top and is in poor condition. This is the only significant, non-viable big leaf maple on the subject property. Common defects include forked trunks, self-corrected leans.

Tree #103 – big leaf maple with broken top

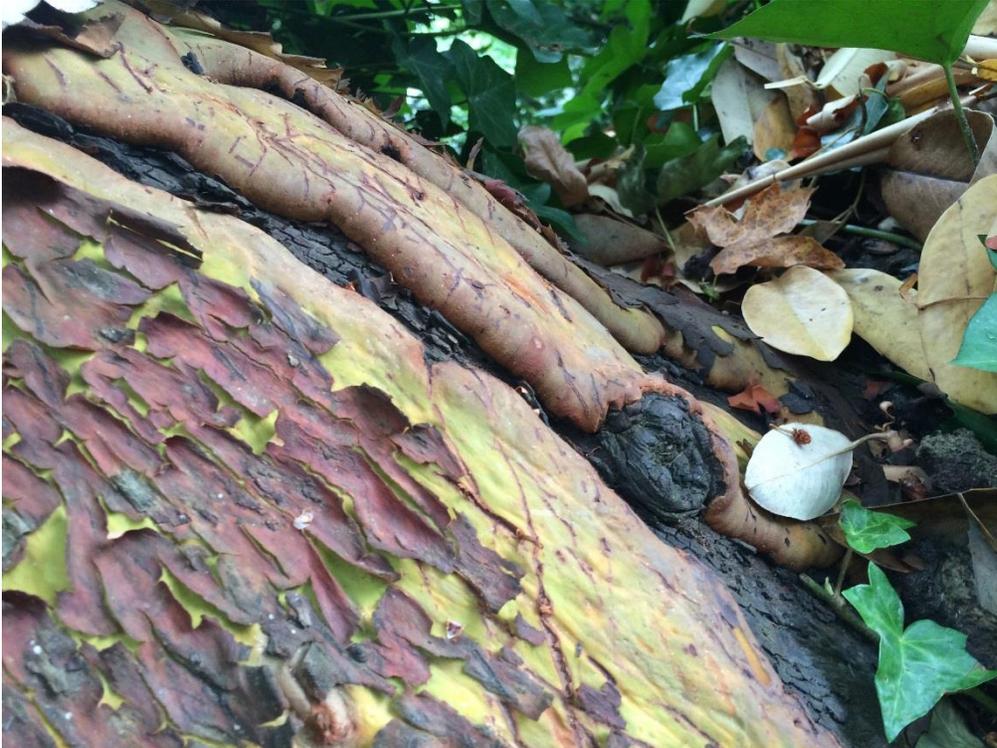
Tree #121 – Pacific madrone with cankers caused by *Nattrassia mangiferae*

121 – In home and shoring wall footprint. This tree is well within the buildable site. The building has been pulled off the setbacks more than the requirements. The home footprint is smaller than what could be built. This tree would limit the buildable gross square footage to less than 75%.

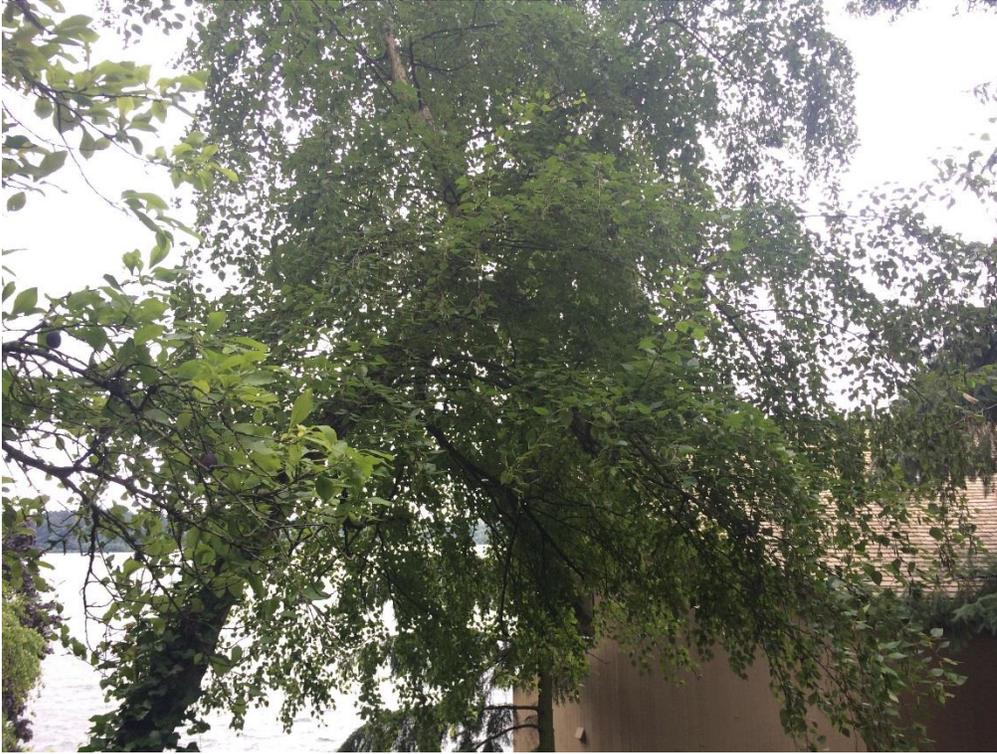
Tree #123 – paper birch leaning west, ivy on the trunk

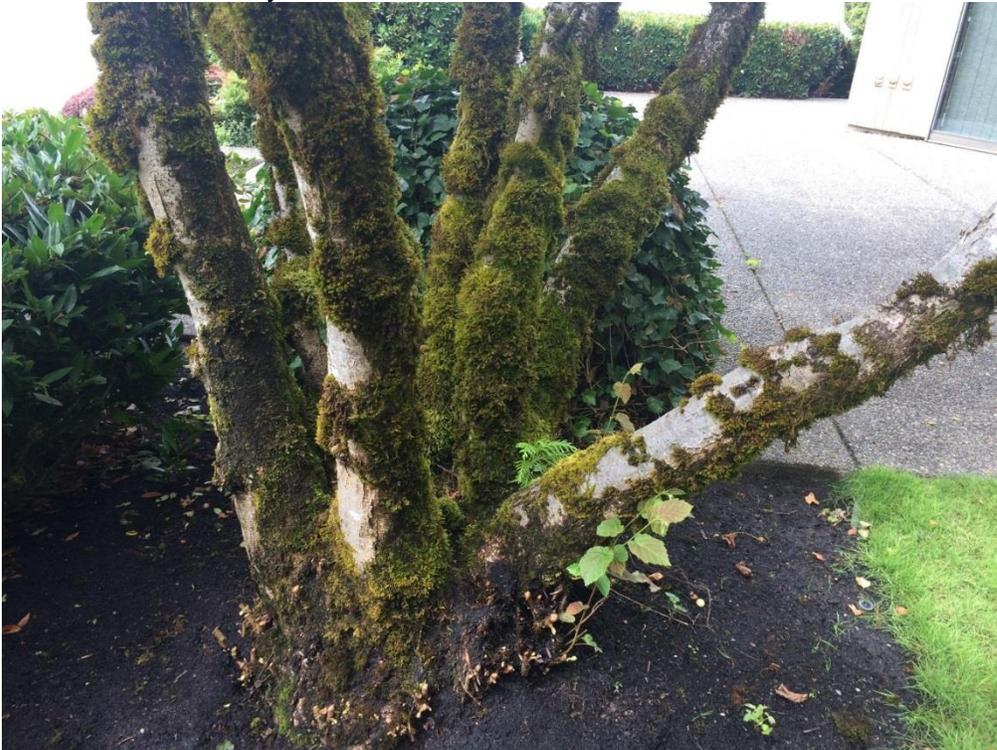
Tree #140 – mulberry tree with co-dominant stems

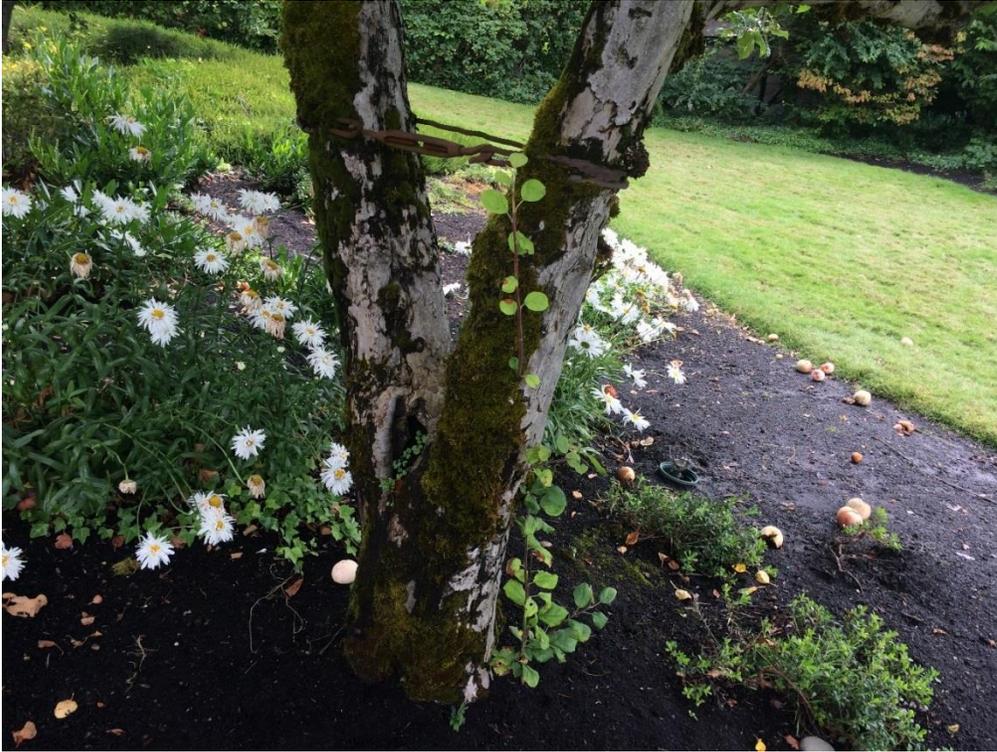
Tree #141 – apple tree with old cabling

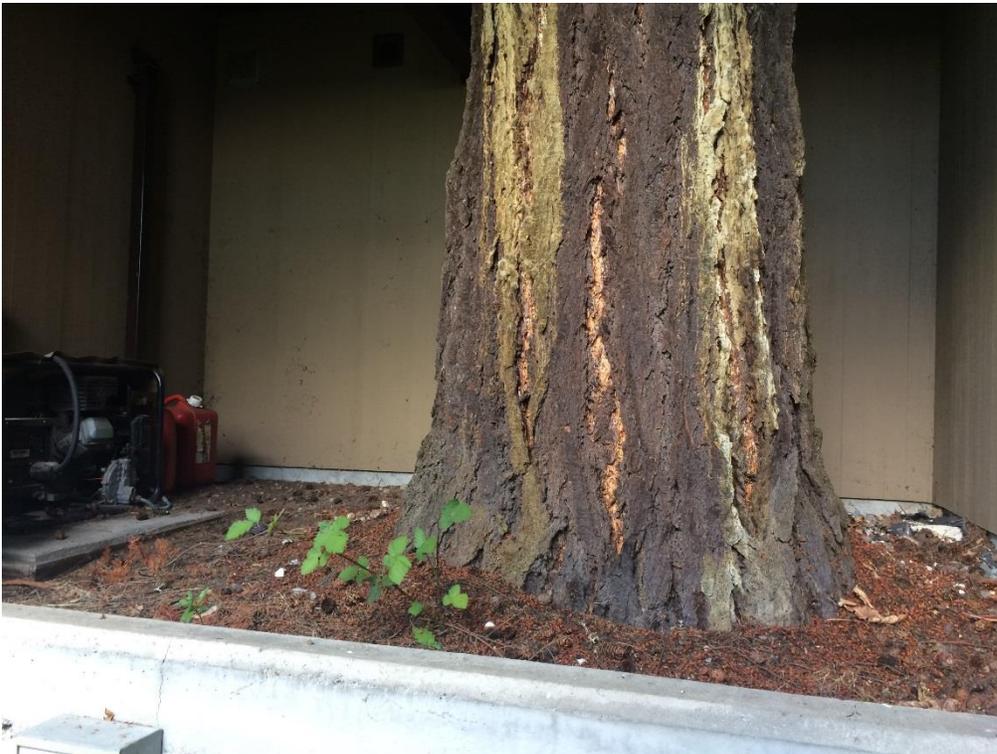
Tree #162 – mature Douglas-fir in small planter box adjacent to home, cambium ruptures on the trunk

162 – In home footprint. Tree would not survive demolition of the existing home and would limit the buildable gross square footage to less than 75%.

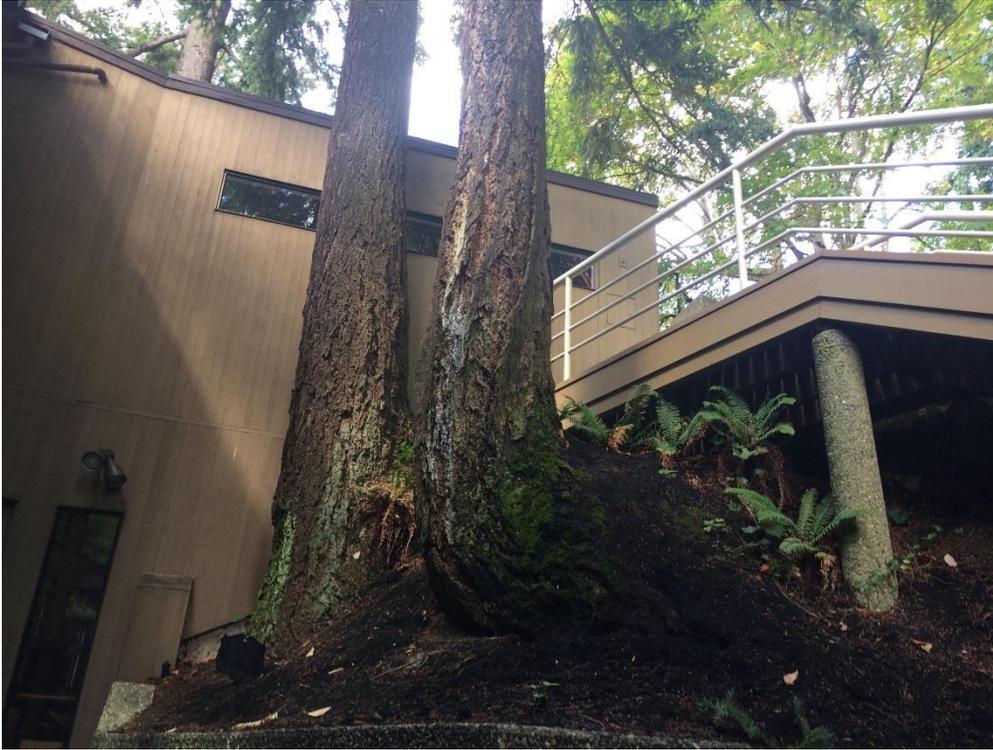
Tree #163 and #164 – Douglas-fir trees adjacent to the home in a small planter box

163 – In home footprint. Tree would not survive demolition of the existing home and would limit the buildable gross square footage to less than 75%.

164 – In home footprint. Tree would not survive demolition of the existing home and would limit the buildable gross square footage to less than 75%.

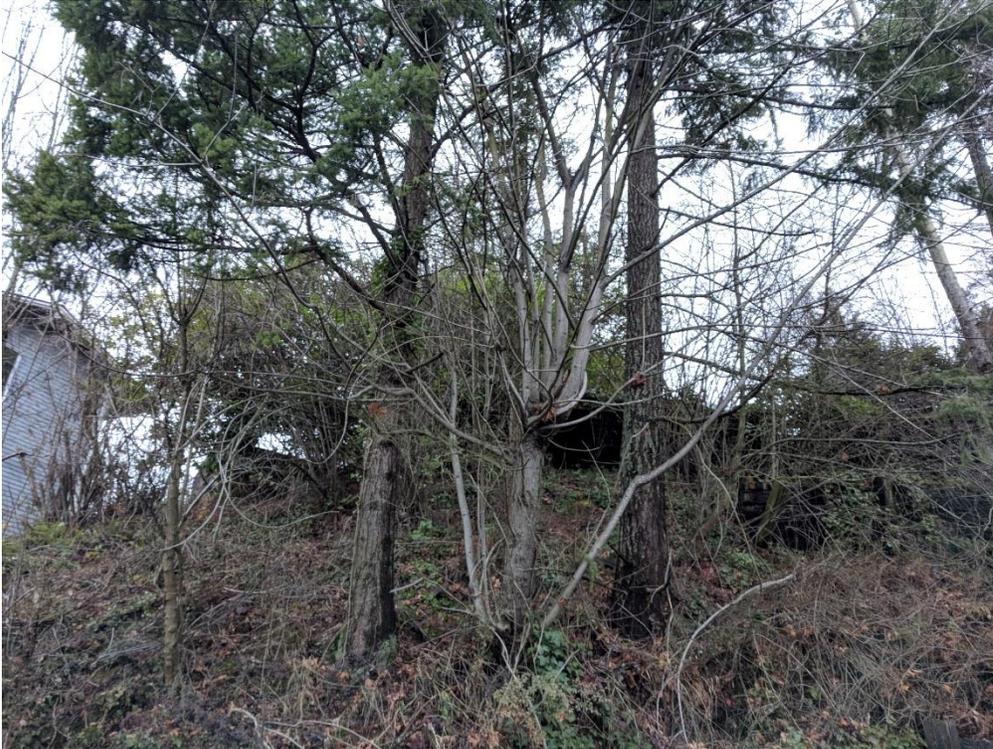
Tree #1804 is a semi-mature Douglas fir tree on the steep slope. This tree has a healthy crown. Condition is rated as good.

Tree #1805 is a big leaf maple growing between tree #1804 and #1806. This tree was topped in the past and has multiple leaders. Condition is rated as fair.

Tree #1806 is a Douglas fir tree growing on the steep slope. This tree has good trunk taper and a full crown. Condition is rated as good.

Tree #1804, #1805 and #1806 – neighboring Douglas fir and big leaf maple trees, utility trenching will occur to the left of tree #1804

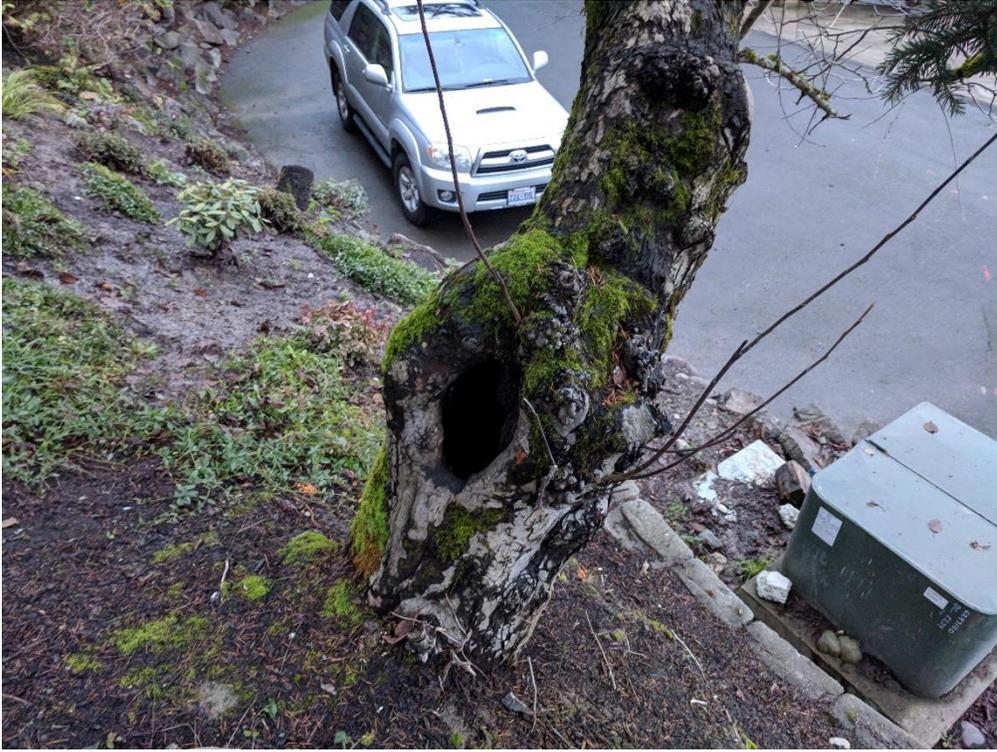
Tree #1801 is a mature apple tree. This tree was pruned periodically. There is a large cavity in the lower trunk. Condition is rated as fair.

Cavity in lower trunk of tree #1801
