June 19, 2017

Re: **Mercer Island Center for the Arts**
Slope Stability Study - Revision 01
19120-01

This report is the first revision to our original report dated November 22, 2016 and is submitted to address comments by Perrone Consulting, Inc., P.S.

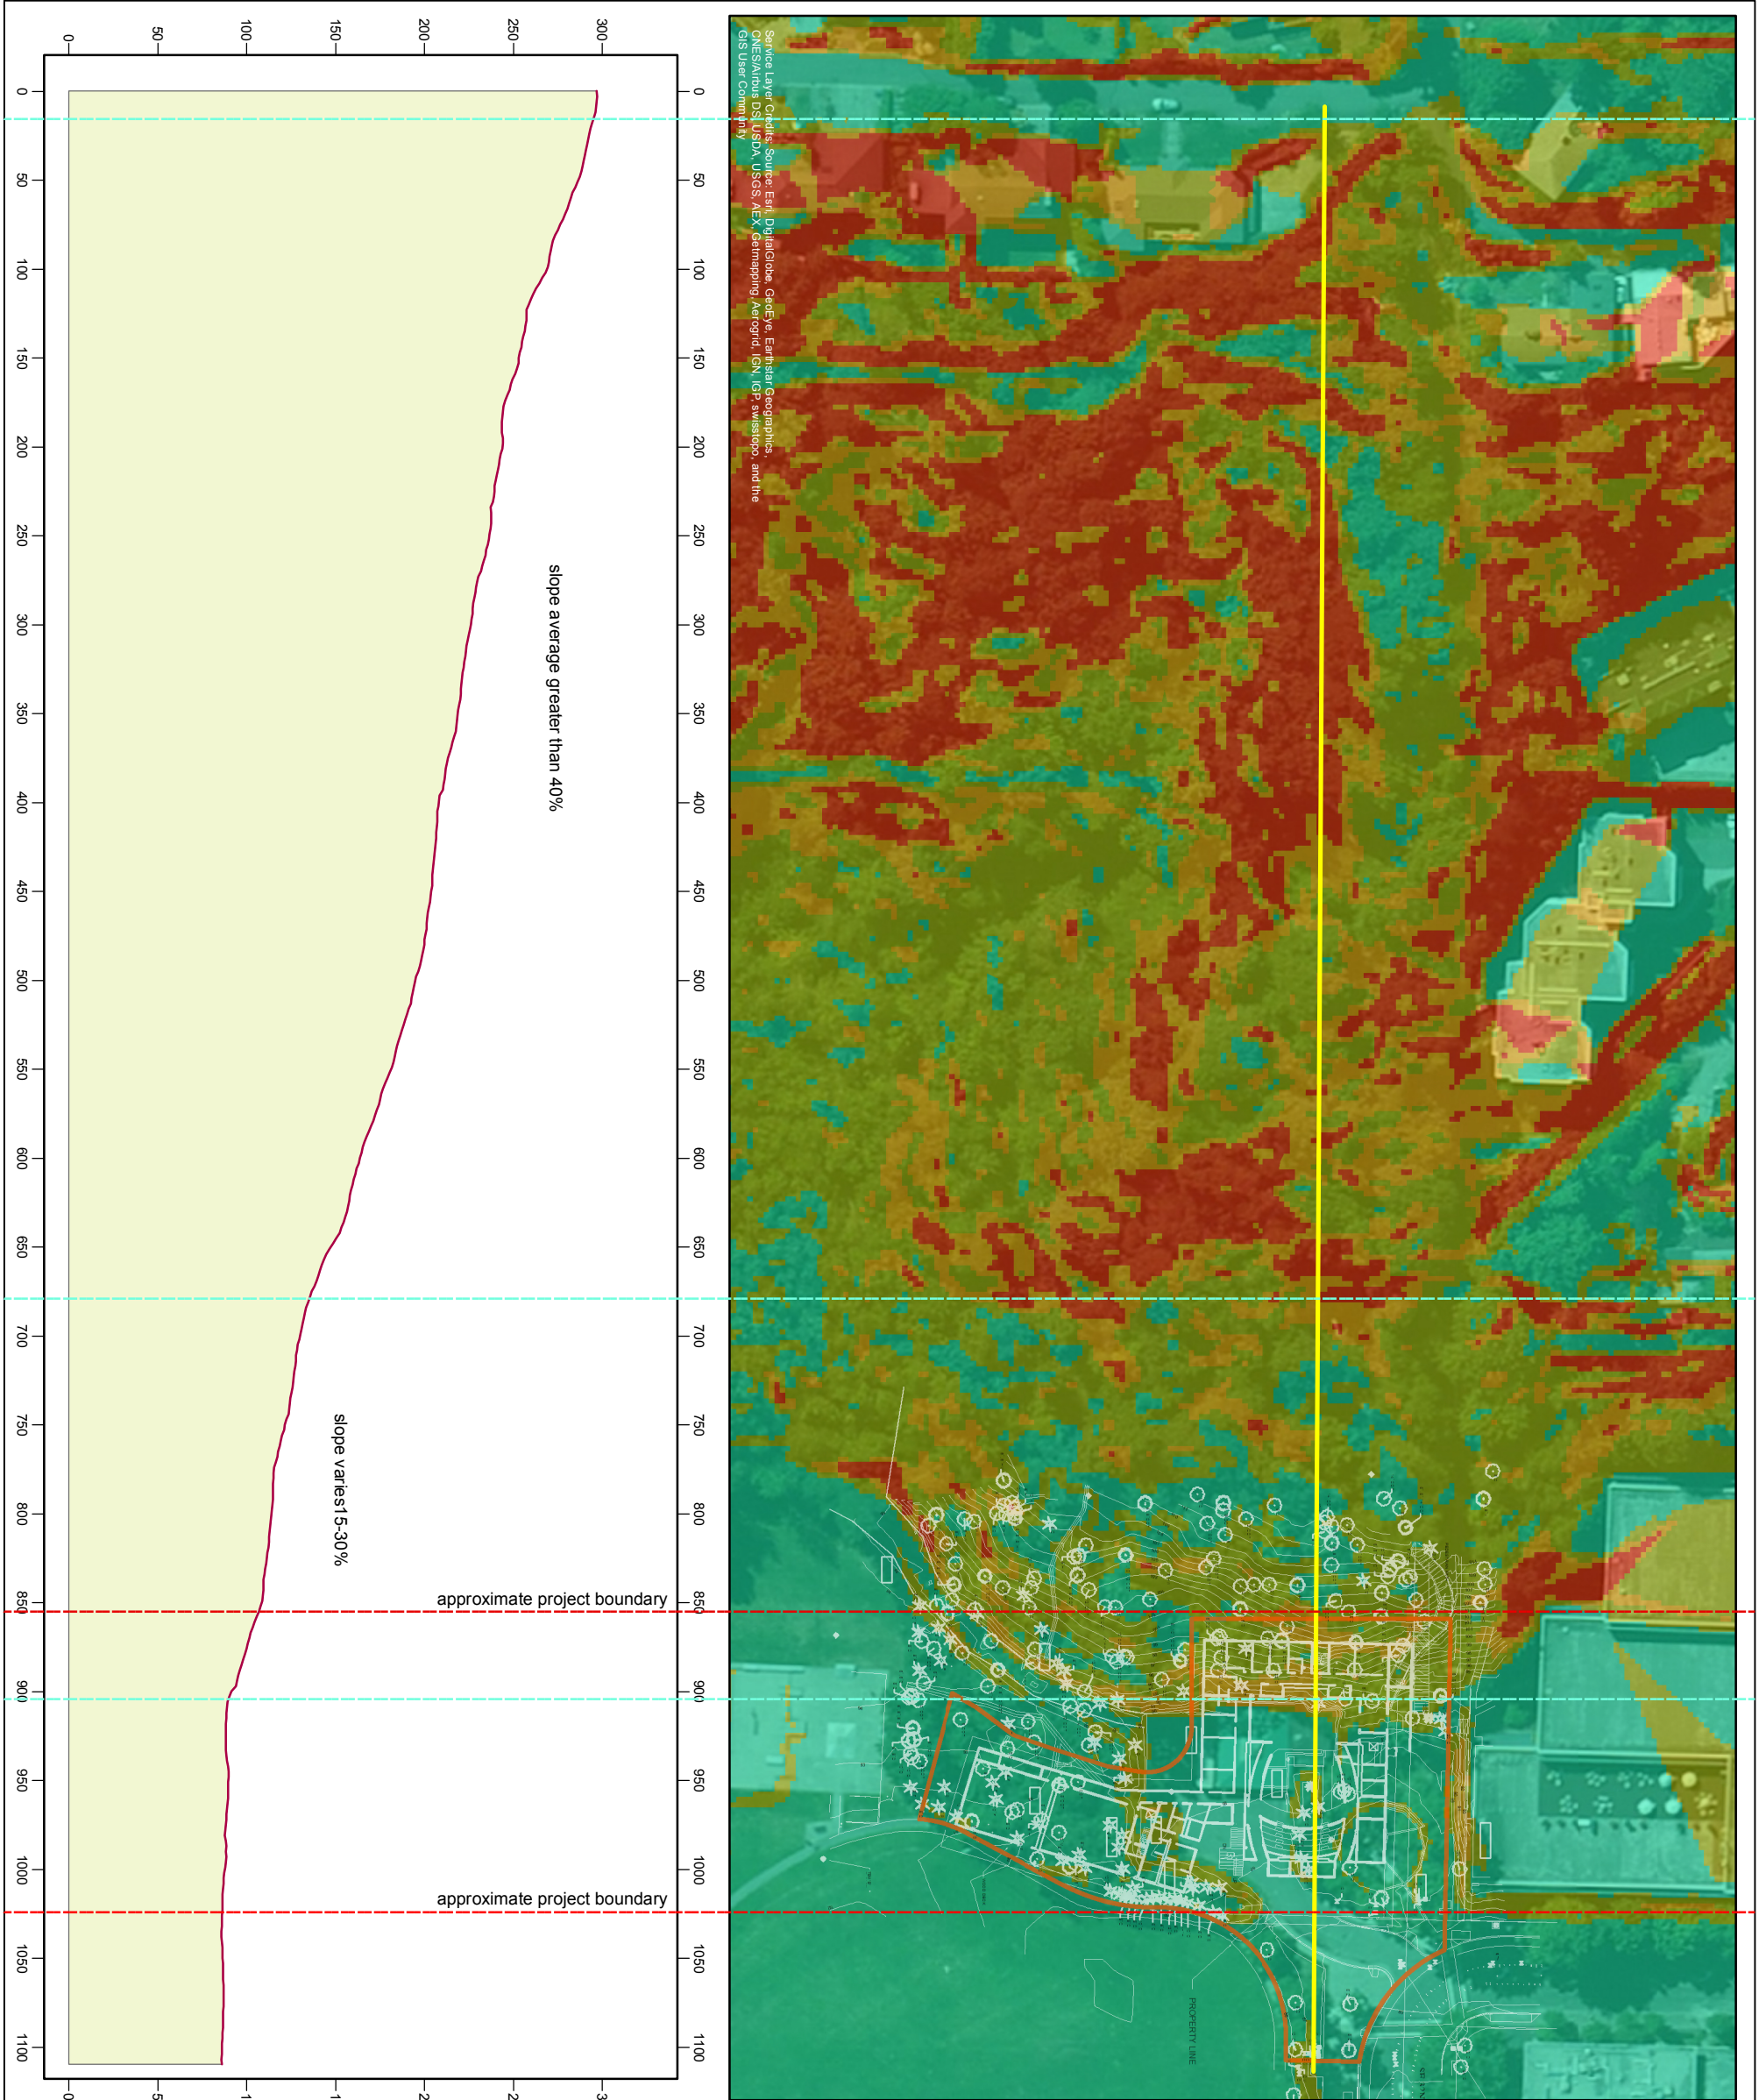
Figure **1**

We previously conducted a site visit and further analyses to assess the landslide risks for the proposed development site. We developed a cross section through the site and the adjacent hillside. It is presented as Figure 1 attached to this letter. Figure 1 also demonstrates the changing steepness of the slopes, from near flat at the building site, to 15% - 30% directly behind the building, to average slopes steeper than 40% up the rest of the hill.

Based on our borings, other borings in the vicinity, geologic mapping, and published sources, we prepared a subsurface cross section as shown in Figure 1. The soil layering is approximate, both in depth and thickness. As noted, the soils are generally glacial in origin and very dense or hard, except for surficial deposits.

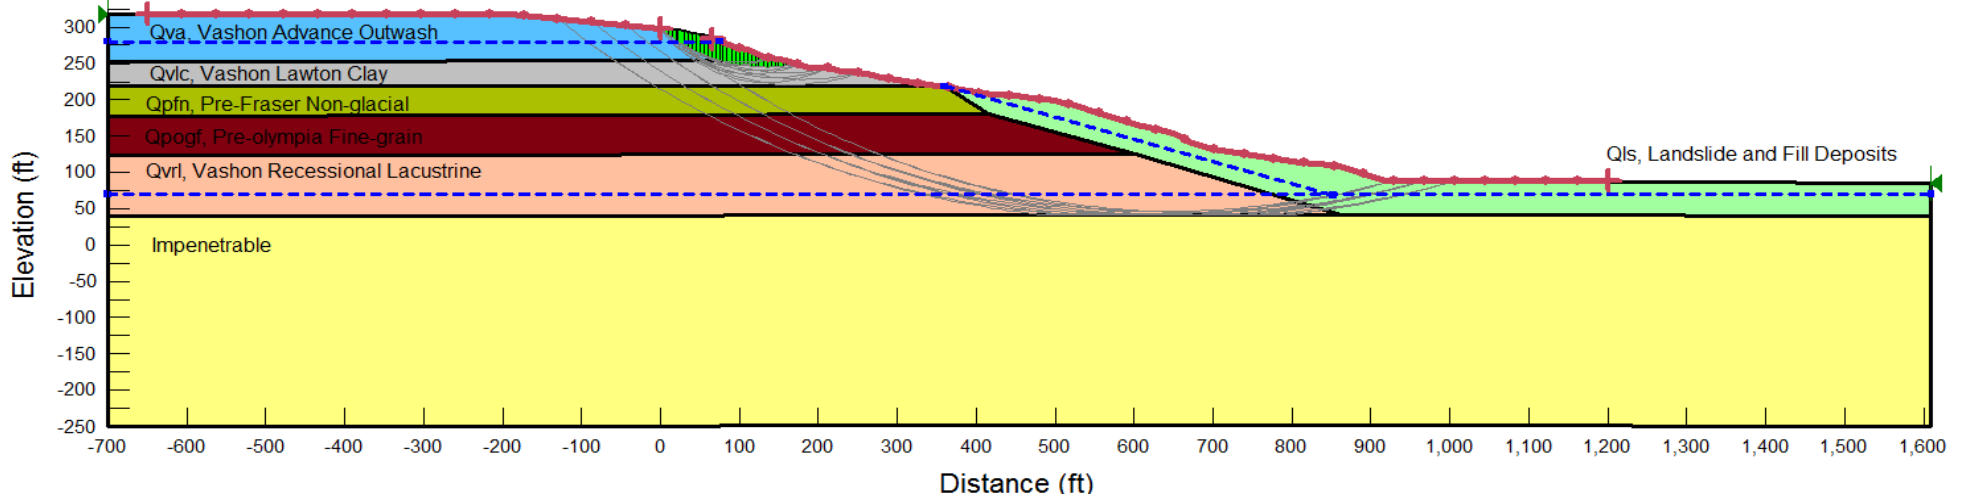
Mercer Island Center for the Arts Seattle, WA	
Limit Equilibrium Slope Stability Analysis Results: Static, Effective Stress Strength	
19120-01	06/18/17
	Figure
3

The first analysis is shown in Figure 3, and assumes effective stress strength parameters and no seismic force. The critical failure surface is expected to occur near the top of the slope, across the intersection of the advance outwash and underlying Lawton clay deposits. Such a failure surface would result in soil slumping on the slope, but would not be catastrophic. The calculated factor of safety (ratio of the resisting forces to the driving forces along the potential failure surface) for this surface and static load conditions is about 2.3, indicating that a slope stability failure is unlikely to occur. Other, deeper failure surfaces presented by the analysis have factors of safety greater than 2.3, and so are also unlikely to occur.

FS = 2.3

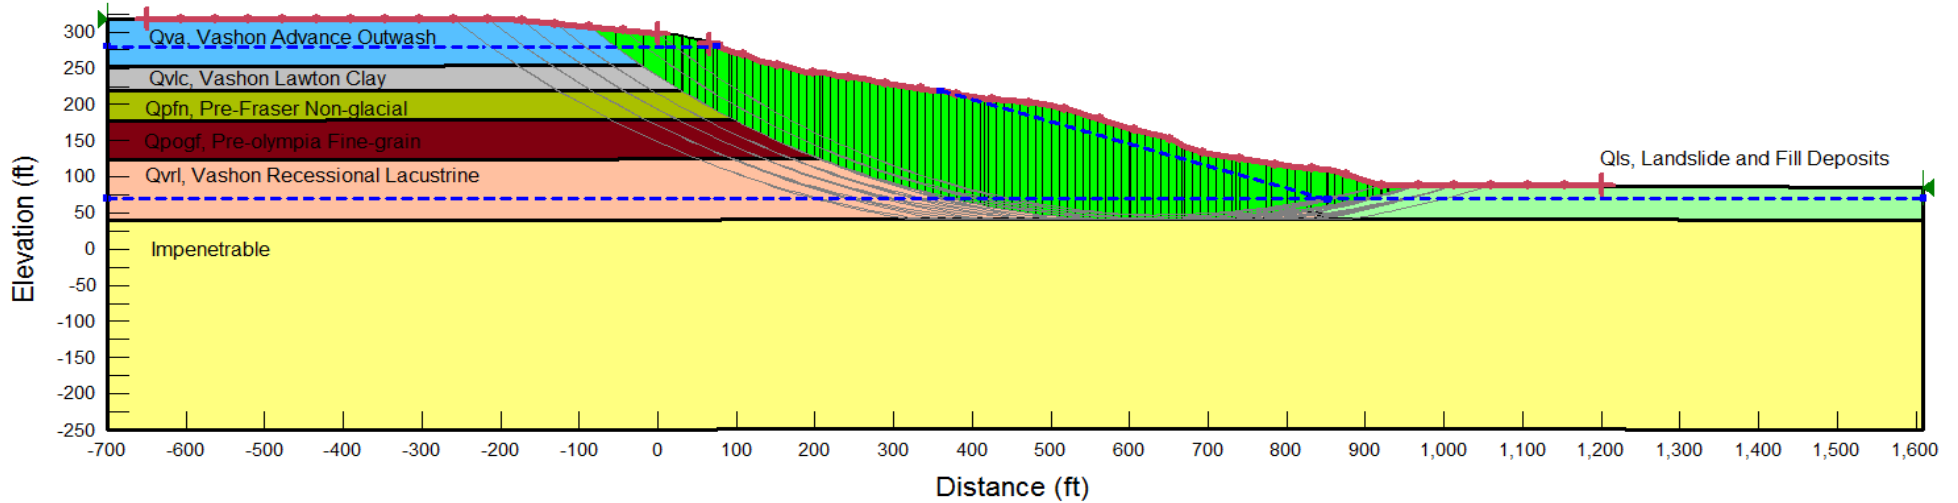
Mercer Island Center for the Arts Seattle, WA	
Limit Equilibrium Slope Stability Analysis Results: Seismic, Effective Stress Strength	
19120-01 HARTCROWSER	06/18/17 Figure 4

Figure 4 presents the results assuming the same effective stress soil strength parameters that were used for the static case. Figure 5 presents the results assuming undrained strength parameters for the Lawton clay, pre-Olympia fine-grain, and recessional lacustrine deposits. The results present slip surfaces likely to exit near the middle or toe of the slope with a factor of safety of about 1.0.

FS = 1.0

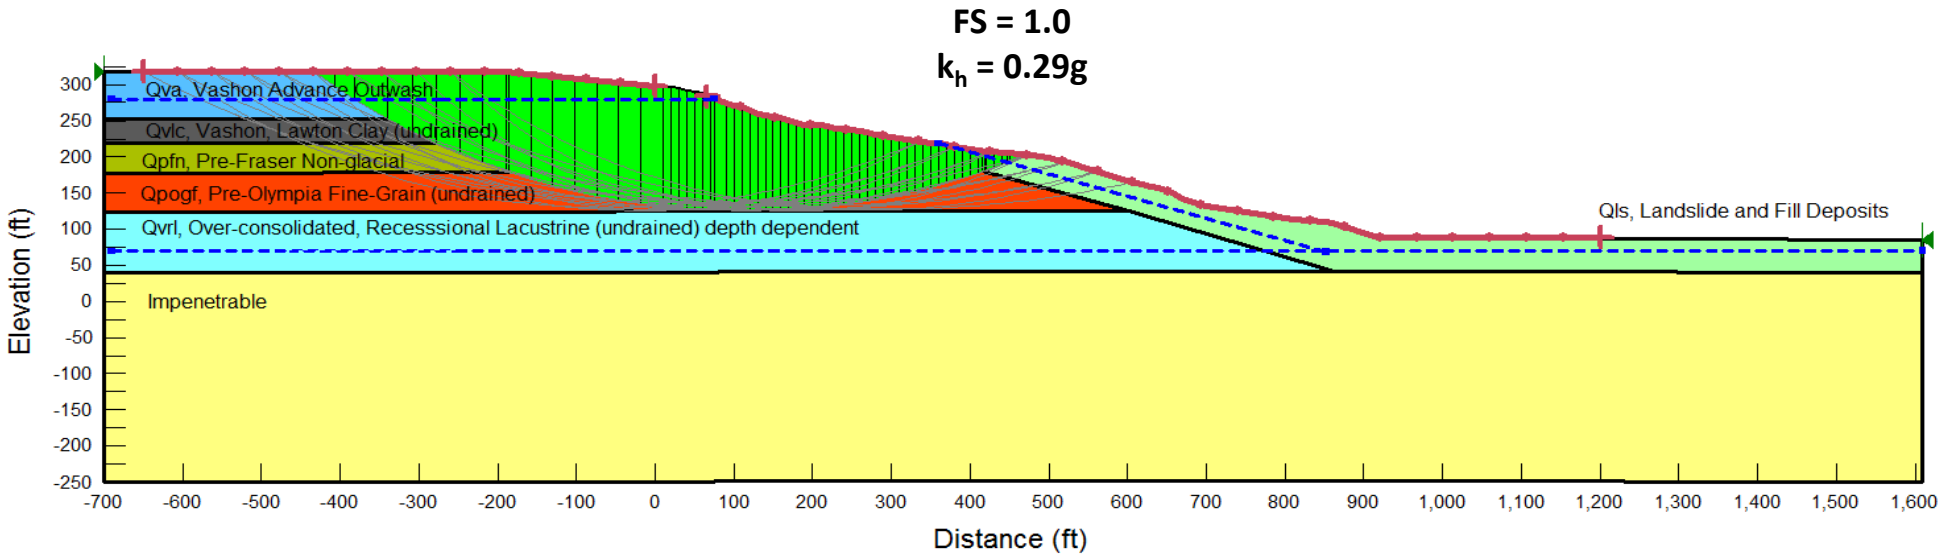
HART CROWSER	Mercer Island Center for the Arts Seattle, WA
	Limit Equilibrium Slope Stability Analysis Results: Seismic, Undrained Strength
19120-01 06/18/17	Figure 3

Even during this extreme seismic event the factor of safety for the slope above the MICA development area on this deep potential failure surface is near 1, as shown on Figure
