SEPA Environmental Checklist
Mercer Island Center for the Arts

Attachment I
Tree Assessment

November 16, 2016

RE: Tree Assessment within proposed MICA Project Limits at Mercerdale Park

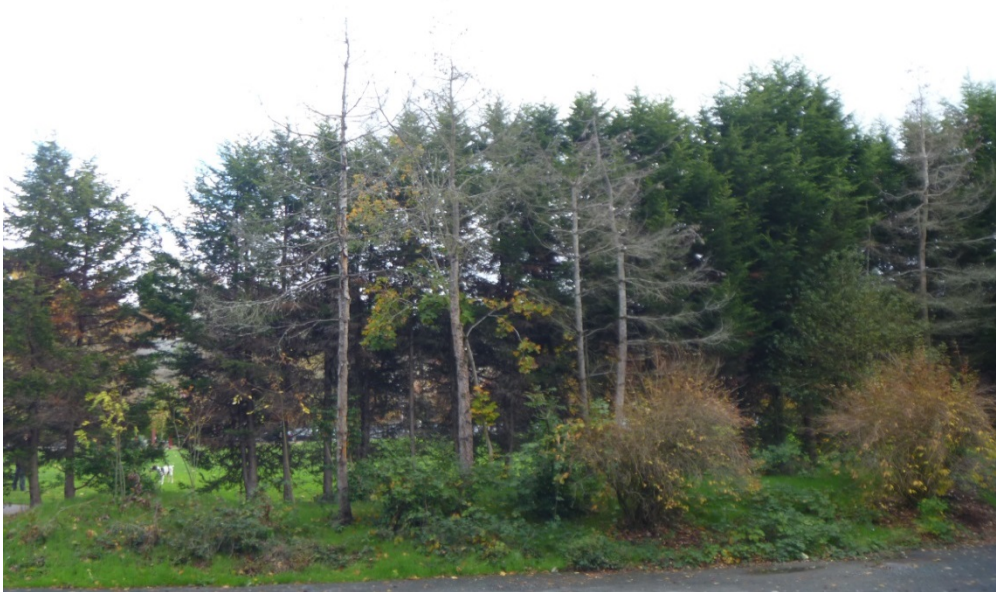
Located on the west side of the large, central lawn is a hedgerow consisting of 15 Leyland Cypress (*Cupressus x leylandii*). These trees are approximately 10-15 years old and have been consistently hedged since their installation (Figure 2). These trees have very little habitat function and are also in poor health. They were also planted very close together to serve as screening for the recycling center; this has resulted in die-off of many of the inside branches. If these trees were to be removed it would result in no loss of function to the overall forest health.

Figure 2 – Dead Douglas-firs (*Pseudotsuga menziesii*) located near the former recycling center and Leyland Cypress (*Cupressus x leylandii*) hedge located behind the Douglas-firs.

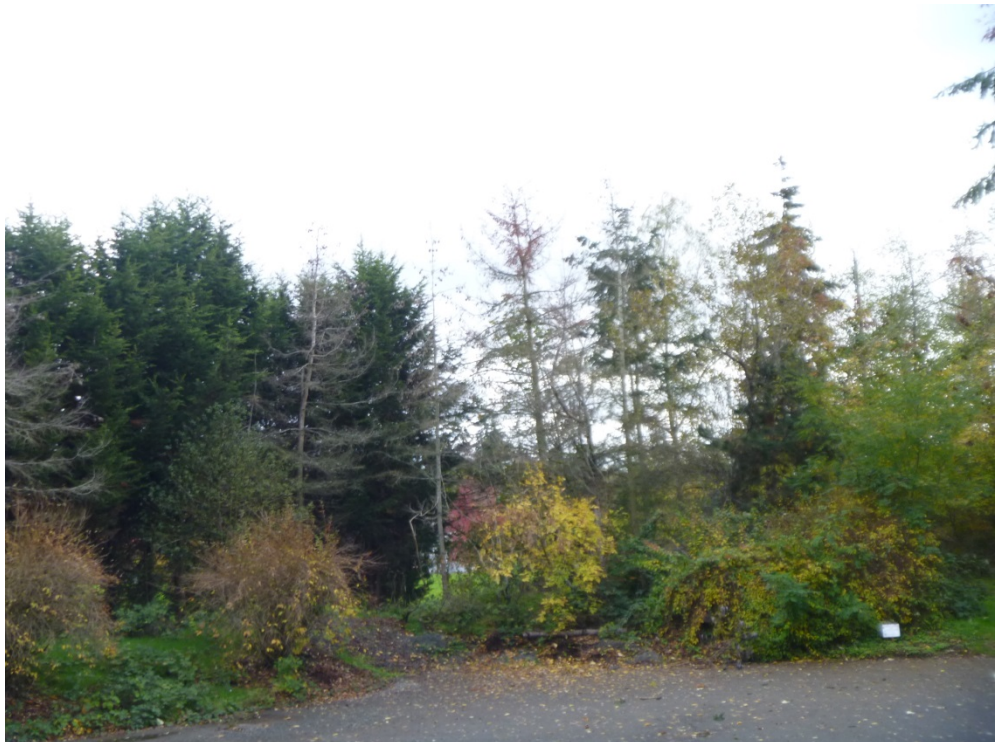
Figure 3 – Dead conifers located near hedge row and former recycling center.

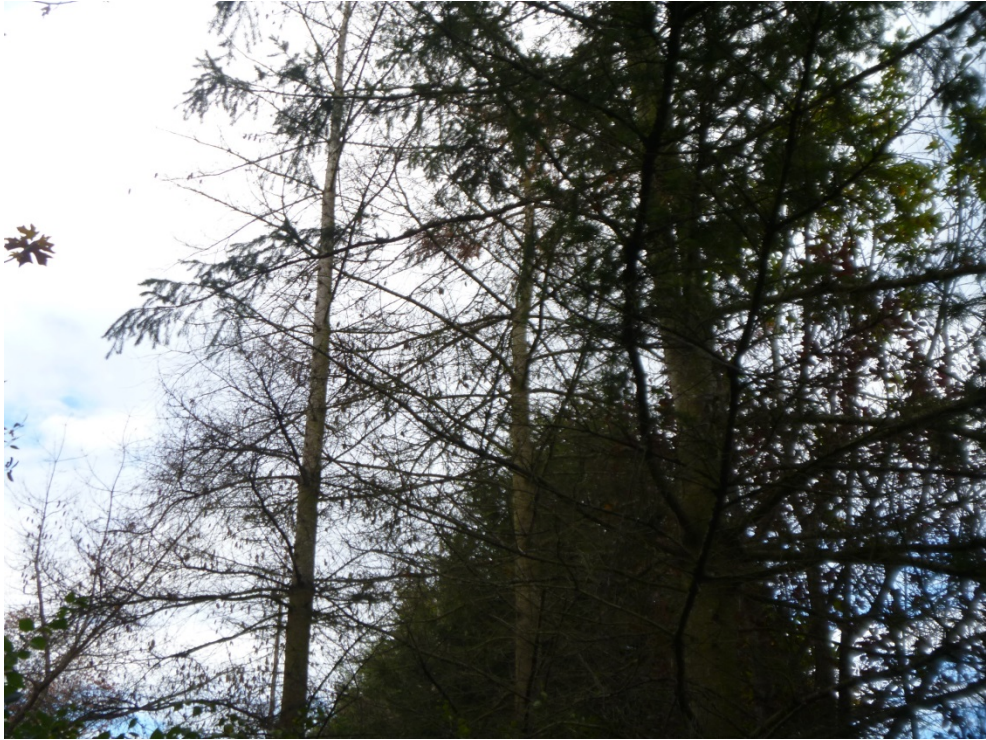
resulted in a significant amount of drought stress on many of the trees in the region. This has caused many of the Douglas-firs (*Pseudotsuga menziesii*) and western red cedar (*Thuja plicata*) in the region to become unusually susceptible to disease and pests.

Figure 4 – Dead Douglas-firs (*Pseudotsuga menziesii*) located in project area.

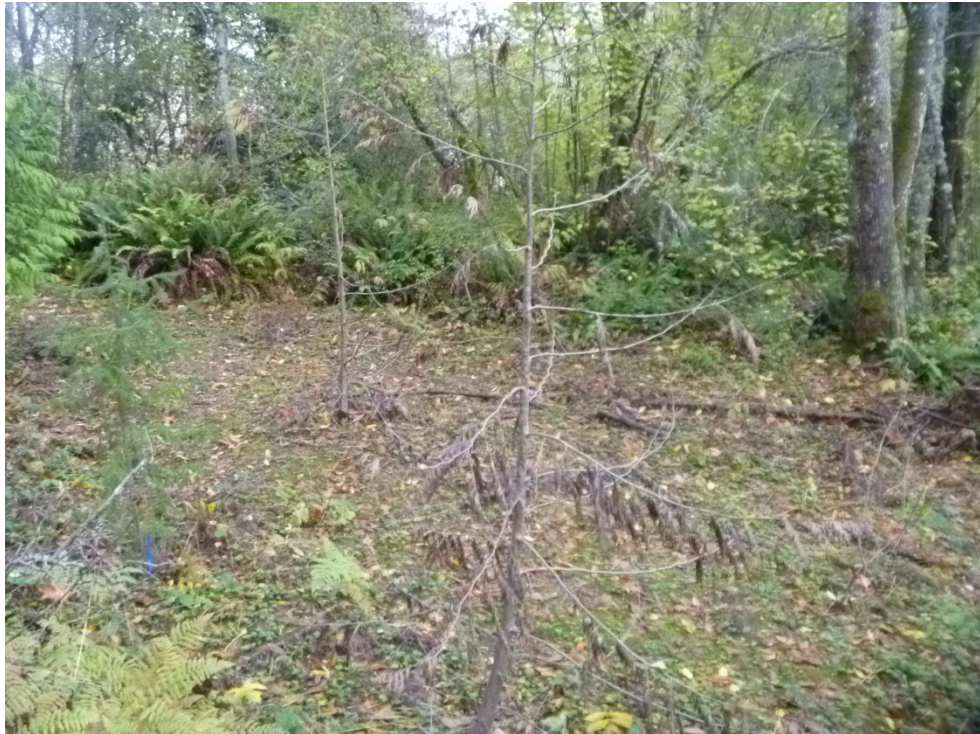
There are also many newly planted young trees throughout the project area (Figure 5), but many of the young trees are also dead or in severe condition. The suspected cause of the poor health of the young trees is also lack of sufficient water in the summer and fall, making them more susceptible to other biotic issues.

Figure 5 – Dead young western red cedars (*Thuja plicata*).

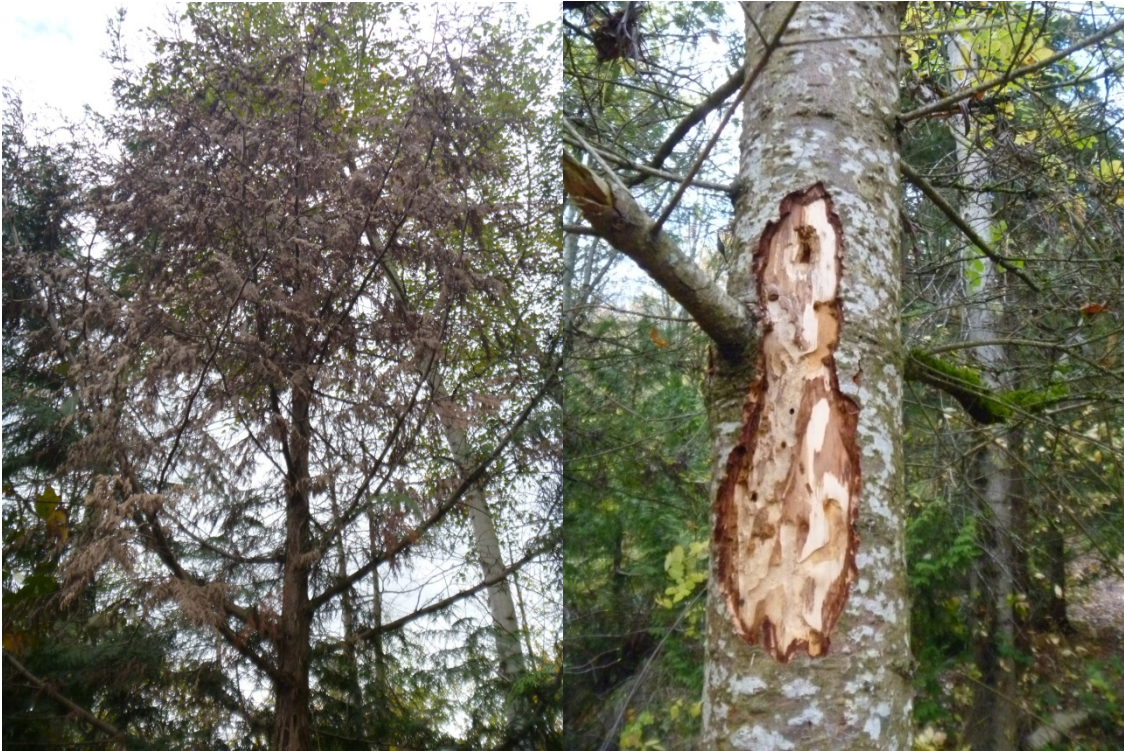
Figure 6 & 7 – Dead western red cedar (*Thuja plicata*) and Douglas-fir (*Pseudotsuga menziesii*).

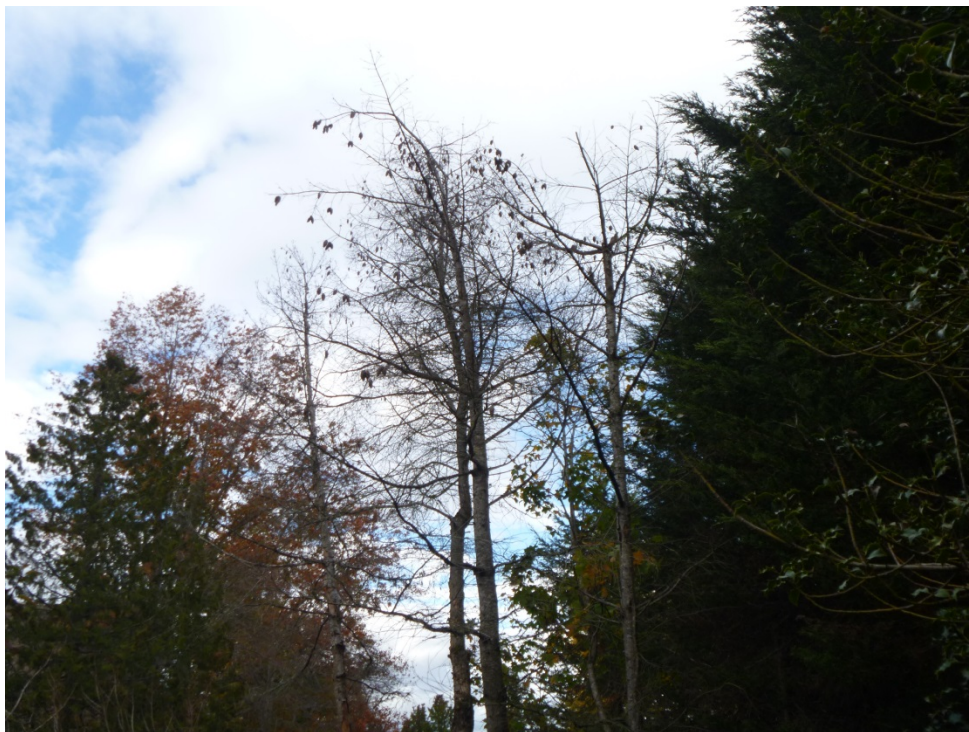
Figure 8 – Dead conifers located near former recycling center.
