SEPA Environmental Checklist
Mercer Island Center for the Arts

Attachment G
Slope Stability Review

November 22, 2016

Re: **Mercer Island Center for the Arts**
Slope Stability Study
19120-01

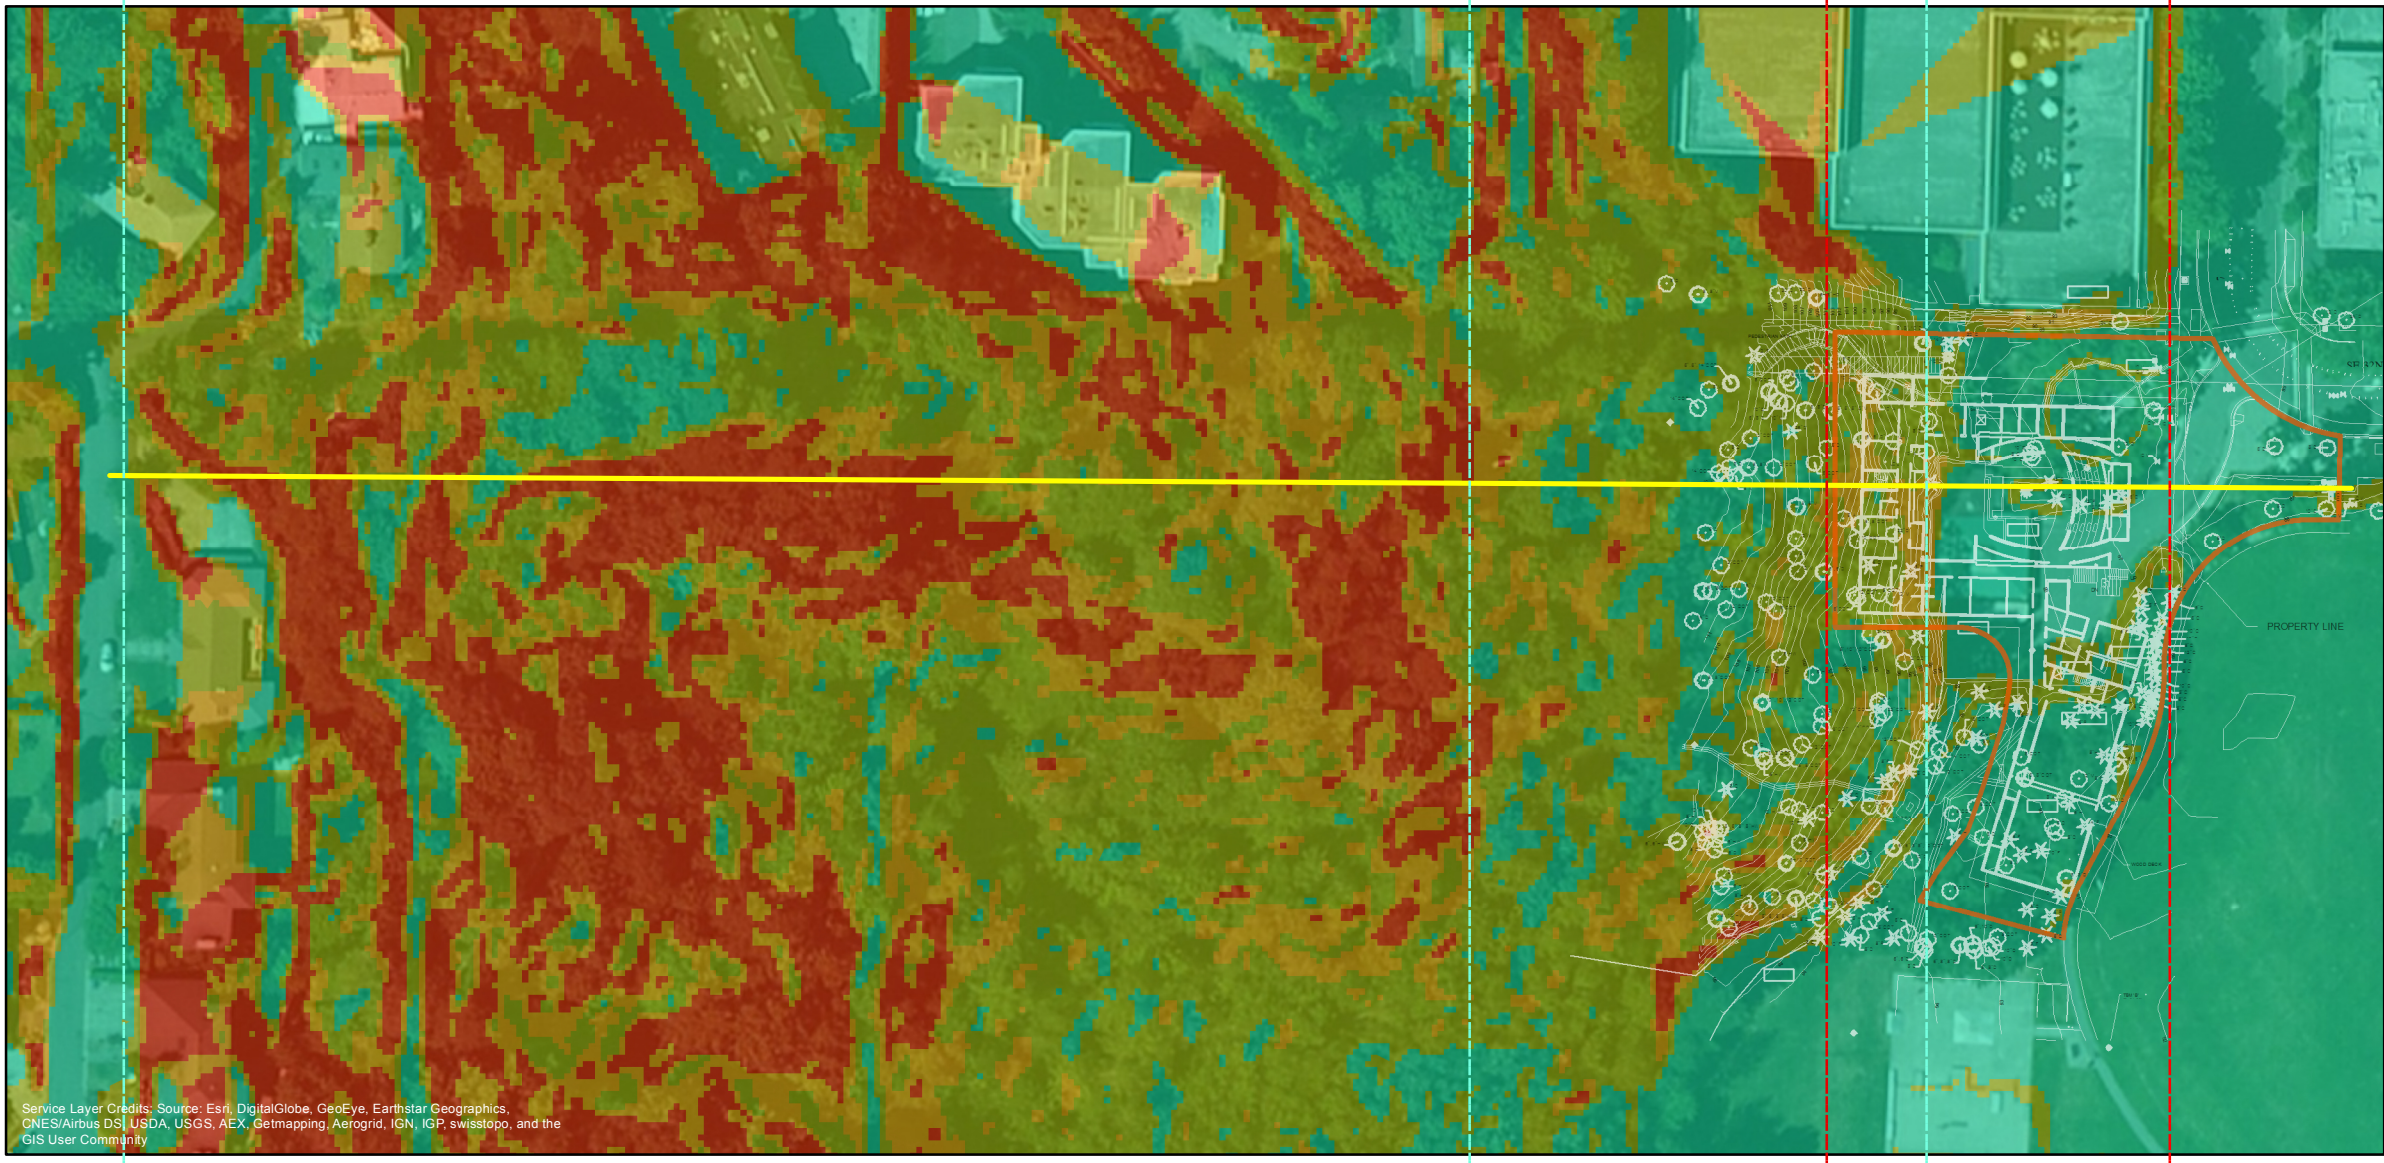
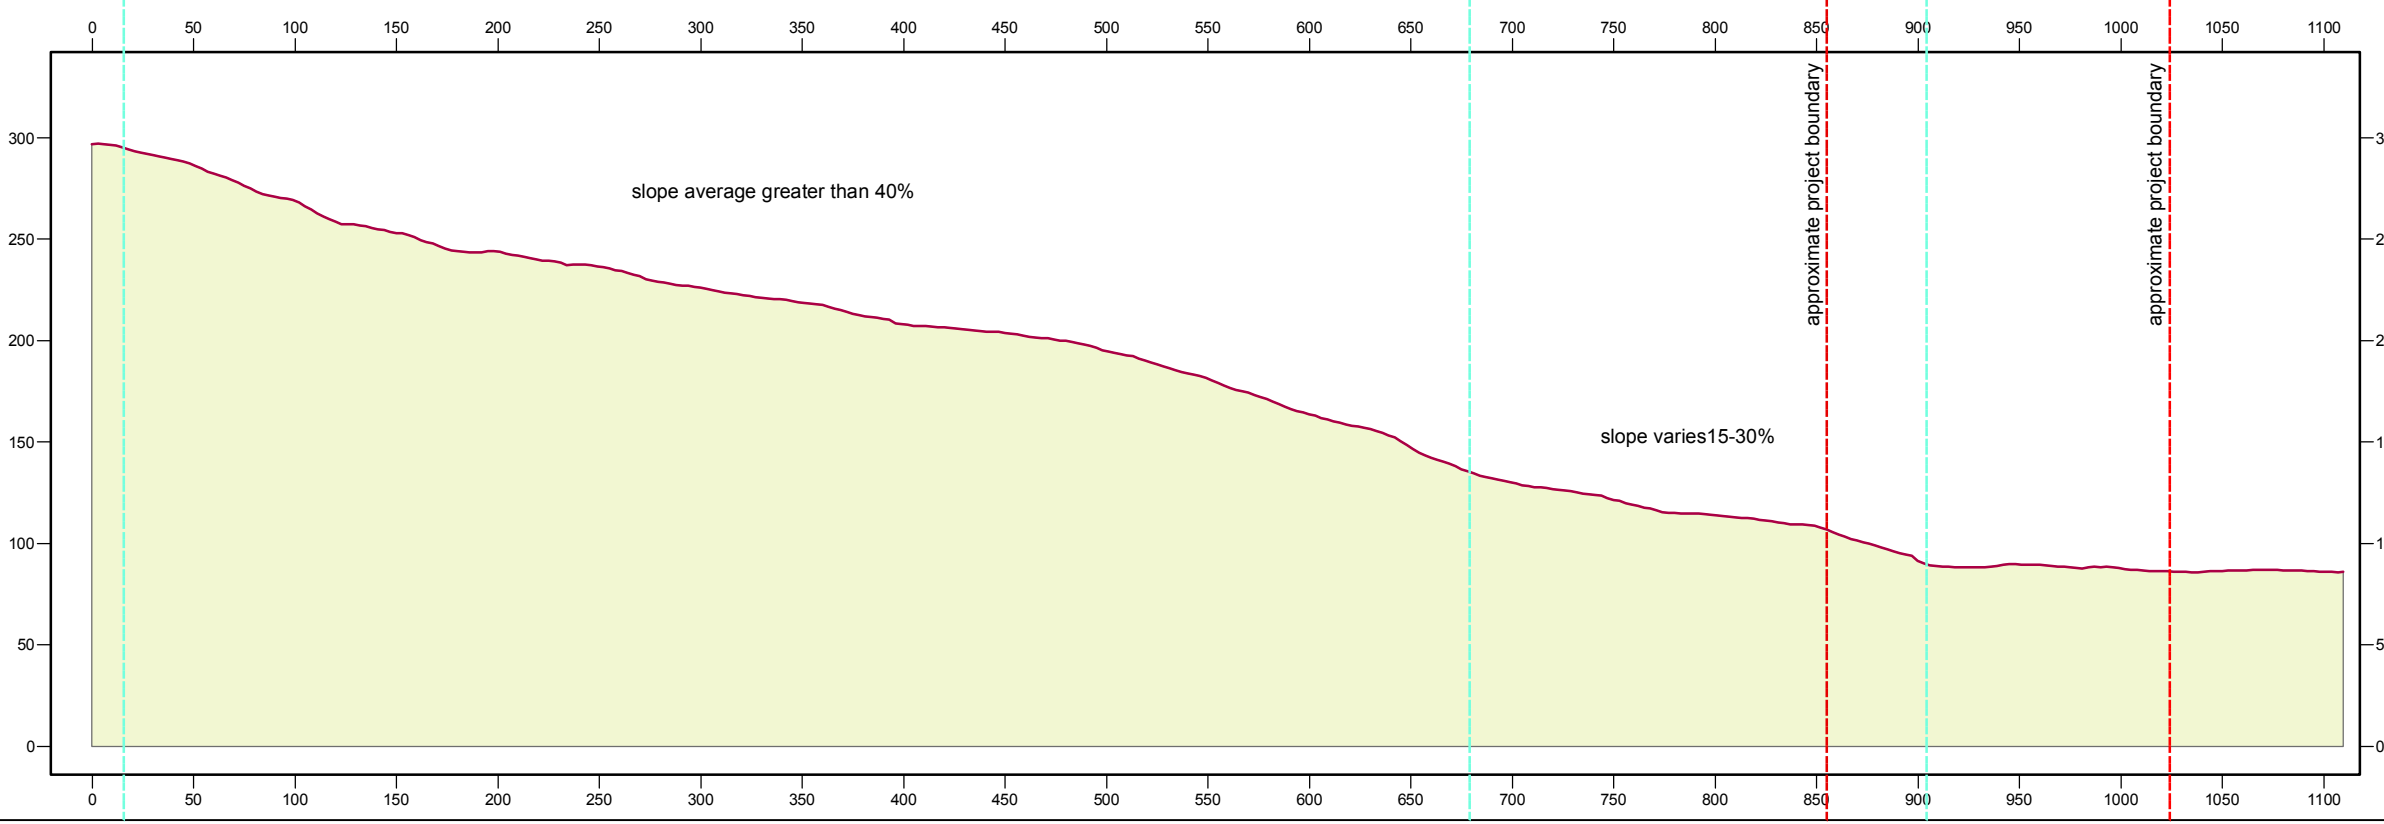
We have conducted an additional site visit and further analyses to assess the landslide risks for the proposed development site. We developed a cross section through the site and the adjacent hillside. It is presented as Figure 1 attached to this letter. Figure 1 also demonstrates the changing steepness of the slopes, from near flat at the building site, to 15% - 30% directly behind the building, to average slopes steeper than 40% up the rest of the hill.

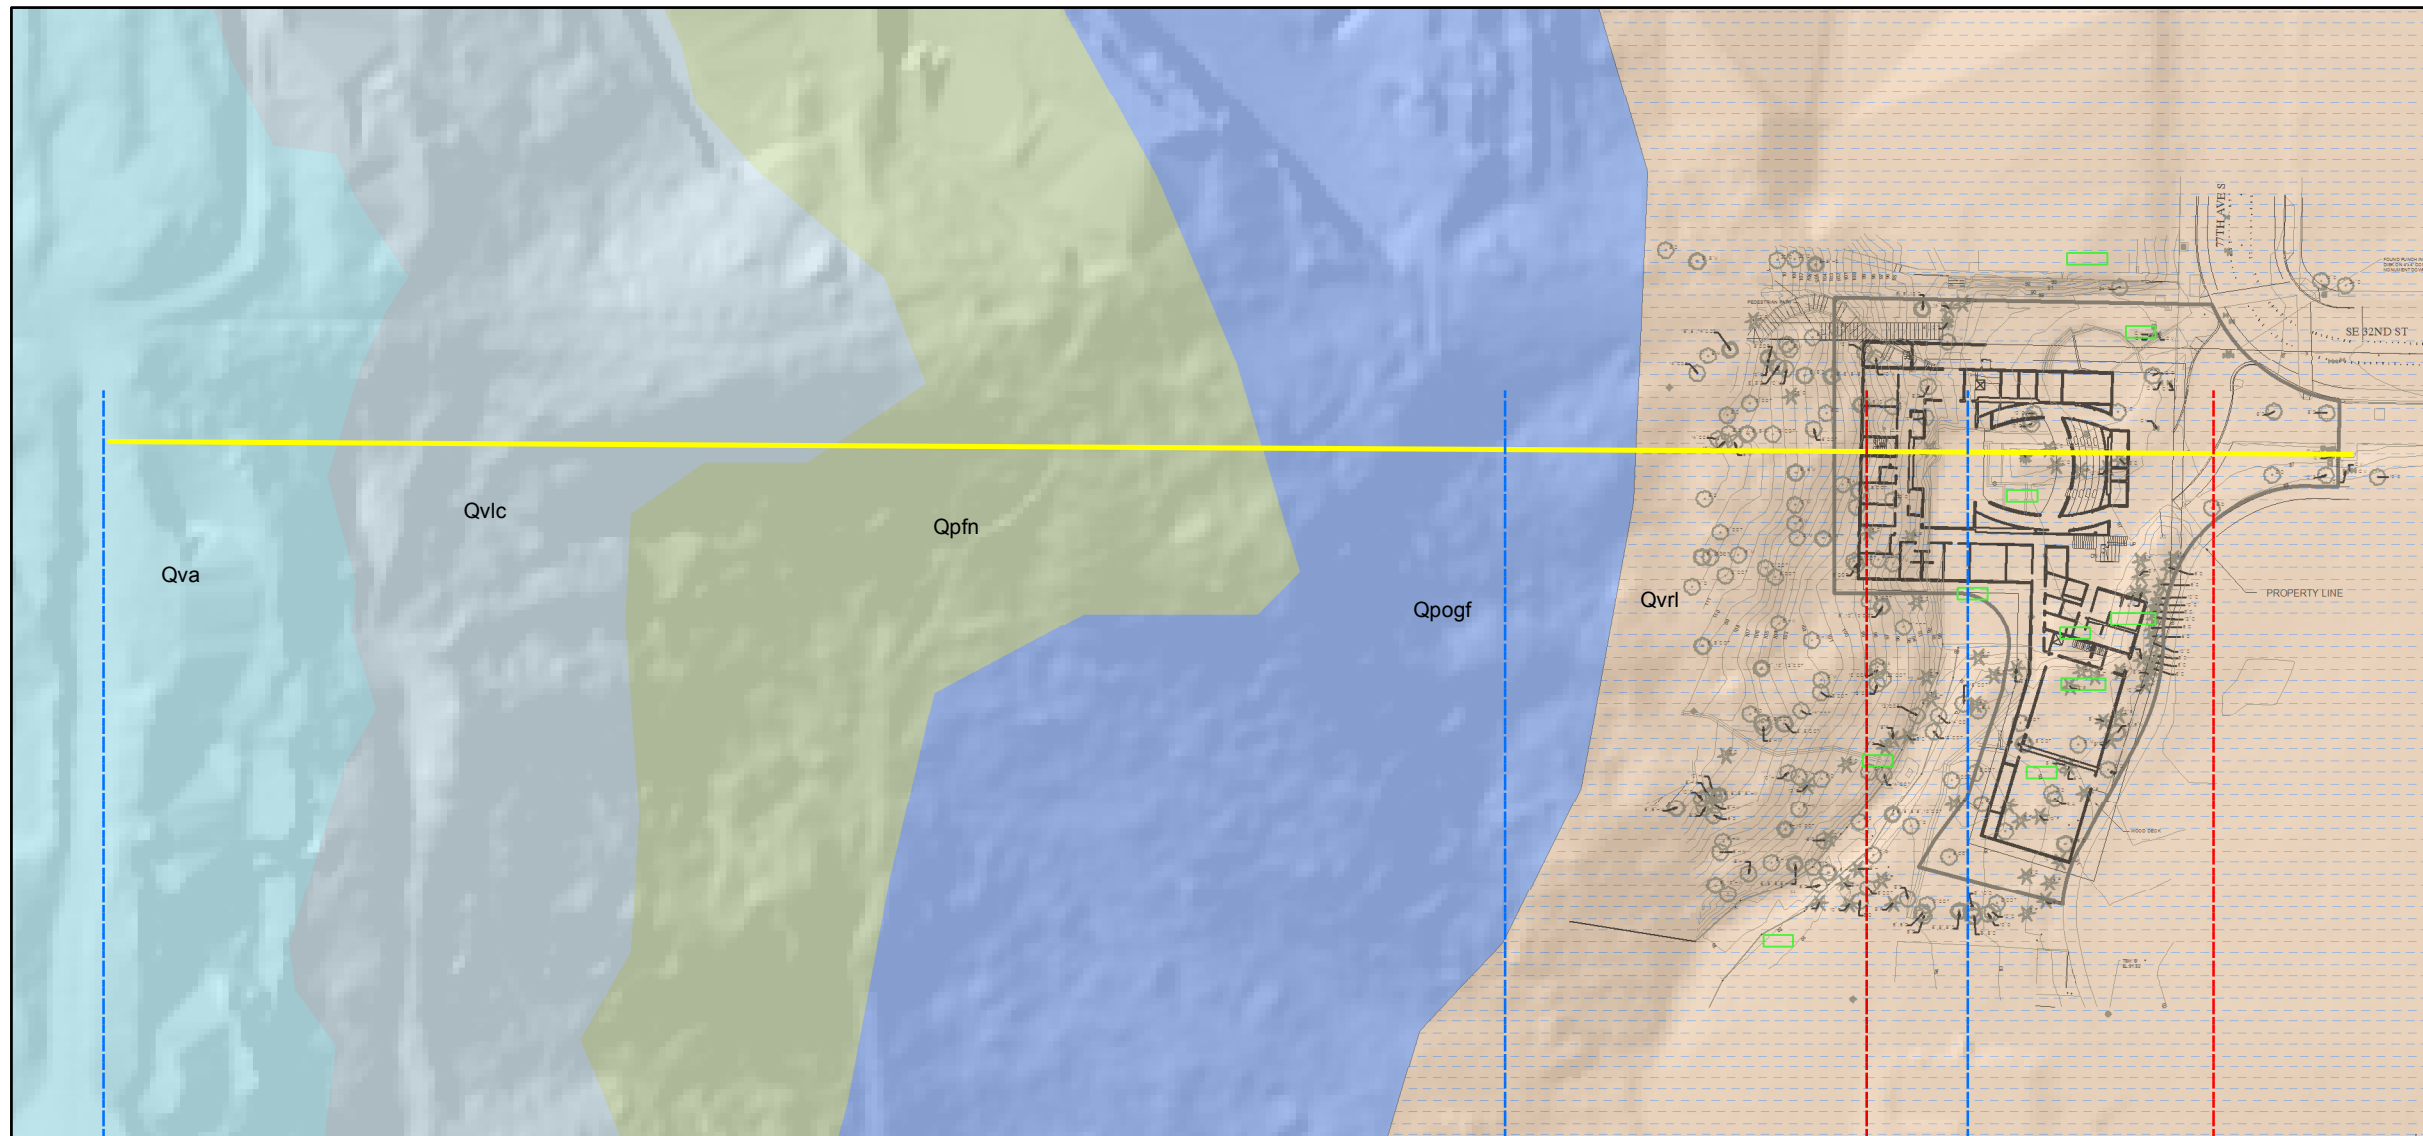
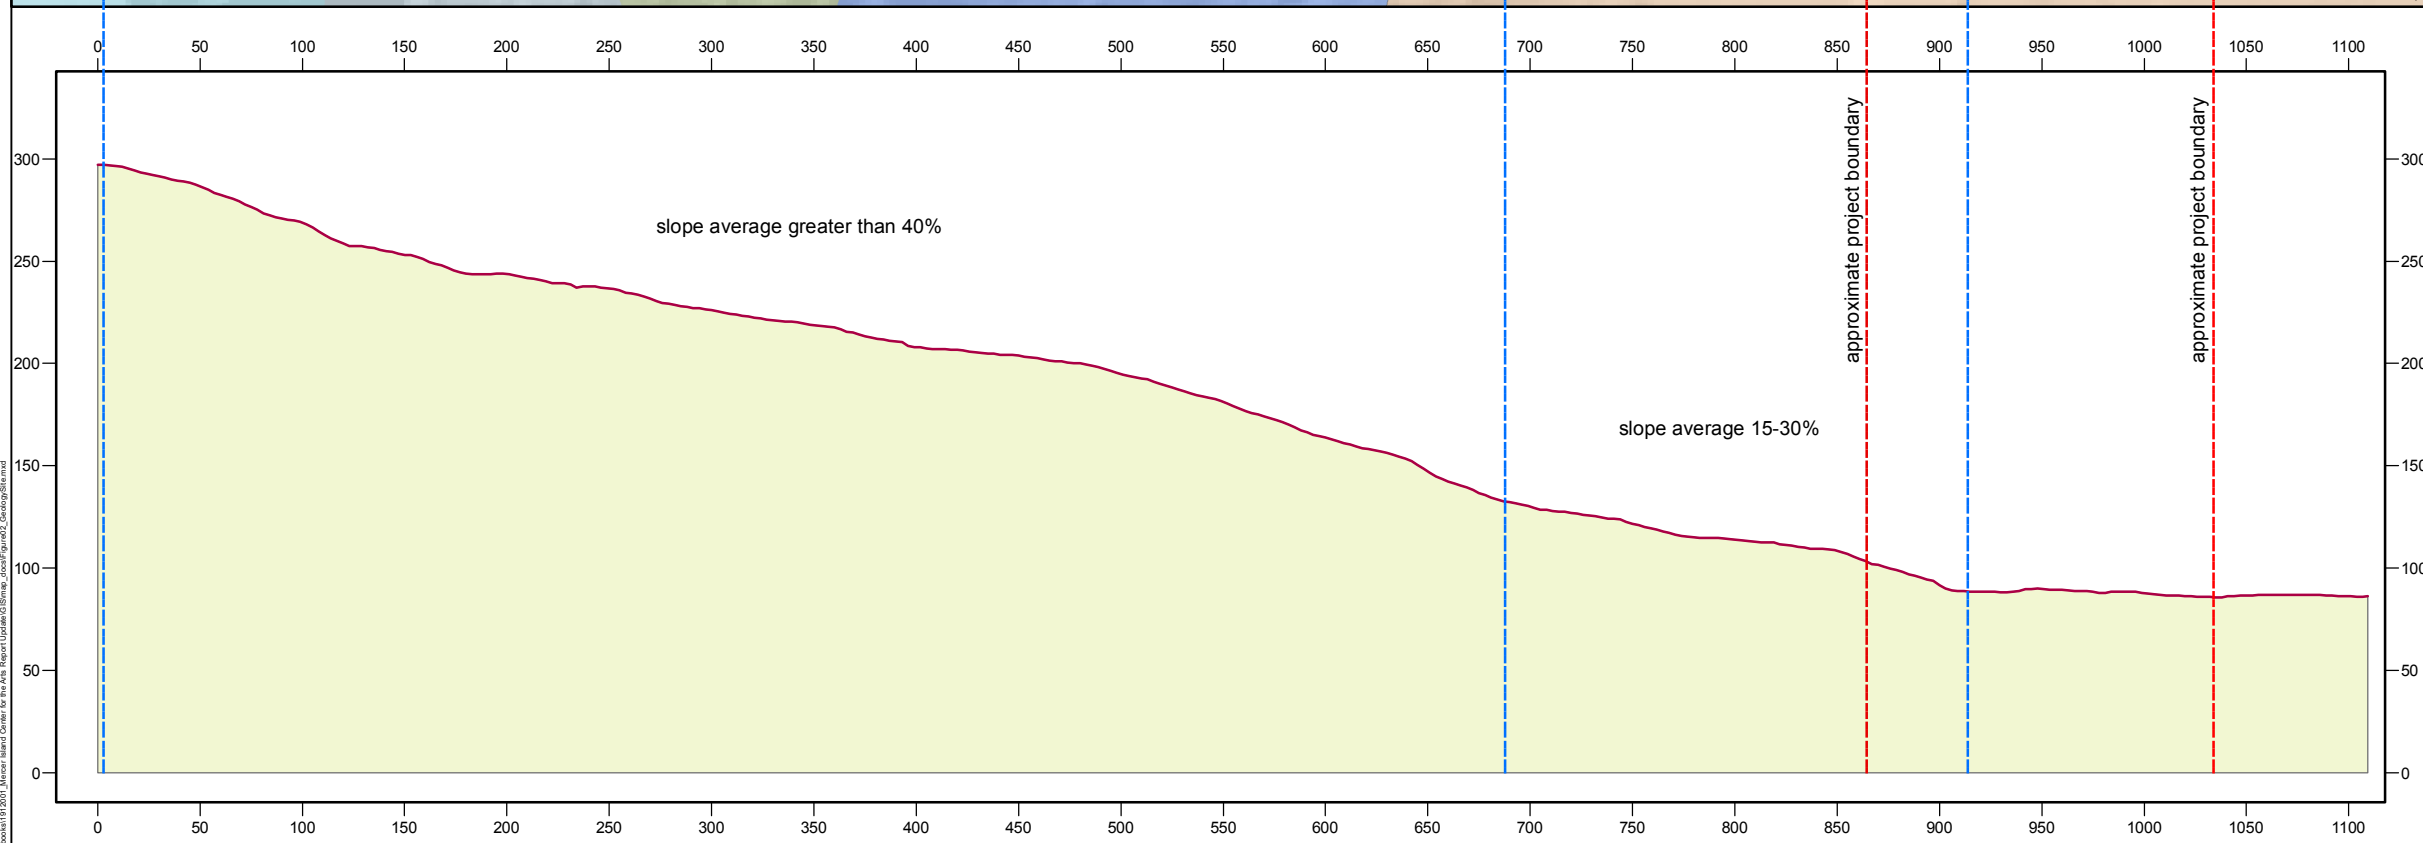
Figure
02

Based on our borings, other borings in the vicinity, geologic mapping, and published sources, we prepared a subsurface cross section as shown in Figure 2. The different layering is approximate, both in depth and thickness. As noted, the soils are generally glacial in origin and very dense, except for surficial deposits.

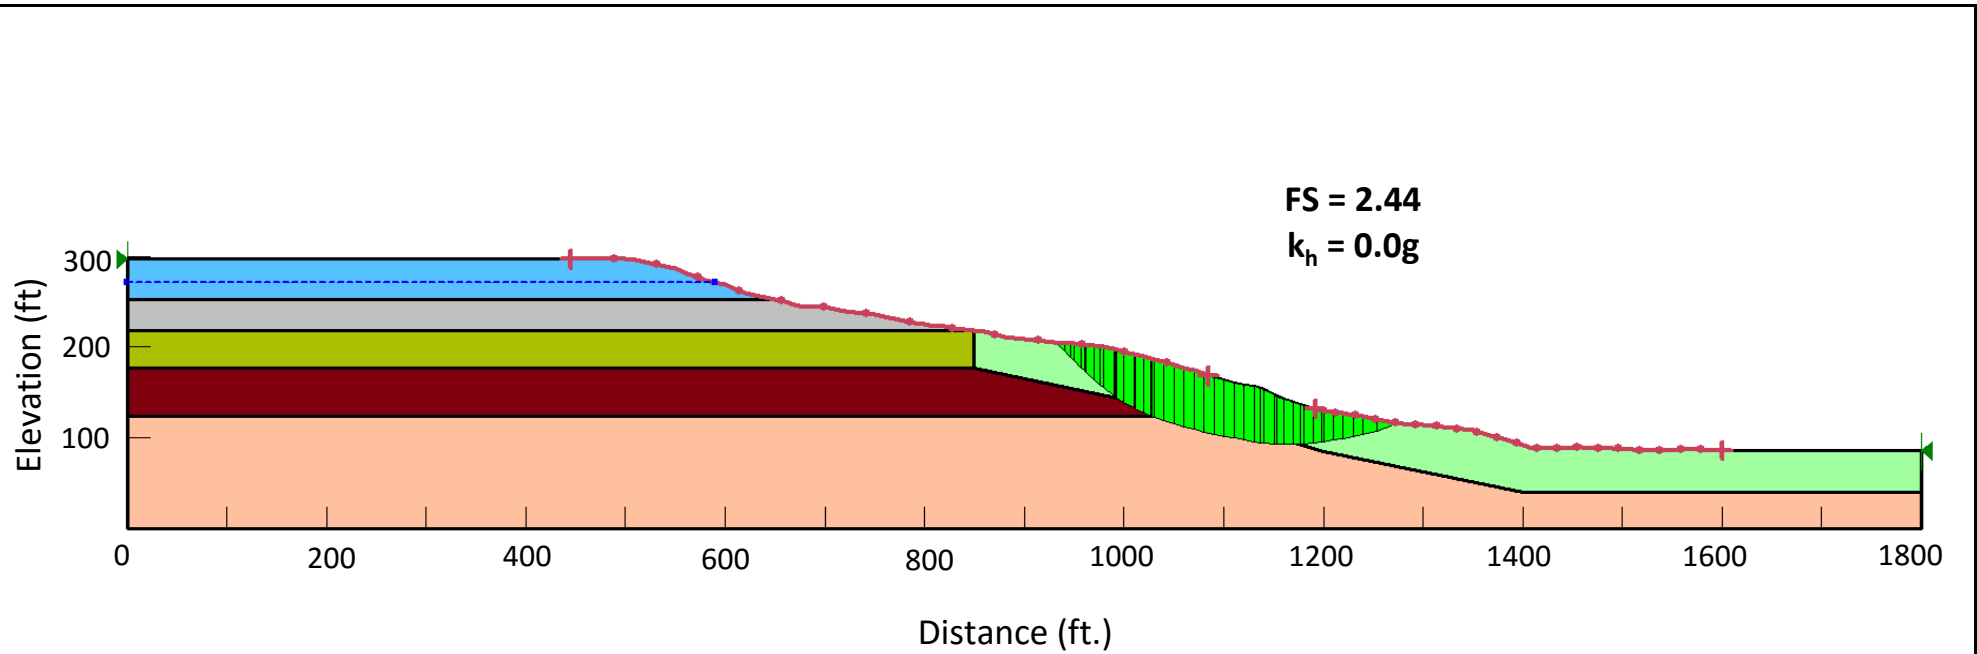
HARTCROWSER	19120-01 11/8/16	Mercer Island Center for the Arts Seattle, WA Limit Equilibrium Slope Stability Analysis: Shallow Static Conditions
3	Figure

To further analyze the conditions Hart Crowser assigned reasonable soil properties to the soil units and used the computer program Slope/W to calculate safety factors on presumed critical surfaces. The first analysis is shown in Figure 3, and assumes a critical failure surface through the surficial soils. Such a failure surface would result in soil slumping on the slope, but would not be catastrophic. The calculated factor of safety (ratio of the resisting forces to the driving forces along the potential failure surface) for this surface and static load conditions is about 2.4, indicating that a slope stability failure of this sort is unlikely to occur.

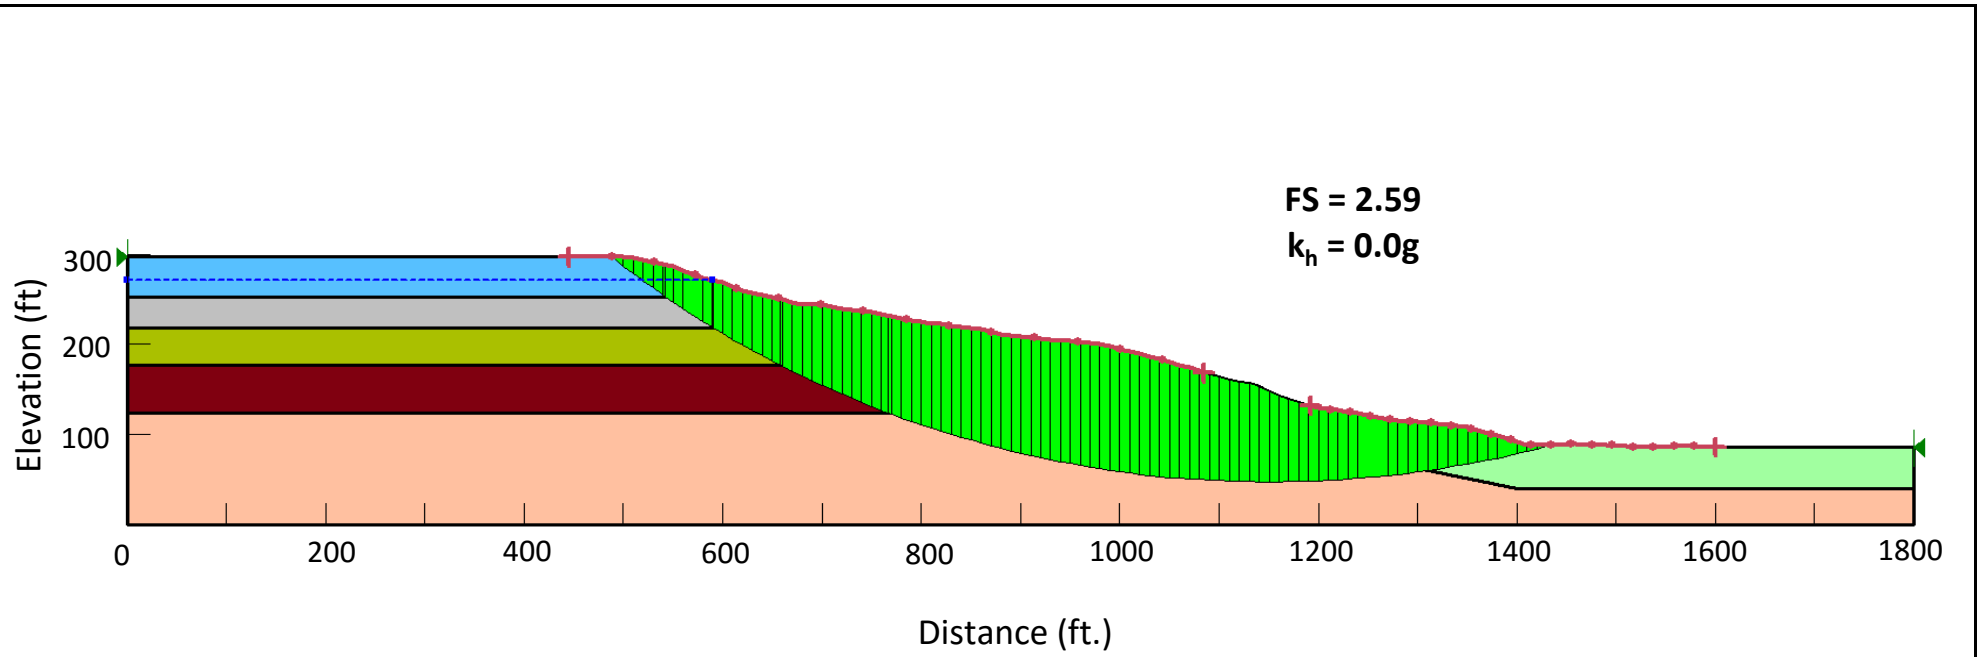
Limit Equilibrium Slope Stability Analysis:
Deep Static Condition

Figure 4 presents a critical failure surface that is deep seated, starts near the top of the hill, and is long enough to intersect the new arts structure. Movement on such a surface would be a major landslide. We calculated a factor of safety of about 2.6 for this surface under static loading conditions, again indicating that a deep seated slope failure such as this is unlikely to occur.

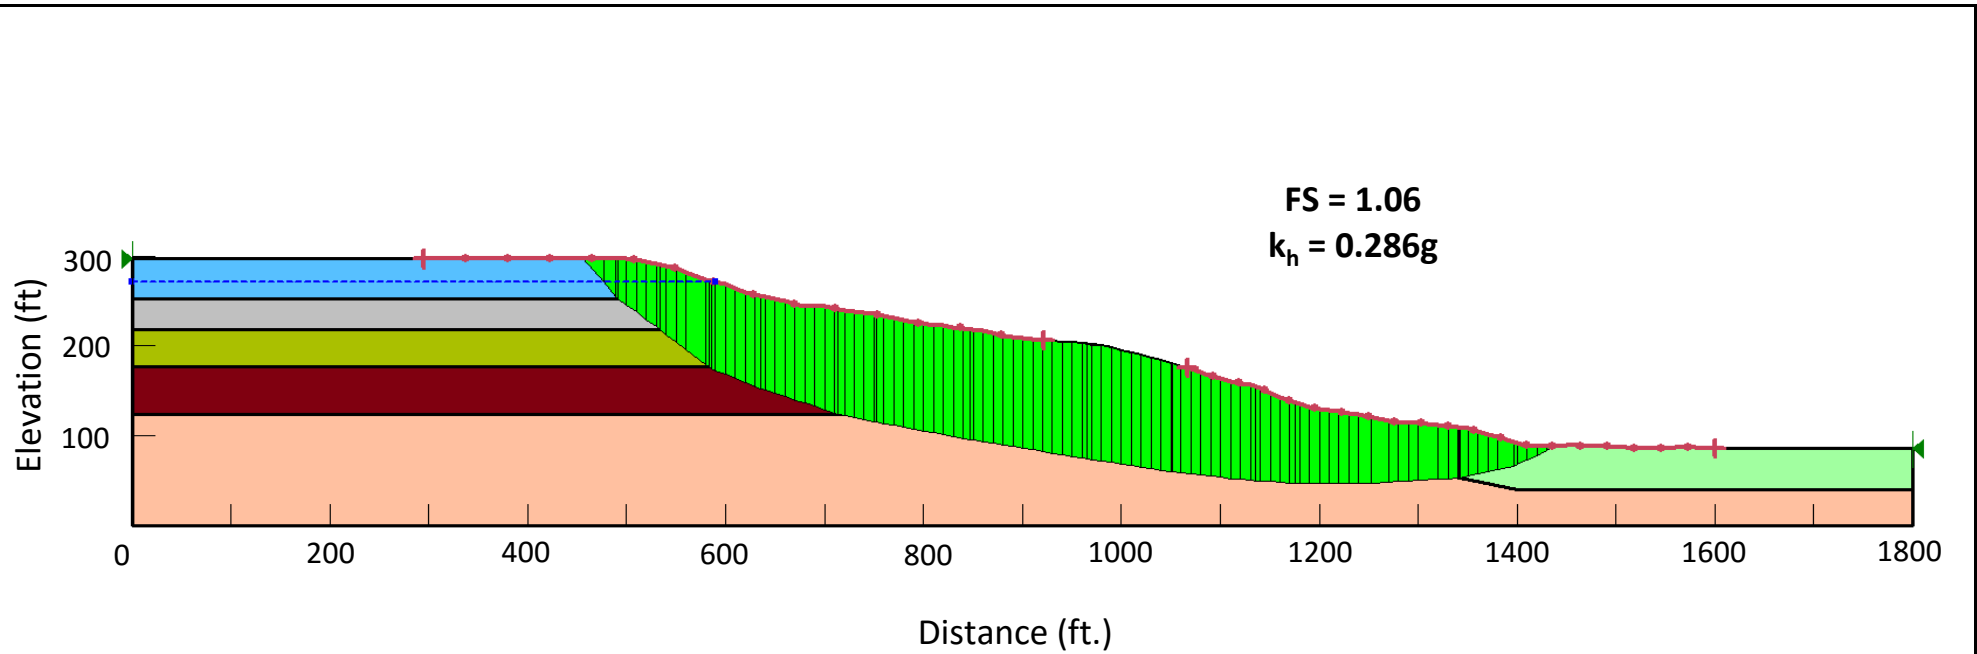
Figure
5

We also estimated the safety factor for this deep seated failure surface under seismic loading by applying forces to the slope that would only occur during a major event. We conducted pseudo-static analysis with a seismic coefficient of 0.286g. This value represents the imparted forces from an earthquake with a return period of 2, 475 years, referred to as the maximum considered earthquake. This is the most severe earthquake typically used in the design of new structures. The value of 0.286g is one-half the maximum credible peak ground acceleration. This is a catastrophic seismic event. For buildings the code is roughly based on "collapse prevention" performance under the 2,475-year return period earthquake and "life safety" performance under 2/3 of this earthquake. Although not directly comparable, an earthquake with a magnitude of 7.5 to 9 could cause such accelerations, depending on the depth and location of the epicenter. If such an earthquake would hit the region many buildings and infrastructure would be severely damaged or could collapse. Yet even during this extreme seismic event the factor of safety for the slope above the MICA development area on this deep potential failure surface is nearly 1.1, as shown on Figure 5.

Our conclusion is that this is a relatively stable, low risk slope under static conditions. Although a major earthquake would increase the risk of a slope failure, the safety factor is still above 1.0 (and thus the slope is still stable) even under a major seismic event, based on our assumptions of stratigraphy and soil

properties. The stability of the slope is enhanced or maintained if the slope remains vegetated and relatively undisturbed.
