Adams Tree Consulting

Date: July 14, 2023

Subject: Arborist Report - Covenant Living at the Shores

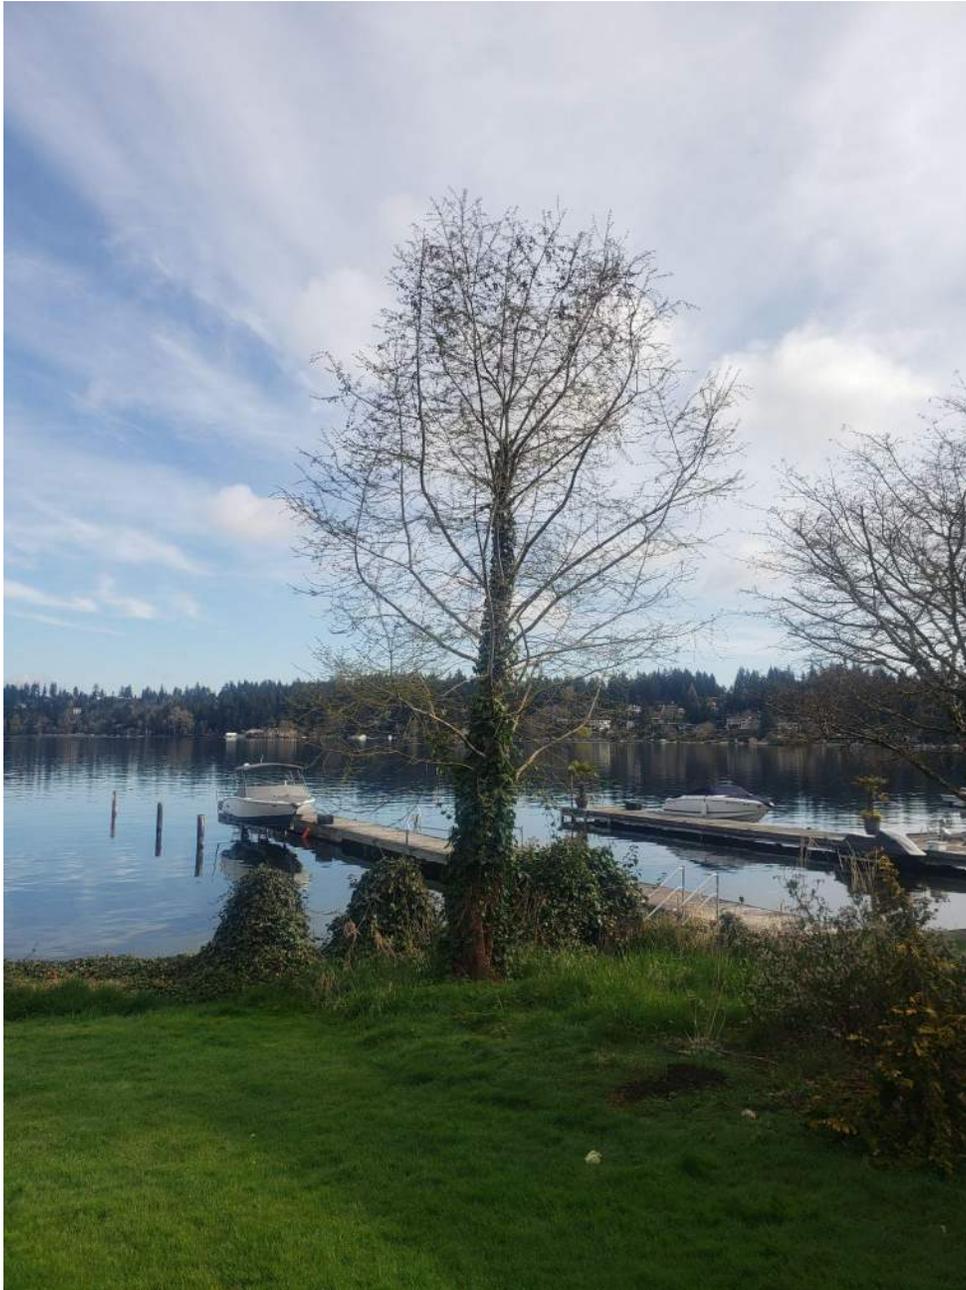
Tree 1 is a dawn redwood (*Metasequoia glyptostroboides*) that measures 13.7" DSH and is located near the shoreline. It has good health and structural condition. Proposed site plans show construction of a turnaround that extends within approximately 50% of the tree's CRZ. At this time, it does not appear that this tree can be retained with the proposed construction.

Photo 1 - Tree 1, a dawn redwood near the shoreline.

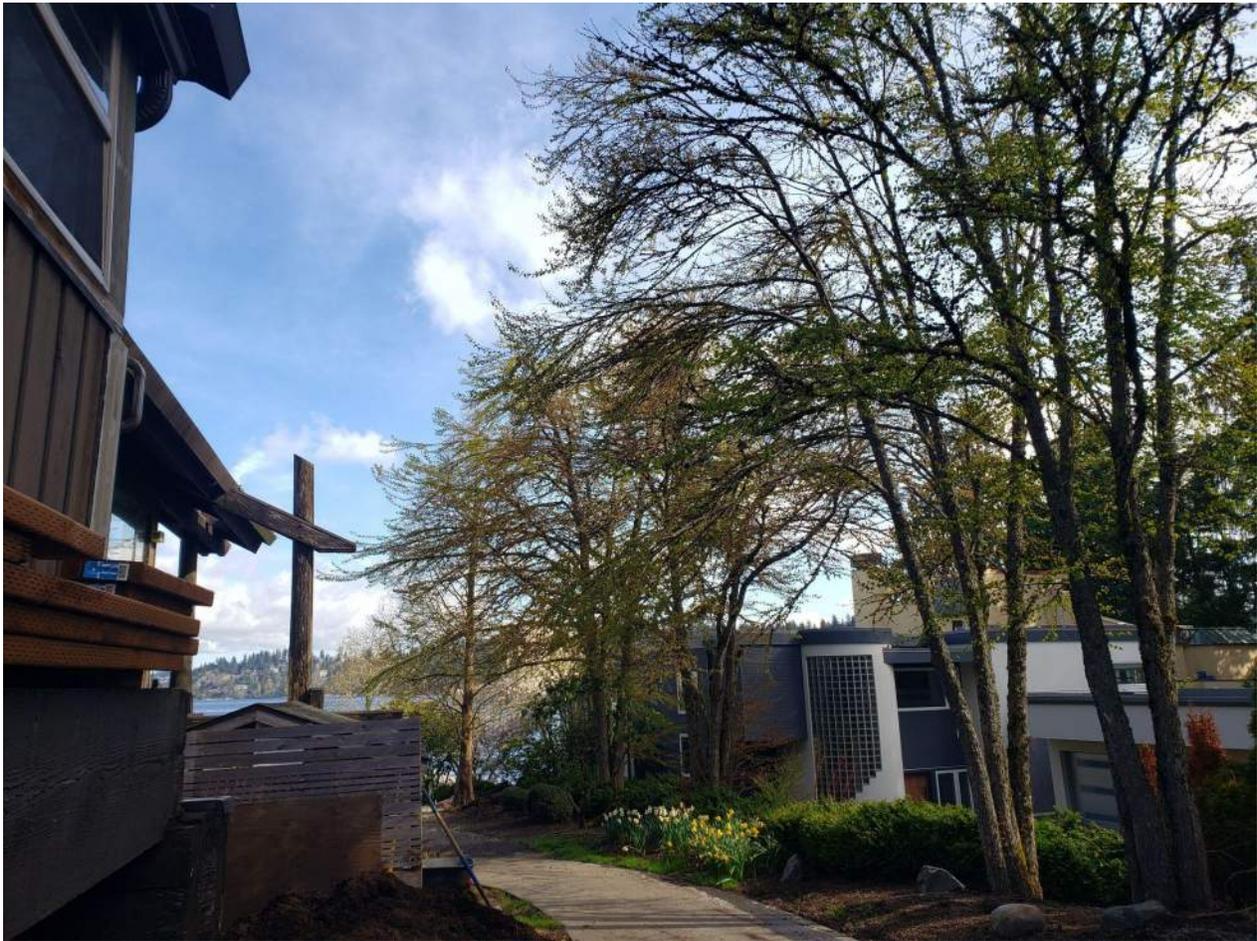
Tree 2 is a dawn redwood (*Metasequoia glyptostroboides*) that measures 12" DSH. It has good health and structural condition. The trunk of this tree is located approximately 10' from a proposed water line and directly adjacent to a proposed access road. The level of disturbance to this tree will be significant and it is not suitable for retention.

Trees 3-6 are katsuras (*Cercidiphyllum japonicum*) that measure between 13 and 18.5" DSH. They are in good health and structural condition. The proposed development would include extensive disturbance of the roots on the west side of these trees. This species has a poor tolerance to construction impacts and I don't believe it would be possible to retain these trees.

Photo 2 - Trees 2, 3, 4, 5, 6; a dawn redwood and 4 katsuras (left to right).

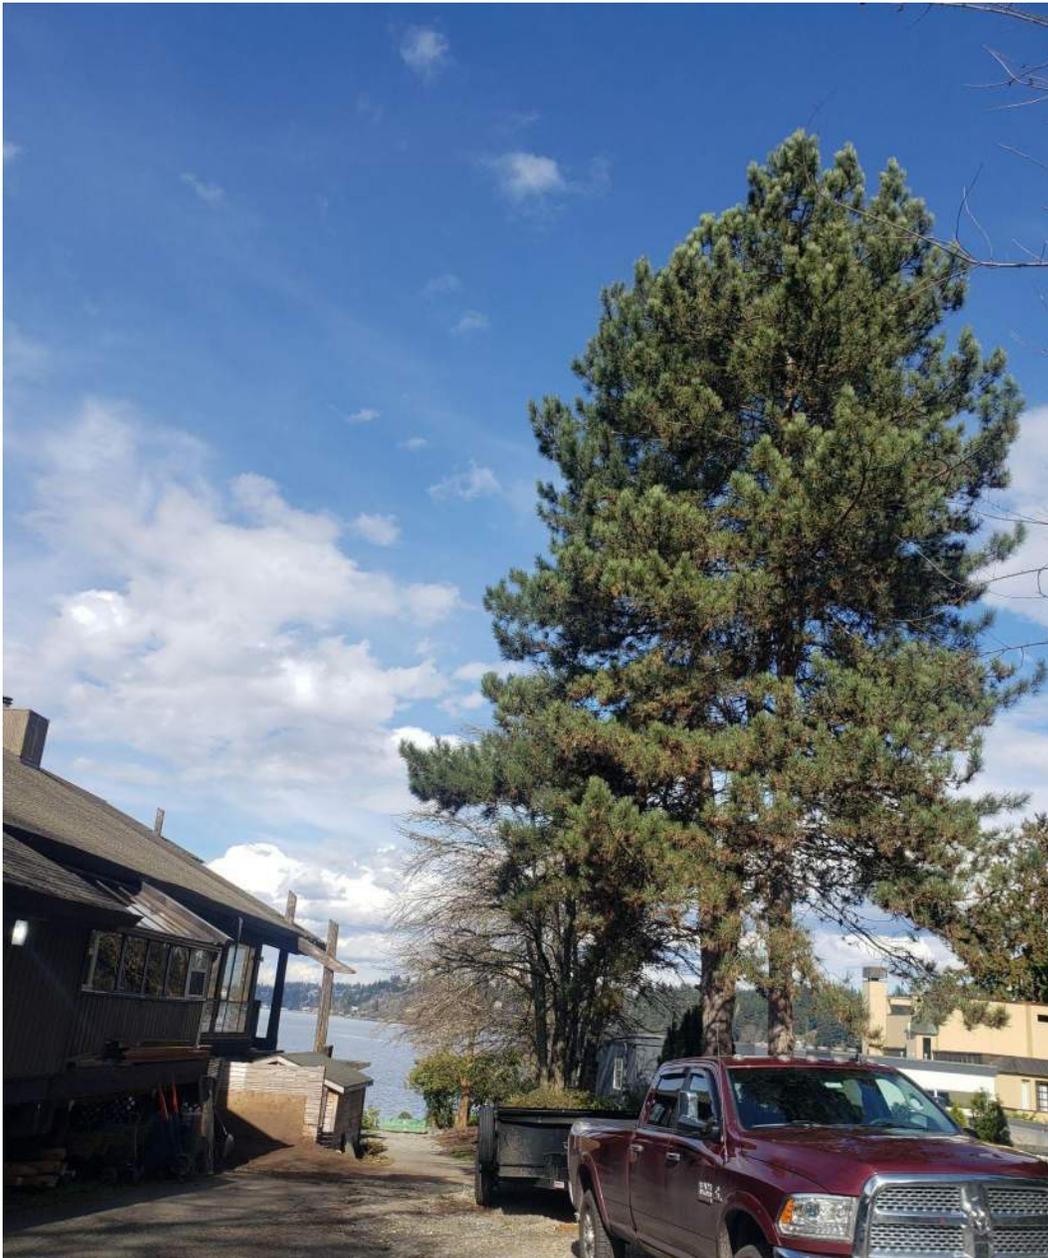
Trees 7 and 8 are Austrian black pines (*Pinus nigra*) that measure 17.3" and 12.9" DSH, respectively. These trees are in good health and structural condition. The proposed development would include extensive disturbance of the roots on the west side of these trees and will need to be removed.

Photo 3 - Trees 7 and 8, two Austrian black pines in the foreground of this photo.

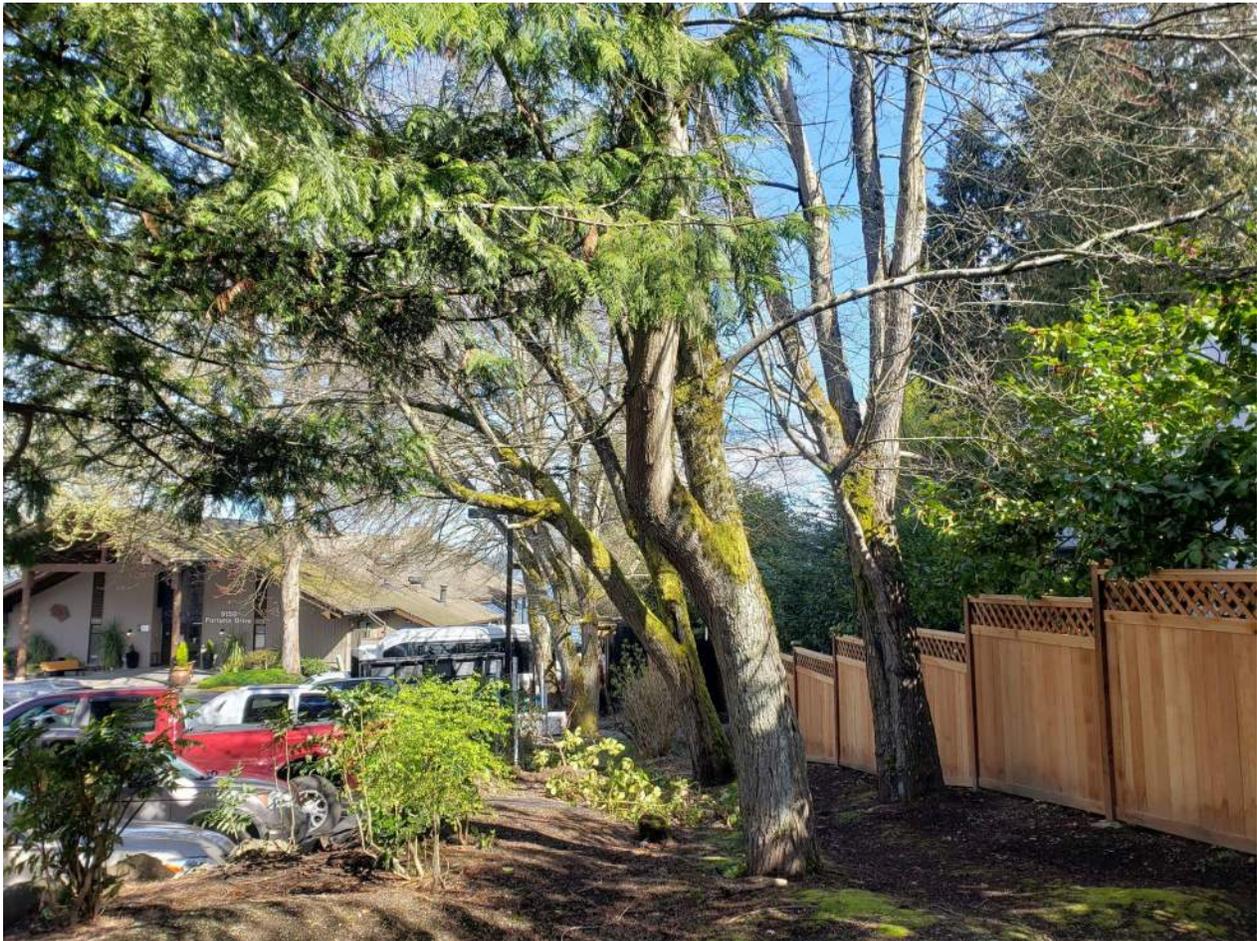
Trees 10-14 are red maples (*Acer rubrum*) that measure between 17" and 26" DSH. Trees 10, 11, 13, and 14 are in good health and structural condition. Trees 10 and 11 are located well within the proposed construction limits and will need to be removed. Tree 12 has some heartwood decay in the lower trunk and a slight lean. The trunks of trees 12, 13 and 14 are located approximately 12' from the proposed access driveway. If the rock retaining wall can be left intact then trees 12-14 can be retained, as the impacts will be outside the ICRZs.

Photo 4 - Trees 10, 11, 12, 13 and 14, all red maples.

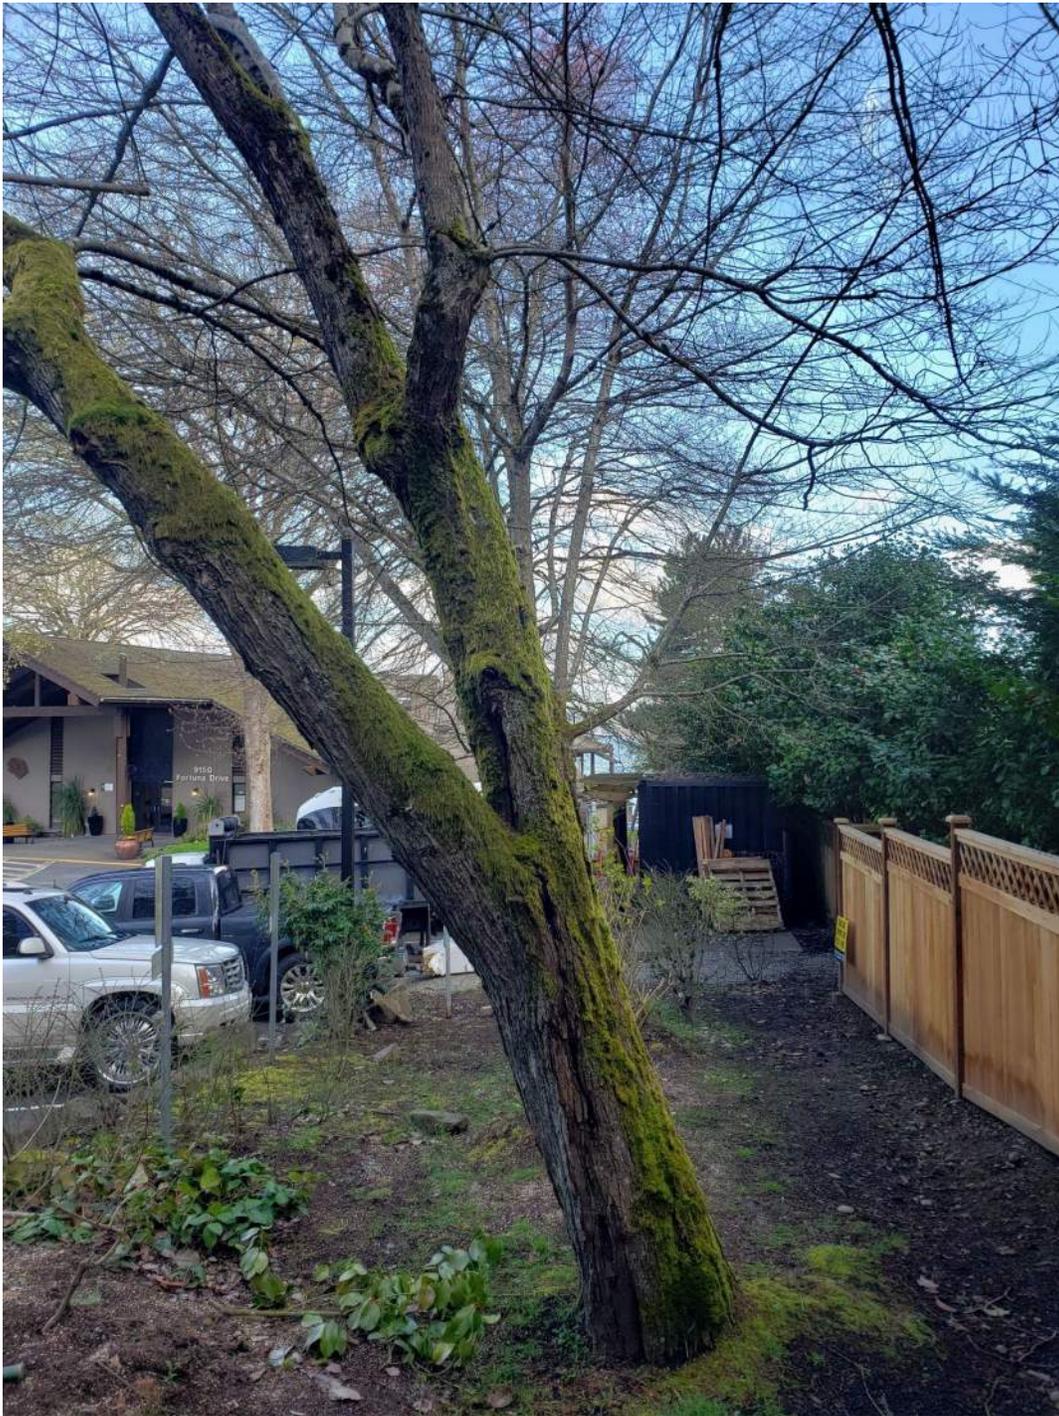
Photo 5 - Tree 12, a red maple with decay in trunk and slight root plate uplifting.

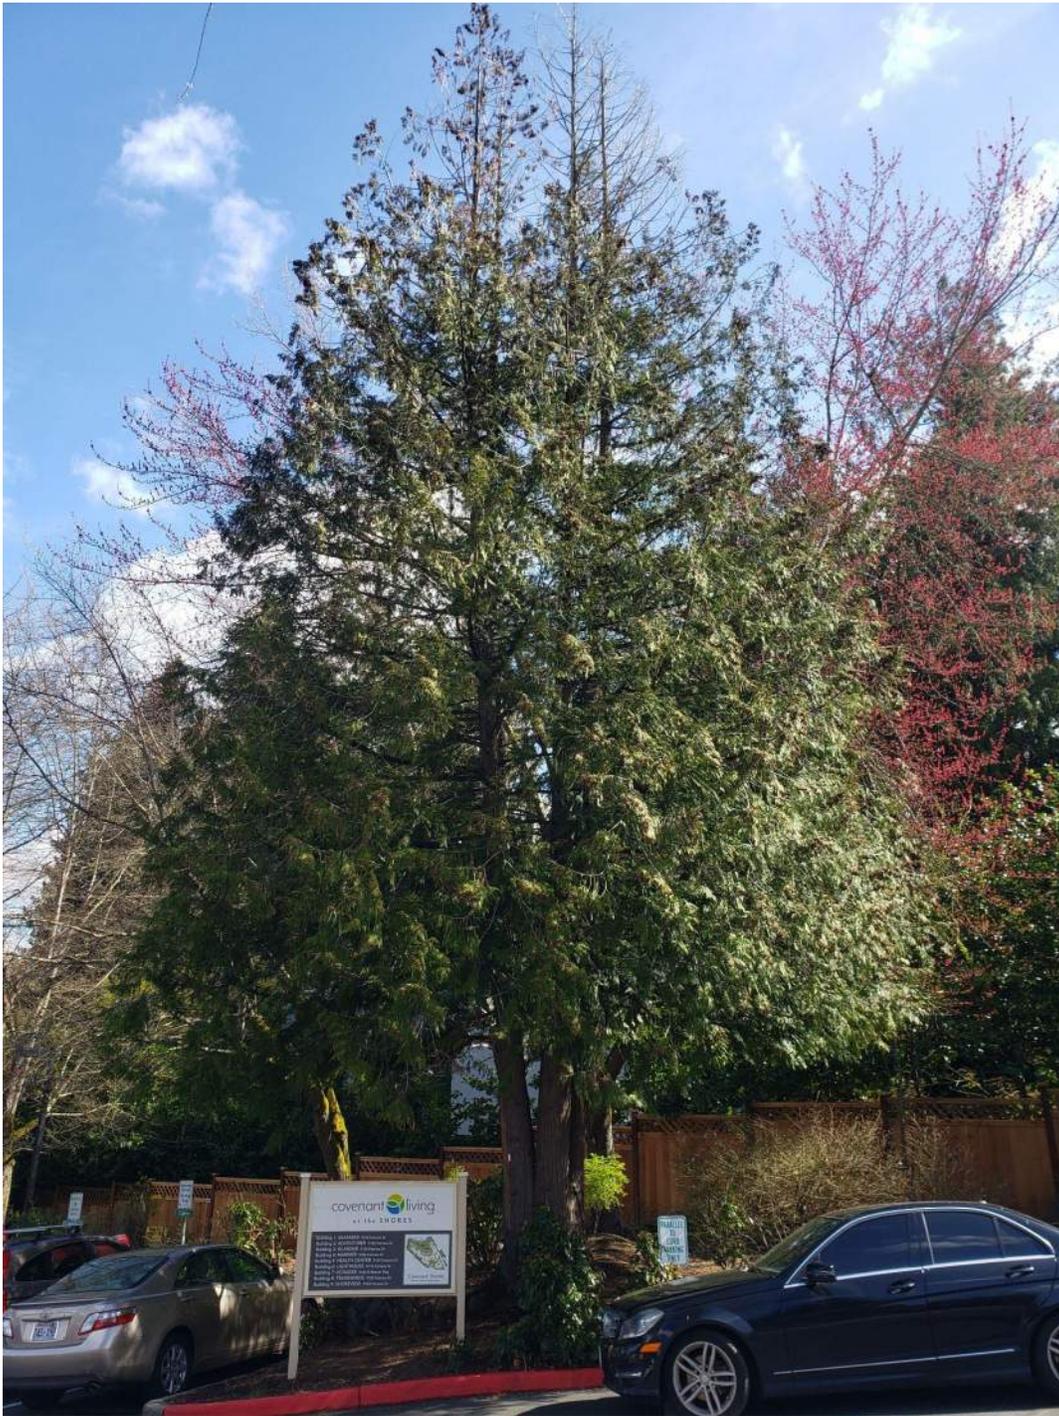
Tree 15 is a Western red cedar (*Thuja plicata*) that measures 30" DSH and has a CRZ of 30'. It is in fair health and structural condition and meets the definition of an exceptional tree. It has multiple stems and splits at approximately 1' above the ground into 5 trunks. There is included bark in the lower 2' between 3 of the stems. The canopy of the tree is thinning with top-down dieback. The trunk of this tree is located approximately 10' from a proposed water line and directly adjacent to a proposed access road. The level of disturbance to this tree will be significant and it is not suitable for retention.

Photo 6 - Tree 15, an exceptional Western red cedar with thinning canopy and top-down dieback.

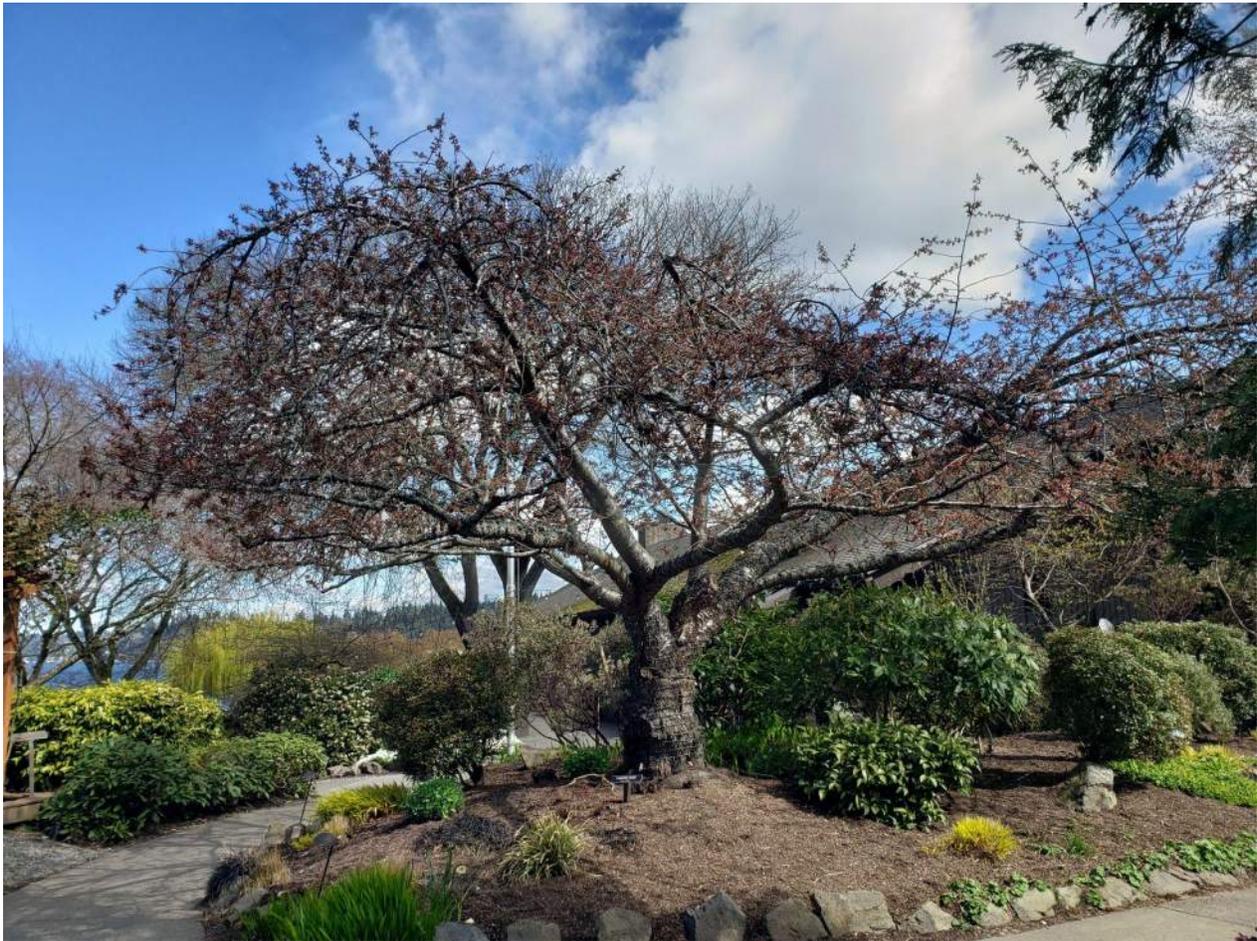
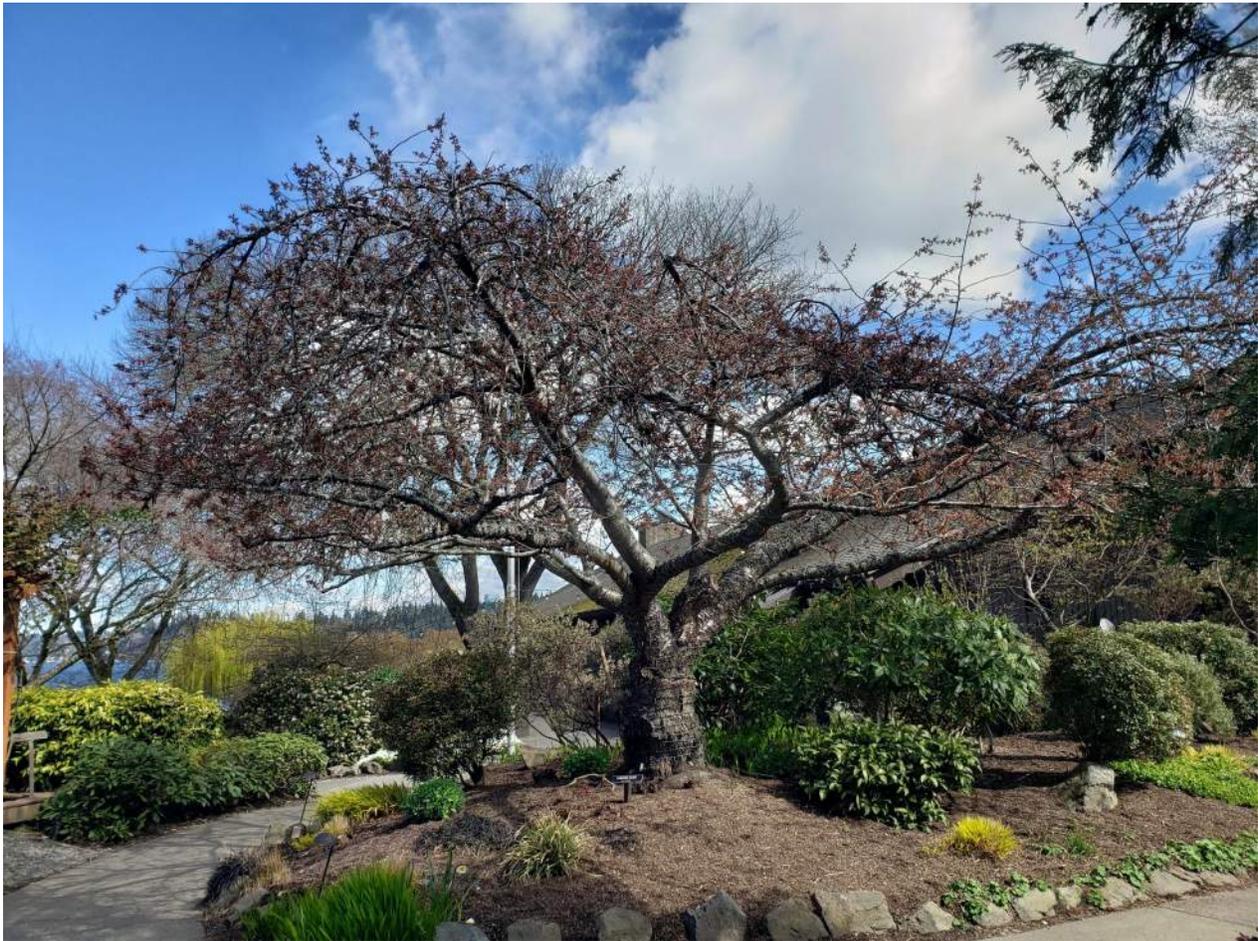
Tree 21 is a flowering cherry (*Prunus spp.*) that measures 23.4" DSH and is an exceptional tree. I observed a fungal fruiting body at the base of the trunk, however there was no indication of serious decay when I sounded the trunk with a mallet. Overall, this tree is in good health and

structural condition. The trunk of this tree is located well within the proposed building footprint and would need to be removed for construction.

Photo 7 - Tree 21, an exceptional flowering cherry.

Photo 9 - Tree 21, an exceptional flowering cherry.

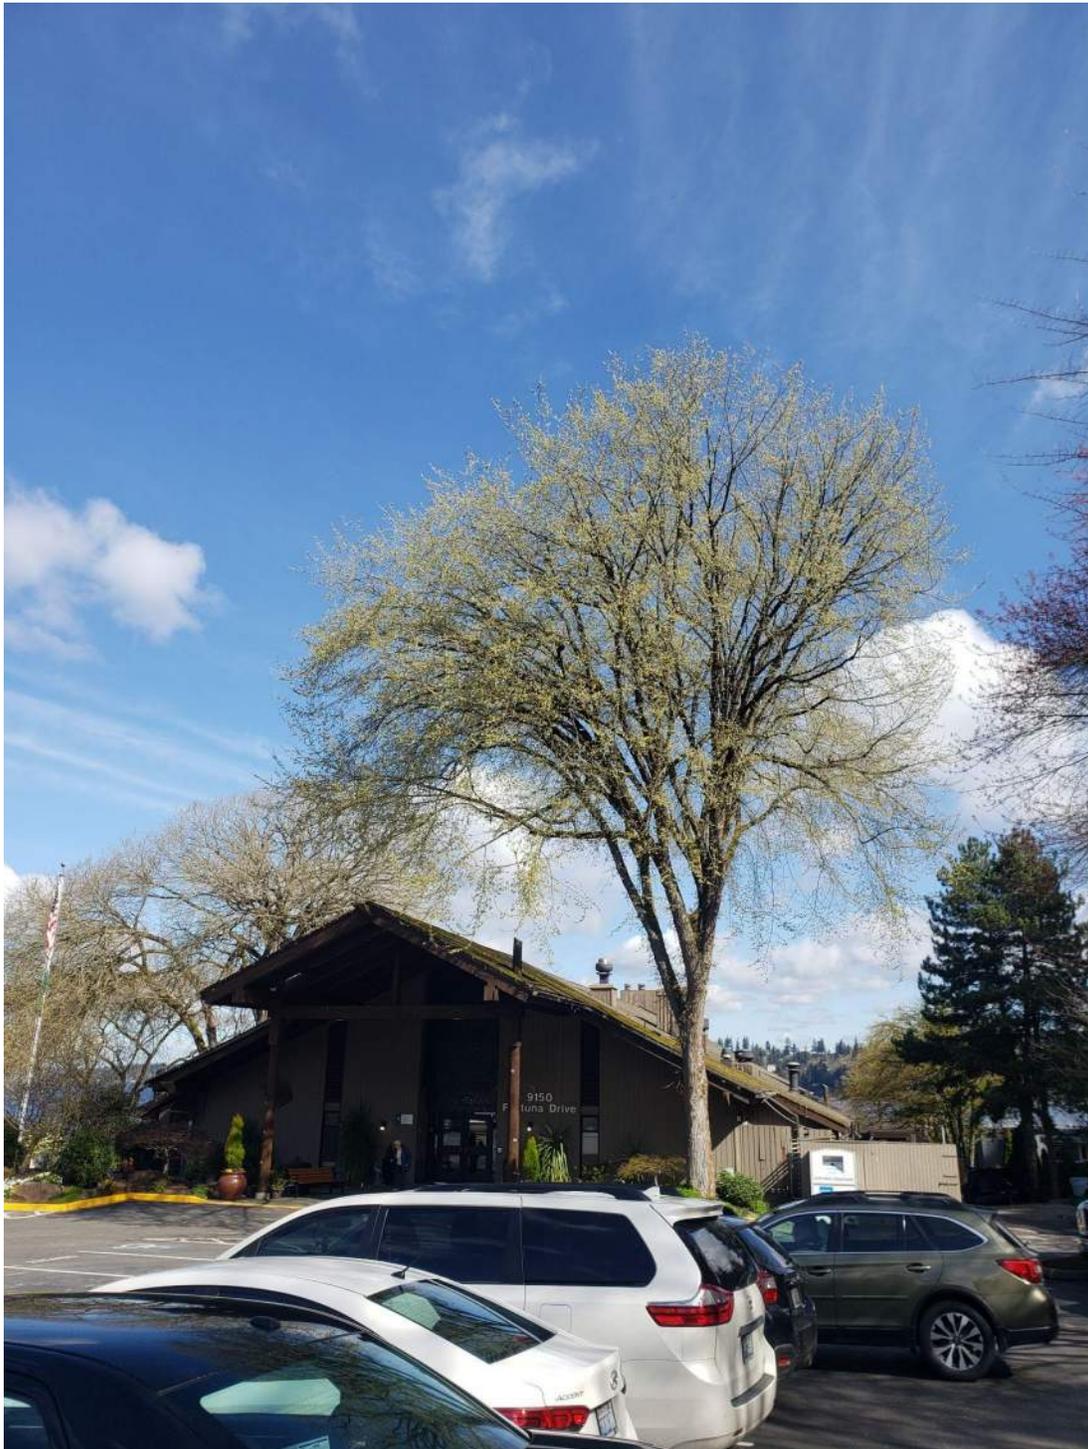
Tree 16 is an American elm (*Ulmus americana*) that measures 30" DSH and meets the size threshold of an exceptional tree. This is a tall, stately tree located directly in front of the existing lodge building. Overall, this tree appears to be in good health and structural condition despite the compacted and confined root spacing. The trunk of this tree is located well within the proposed building footprint and would need to be removed for construction.

Photo 8 - Tree 16, an exceptional American elm tree.

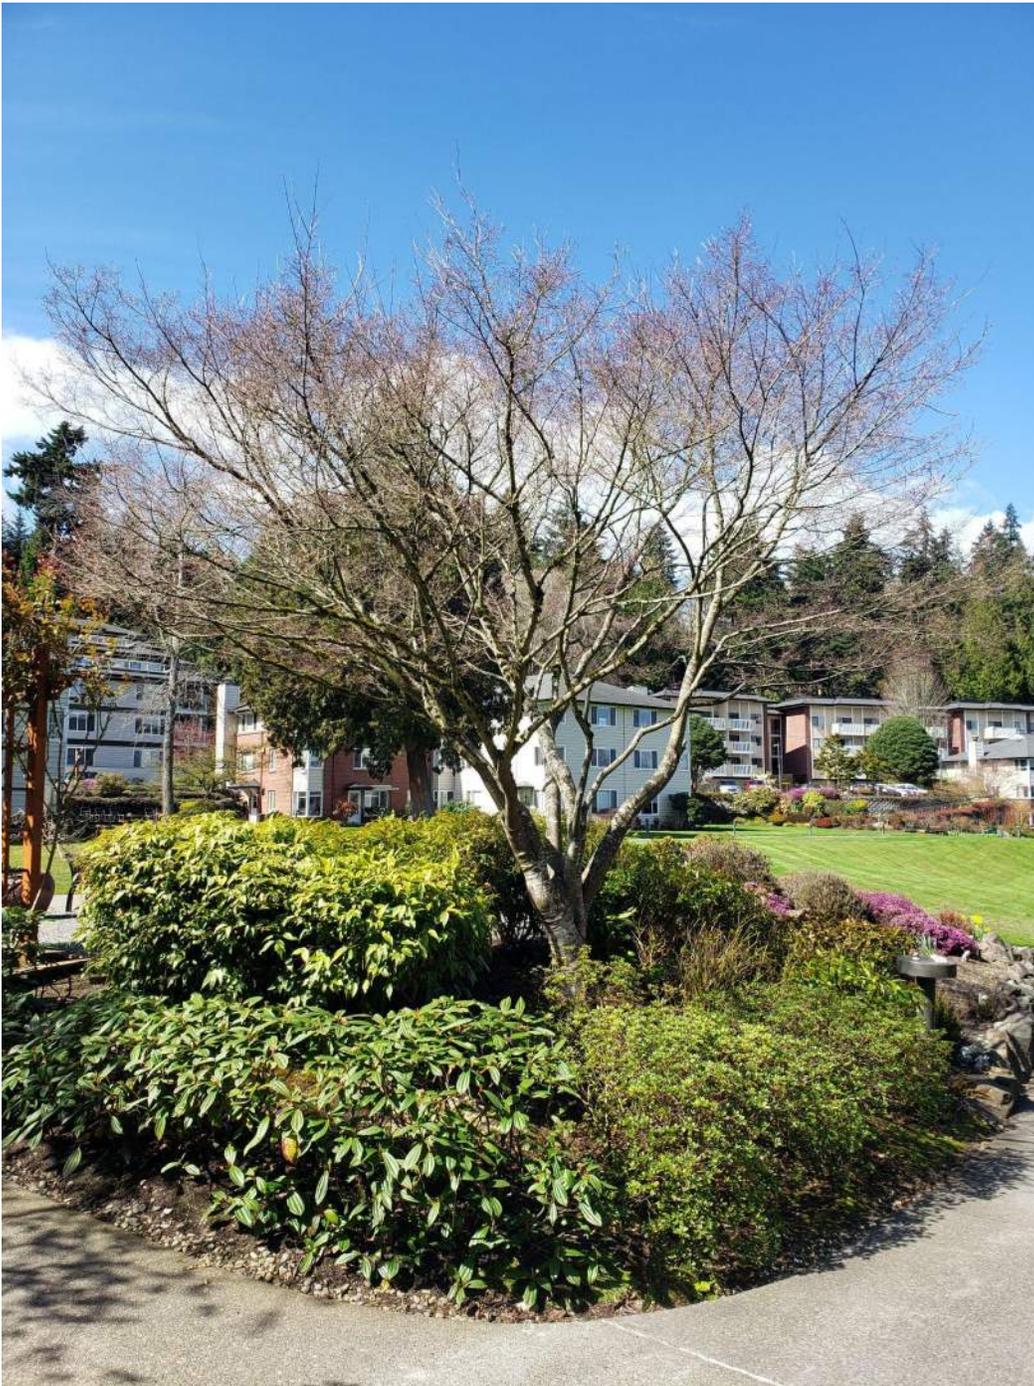
Tree 24 is a Japanese maple (*Acer palmatum*) that measures 11.5" DSH. It is in good health and structural condition with no noticeable defects. The trunk of this tree is located well within the proposed building footprint and would need to be removed for construction.

Photo 10 - Tree 24, a Japanese maple.

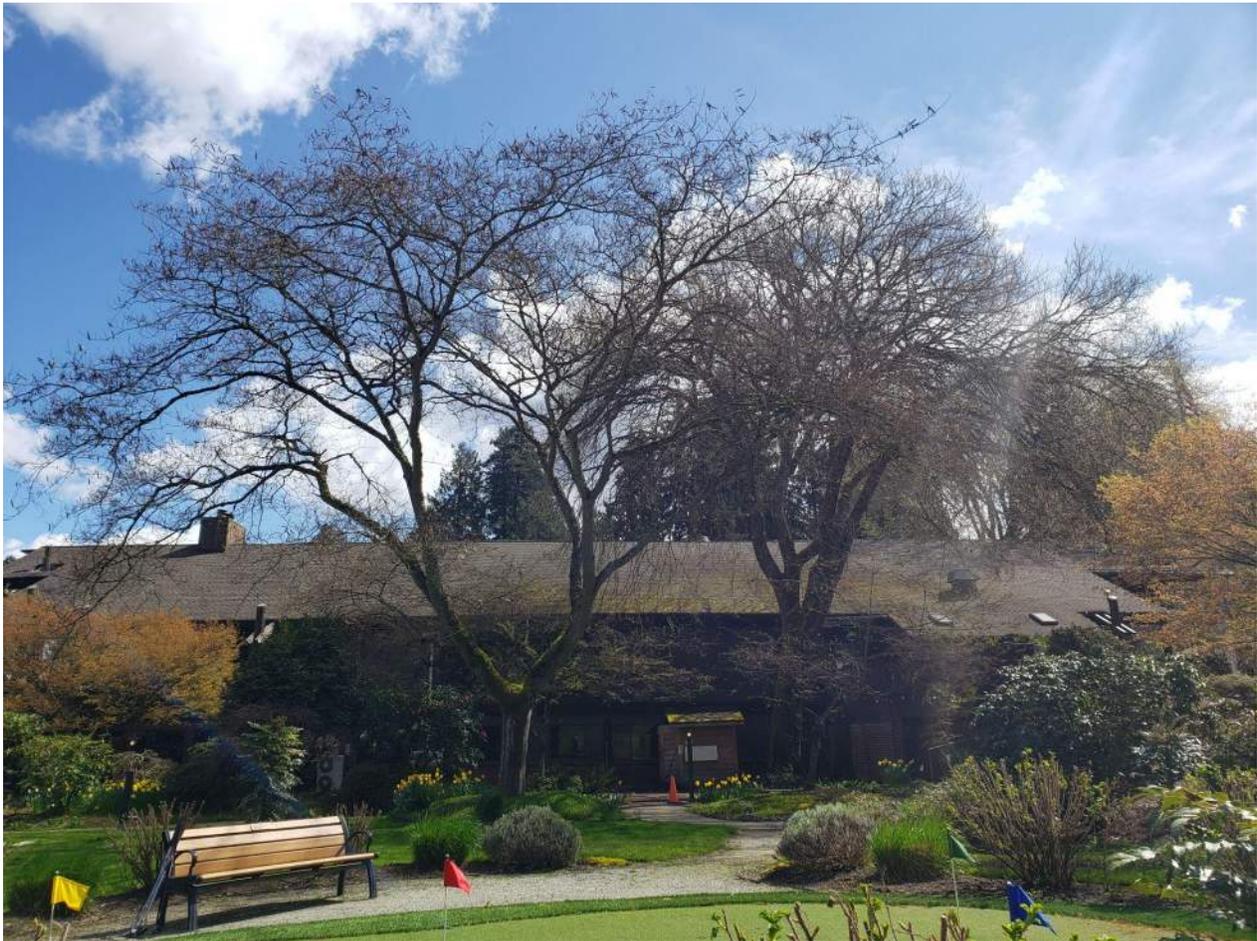
Tree 27 is a honey locust (*Gleditsia triacanthos*) that measures 19" DSH. The trunk splits at 6' and the junction has a strong, u-shaped union. Overall, this tree is in good health and structural condition. The trunk of this tree is located approximately 20' from the building footprint, but grading and heavy equipment presence in this area will cause significant damage. This tree will need to be removed for construction.

Tree 28 is an American elm (*Ulmus americana*) that measures 34" DSH and meets the size threshold of an exceptional tree. Overall, this tree appears to be in good health and structural condition despite the compacted and confined root spacing. Proposed conceptual plans show the trunk of this tree well within the proposed building footprint and would need to be removed for construction.

Photo 11 - Tree 27, a honey locust (left) and tree 28, an exceptional American elm (right).

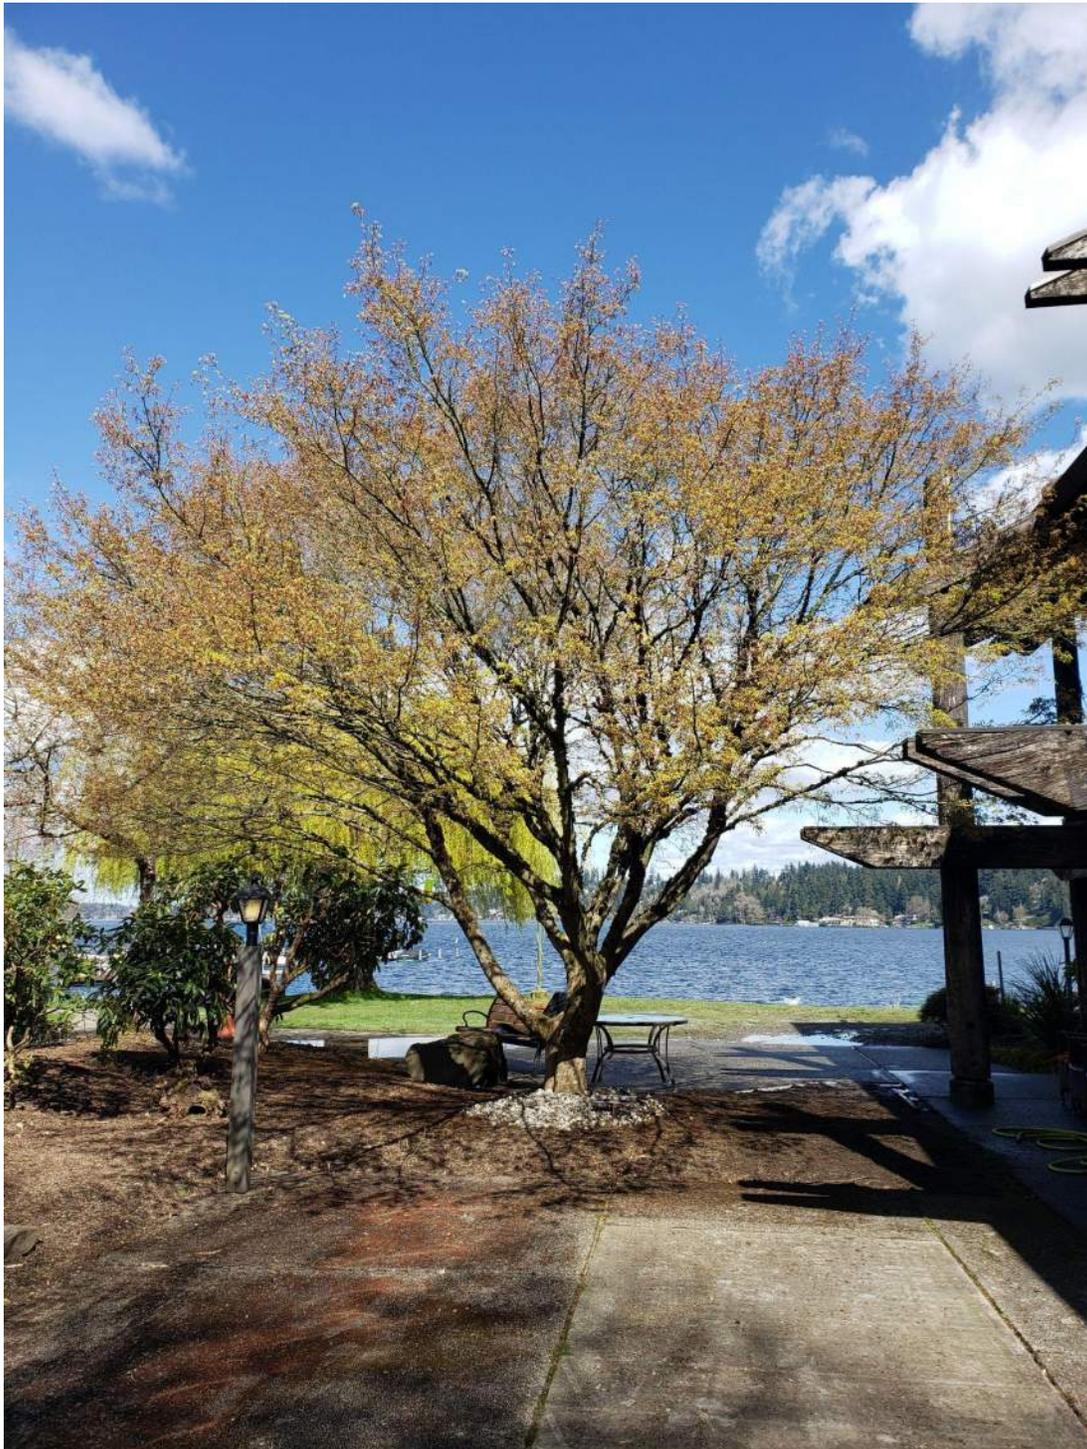
Tree 31 is a Japanese maple (*Acer palmatum*) that measures 14.5" DSH and is an exceptional tree. Overall, this tree is in good health and structural condition. However, the proposed construction will negatively impact more than 50% of the tree's roots and crown. This tree would not be expected to survive this level of disturbance and would need to be removed for construction.

Photo 12 - Tree 31, an exceptional Japanese maple.

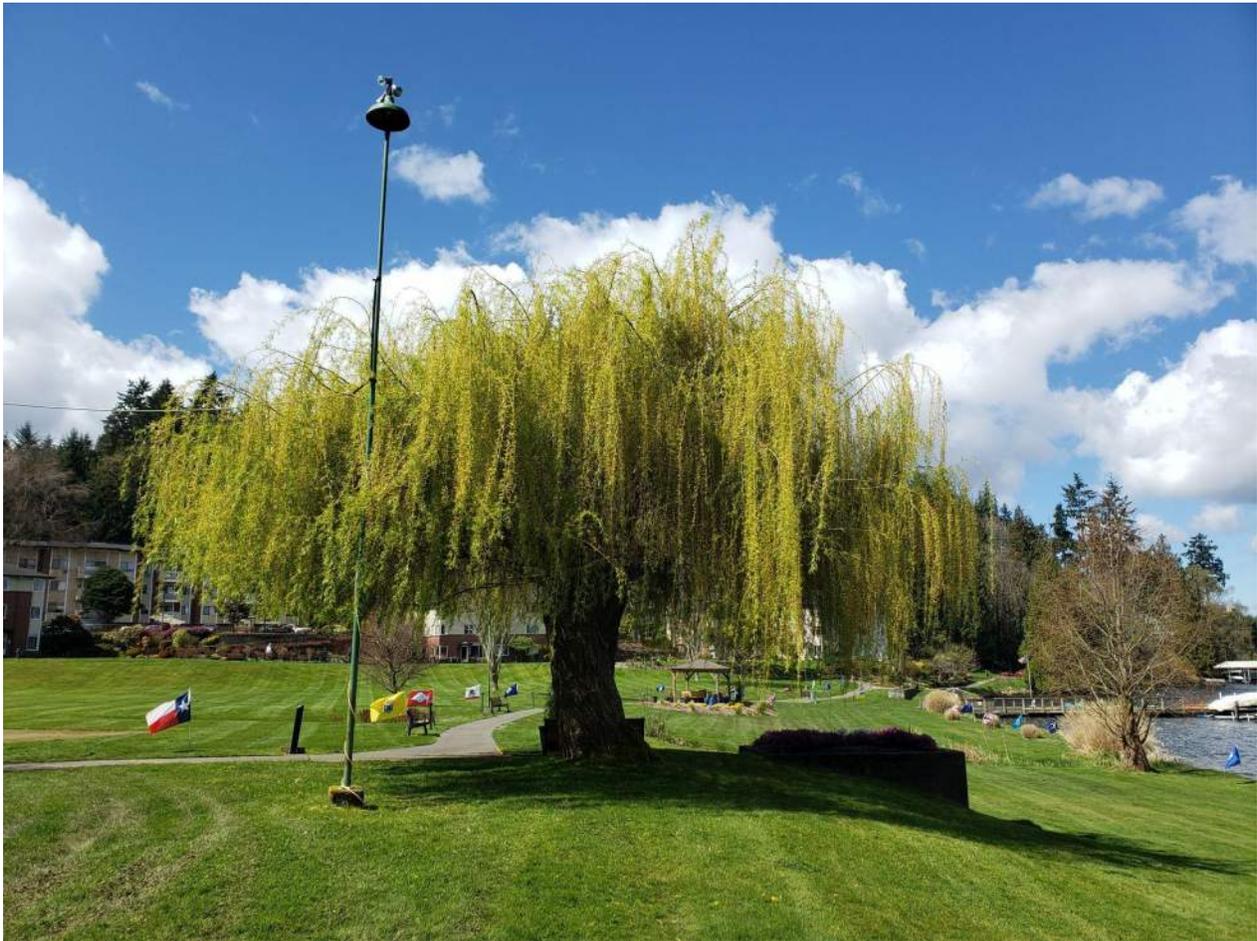
Tree 33 is a weeping willow (*Salix babylonica*) that measures 41.3" DSH and is an exceptional tree. It has been recently topped at 10' above ground, however there was no indication of serious decay at the location of topping nor when I sounded the trunk with a mallet. Overall, this tree is in good health and fair structural condition. The proposed development shows several utility lines running well within the ICRZ of this tree. It will need to be removed for construction.

Photo 13 - Tree 33, an exceptional weeping willow.

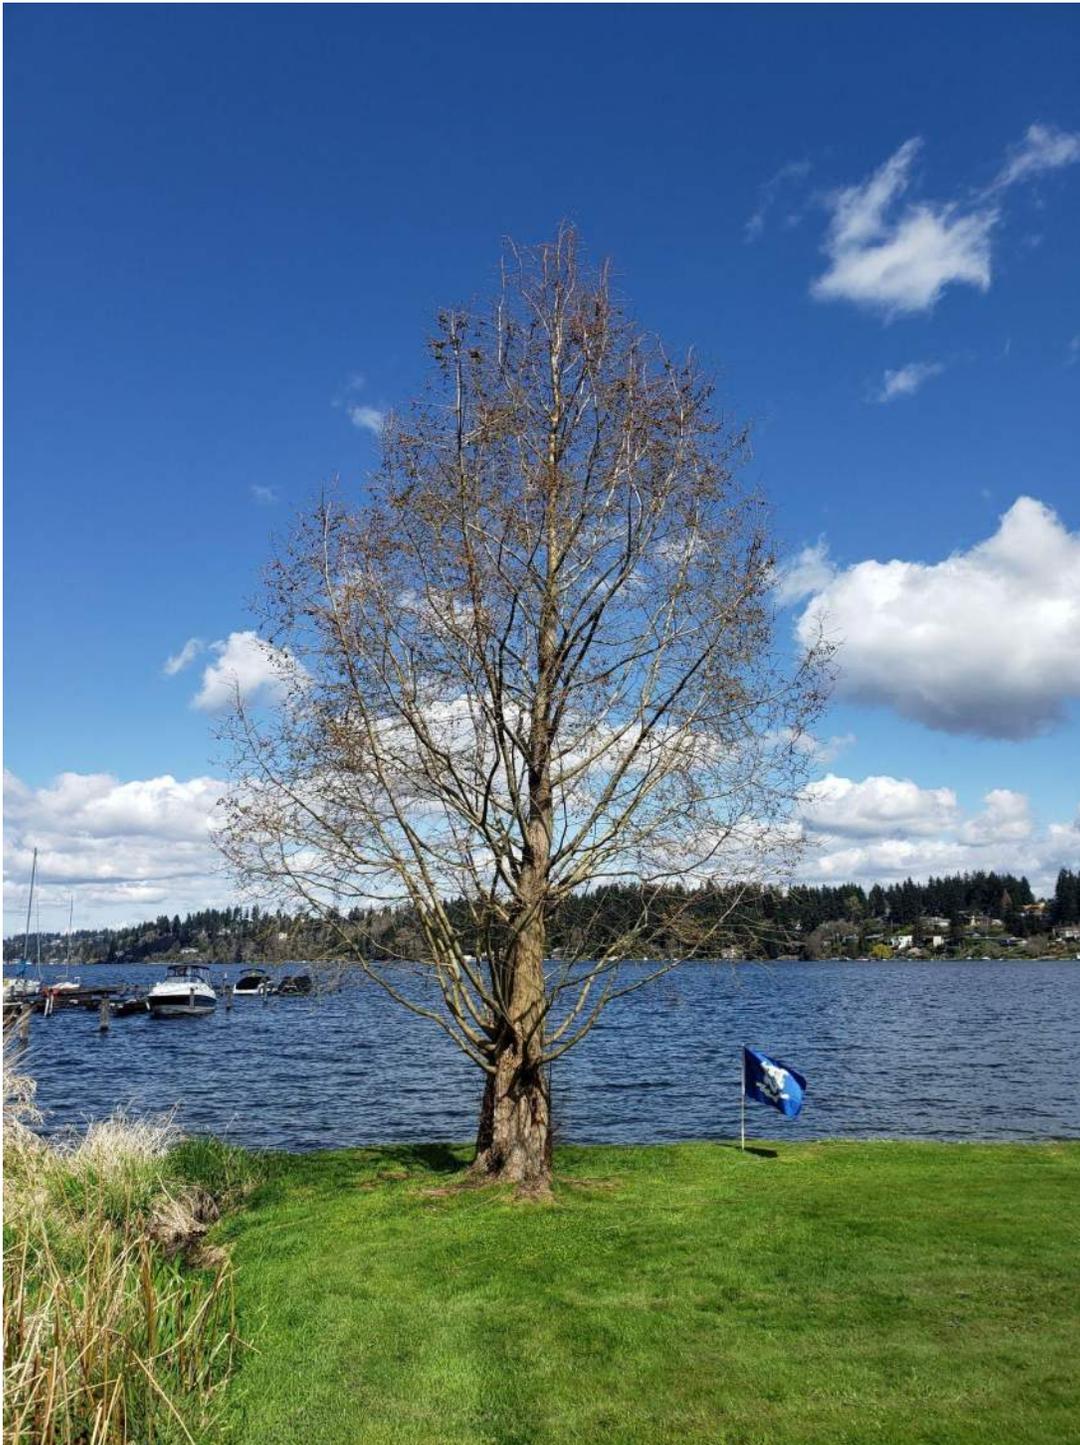
Tree 34 is a dawn redwood (*Metasequoia glyptostroboides*) that measures 21.3" DSH. It has some exposed surface roots, but overall it's in good health and structural condition. The proposed conceptual plans show installation of a new storm drain approximately 12' from the tree trunk, which is outside the ICRZ of this tree. This tree can be retained.

Photo 14 - Tree 34, a dawn redwood.

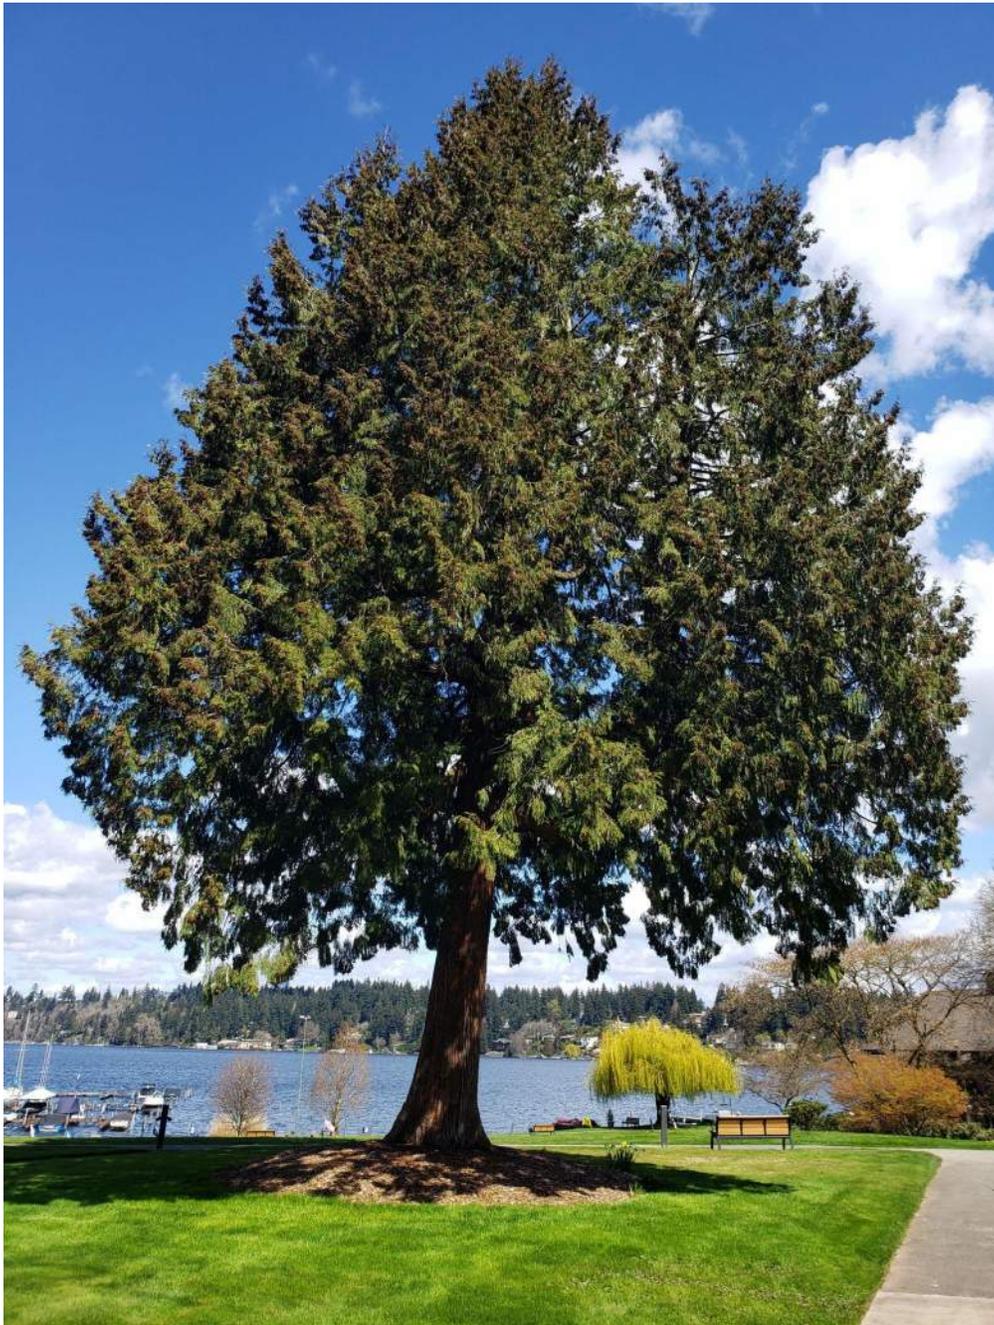
Tree 36 is a Western red cedar (*Thuja plicata*) that measures 35.5" DSH and is an exceptional tree. It has good health and fair structural condition. The proposed conceptual plans show installation of a new storm drain approximately 20' from the tree trunk, which is outside the ICRZ of this tree. This tree can be retained.

Photo 15 - Tree 36, an exceptional Western red cedar.
