Adams Tree Consulting

Date: July 14, 2023

Subject: Arborist Report - Covenant Living at the Shores

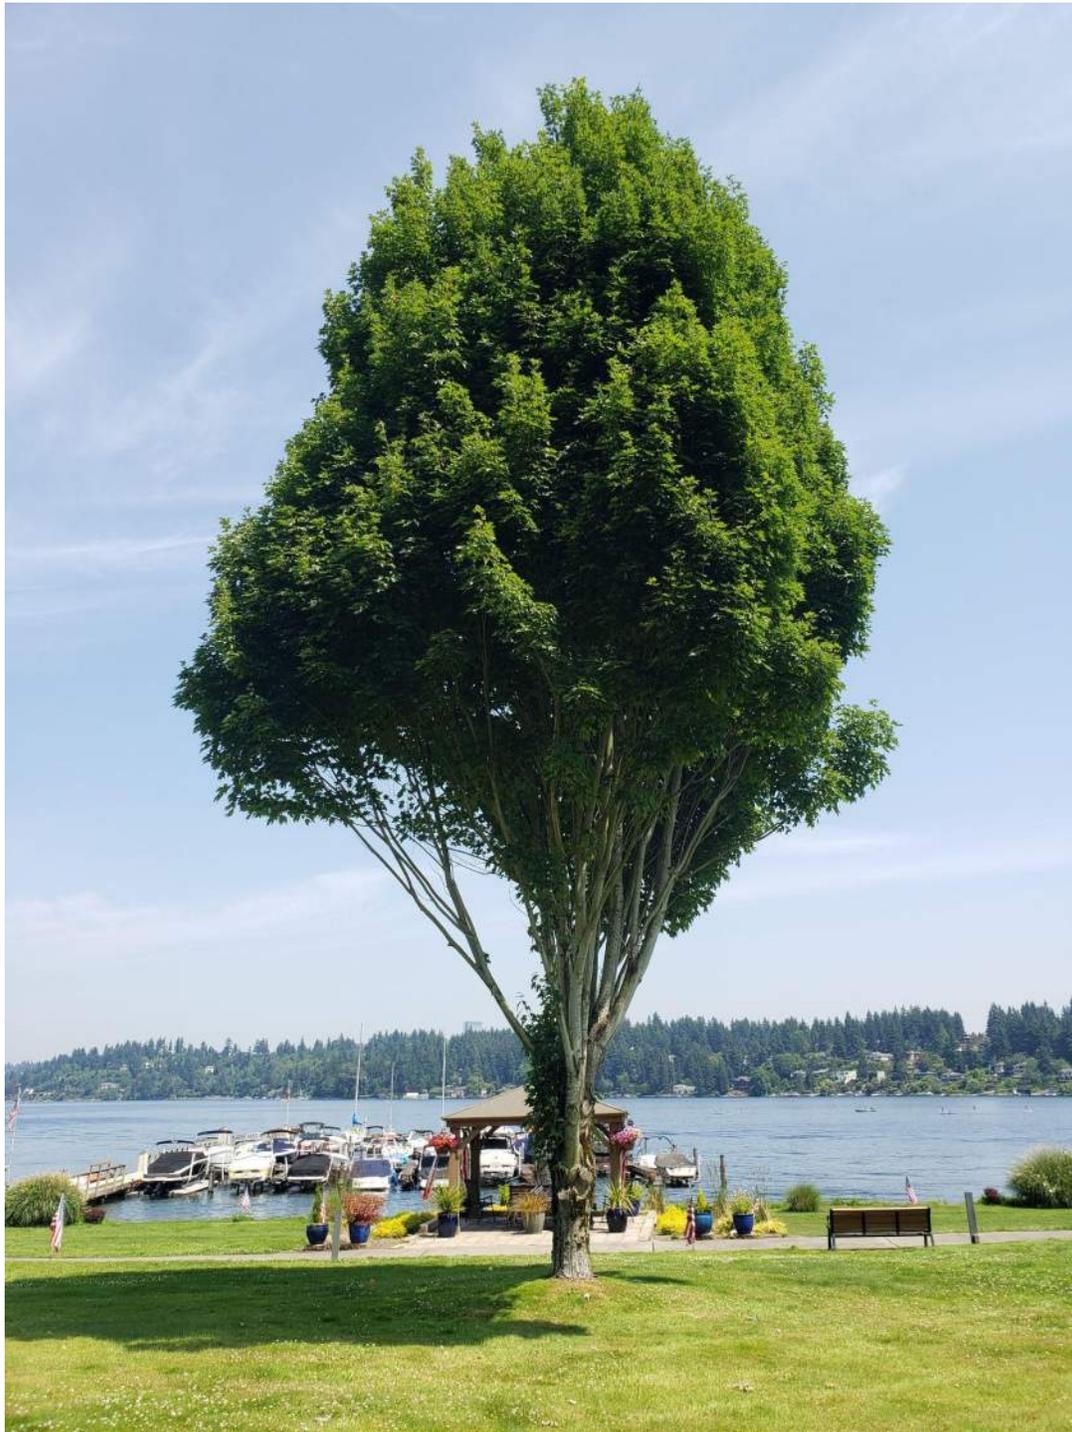
Tree 37 is a red maple (*Acer rubrum*) that measures 18" DSH. It has good health and good structural condition with no noticeable defects. The proposed conceptual plans show installation

of a new storm drain approximately 18' from the tree trunk, which is well outside the ICRZ of this tree. This tree can be retained.

Photo 16 - Tree 37, a red maple.

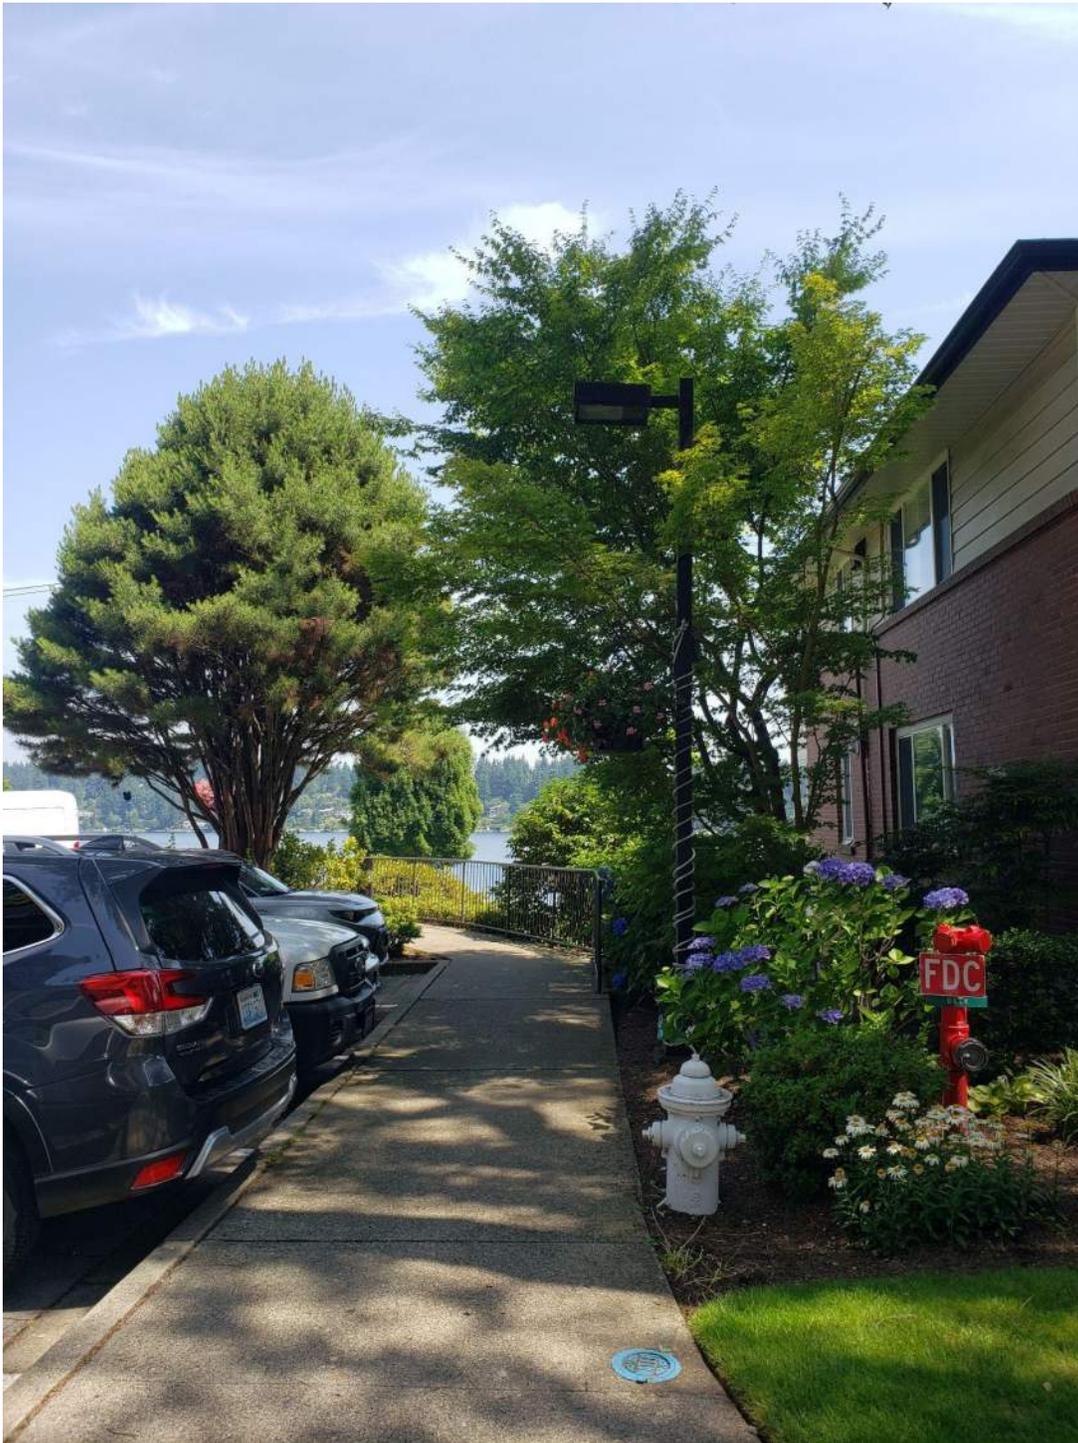
Tree 38 is a Japanese red pine (*Pinus densiflora*) that measures 18" DSH. It has good health and good structural condition with no noticeable defects. The proposed conceptual plans show installation of a new water line approximately 18" from the tree trunk, which is outside the CRZ of this tree. This tree can be retained.

Tree 39 is a Japanese maple (*Acer palmatum*) that measures 18" DSH and is an exceptional tree. It has good health and good structural condition with no noticeable defects. The proposed plans show installation of a water line outside the CRZ of this tree. This tree can be retained.

Photo 17 - Tree 38 (left) and 39 (right), a Japanese red pine and an exceptional Japanese maple.

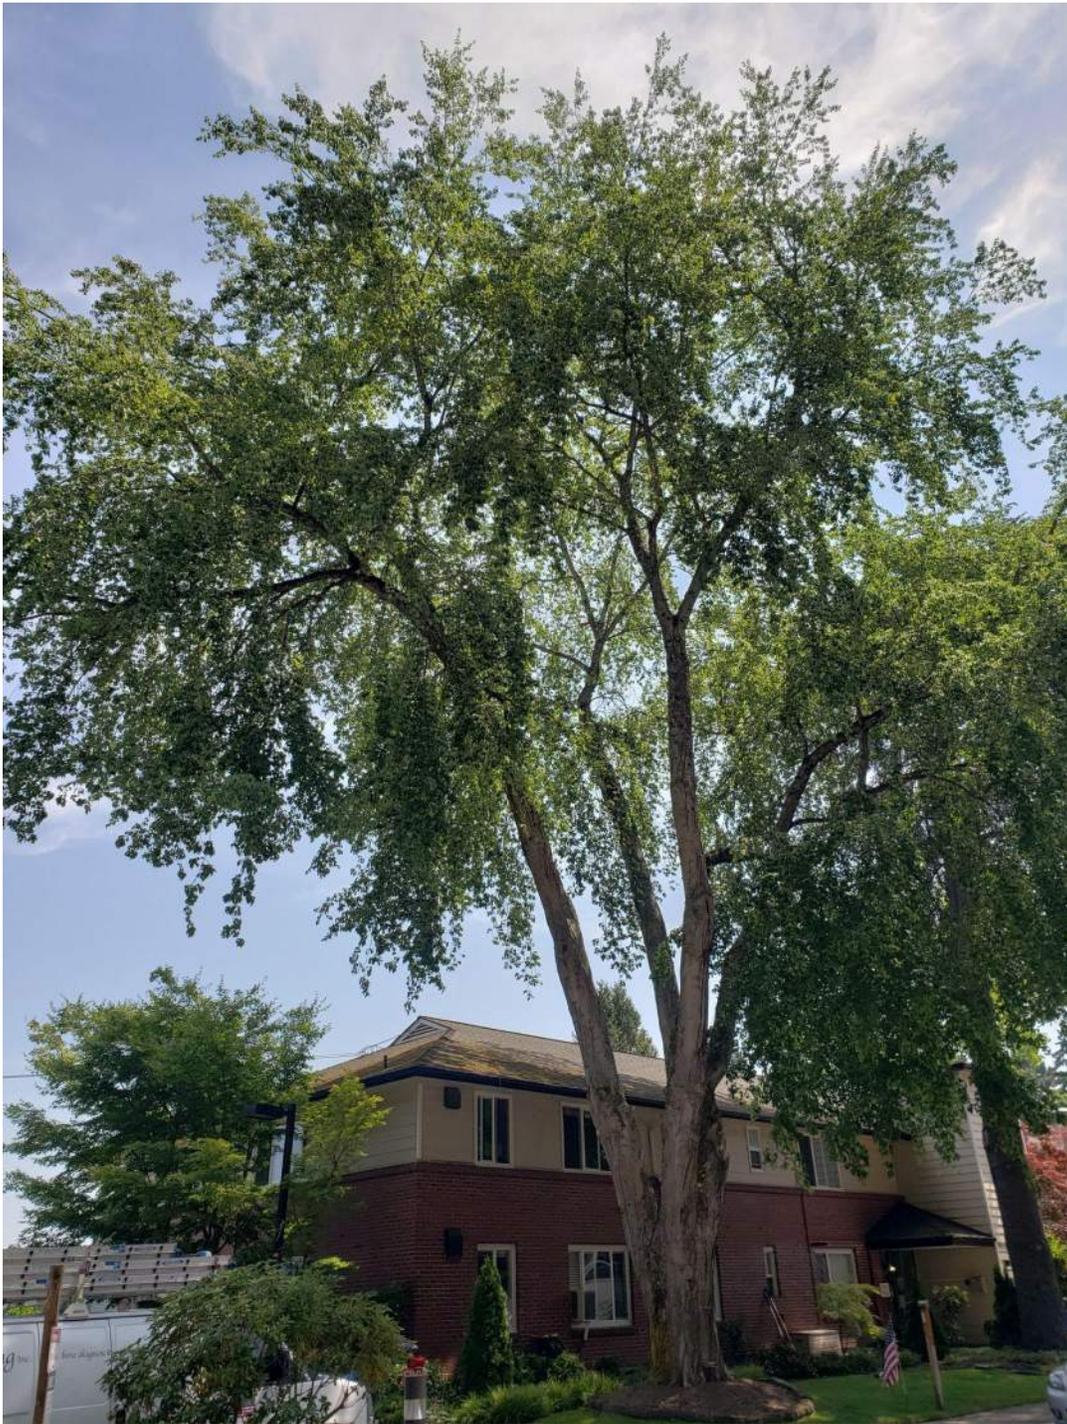
Tree 40 is a red maple (*Acer rubrum*) that measures 41.8" DSH and is an exceptional tree. It has fair health and fair structural condition with a thinning canopy and heartwood decay at previous scaffold branch locations. The proposed plans show installation of a new water line, which connects to an existing water main outside the ICRZ of this tree. This tree can be retained.

Photo 18 - Tree 40, an exceptional red maple.

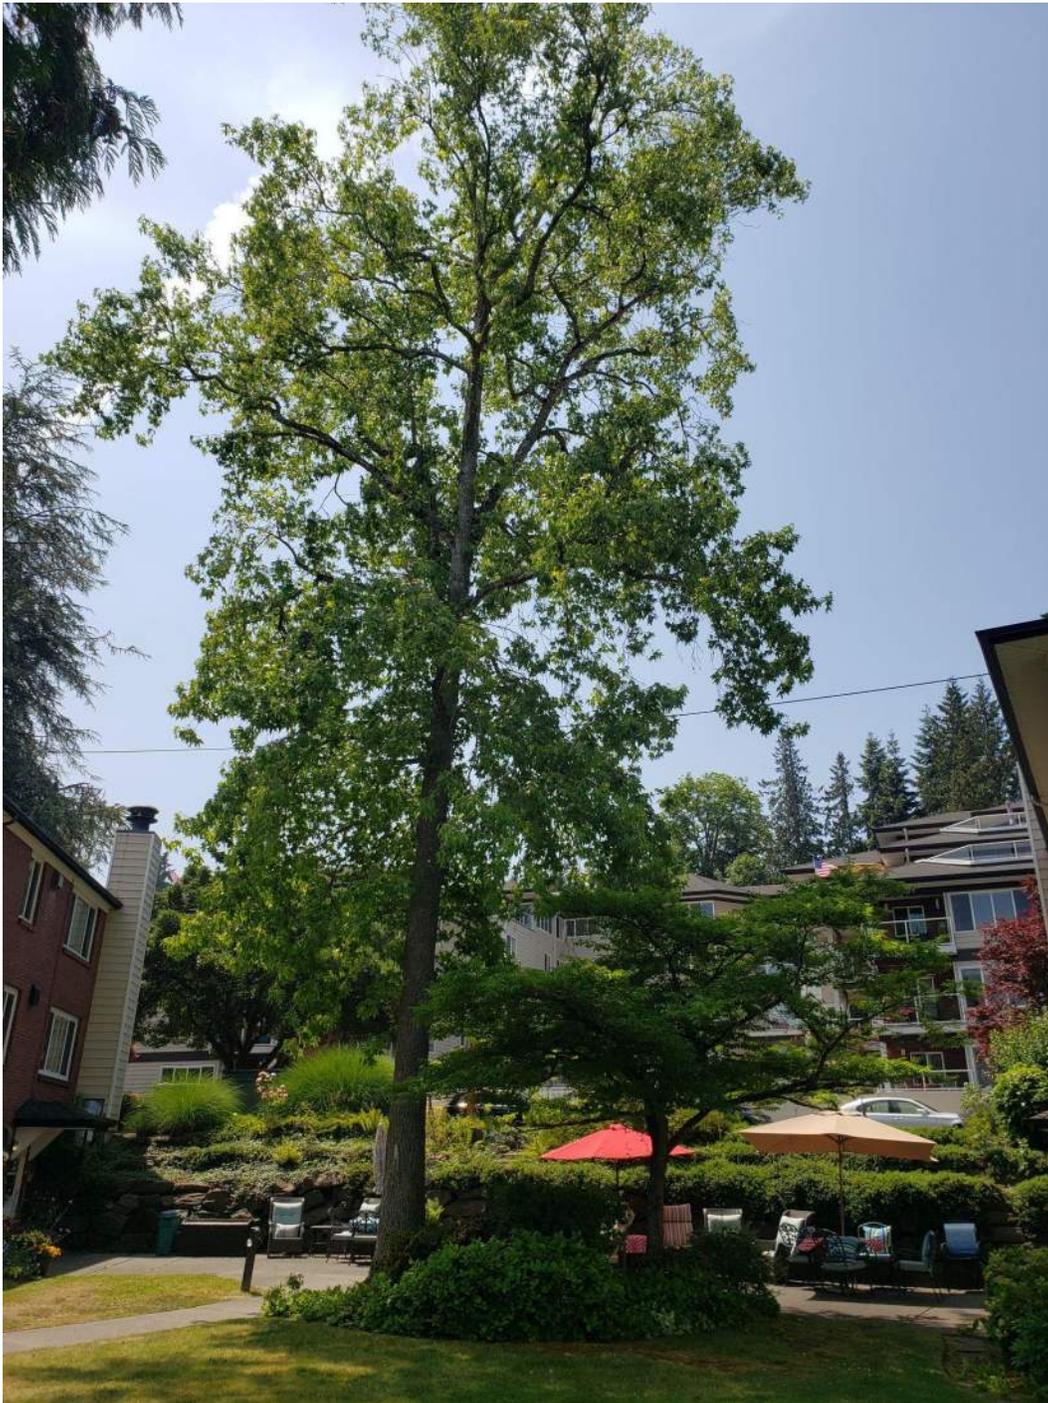
Tree 42 is an American sweetgum (*Liquidambar styraciflua*) that measures 22" DSH. It has good structural condition and fair health with a thin canopy. The proposed plans show installation of a new storm drain approximately 20' from the tree trunk, which is well outside the ICRZ of this tree. This tree can be retained.

Photo 19 - Tree 42, an American sweetgum.

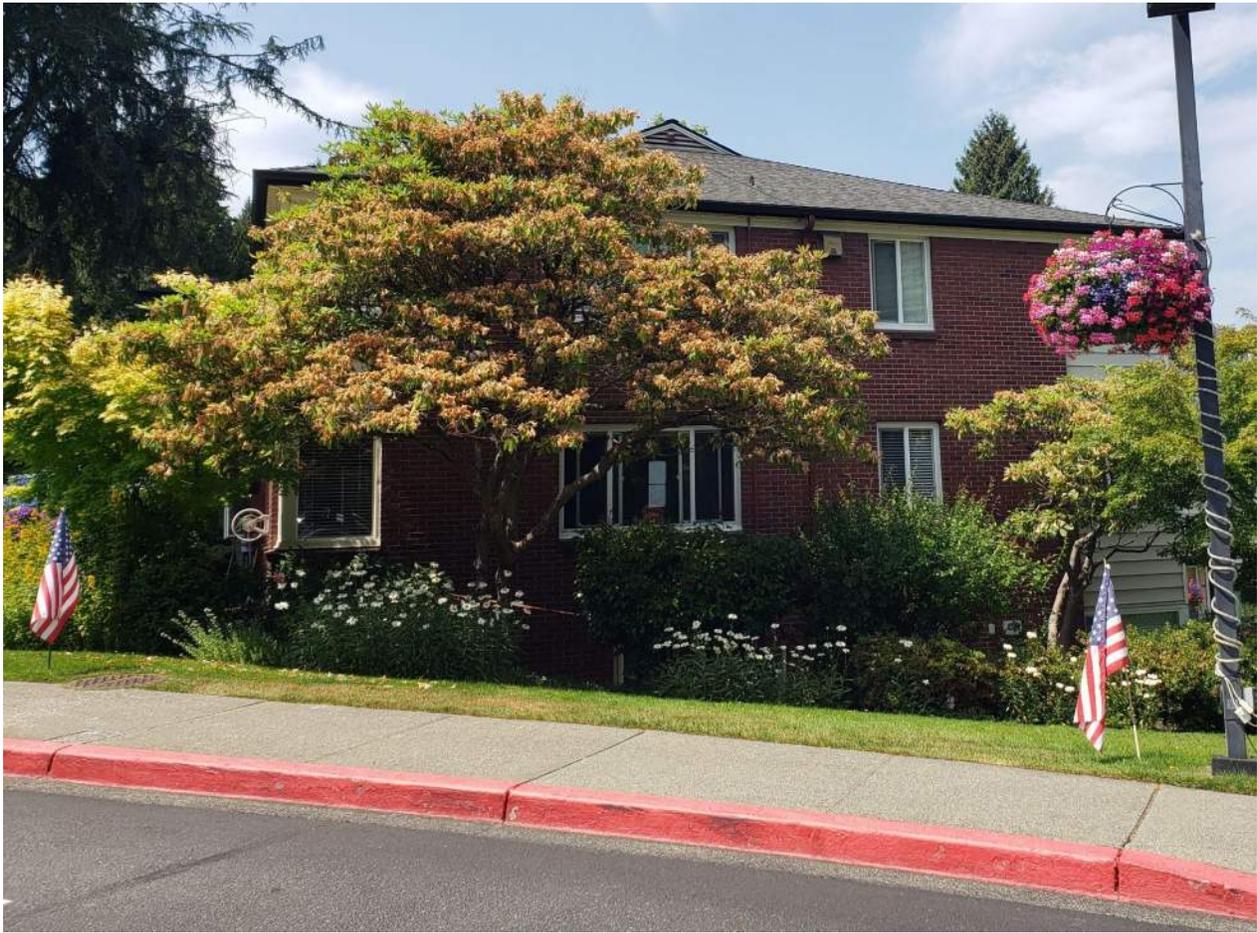
Tree 45 is a rhododendron (*Rhododendron spp.*) that measures 13.5" DSH and has a tree-like form. It has fair health and fair structural condition with a large girdling root around the base of the tree. The proposed plans show installation of a new side sewer approximately 15' from the tree trunk, which is well outside the CRZ for this tree. This tree can be retained if grading is kept to a minimum within the ICRZ.

Photo 20 - Tree 45, a rhododendron.

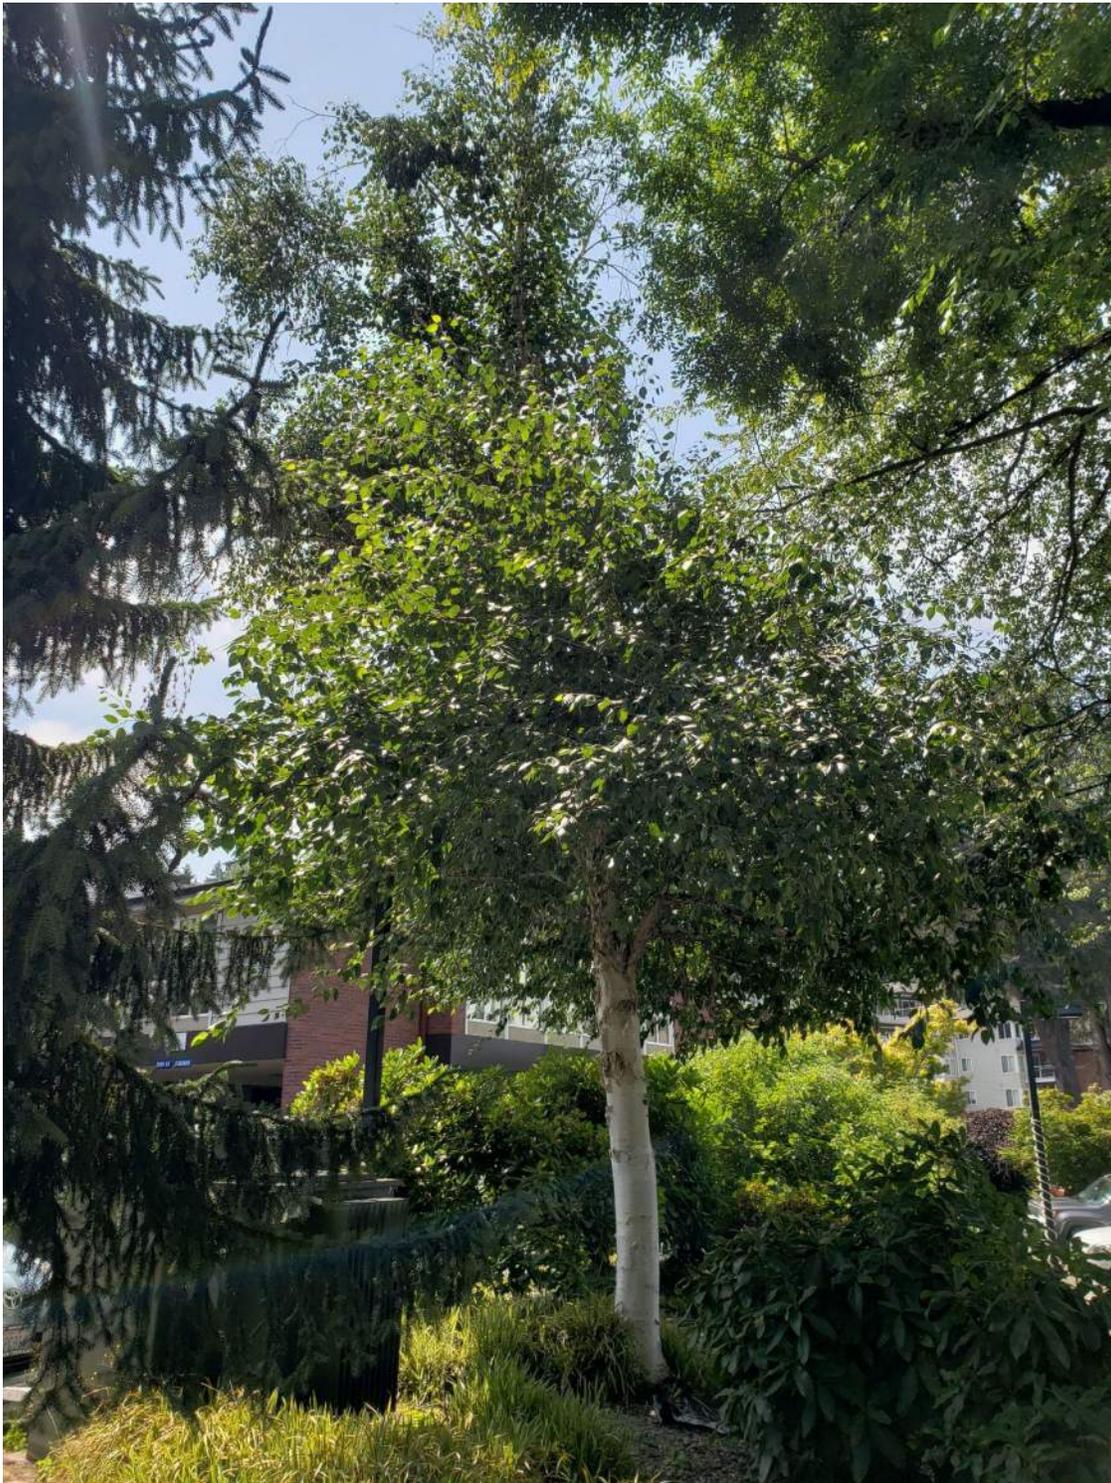
Tree 47 is paper birch (*Betula papyrifera*) that measures 10.3" DSH. It has good health and good structural condition. The proposed plans show grading and installation of a new parking area within the ICRZ of this tree. It will need to be removed for construction.

Photo 21 - Tree 47, a paper birch.

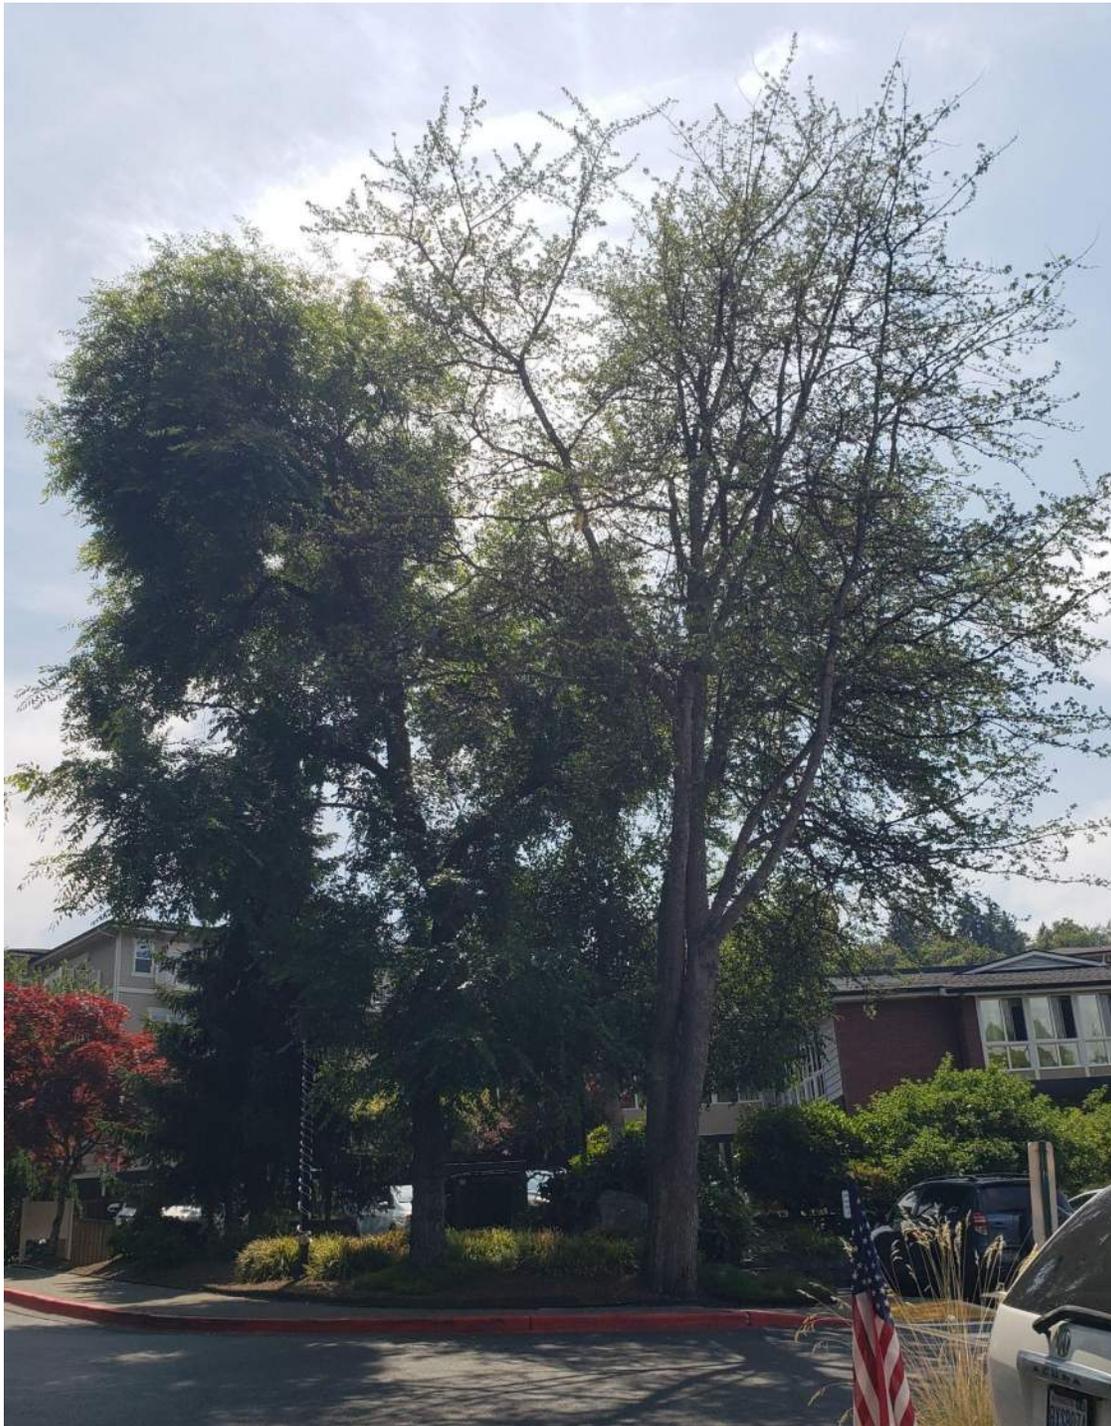
Tree 48 red maple (*Acer rubrum*) that measures 28" DSH and is an exceptional tree. It has fair health and fair structural condition with a thin canopy, sap drip at the base of the trunk, dead branches, and crossing trunks. The proposed plans include installation of a stormwater detention vault within a few feet of the tree trunk, as well as grading and parking lot construction around the tree. This tree will need to be removed for construction.

Tree 49 is a Siberian elm (*Ulmus pumila*) that measures 17.5" DSH. It has good health and good structural condition with no noticeable defects. The proposed plans show construction impacts approximately 14' from the tree trunk, which is outside the ICRZ for the tree. This tree can be retained.

Photo 22 - Tree 48 (right) and 49 (left), an exceptional red maple and a Siberian elm.
