**Title:** 3003 77<sup>th</sup> Ave Project – Mercer Park Project  
Arborist Addendum and ROW Tree Assessment  
Mercer Island, Washington

**Date:** August 26, 2021

**Tree Assessment Site Plan—ROW Trees**  
**Mercer Park Project**  
 3003 77th Avenue SE, Mercer Island, WA

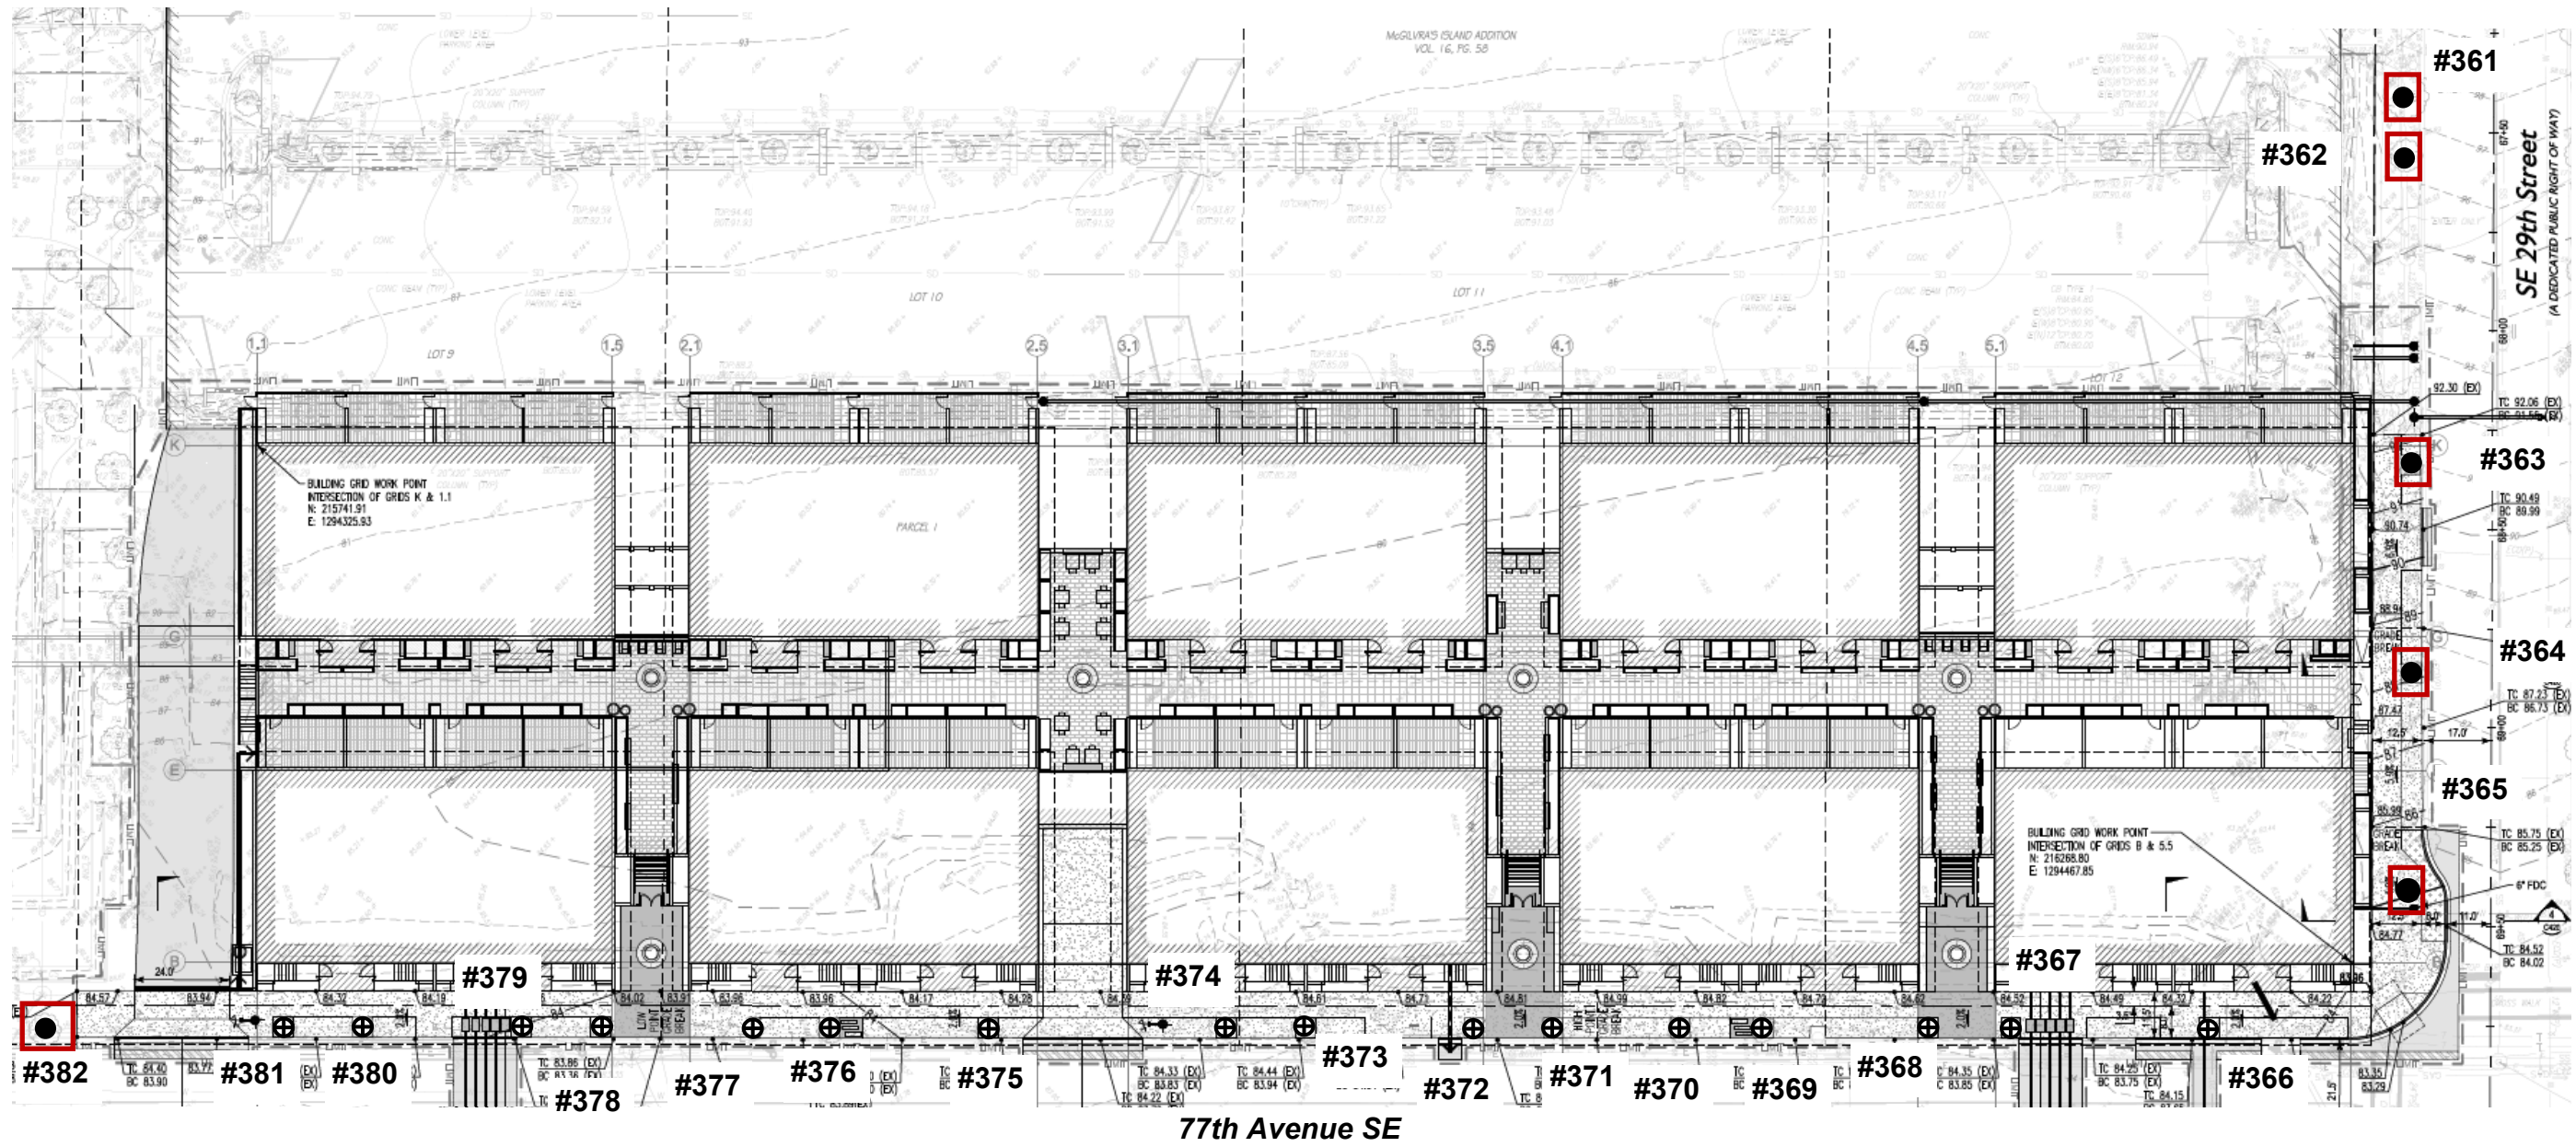
Remove the Callery pear trees #366 through #381. The proposed site changes are expected to significantly affect their health and stability. They are low value trees and should be replaced with new trees that have greater potential to provide ecosystem services for the neighborhood.

Retain trees #361 through #365 and #382. Install tree protection fencing per the details on the landscape plans provided by the project landscape architect. At a minimum, the limits of disturbance should be the existing curb, sidewalk edge, or planting pit boundary.
