**Title: 3003 77th Ave Project – Mercer South Park Project
Full Tree Inventory and Health Assessment
Level 2 Basic Tree Risk Assessment
3003 77th Ave SE
Mercer Island, Washington**

Date: July 15, 2020; updated July 24, 2020

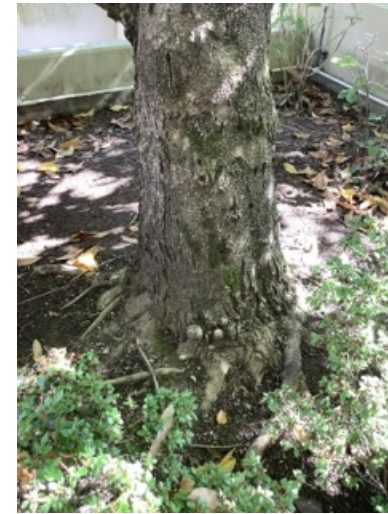
Tree	Species	DBH (in)	Drip Rad.	CRZ (ft)	Vigor	Structure	Risk	Pres Value	Recommendations
202	Southern magnolia <i>Magnolia grandiflora</i>	16.5	11.0	16.5	Good	Good	Low	Low	
Notes/ Defects	The tree is growing in a planting area next to garage. The foliage is slightly chlorotic.

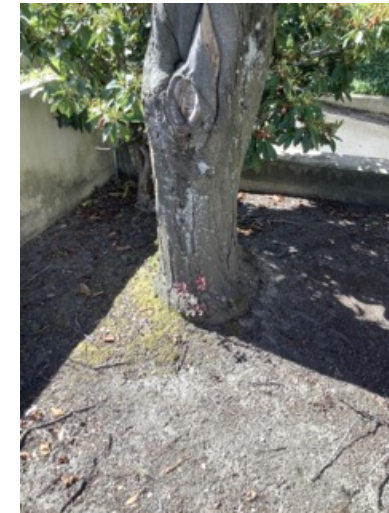
Tree	Species	DBH (in)	Drip Rad.	CRZ (ft)	Vigor	Structure	Risk	Pres Value	Recommendations
203	Plum <i>Prunus sp</i>	17.5	9.0	17.5	Poor to Fair	Fair	Low	Low	
Notes/ Defects	The tree is growing in a planting area. There is a fungus growing on the trunk and there is some branch dieback.

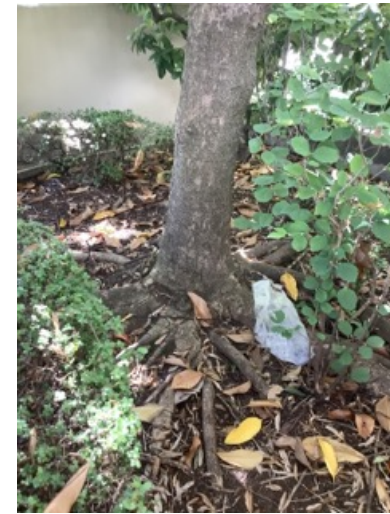
Tree	Species	DBH (in)	Drip Rad.	CRZ (ft)	Vigor	Structure	Risk	Pres Value	Recommendations
204	Magnolia <i>Magnolia species</i>	9.3	13.0	9.3	Good	Good	Low	Low	
Notes/ Defects	The tree is growing in a planting area. There are several roots on the surface.

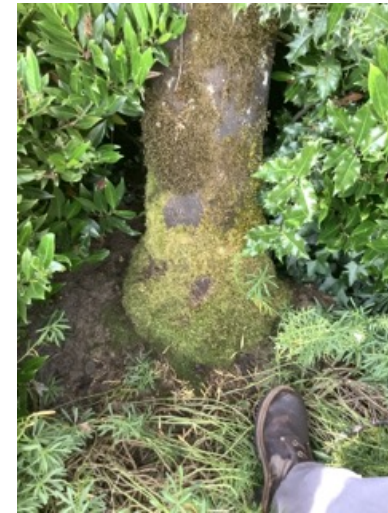
Tree	Species	DBH (in)	Drip Rad.	CRZ (ft)	Vigor	Structure	Risk	Pres Value	Recommendations
206	Plum <i>Prunus sp</i>	12.9	8.0	12.9	Poor	Fair to Good	Low	Low	Retain
Notes/ Defects	The crown is almost half dead. The tree is growing in a raised planting box.

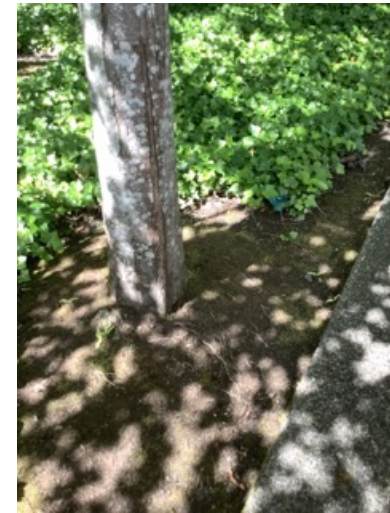
Tree	Species	DBH (in)	Drip Rad.	CRZ (ft)	Vigor	Structure	Risk	Pres Value	Recommendations
212	Norway maple <i>Acer platanoides</i>	10.2	14.0	10.2	Good	Good	Low	Medium	
Notes/ Defects	The tree is in a group of five maples. It does not have any visible defects.

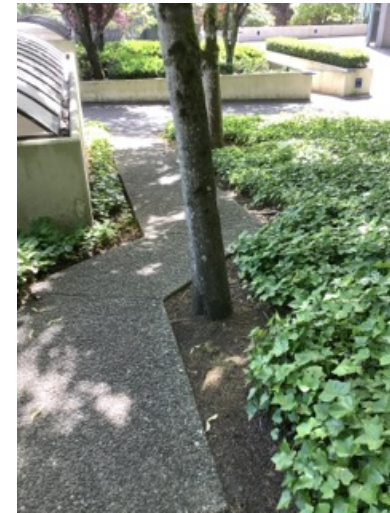
Tree	Species	DBH (in)	Drip Rad.	CRZ (ft)	Vigor	Structure	Risk	Pres Value	Recommendations
215	Norway maple <i>Acer platanoides</i>	6.5	8.0	6.5	Fair	Fair	Low	Low	
Notes/ Defects	This is the smallest tree in the group. It has a small crown.

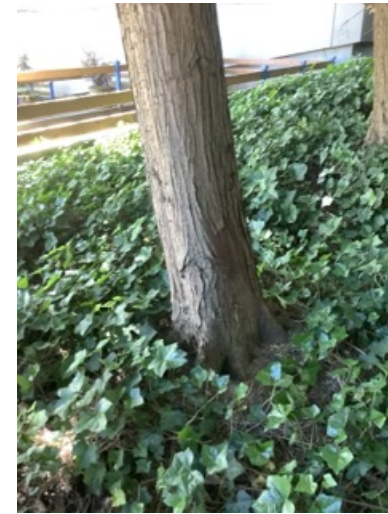
Tree	Species	DBH (in)	Drip Rad.	CRZ (ft)	Vigor	Structure	Risk	Pres Value	Recommendations
217	Western red cedar <i>Thuja plicata</i>	10.8	11.0	10.8	Good	Fair to Good	Low	Low	
Notes/ Defects	The tree is in a group of five cedars. English ivy is the dominant ground cover and encroaching on the crown of some trees.

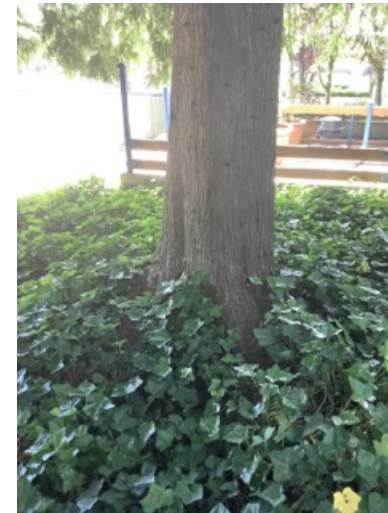
Tree	Species	DBH (in)	Drip Rad.	CRZ (ft)	Vigor	Structure	Risk	Pres Value	Recommendations
218	Western red cedar <i>Thuja plicata</i>	19.4	12.0	19.4	Good	Fair to Good	Low	Medium	
Notes/ Defects	This is the largest tree in the group.

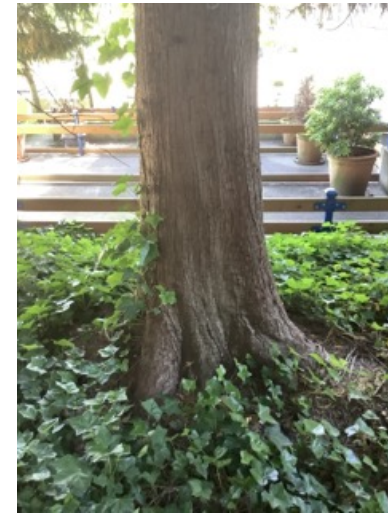
Tree	Species	DBH (in)	Drip Rad.	CRZ (ft)	Vigor	Structure	Risk	Pres Value	Recommendations
220	Western red cedar <i>Thuja plicata</i>	19.5	11.0	19.5	Good	Fair to Good	Low	Medium	
Notes/ Defects	The crown is starting to encroach on the building wall.

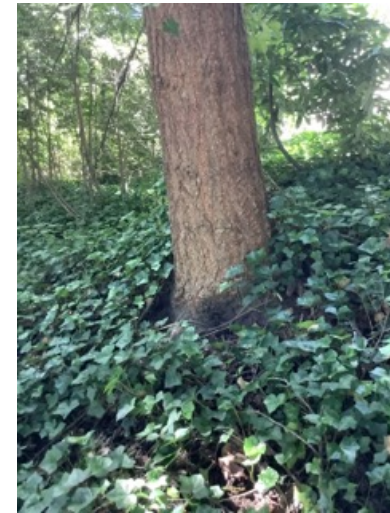
Tree	Species	DBH (in)	Drip Rad.	CRZ (ft)	Vigor	Structure	Risk	Pres Value	Recommendations
223	Douglas fir <i>Pseudotsuga menziesii</i>	19.5	13.0	19.5	Fair	Fair	Low	Medium	
Notes/ Defects	The lower crown is being choked out by ivy.

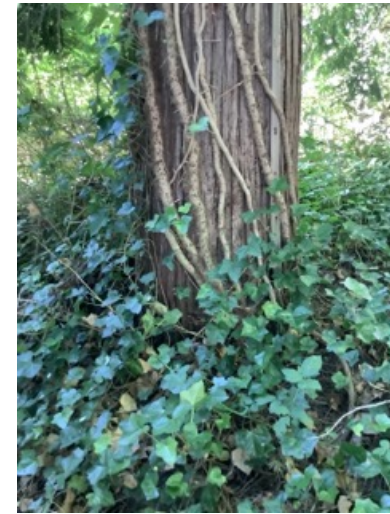
Tree	Species	DBH (in)	Drip Rad.	CRZ (ft)	Vigor	Structure	Risk	Pres Value	Recommendations
224	Western red cedar <i>Thuja plicata</i>	25.4	11.0	25.4	Fair	Fair to Good	Low	Medium	
Notes/ Defects	There is ivy throughout the crown and the top is thinning.

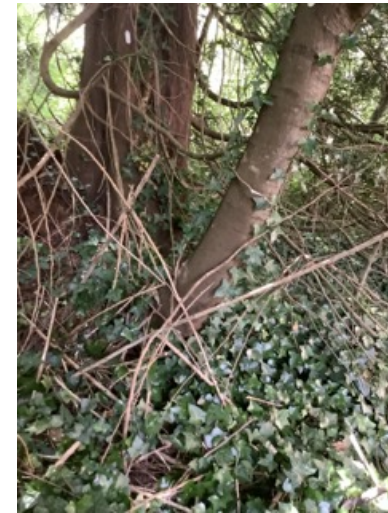
Tree	Species	DBH (in)	Drip Rad.	CRZ (ft)	Vigor	Structure	Risk	Pres Value	Recommendations
230	Bigleaf maple <i>Acer macrophyllum</i>	7.8	13.5	7.8	Good	Poor to Fair	Low	Low	
Notes/ Defects	This is a short leaning tree.

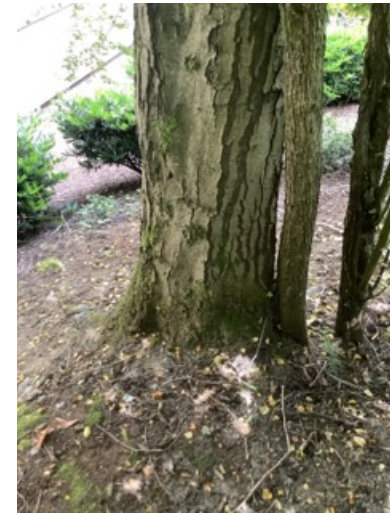
Tree	Species	DBH (in)	Drip Rad.	CRZ (ft)	Vigor	Structure	Risk	Pres Value	Recommendations
238	Red alder <i>Alnus rubra</i>	18.0	18.0	18.0	Good	Fair to Good	Low	Low	
Notes/ Defects	This is a healthy tree in good condition.

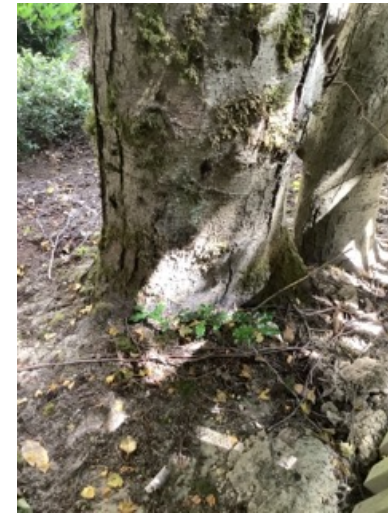
Tree	Species	DBH (in)	Drip Rad.	CRZ (ft)	Vigor	Structure	Risk	Pres Value	Recommendations
239	Red alder <i>Alnus rubra</i>	16.5	17.0	16.5	Good	Fair	Low	Low	
Notes/ Defects	The tree has a single trunk with a nice shape.

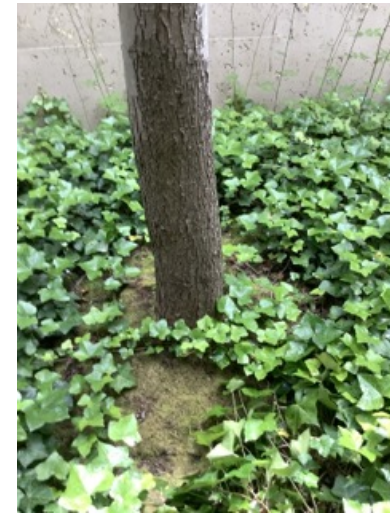
Tree	Species	DBH (in)	Drip Rad.	CRZ (ft)	Vigor	Structure	Risk	Pres Value	Recommendations
242	Armstrong maple <i>Acer x freemanii</i> 'Armstrong'	7.2	6.0	7.2	Fair to Good	Good	Low	Low	
Notes/ Defects	There is some dieback in the crown. The irrigation system is operating.

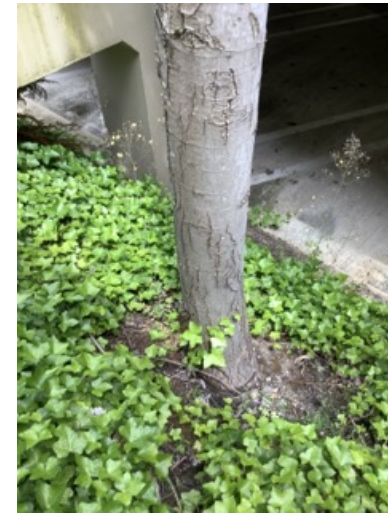
Tree	Species	DBH (in)	Drip Rad.	CRZ (ft)	Vigor	Structure	Risk	Pres Value	Recommendations
243	Armstrong maple <i>Acer x freemanii</i> 'Armstrong'	6.4	5.0	6.4	Fair to Good	Good	Low	Low	
Notes/ Defects	The tree has a full length crown.

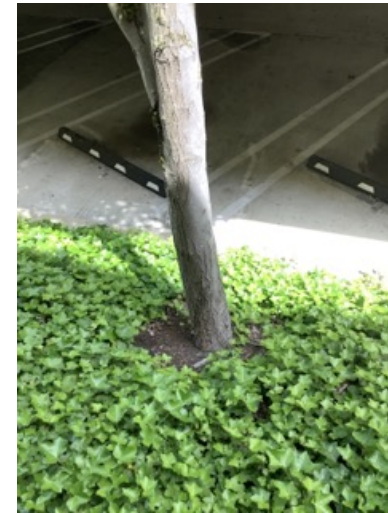
Tree	Species	DBH (in)	Drip Rad.	CRZ (ft)	Vigor	Structure	Risk	Pres Value	Recommendations
247	Armstrong maple <i>Acer x freemanii</i> 'Armstrong'		5.0	6.9	Good	Good	Low	Low	
Notes/ Defects	The tree has a full length and healthy crown.

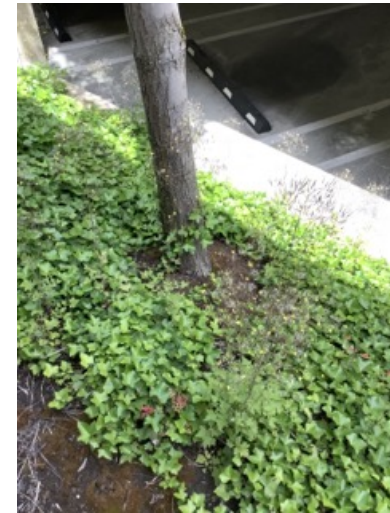
Tree	Species	DBH (in)	Drip Rad.	CRZ (ft)	Vigor	Structure	Risk	Pres Value	Recommendations
249	Armstrong maple <i>Acer x freemanii</i> 'Armstrong'	6.5	5.0	6.5	Fair to Good	Good	Low	Low	
Notes/ Defects	The tree has a full length and healthy crown.

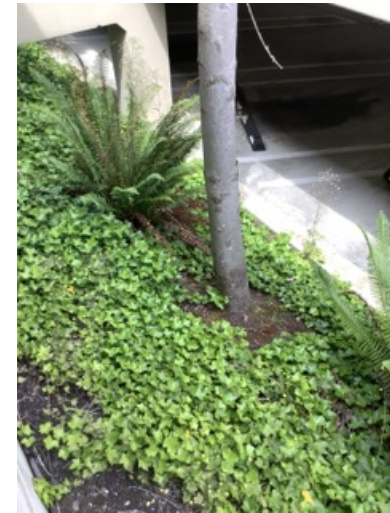
Tree	Species	DBH (in)	Drip Rad.	CRZ (ft)	Vigor	Structure	Risk	Pres Value	Recommendations
250	Armstrong maple <i>Acer x freemanii</i> 'Armstrong'	6.2	5.0	6.2	Poor to Fair	Good	Low	Low	
Notes/ Defects	The tree has a weak crown with some dieback.

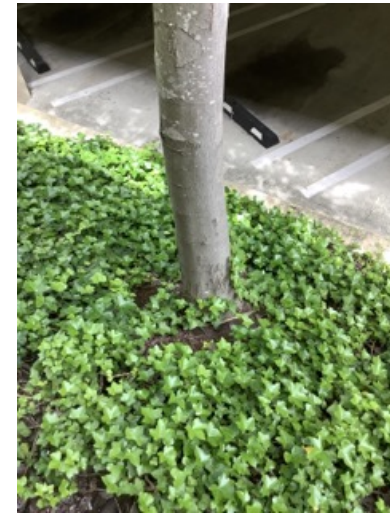
Tree	Species	DBH (in)	Drip Rad.	CRZ (ft)	Vigor	Structure	Risk	Pres Value	Recommendations
251	Armstrong maple <i>Acer x freemanii</i> 'Armstrong'	8.0	5.0	8.0	Good	Good	Low	Low	
Notes/ Defects	The crown is broad instead of columnar. It is healthy and in good condition.

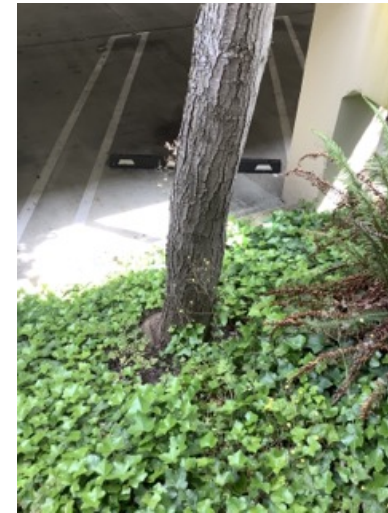
Tree	Species	DBH (in)	Drip Rad.	CRZ (ft)	Vigor	Structure	Risk	Pres Value	Recommendations
252	Armstrong maple <i>Acer x freemanii</i> 'Armstrong'	10.0	5.0	10.0	Good	Good	Low	Low	
Notes/ Defects	The tree has a full length crown in good condition.

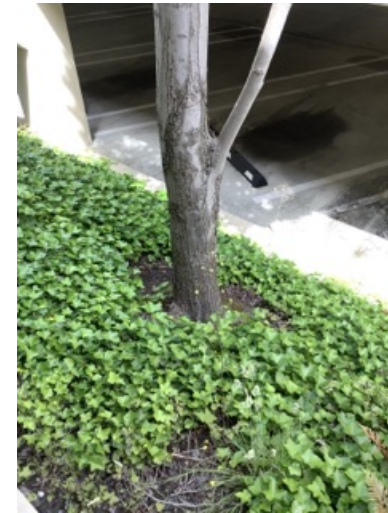
Tree	Species	DBH (in)	Drip Rad.	CRZ (ft)	Vigor	Structure	Risk	Pres Value	Recommendations
253	Armstrong maple <i>Acer x freemanii</i> 'Armstrong'	7.9	5.0	7.9	Good	Good	Low	Low	
Notes/ Defects	This is a tall tree with a full crown.

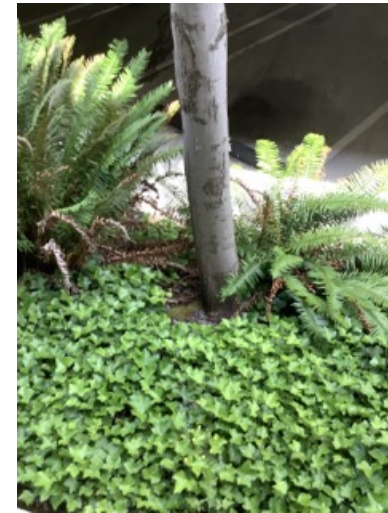
Tree	Species	DBH (in)	Drip Rad.	CRZ (ft)	Vigor	Structure	Risk	Pres Value	Recommendations
254	Armstrong maple <i>Acer x freemanii</i> 'Armstrong'	7.2	5.0	7.2	Fair to Good	Good	Low	Low	
Notes/ Defects	The tree is healthy and in good condition.

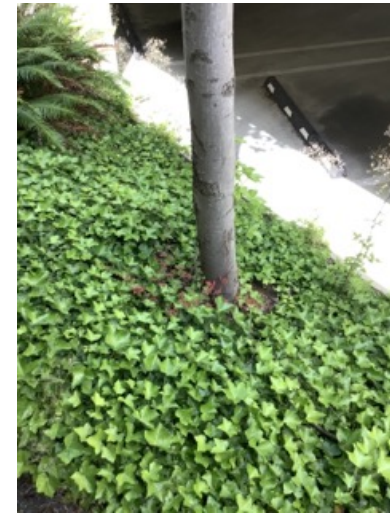
Tree	Species	DBH (in)	Drip Rad.	CRZ (ft)	Vigor	Structure	Risk	Pres Value	Recommendations
256	Armstrong maple <i>Acer x freemanii</i> 'Armstrong'	6.1	5.0	6.1	Fair to Good	Good	Low	Low	
Notes/ Defects	There is some minor dieback in the crown.

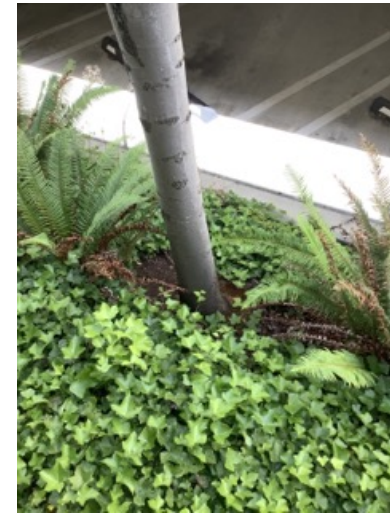
Tree	Species	DBH (in)	Drip Rad.	CRZ (ft)	Vigor	Structure	Risk	Pres Value	Recommendations
258	Armstrong maple <i>Acer x freemanii</i> 'Armstrong'	6.3	5.0	6.3	Good	Good	Low	Low	
Notes/ Defects	The crown is weak with some dieback.

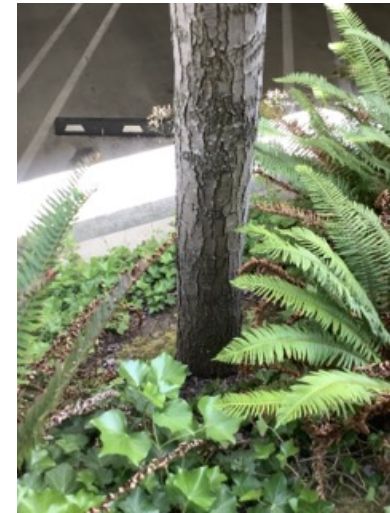
Tree	Species	DBH (in)	Drip Rad.	CRZ (ft)	Vigor	Structure	Risk	Pres Value	Recommendations
260	Armstrong maple <i>Acer x freemanii</i> 'Armstrong'	7.0	5.0	7.0	Fair to Good	Good	Low	Low	
Notes/ Defects	There is some minor dieback in the crown.

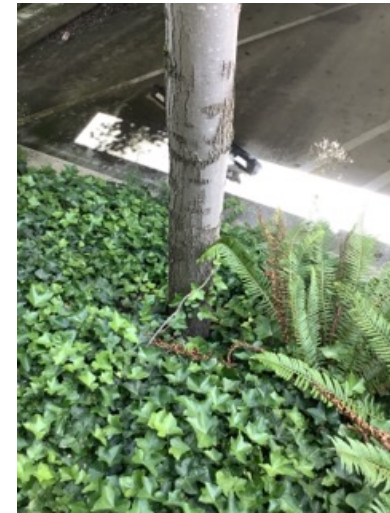
Tree	Species	DBH (in)	Drip Rad.	CRZ (ft)	Vigor	Structure	Risk	Pres Value	Recommendations
262	Armstrong maple <i>Acer x freemanii</i> 'Armstrong'	7.2	5.0	7.2	Poor to Fair	Good	Low	Low	
Notes/ Defects	The tree has a small crown with minor dieback.

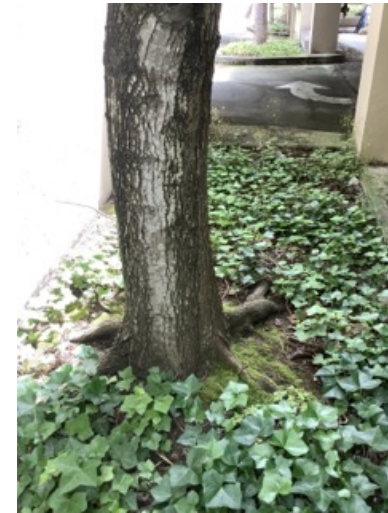
Tree	Species	DBH (in)	Drip Rad.	CRZ (ft)	Vigor	Structure	Risk	Pres Value	Recommendations
264	Armstrong maple <i>Acer x freemanii</i> 'Armstrong'	10.8	9.5	10.8	Good	Fair to Good	Low	Low	
Notes/ Defects	This is a healthy tree with a broad crown.

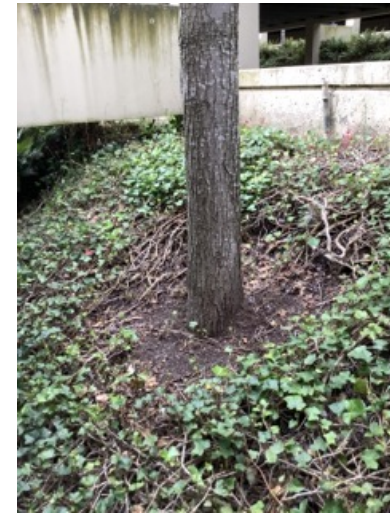
Tree	Species	DBH (in)	Drip Rad.	CRZ (ft)	Vigor	Structure	Risk	Pres Value	Recommendations
267	Armstrong maple <i>Acer x freemanii</i> 'Armstrong'	6.9	5.0	6.9	Fair to Good	Good	Low	Low	
Notes/ Defects	There is some minor dieback in the crown.

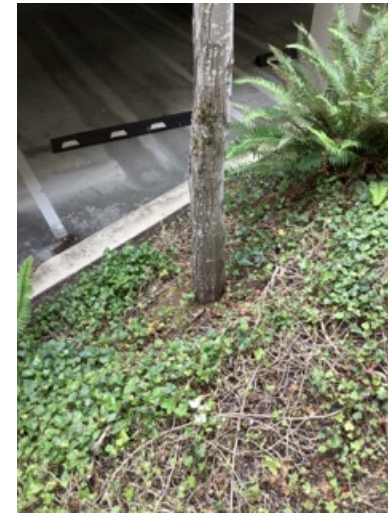
Tree	Species	DBH (in)	Drip Rad.	CRZ (ft)	Vigor	Structure	Risk	Pres Value	Recommendations
268	Armstrong maple <i>Acer x freemanii</i> 'Armstrong'	5.5	5.0	5.5	Poor	Poor	Low	Low	
Notes/ Defects	The crown has low branching density and major dieback.

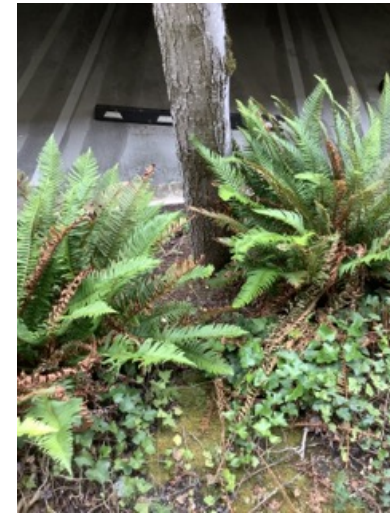
Tree	Species	DBH (in)	Drip Rad.	CRZ (ft)	Vigor	Structure	Risk	Pres Value	Recommendations
269	Armstrong maple <i>Acer x freemanii</i> 'Armstrong'	7.3	5.0	7.3	Fair	Fair to Good	Low	Low	
Notes/ Defects	There is minor dieback in the crown.

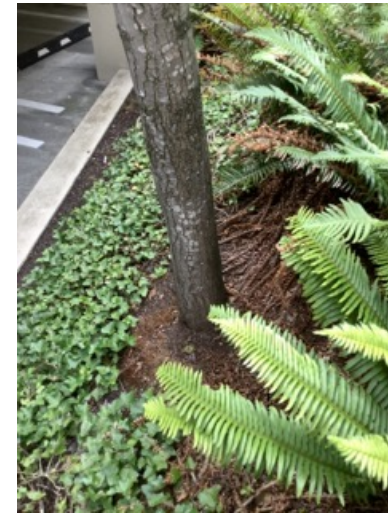
Tree	Species	DBH (in)	Drip Rad.	CRZ (ft)	Vigor	Structure	Risk	Pres Value	Recommendations
271	Armstrong maple <i>Acer x freemanii</i> 'Armstrong'	6.3	5.0	6.3	Fair	Fair to Good	Low	Low	
Notes/ Defects	There is minor dieback in the crown.

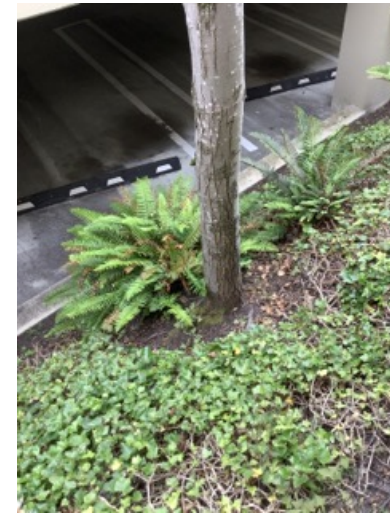
Tree	Species	DBH (in)	Drip Rad.	CRZ (ft)	Vigor	Structure	Risk	Pres Value	Recommendations
274	Armstrong maple <i>Acer x freemanii</i> 'Armstrong'	7.3	5.0	7.3	Fair to Good	Fair to Good	Low	Low	
Notes/ Defects	There is minor dieback in the crown.

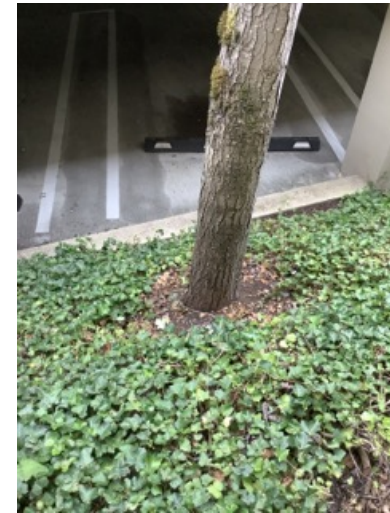
Tree	Species	DBH (in)	Drip Rad.	CRZ (ft)	Vigor	Structure	Risk	Pres Value	Recommendations
278	Armstrong maple <i>Acer x freemanii</i> 'Armstrong'	8.9	5.0	8.9	Good	Good	Low	Low	
Notes/ Defects	The form is broad and short instead of the typical columnar shape.

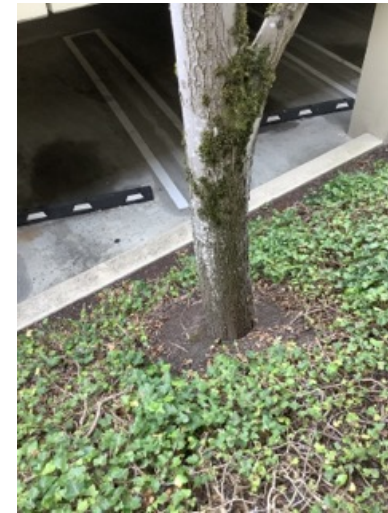
Tree	Species	DBH (in)	Drip Rad.	CRZ (ft)	Vigor	Structure	Risk	Pres Value	Recommendations
280	Armstrong maple <i>Acer x freemanii</i> 'Armstrong'	4.8	5.0	4.8	Fair to Good	Fair to Good	Low	Low	
Notes/ Defects	This is a shorter and broader crown the typical for the cultivar.

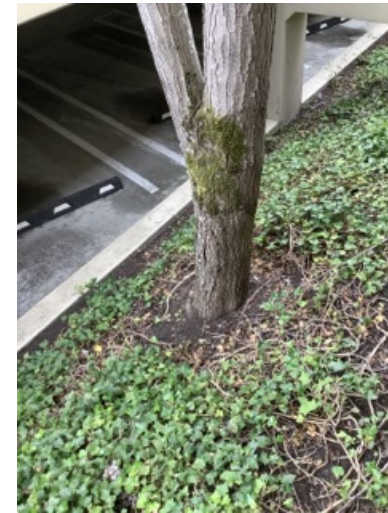
Tree	Species	DBH (in)	Drip Rad.	CRZ (ft)	Vigor	Structure	Risk	Pres Value	Recommendations
282	Armstrong maple <i>Acer x freemanii</i> 'Armstrong'		5.0	15.0	Good	Fair to Good	Low	Low	
Notes/ Defects	This tree has multiple codominant stems.

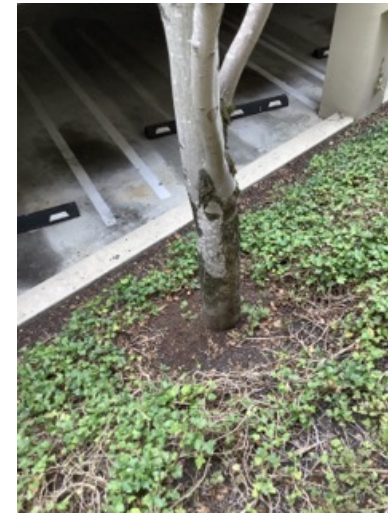
Tree	Species	DBH (in)	Drip Rad.	CRZ (ft)	Vigor	Structure	Risk	Pres Value	Recommendations
283	Armstrong maple <i>Acer x freemanii</i> 'Armstrong'	6.8	5.0	6.8	Poor	Fair	Low	Low	
Notes/ Defects	The crown is weak with some dieback.

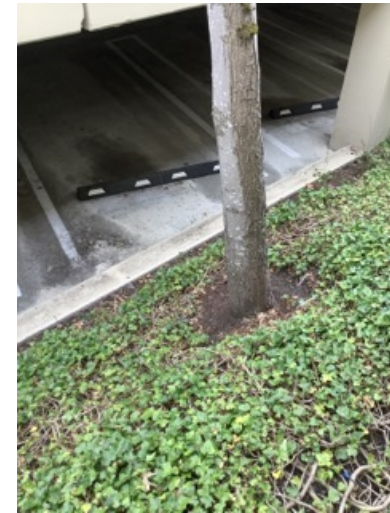
Tree	Species	DBH (in)	Drip Rad.	CRZ (ft)	Vigor	Structure	Risk	Pres Value	Recommendations
284	Armstrong maple <i>Acer x freemanii</i> 'Armstrong'	8.5	5.0	8.5	Fair to Good	Fair to Good	Low	Low	
Notes/ Defects	The crown is broad instead of columnar.

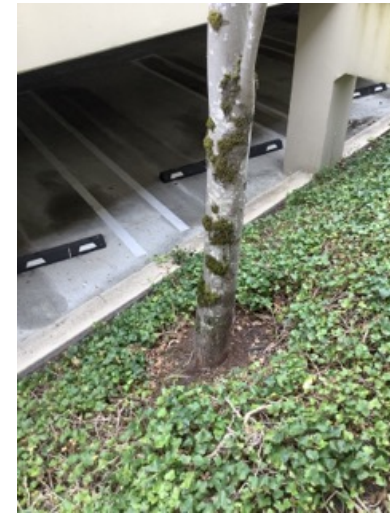
Tree	Species	DBH (in)	Drip Rad.	CRZ (ft)	Vigor	Structure	Risk	Pres Value	Recommendations
285	Armstrong maple <i>Acer x freemanii</i> 'Armstrong'	7.4	5.0	7.4	Fair	Fair to Good	Low	Low	
Notes/ Defects	There is some branch dieback in the crown.

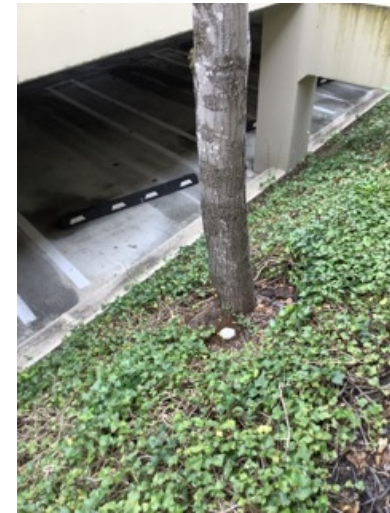
Tree	Species	DBH (in)	Drip Rad.	CRZ (ft)	Vigor	Structure	Risk	Pres Value	Recommendations
286	Armstrong maple <i>Acer x freemanii</i> 'Armstrong'	9.0	5.0	9.0	Fair	Fair to Good	Low	Low	
Notes/ Defects	The crown has minor branch dieback.
