September 1, 2023
File No. 23-242

**Subject: Critical Area 1 Review – Geotechnical Evaluation
Proposed Deck Replacement
4327 Forest Avenue Southeast, Mercer Island, WA 98040**

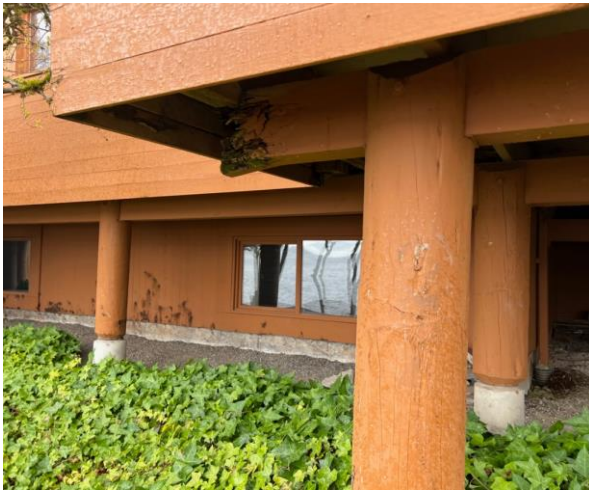
There was an existing deck along the west side of the existing house that has since been demolished. We also understand that the previous deck consisted of about 4 inches of concrete slab surfacing over timber beams. The beams were supported by timber posts connected to concrete spread footings. The spread footings have not been demolished. Based on our review of old photographs of the previous deck, the timber beams and posts were in poor condition with signs of rot and collapse under the weight of the concrete slab surfacing (see Plate 1).

Plate 1. View of the previous deck with rotted beams and posts. Deck has since been demolished.

Based on our understanding of the previous deck and proposed replacement, the new deck will be a lighter weight structure with the removal of the 4-inch concrete slab surface, resulting in a reduction in surcharge pressures from the deck on the existing spread footings to be reused for the new deck.

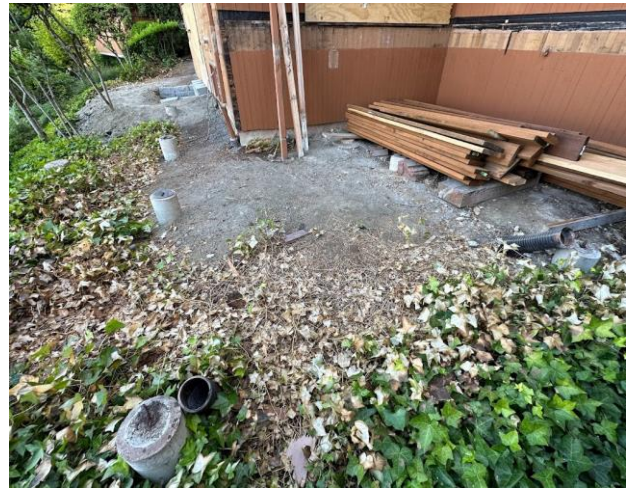
egress window for the partial basement to meet the current building codes for egress. The installation of the egress window would result in the removal of two of the old deck footings and replacement with posts bearing on a retaining wall continuous footing (see Plate 2). The excavation for the egress retaining wall would result in an excavation of about 3 feet below the existing grade.

Plate 2. View of the exposed soils over the replacement deck area, existing footings left in place.
