Arborist Report

Site: 4525 Forest Ave SE, Mercer Island, WA

Re: Tree Inventory and Assessment

Date: October 2, 2023

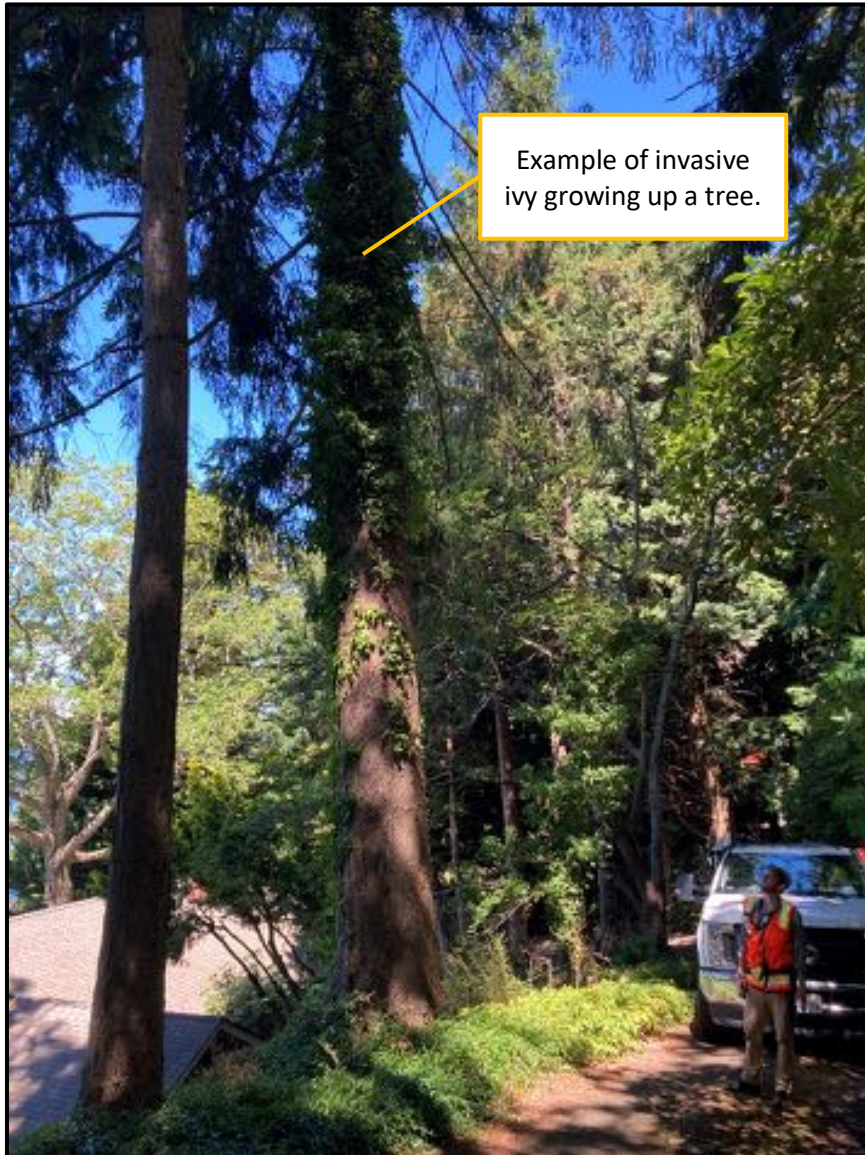
We noted the presence of multiple invasive plant species on site including English ivy (*Hedera* sp.) (Photo 1), holly (*Ilex* spp.), Saint John's wort (*Hypericum* spp.), and black locust (*Robinia pseudoacacia*). Invasive plants should be managed prior to development.

Photo 1. Tree 130 is an exceptional tree with significant vines growing up the main stem. Management of invasive species is easier prior to construction.

- Manage invasive plant species prior to site development.

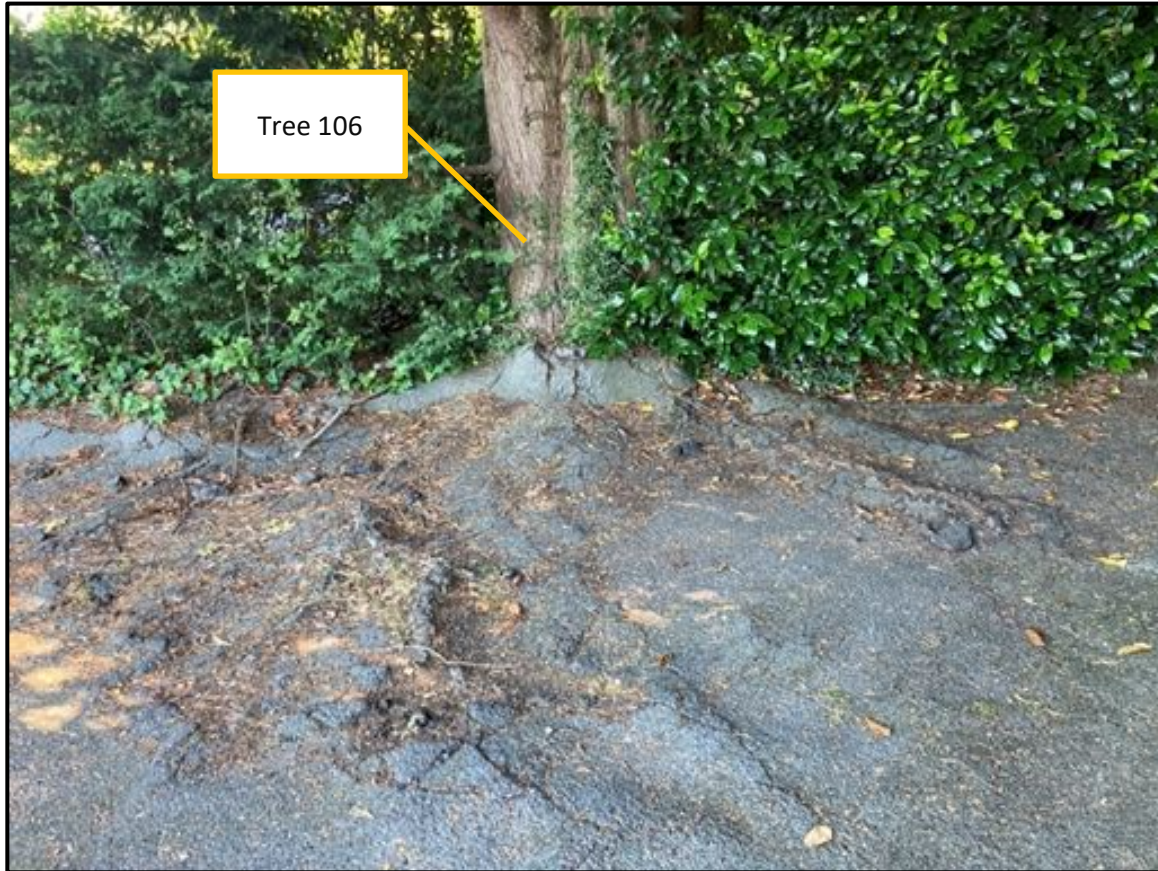
Tree 106 is an exceptional Leyland cypress located north of the existing home. The roots of this tree have significant conflict with the existing driveway (Photo 2). Leyland cypress trees grow rapidly and often outgrow their location.

Trees 106, 123, and 130 are exceptional trees greater than 24 inches DSH that are currently proposed for removal due to conflicts with the footprint of proposed structures and driveway improvements. Removal of these trees is permitted under MICC 19.10.060.3 because their retention would limit the constructable gross floor area to under 85 percent of the maximum allowed. An exhibit comparing the Recommended Limits of Disturbance (RLOD) of the exceptional trees proposed for removal compared to the buildable area is attached to this report.

Photo 2. Tree 106 is causing significant damage to the existing driveway.

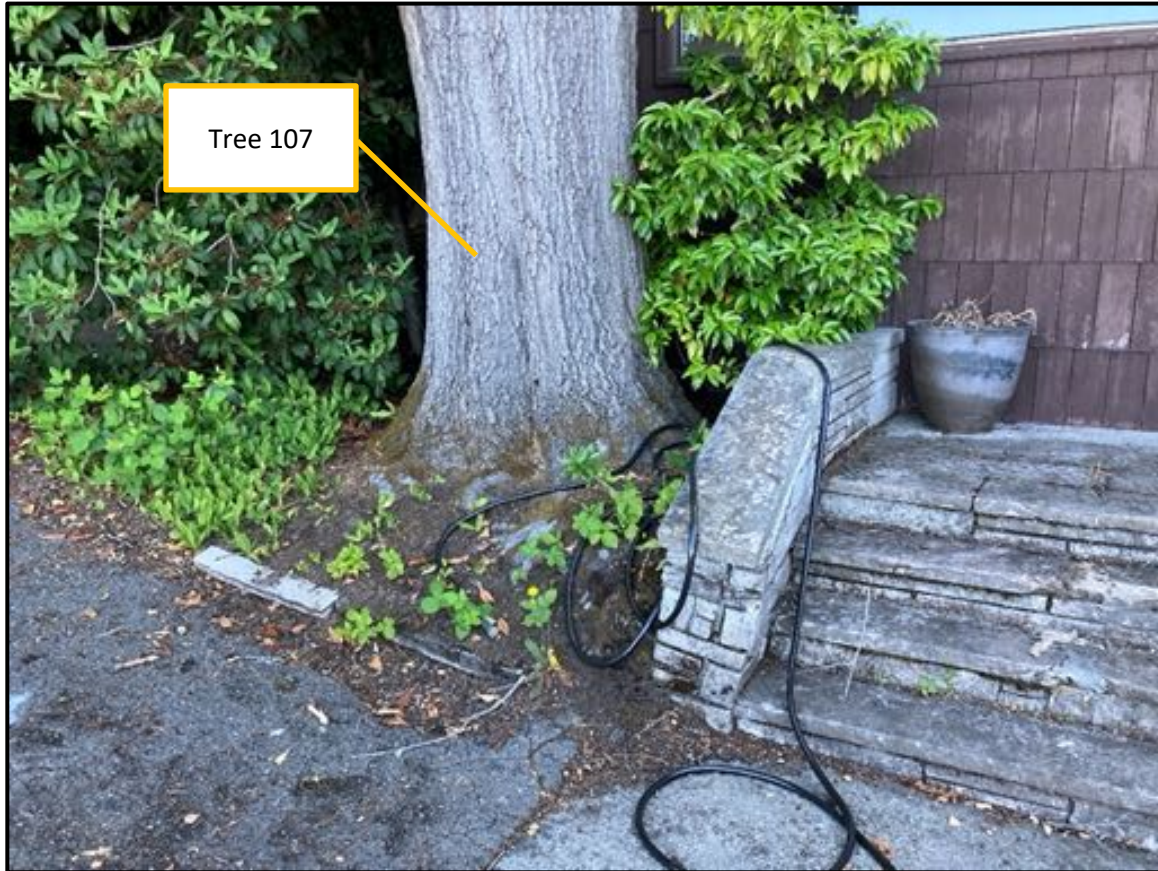
Tree 107 is an exceptional 36.6-inch eastern black oak that is currently proposed for removal. Retention is not possible due to the impacts of the proposed demolition of the existing foundation which is located within inches of the trunk (Photo 4).

Photo 4. Oak tree near existing building and hardscape.

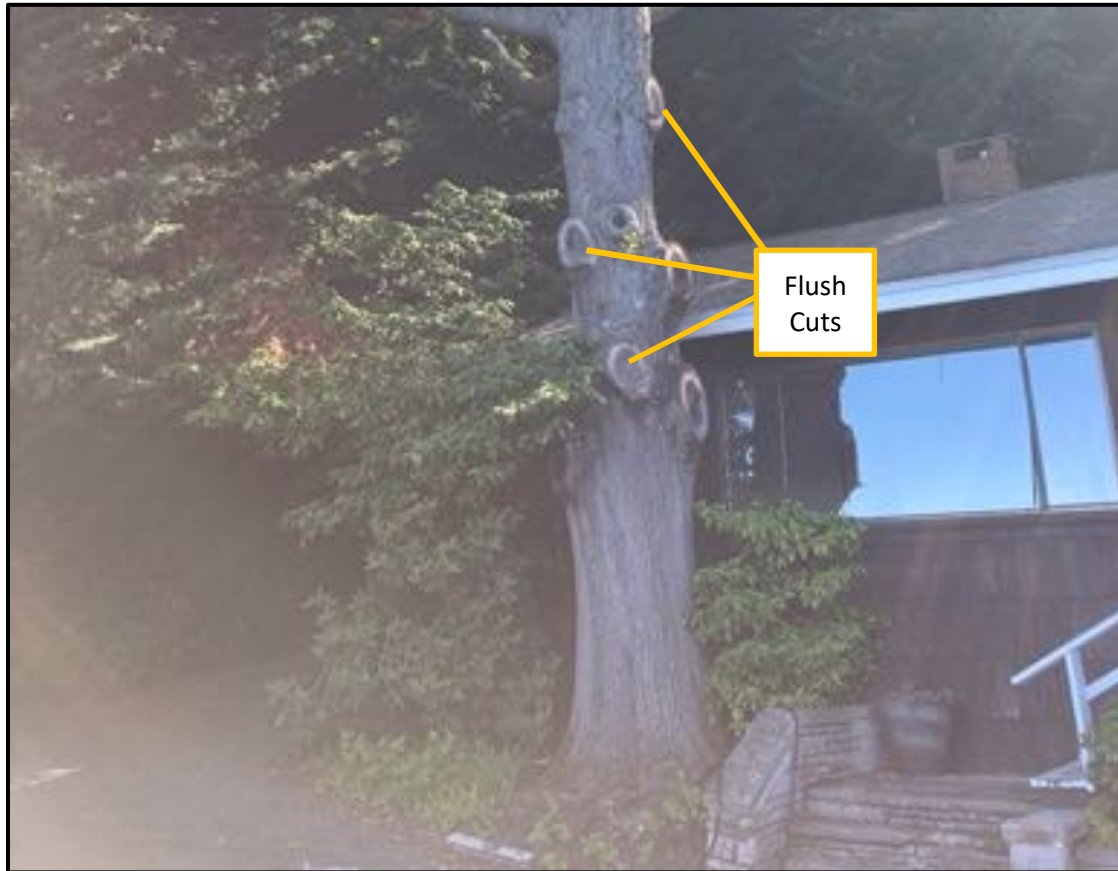
Tree 107 is an exceptional black oak located immediately adjacent to the existing building (Photo 3). This tree was malpruned by the previous property owner. Several large scaffold limbs were removed, with some pruning cuts in excess of 13 inches in diameter. A few of the cuts were made flush to the trunk and did not leave the branch collar intact (Photo 4). Even though oaks are generally strong-wooded trees which compartmentalize decay well, the severity of these wounds and the expected root impacts during demolition make it unlikely to be viable over the long term.

Photo 5. Improper pruning on tree 107.

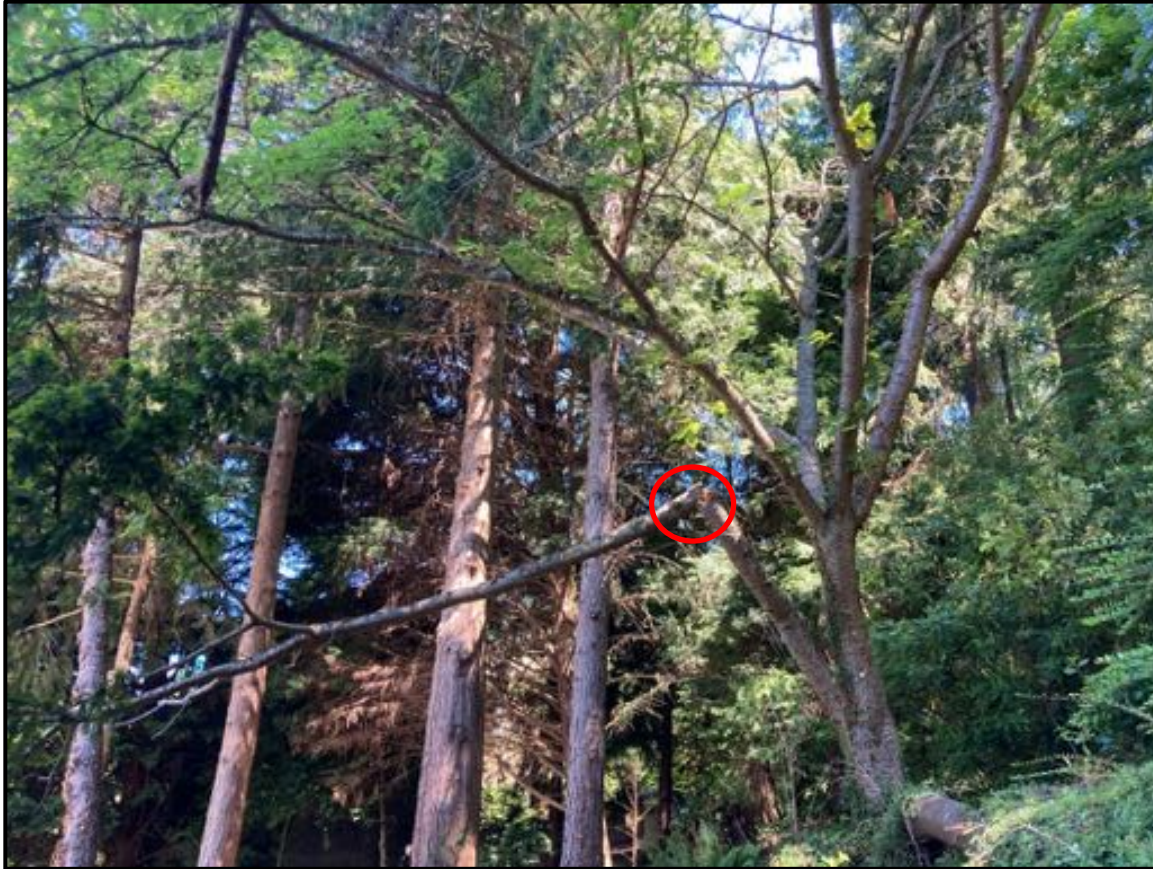
Tree 119 is a flowering cherry located east of the existing house. This tree is in poor health and has a failed limb overhanging the house (Photo 6). In our opinion, this tree should not be prioritized for retention. The broken limb should be removed as soon as possible.

Photo 6. Major damage to tree 119. The tree overall is in poor condition and is not recommended for retention.
