**NELSON GEOTECHNICAL  
ASSOCIATES. INC.**

Geotechnical Engineering Evaluation  
**Sharma Retaining Wall**  
**7905 West Mercer Way**  
**Mercer Island, Washington**  
NGA File No. 1496924

Geotechnical Engineering Evaluation  
Sharma Retaining Wall  
7905 West Mercer Way  
Mercer Island, Washington

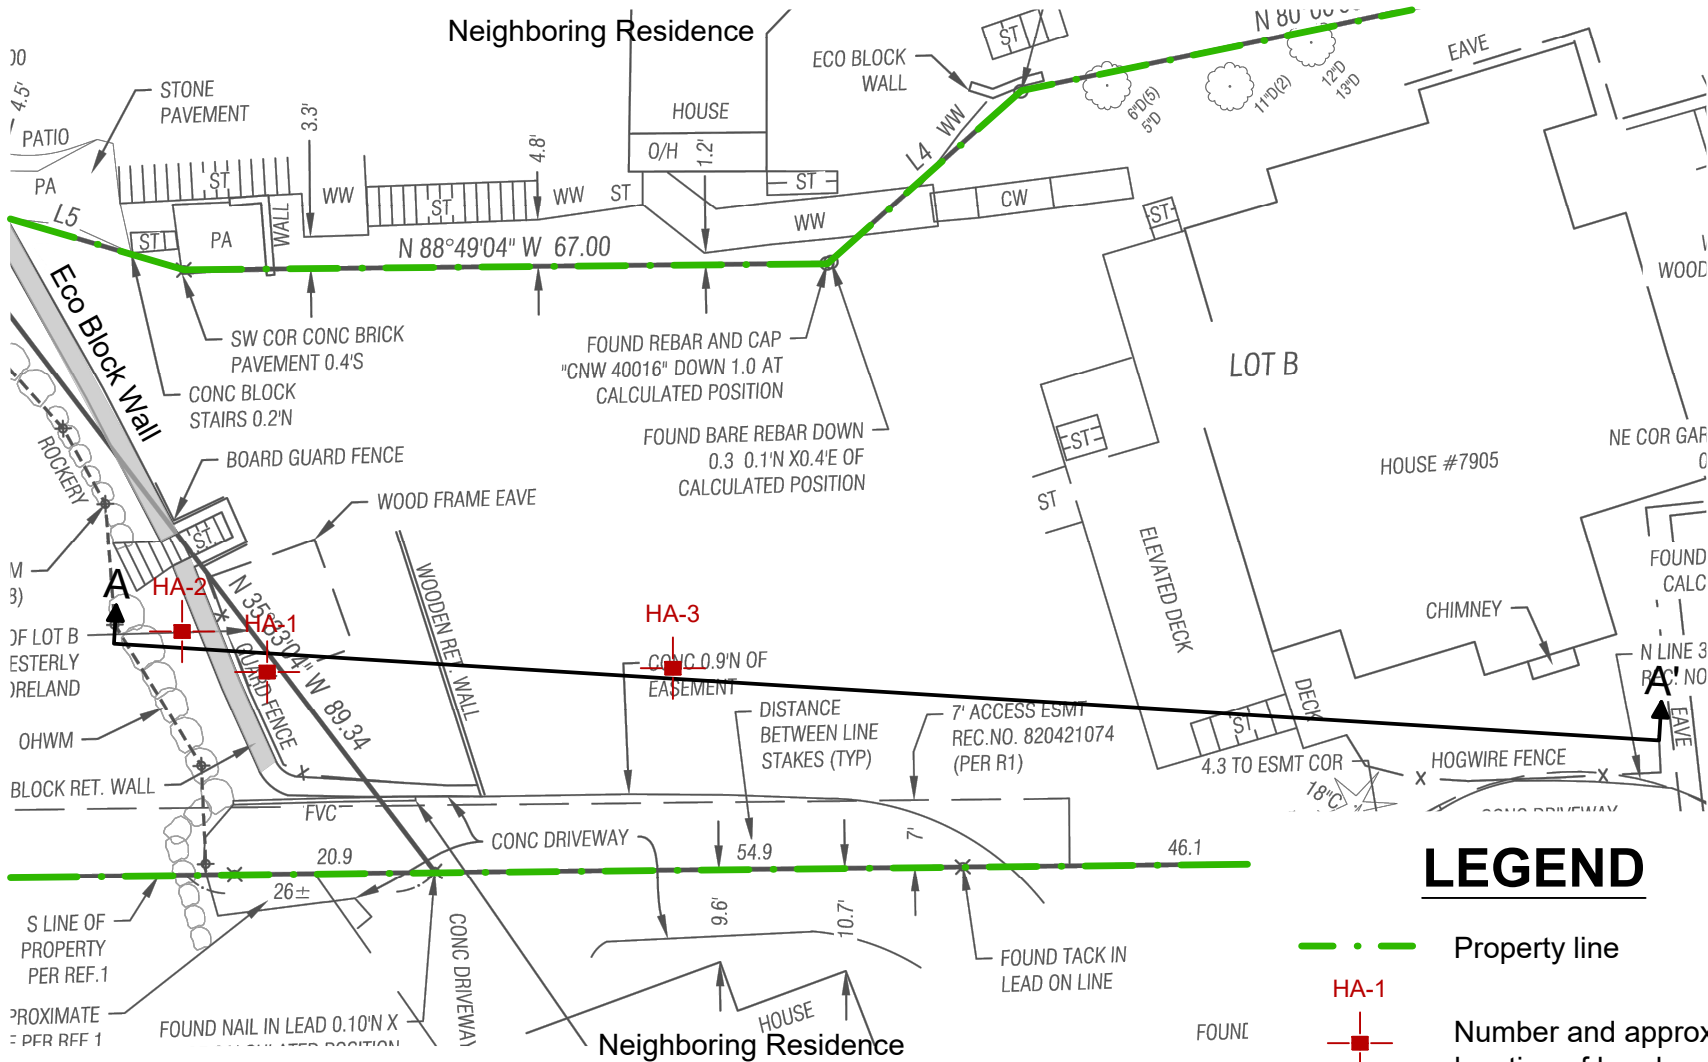
Figure 2

The property is irregular in shape and covers 0.48 acres in area. It is currently occupied by a single-family residence and an associated garage. The property is bordered by an access road from West Mercer Way to the east, Lake Washington to the west, and by neighboring residential properties on all other sides. Topographically, the site slopes moderately to steeply down towards Lake Washington. We understand that you have already constructed a retaining wall along the western portion of the property that ranges in height from 4.5- to 5.0-feet and is approximately 65-feet long. We also understand that the retaining wall was constructed to make a wider, relatively level bench in the slope to provide safer access to your dock as well as to develop a spa/hot tub area. We have been requested to provide this report for a geotechnical evaluation of the property and existing retaining wall, as well as development considerations for the proposed spa/hot tub. The existing site layout is shown on the Site Plan in Figure 2.

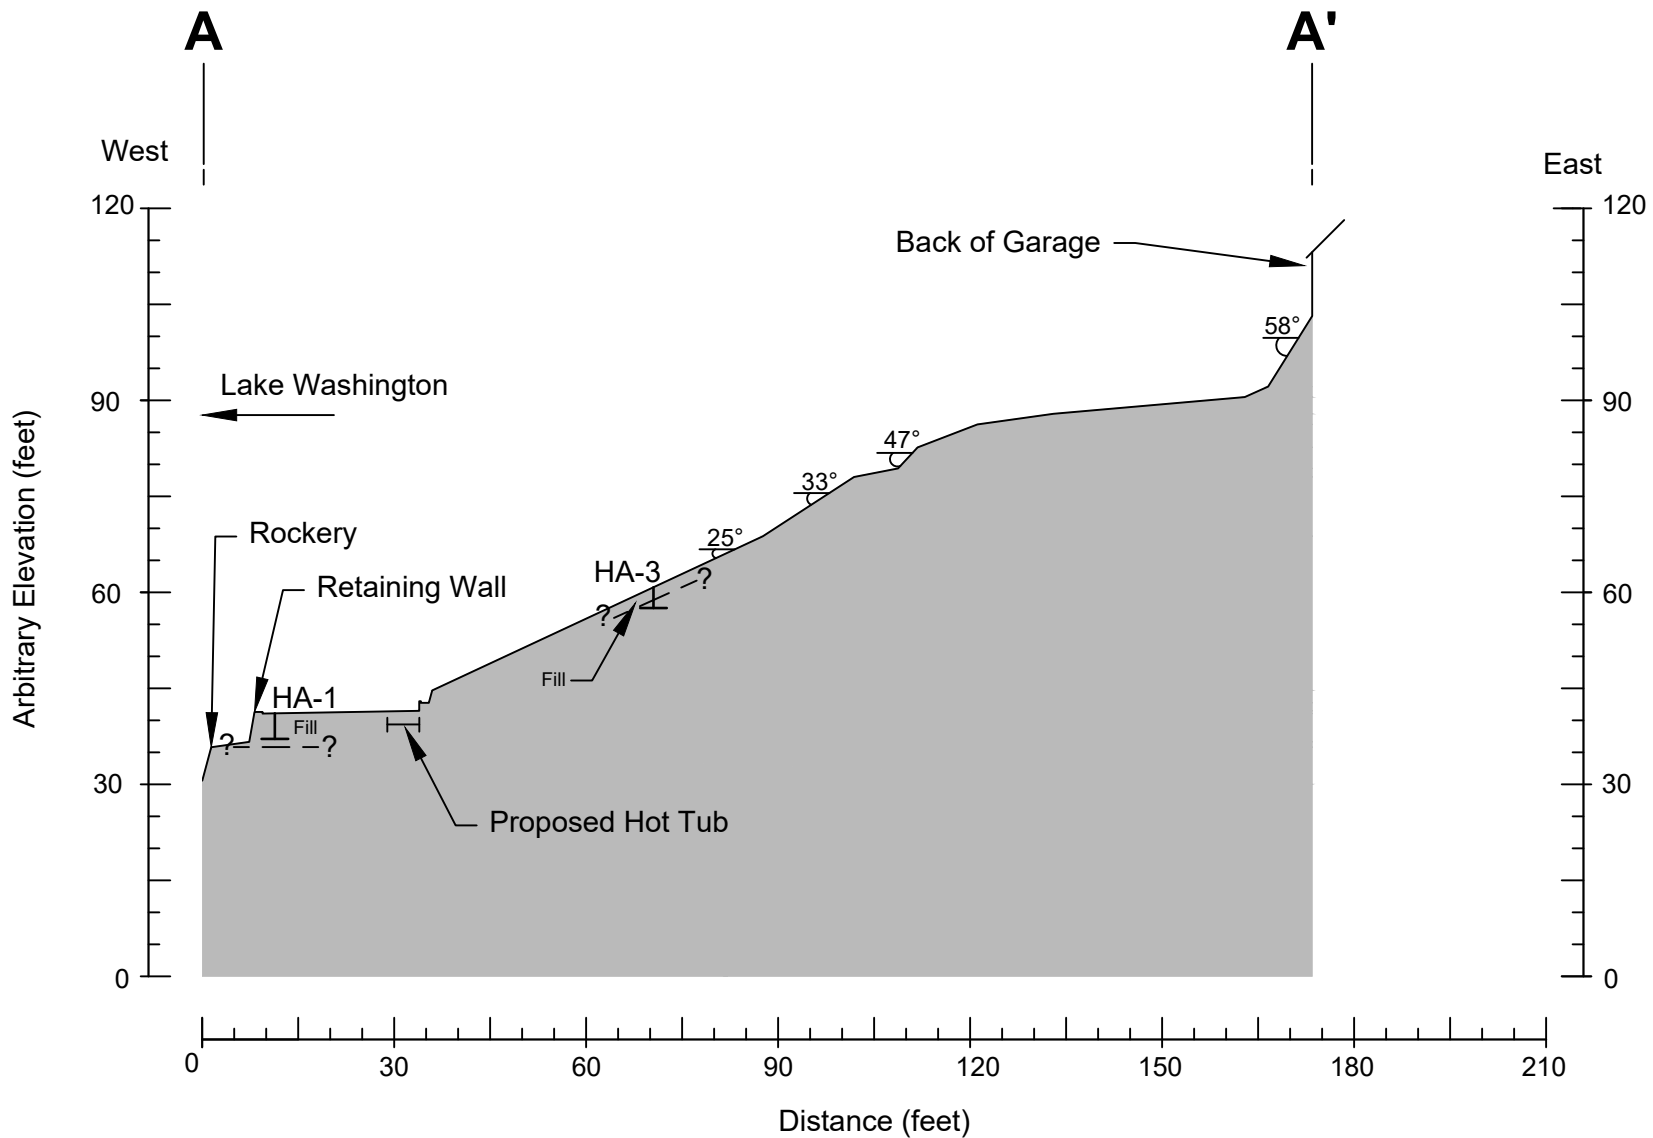
At the surface of all of our explorations we encountered 1.2- to 4.0-feet of dark brown fine to coarse sand with gravel, organics, and varying amounts of silt, which we interpreted to be undocumented fill soils. Hand Auger One met refusal on cobbles within the undocumented fill at 4.0-feet. Underlying the undocumented fill soils in Hand Auger's Two and Three, we encountered gray-brown to brown, silty, fine to medium sand with gravel, cobbles, and trace organics, which we interpreted as older clay till and gravel deposits. Hand Auger's Two and Three met refusal on cobbles within the native older clay till and gravel deposits at depths ranging from 2.5- to 3.25-feet below the existing ground surface.

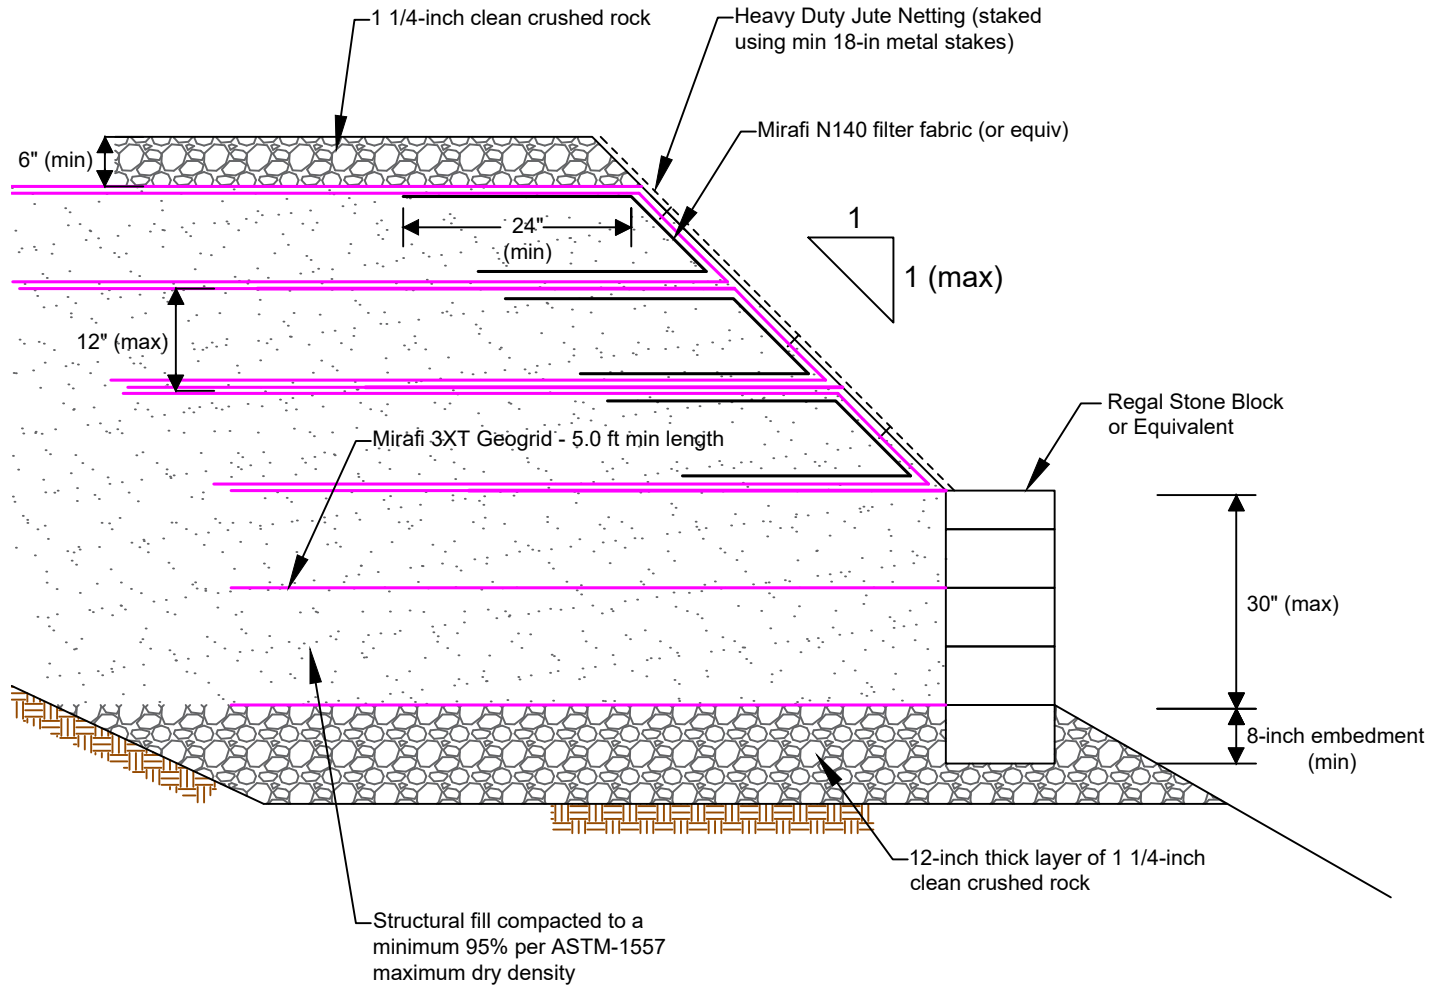
Figure 6

Based on our analysis of the existing retaining wall, it is our opinion that the wall is not stable from an engineering standpoint. A retaining wall in roughly the same location is feasible from a geotechnical standpoint given that the retaining wall is reconstructed in compliance with the City of Mercer Island code and our recommendations provided are strictly followed as well as implemented into the new design.

According to the City of Mercer Island, the exposed height of the proposed replacement retaining wall should be less than 30-inches. The total height of the new retaining wall should be 38-inches, including a minimum recommended embedment of 8-inches below the finished grade. We have provided wall designs for Regal Stone block facing, or equivalent. It is our opinion that the blocks on site are equivalent to the Regal Stone blocks. We recommend that all block walls on this site and backslope above wall be constructed utilizing geogrid-reinforced backfill. The block facing should consist of Regal Stone blocks, or of an equivalent size. The block facing should be placed on a minimum of 12-inches of 1.25-inch clean crushed rock leveling pads placed over competent soils, or structural fill material prepared under the supervision of NGA. Medium dense to dense, bearing soils should be encountered roughly 2.0- to 4.0-feet below the ground surface based on our explorations; however, loose soil may be encountered in unexplored areas of the site.

Above the retaining wall we recommend sloping the backfill back at a 1H:1V slope up to 30-inches. The backfill above the retaining wall should also be reinforced utilizing geogrid every 12-inches. Additionally, filter fabric should be wrapped around the front of the exposed soils, and it should overlap with the geogrid by 24-inches. A minimum of 6-inches of 1.25-inch clean crushed rock should be placed over the top layer of geogrid and filter fabric to prevent them from becoming disturbed.

Mirafi 3xT geogrid (or equivalent) is required and incorporated in the wall design. Each layer of geogrid should be a minimum of 5.0-feet in length, attached to the blocks as recommended by the manufacturer, and extended back into the reinforced fill zone. The grid should be pulled tight before the fill is placed over the geogrid. Care should be taken not to damage the geogrid by operating construction equipment on the exposed grid, or by allowing large rocks to be placed directly on the grid.
