ARBORIST NOTES

SUBJECT: Capital Improvement Project
PS 25 Tree Evaluation
4266 E. Mercer Way

DATE: March 13, 2024

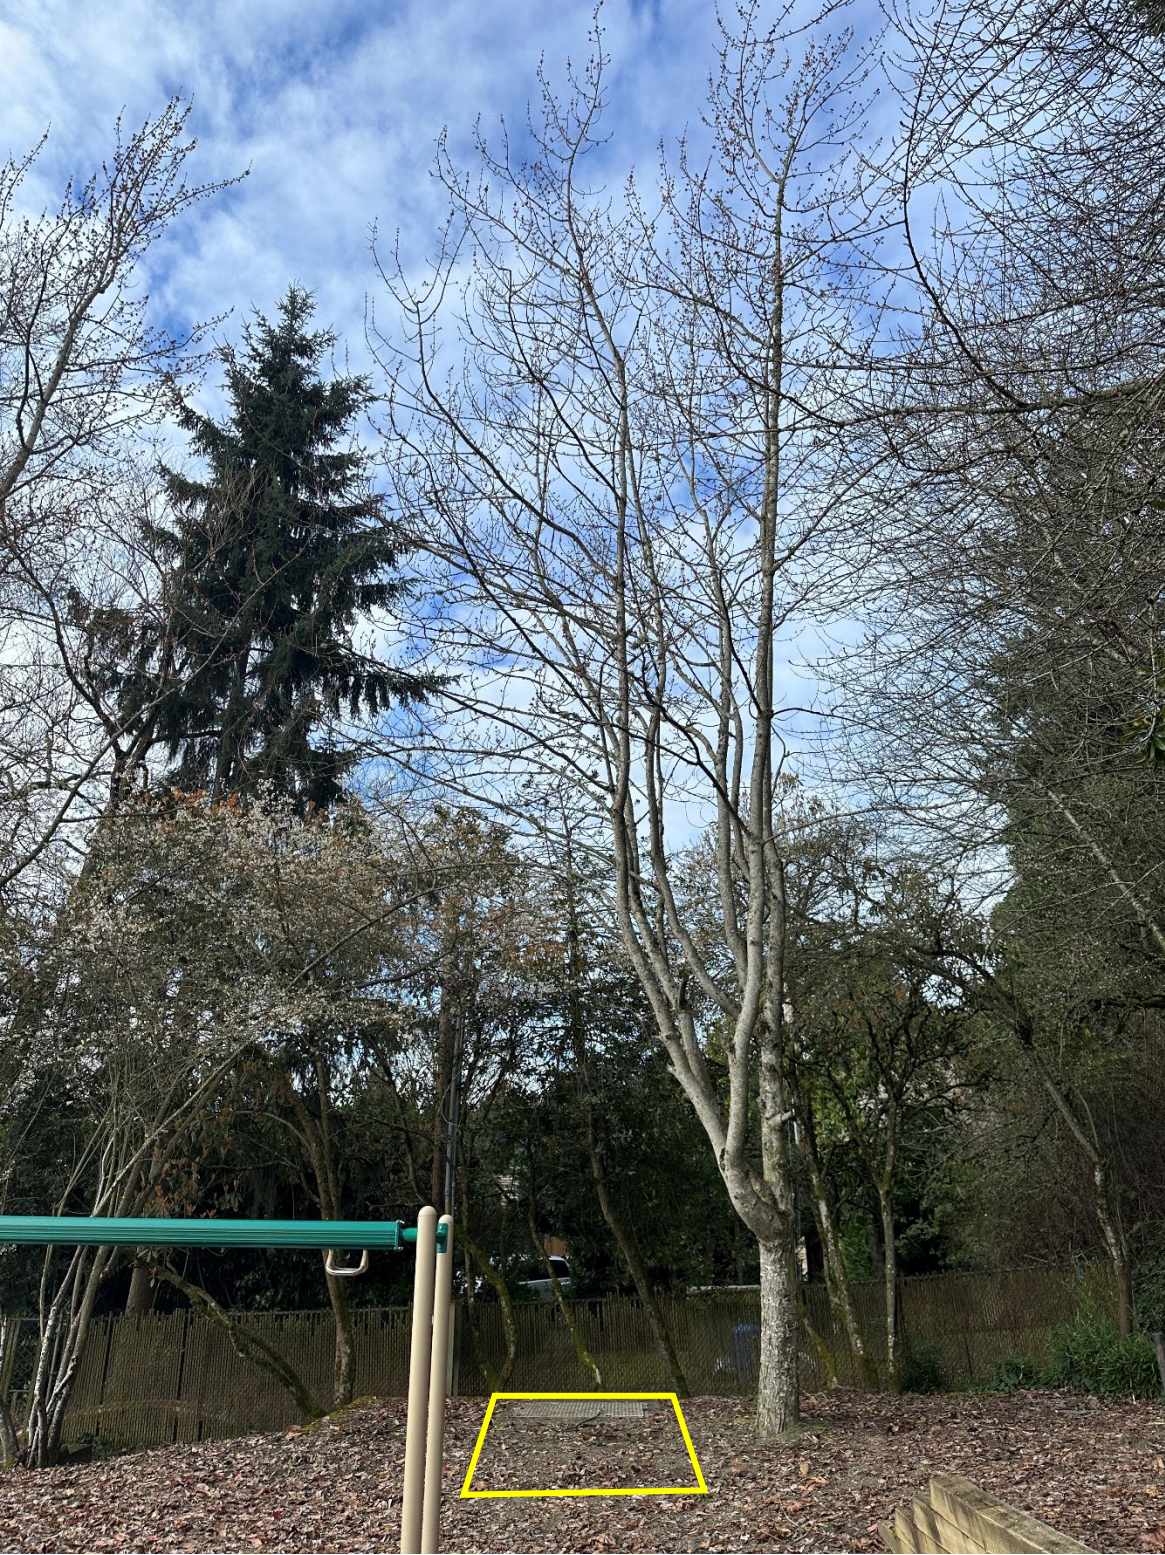
The tree of concern was a red maple (*Acer rubrum*) with an 11.9-inch trunk diameter and an estimated height of 35 feet. It had three primary codominant trunks starting from 5 feet above grade. The tree had good form, structure, and health (Photo 1). All parts of the tree had an improbable likelihood of failure. I marked the tree with an aluminum tag numbered #171.

The tree was growing 2.5 feet northeast of the edge of the concrete lid (Photo 2). I saw at least one root about 3 inches in diameter over the top of the lid. The southern half of the tree's crown was overhanging the lid (Photo 1).

Photo 1. The red maple next to PS 25 has about half its crown overhanging the concrete lid (yellow outline) that will be lifted by an overhead crown. The viewer is looking northwest.

At least one and likely more structural roots of the red maple were in the shallow soil on top of the lid. These roots would need to be cut about 2 feet from the trunk to lift the lid. This could result in a loss of 30 to 40 percent of the critical root zone. Lifting the lid up with a crane will require pruning one of the primary codominant trunks and a couple larger branches higher in the tree. I estimated that the pruning would remove about 40 to 50 percent of the crown.

I do not expect tree #171 to survive the root and crown pruning required for the improvements. Even if it did survive, the crown would be weighted to the northeast and there would be fewer structural roots supporting the side opposite the asymmetrical crown. There was a parking area northeast of the tree and a children's play area on east of the tree that was within striking range if the tree failed.

Given the lower survival and increased likelihood of failure after construction, I recommend removing the red maple.

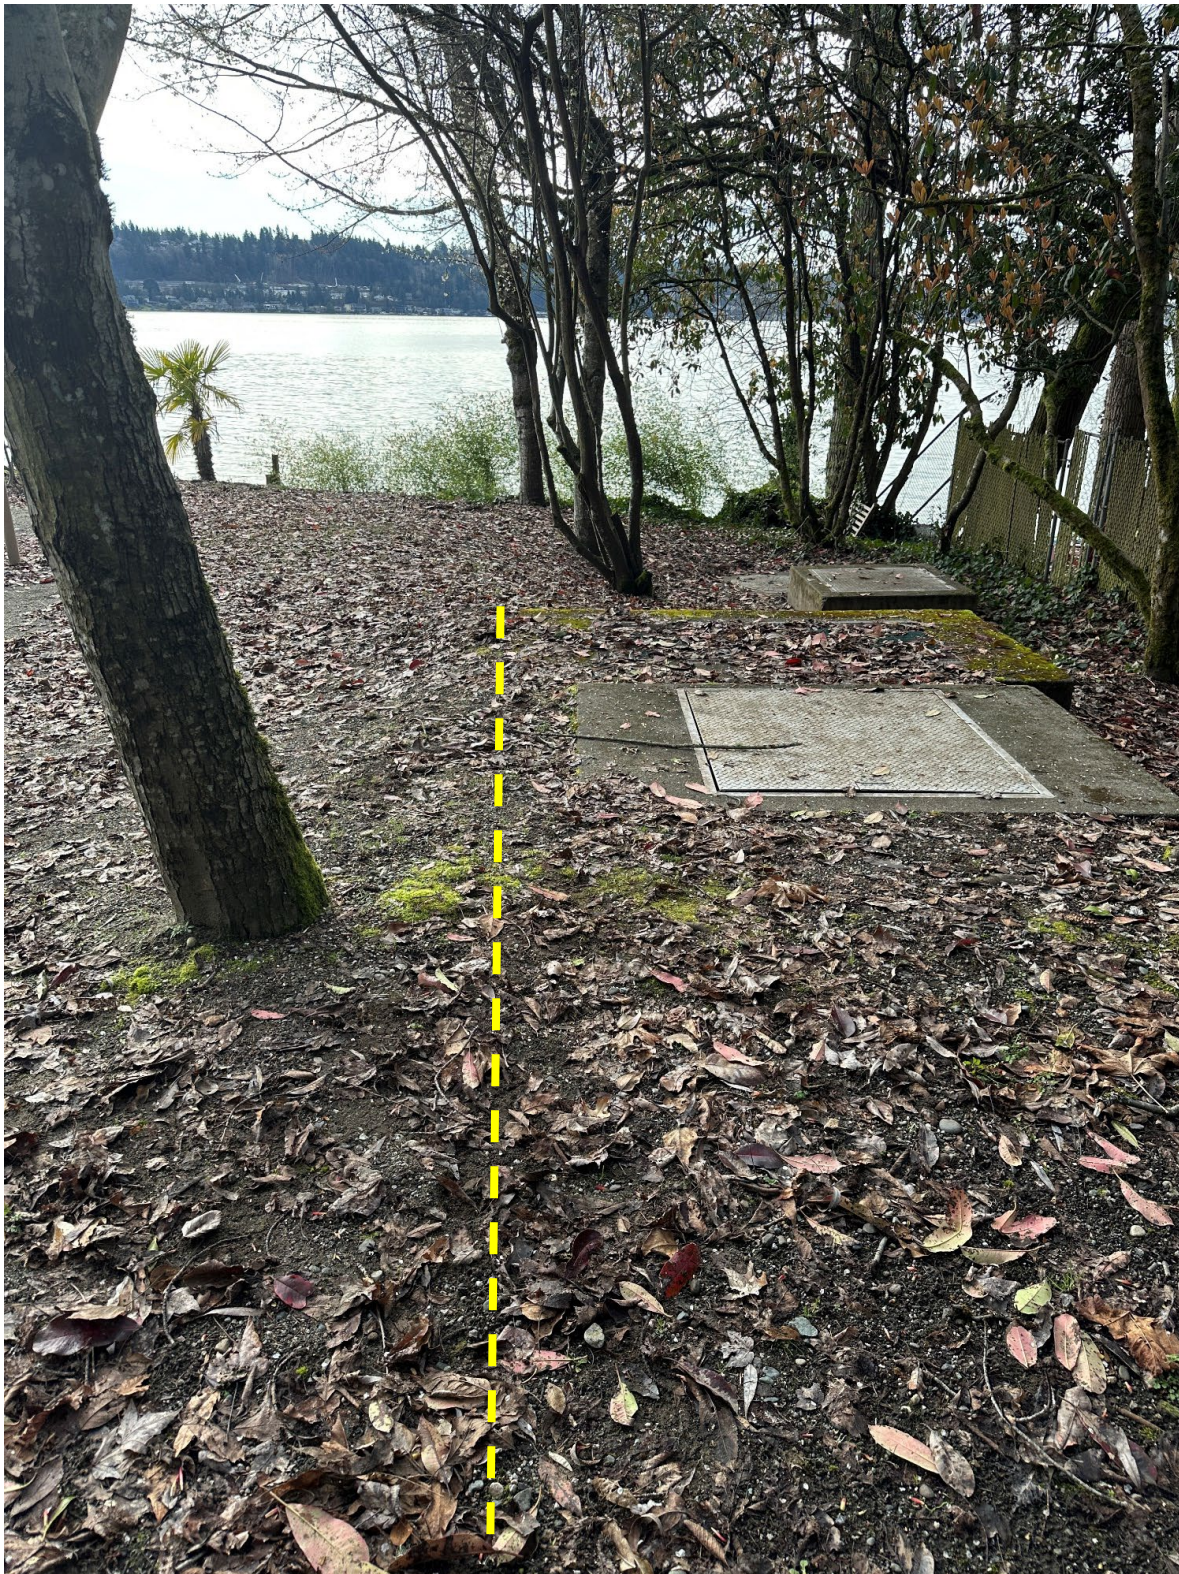
Photo 2. The edge of the concrete lid was less than 3 feet from the trunk of the red maple. The yellow dashed line is the approximate edge of the lid. A shallow layer of soil covered the lid. The viewer is looking southeast.
