Arborist Report

November 17th, 2023

Rosen Trellis Project
David Taber

3009 60th Ave SE
Mercer Island, Wa

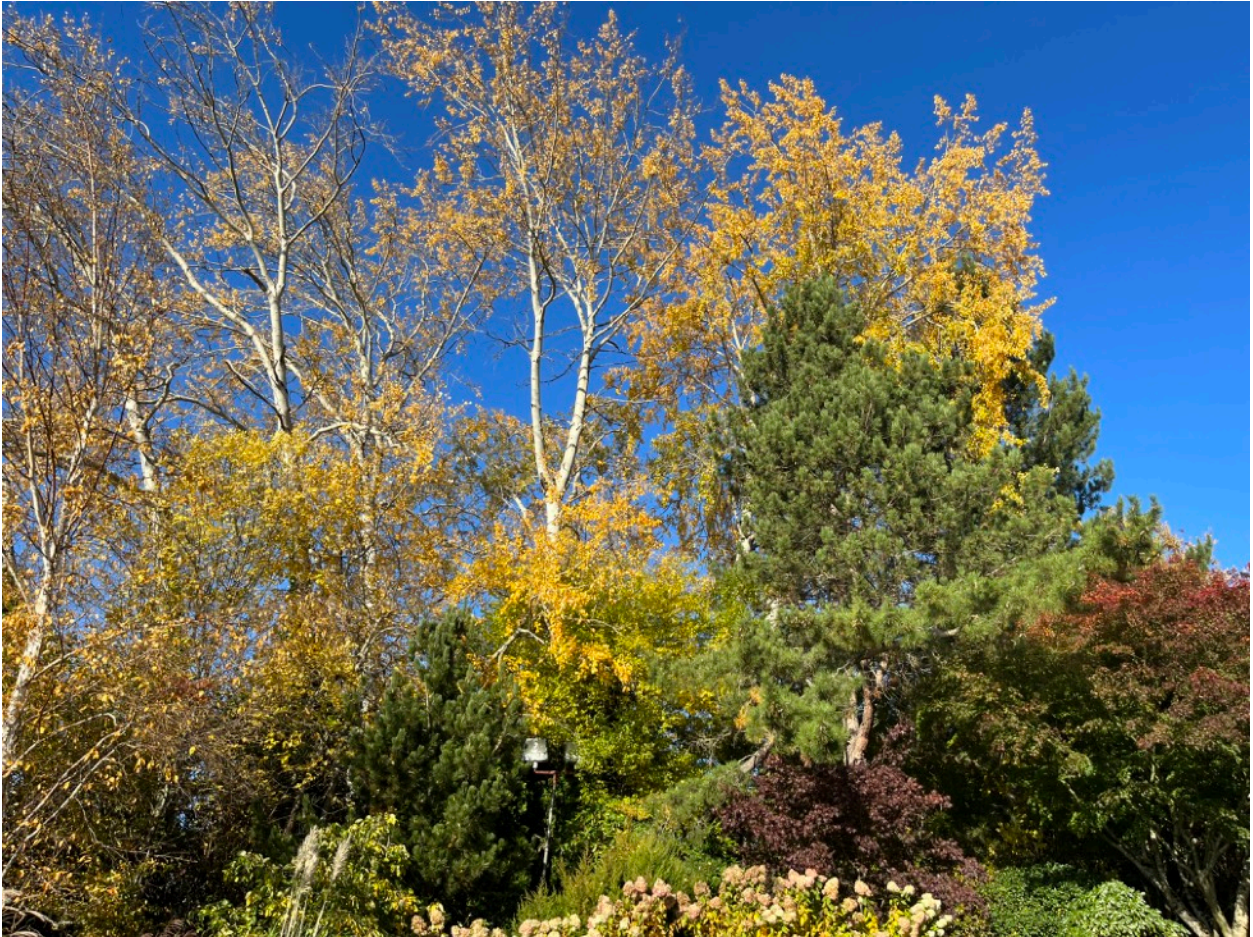
There is an impressive row of Quaking Aspen on the north neighbor's lot and while those trees are growing close to the property line with drip lines that extend over my client's site, none of the Aspen that are visible in the photographs are at my client's address.

The Pines and the neighbor's Aspens

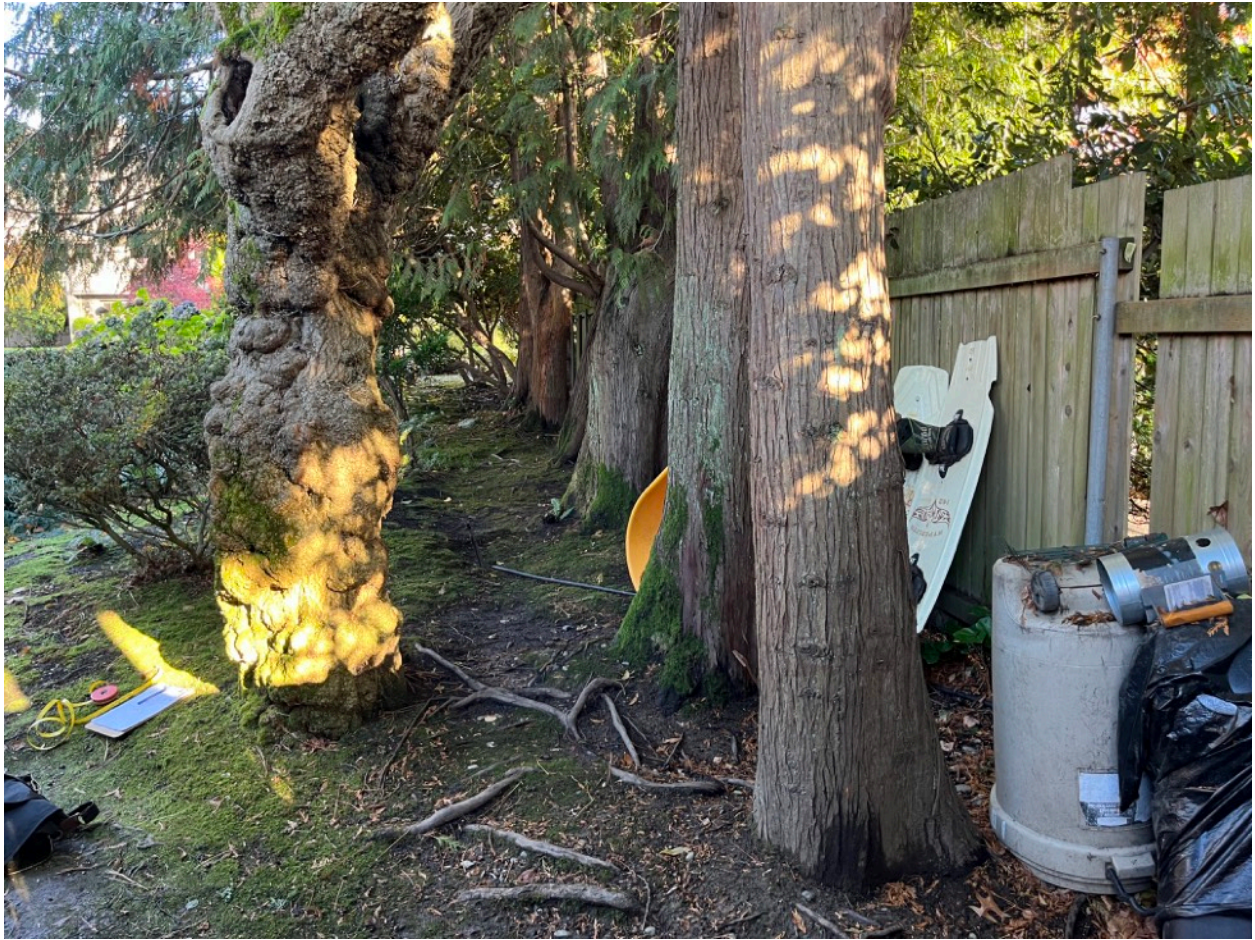
Just to the south of the walkway that accesses the backyard is what appears to be a Box Elder tree, although it was completely defoliated it at the time of the site visit and the ground beneath the tree was fairly well cleaned up. This tree has a very cool pedestal region and I do suggest having tree protection fencing installed to protect the trunks of these trees from unintentional mechanical damage as materials are being shuttled in and out of the backyard.

Some of the cedar trunks and the trunk of the Box Elder

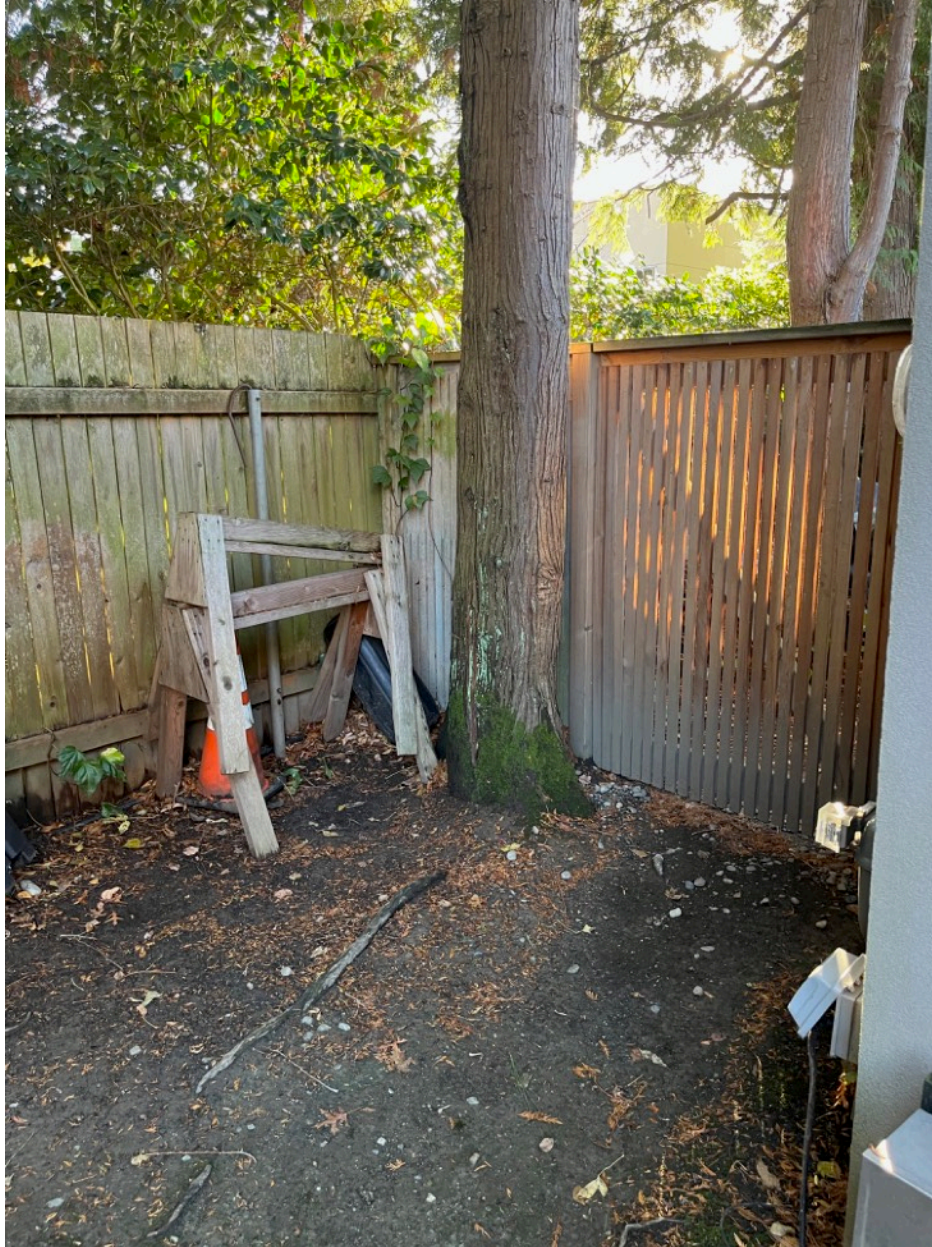
This is the access around the north side and some of the cedar trunks near it.

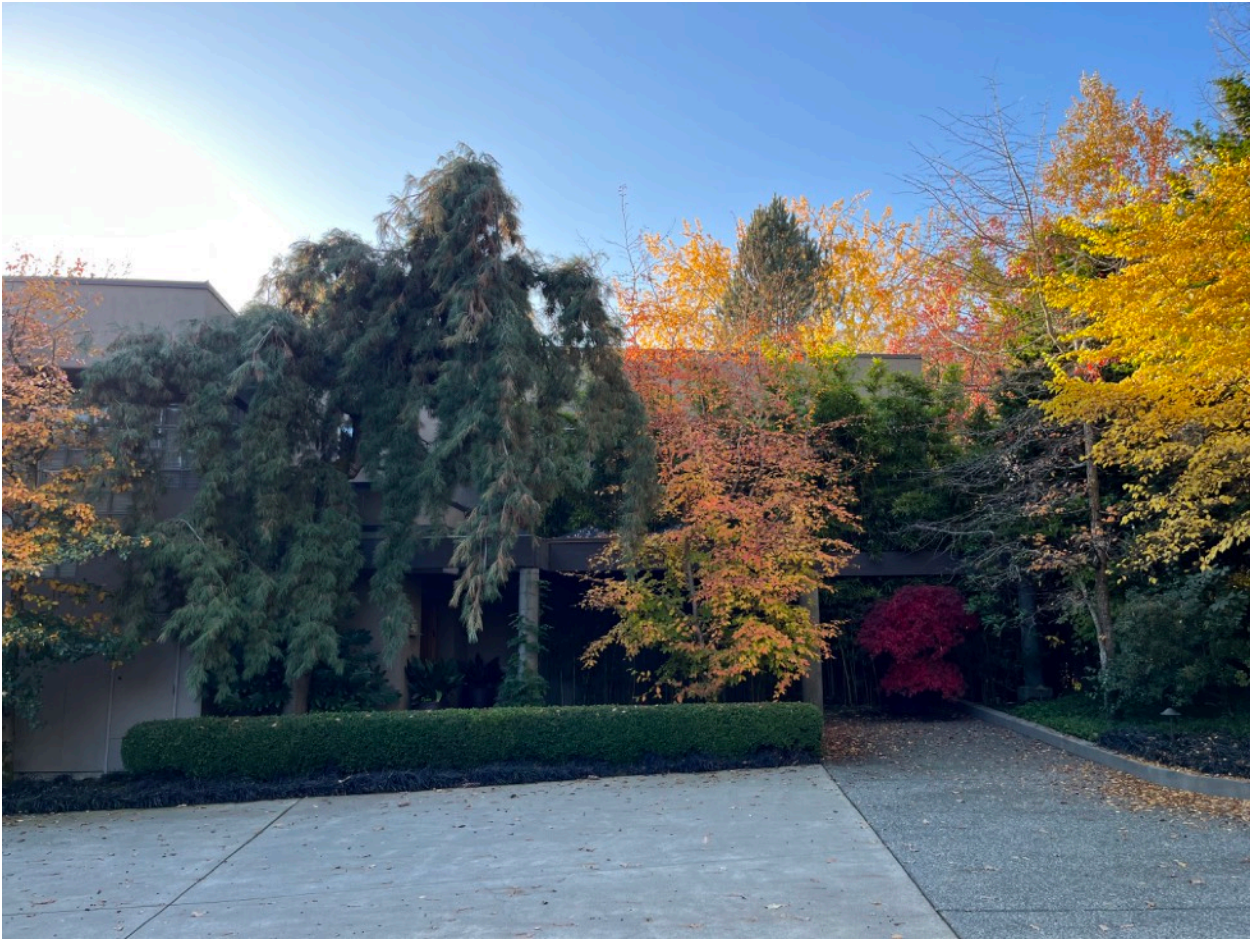
Main entrance. These trees are not near the project.
