June 1, 2020

Project: Tree review and assessment at 3633 90th Avenue SE, Mercer Island, WA.
Parcel number 5021900400.

Objectives: Addendum to MacCoy report dated 2/21/2020 correcting tree species, conditions, and sizes as necessary.

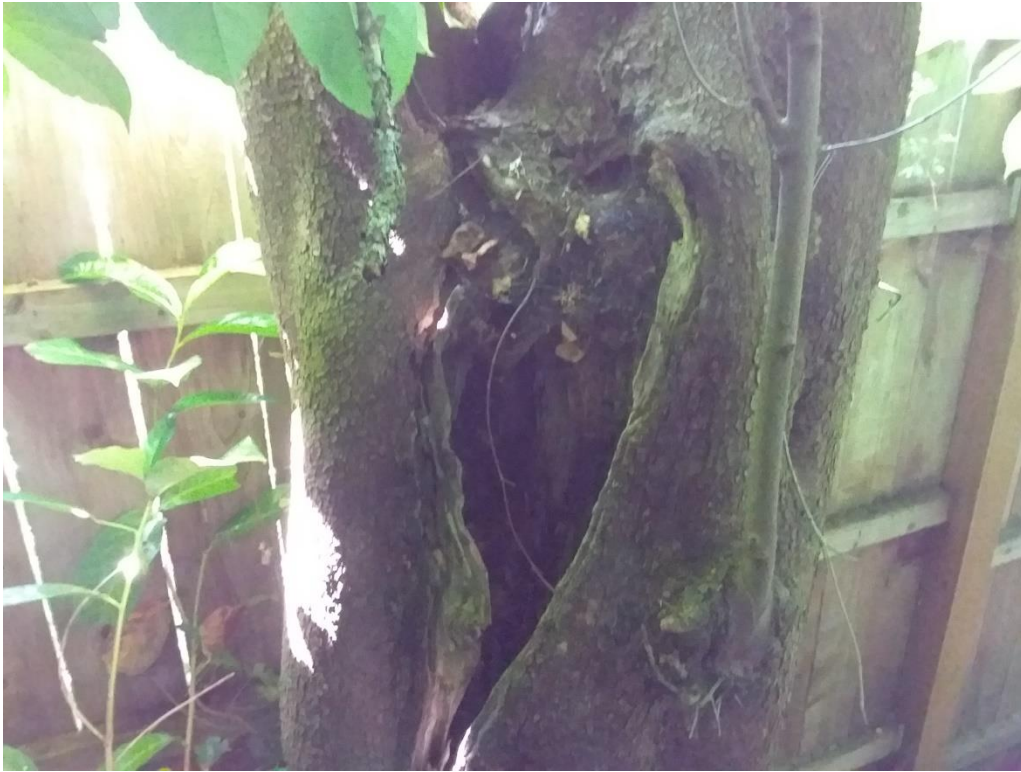
- 1) Given as offsite in the previous report. Not known what tree this was supposed to be.
- 2) Pacific Dogwood (*Cornus nuttalli*) standing against the west fence in the NW corner of the yard. The tree is decayed/hollow from its base to near the 5’ mark as shown in Figures 3 and 4. The tree measured 22” DSH, reached close to 40’ tall, and had a 16’ radial spread with the majority of the canopy extending to the west.

Figure 3. Photo of the top of the decay column of the dogwood.

Recommendations: Based solely on their conditions and suitability for retention the author would advise that the #2, #4, and #7 trees be removed.

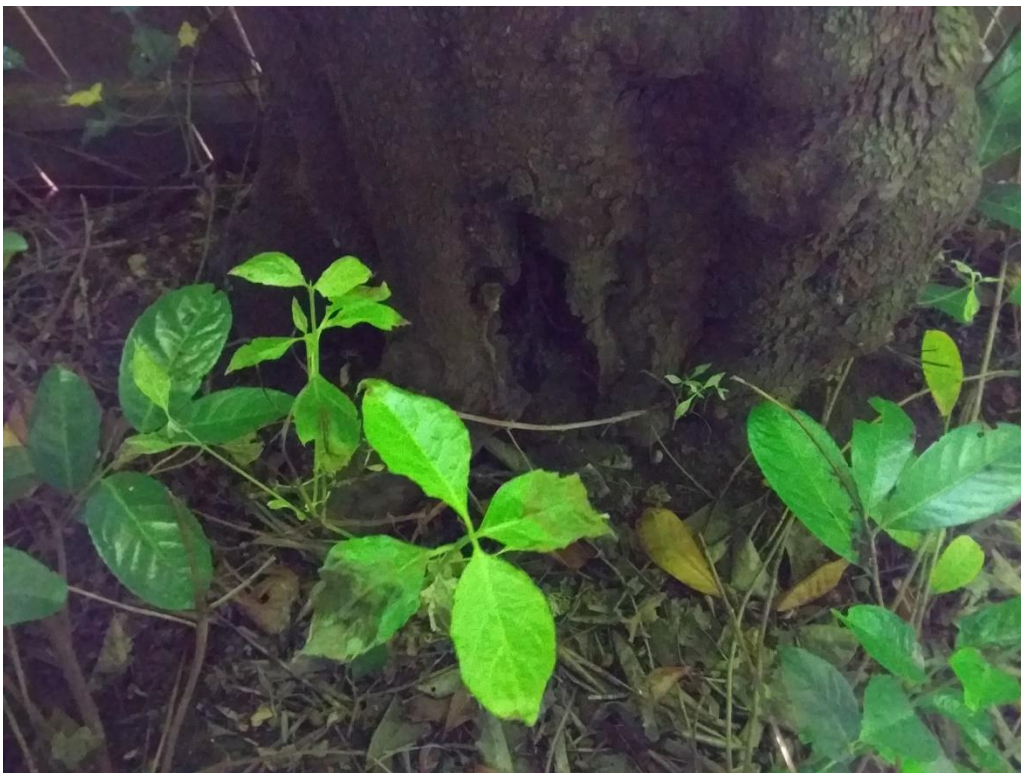
Figure 4. Photo of the base of the dogwood showing the open decay.

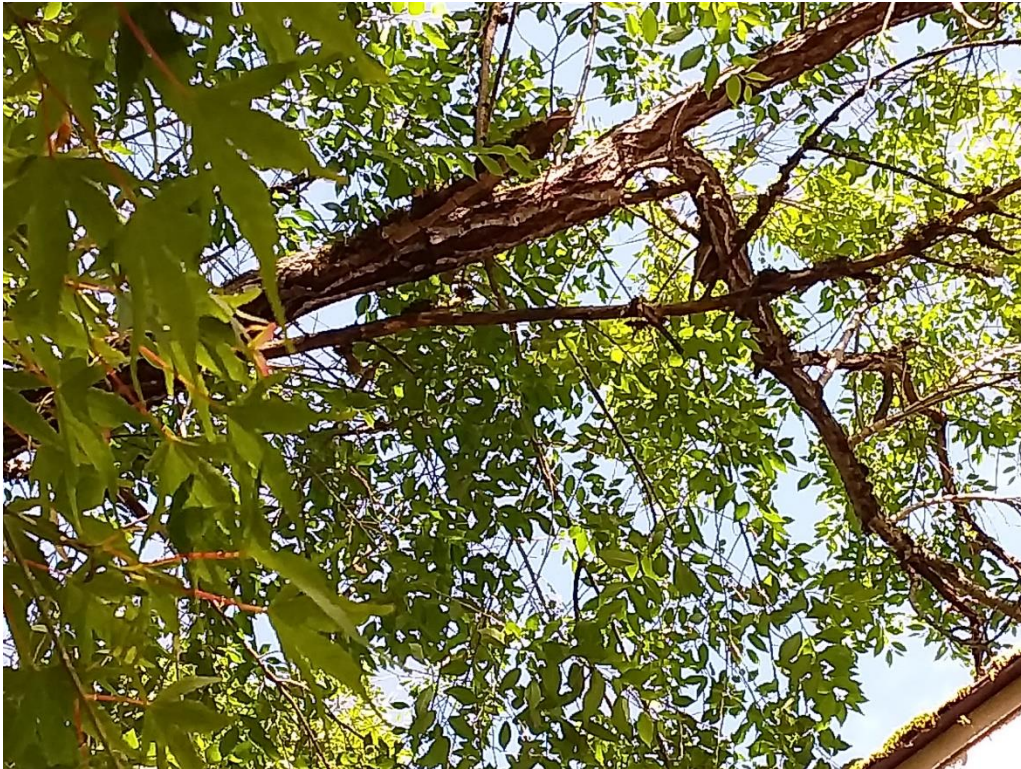
- 3) Weeping Cherry (*Prunus sp*) 8” DSH, 7’ tall, 4’ radial spread. Fair condition.
- 4) Siberian Elm (*Ulmus pumila*) 27” DSH, 45’ tall in highest reaches but has been breaking down in the 30’ range and then resprouting. It spreads unevenly 18-24’ radially and has breakage along the limbs of most of its scaffolds (Figure 5 and 6). It is heavy coated in ivy from the base to at least the mid canopy. This elm is in weak condition with limited new growth, elongation, and poor color.

Figure 5. Photo of breakage in the crown of the elm.

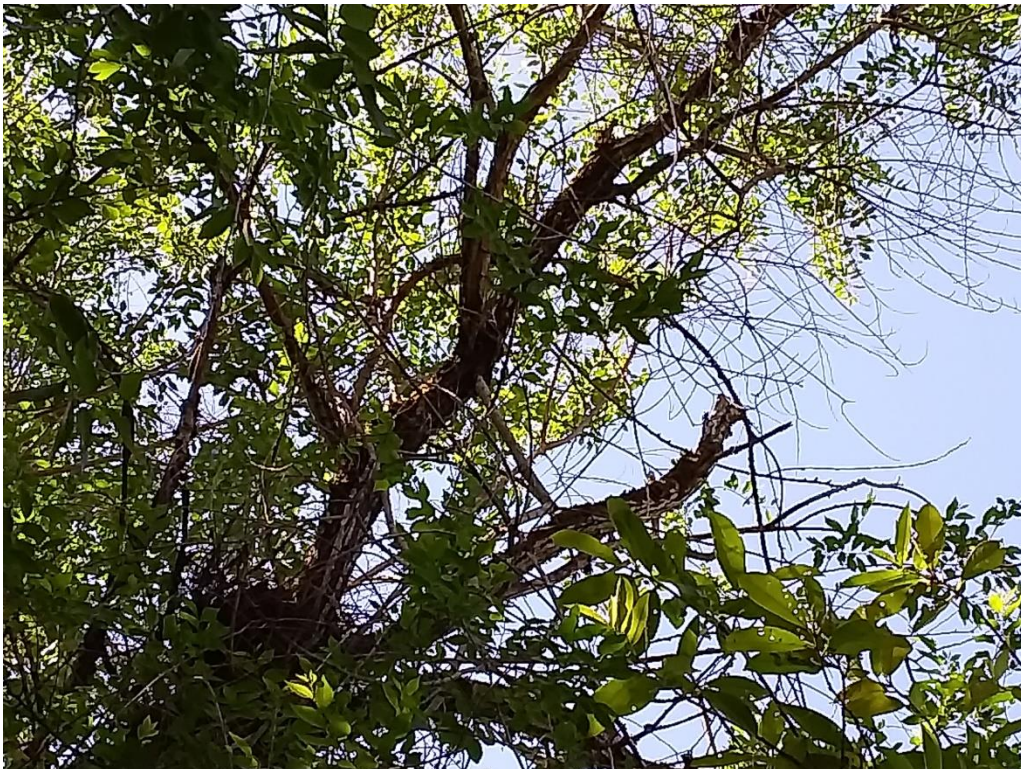
Figure 6. Another breakage area in the canopy of the elm.

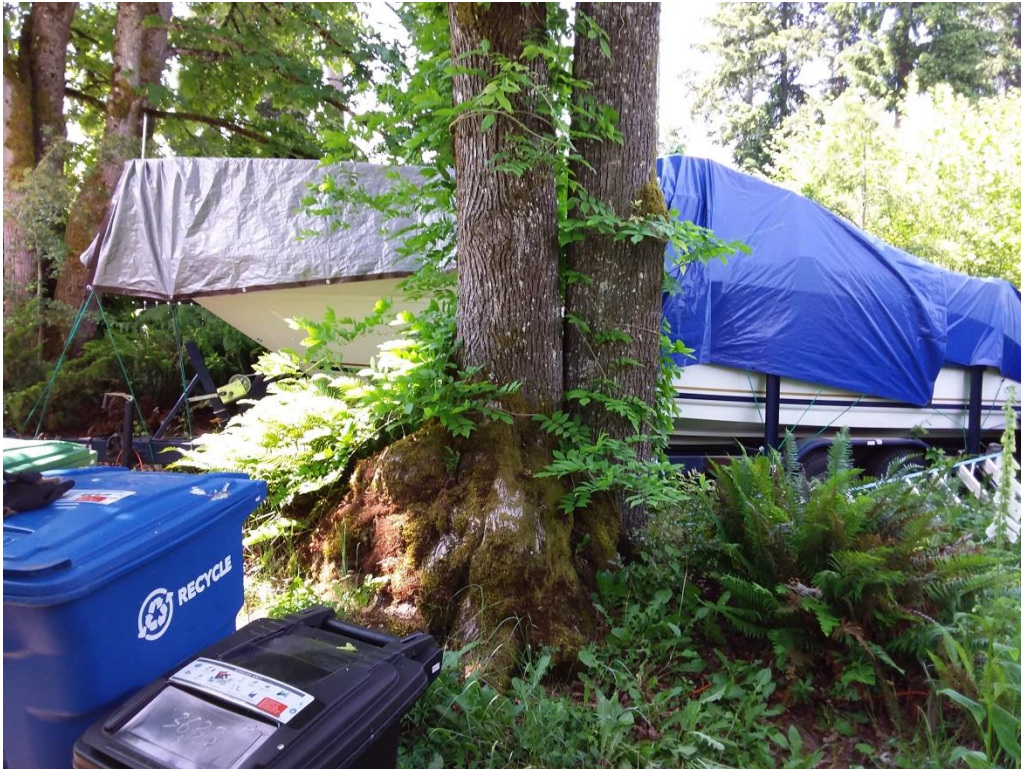
- 7) Big Leaf Maple with three stems coming off a humped up base (Figure 7). Likely formed as stump sprouts. The stems measured 15, 17.5", and 18" DSH, rise to 55', and they each reach out to around 18'. Some sections of the tree are stunted and exhibiting die-back others have decent new growth and color. The center column of the 18" stem has atrophied down to the 16' level and all its scaffolds are coming off compromised attachment points (Figure 8). The 17.5" stem is dead from the 20' level and there is a split between one of its larger scaffolds and the column. The top of the 15" stem broke off and has several leaders growing from that point. South side of the tree's canopy has been pruned for power line clearance. Existing driveway runs along the base of the tree less than 30" to the south and there is a driveway spur used for parking 6' to the west.

The corrected diameters still puts the #7 maple technically over its 30" Exceptional Tree threshold. However this tree is in quite poor structural condition resulting from it being in an advanced state of decline. It is an inadvisable candidate for retention. While its risk could be mitigated by hard pruning of the various dead, weak, and broken sections there would not be a great deal of the tree left. The maple will continue to decline and have adverse growth response.

Figure 7. Photo of base of the #7 maple.

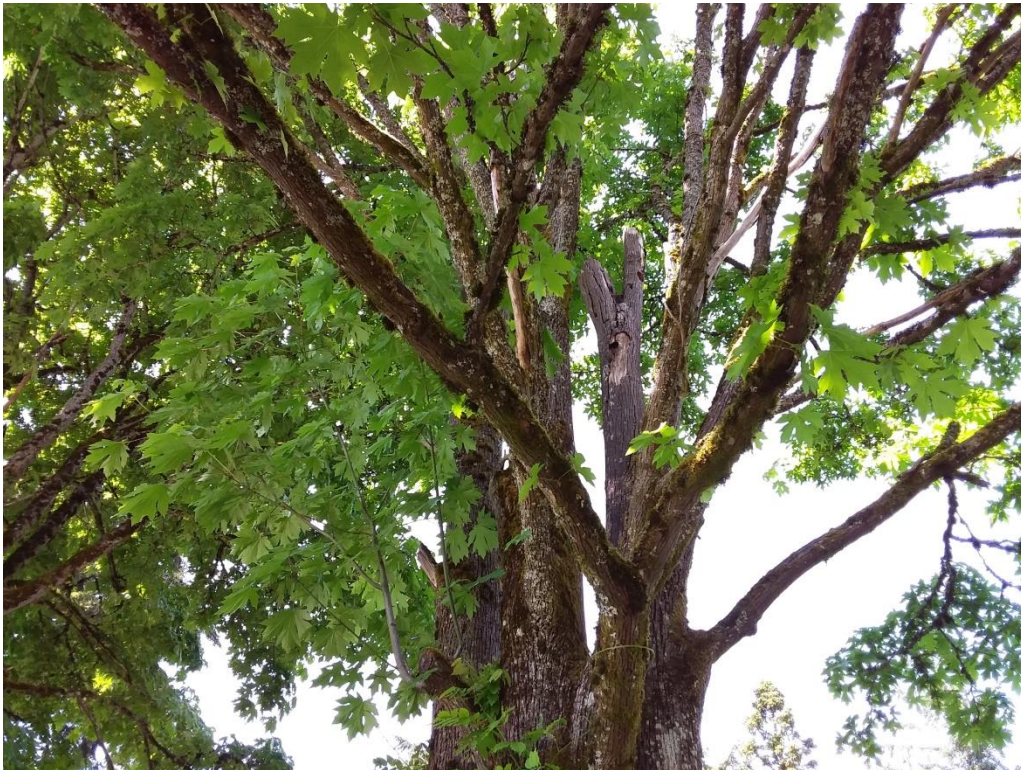
Figure 8. Photo of atrophied center column on the large stem in the #7 maple. Note the large caliper deadwood also present.
