# Greenforest Incorporated

REFERENCE: Arborist Report

SITE ADDRESS: 2825 West Mercer Way, Mercer Island WA

DATE: February 21, 2019

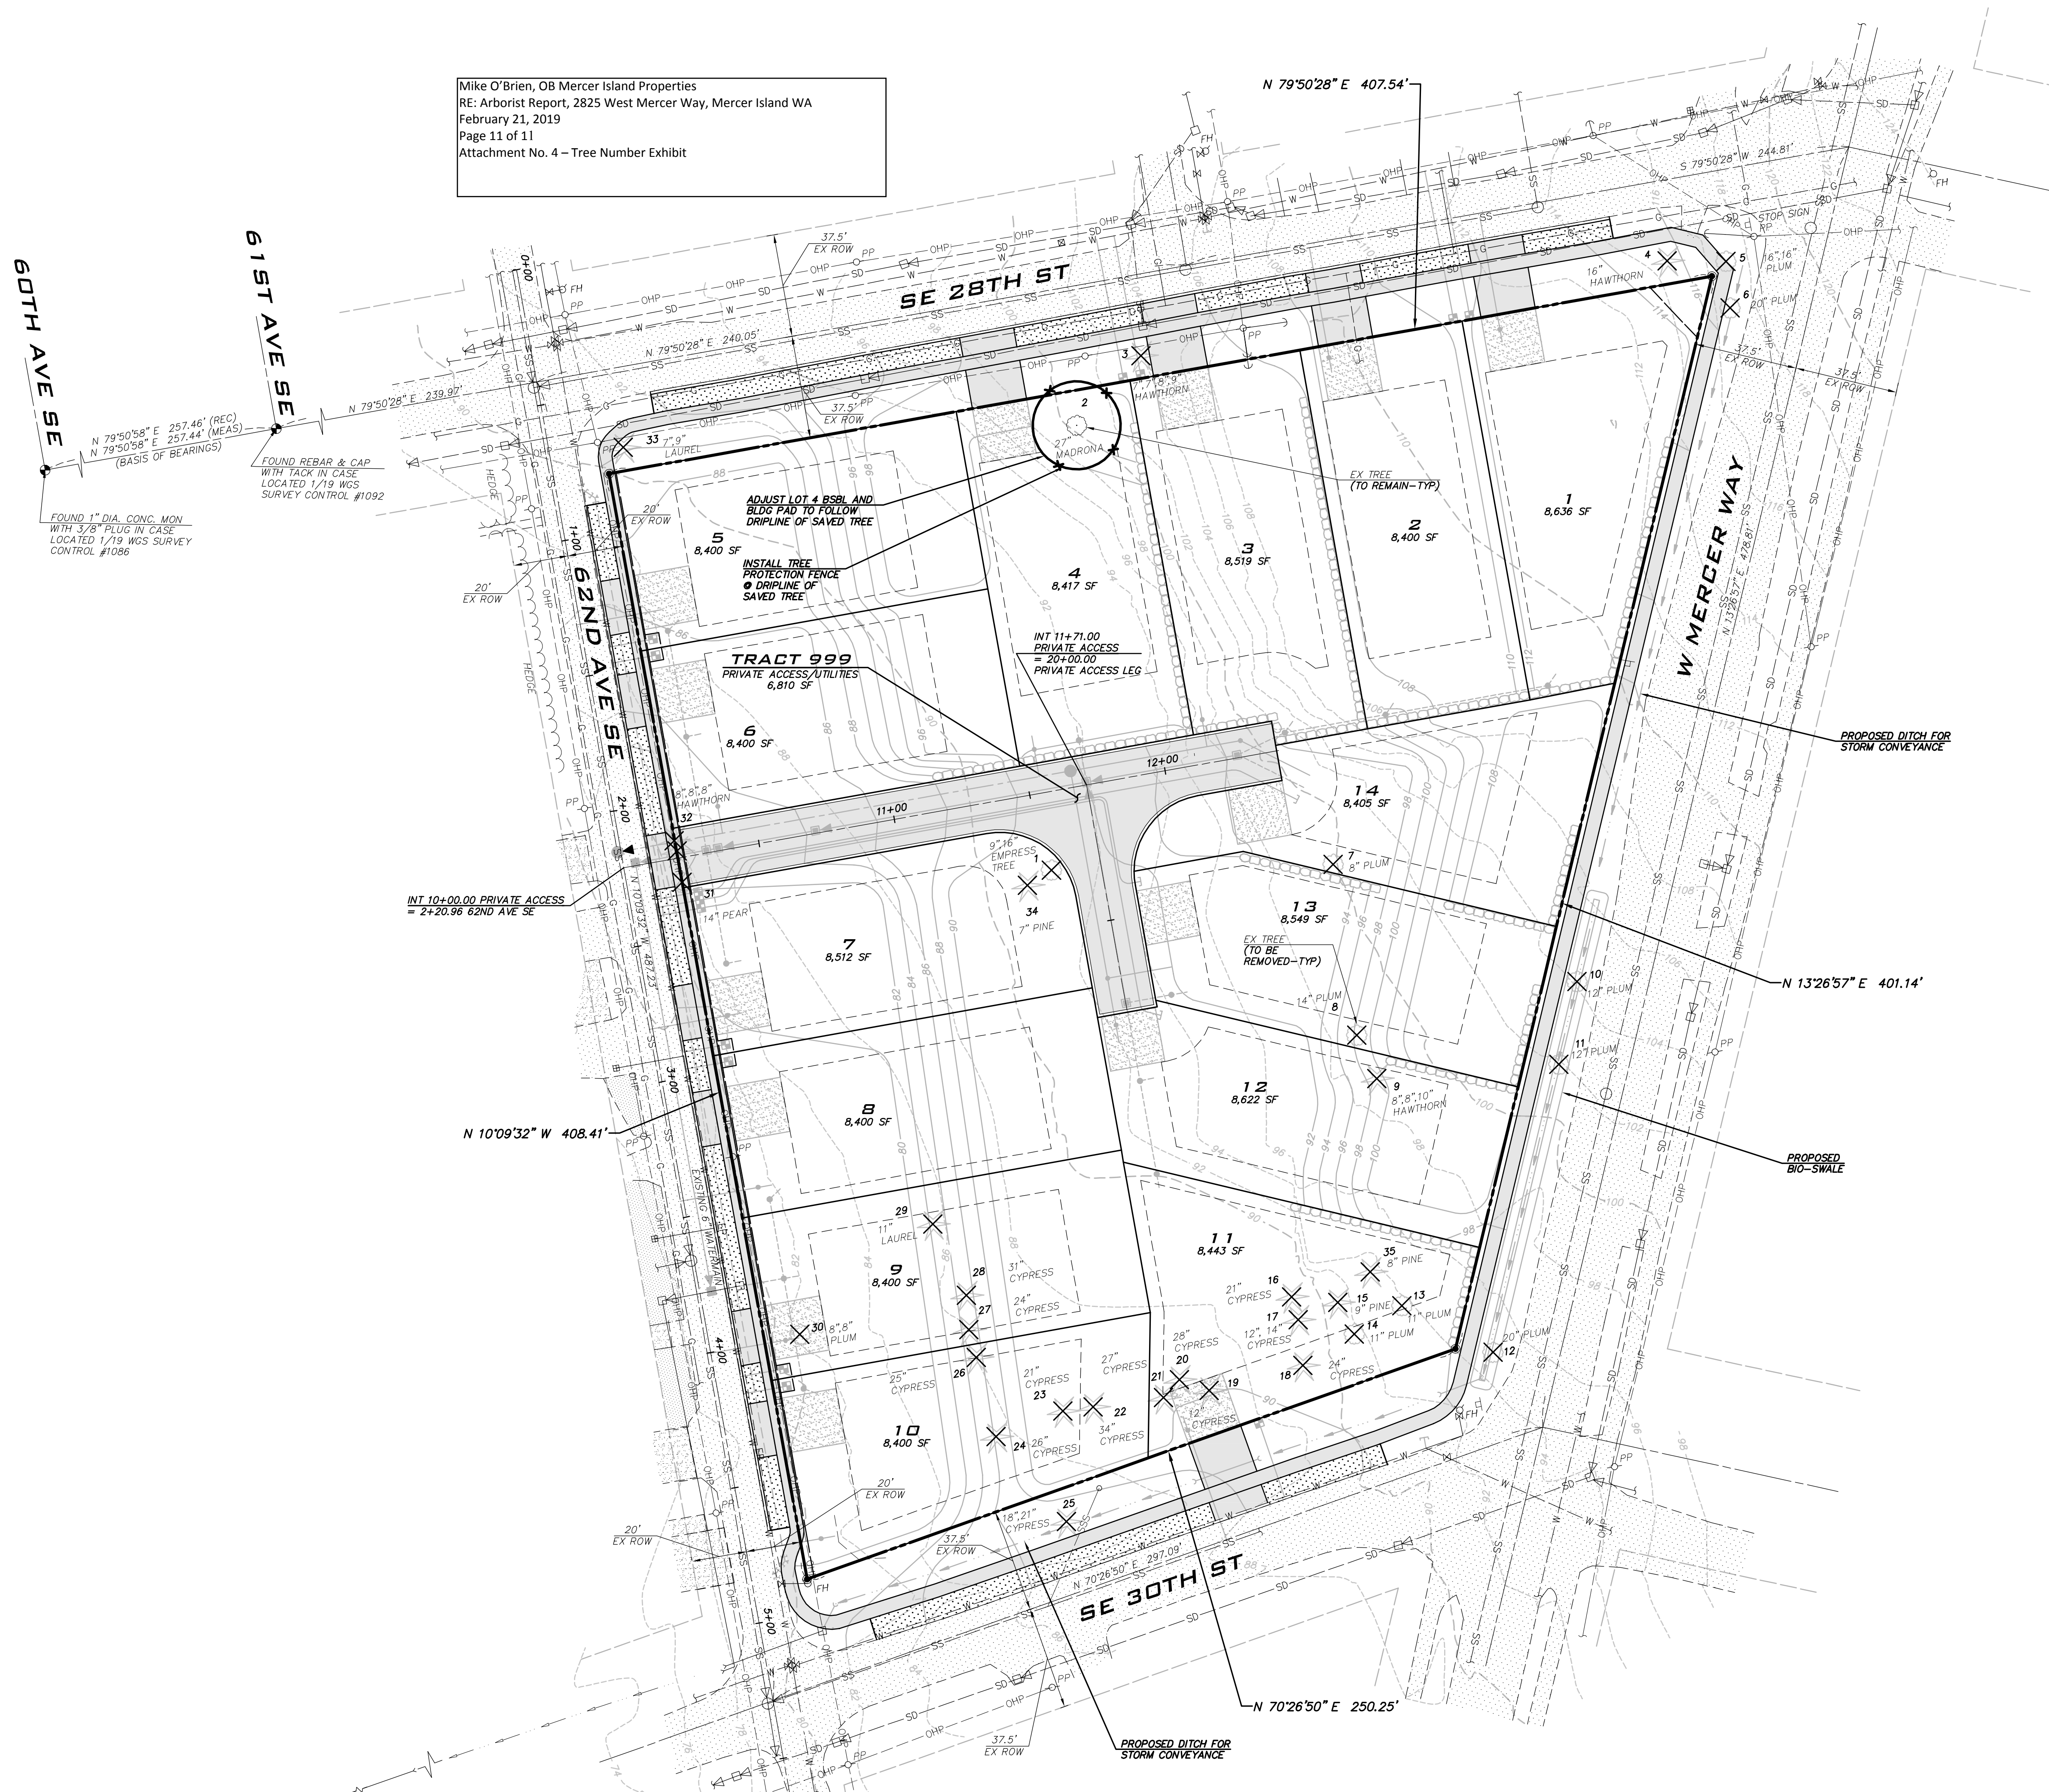
SHEET NAME:  
**TR-01**

Tree #2, an *exceptional* Pacific madrone is proposed for retention. This tree has a 27" DBH trunk, and a 16-foot radius dripline.

The LOD for this madrone tree is a 16-foot radius from the base of the trunk, or the tree's dripline.

Minimum six (6) foot temporary chain-link fence shall be installed at the driplines of tree 2. Fencing shall completely encircle the tree. Install fence posts using pier block only. A City planner must approve any modifications to the fencing material and location.

No stockpiling of materials, vehicular or pedestrian traffic, material storage or use of equipment or machinery shall be allowed within the protective fencing. Fencing shall not be moved or removed unless approved by a City planner. Any work, activity or soil disturbance within the protection fencing, or critical root zone, shall be reviewed, approved and monitored by the project arborist.
