Preliminary Arborist Report

To: Offe Engineers, Constantine Builders
Site: 8817 SE 44th St, Mercer Island, 98040
Re: Tree Inventory for proposed parcel division
Date: Oct. 29, 2020
Project Arborist: Joseph Sutton-Holcomb
ISA Certified Arborist #PN- 8397A
ISA Qualified Tree Risk Assessor
Reviewed By: Josh Petter
ISA Certified Arborist #PN-8406A
ISA Qualified Tree Risk Assessor
Referenced Documents: Site Plan – Offe Engineers (dated 10.20.2020)
Attached: Table of Trees
Tree Site Map
Short Plat Drawings (Offe Engineers, dated 10.28.2020)

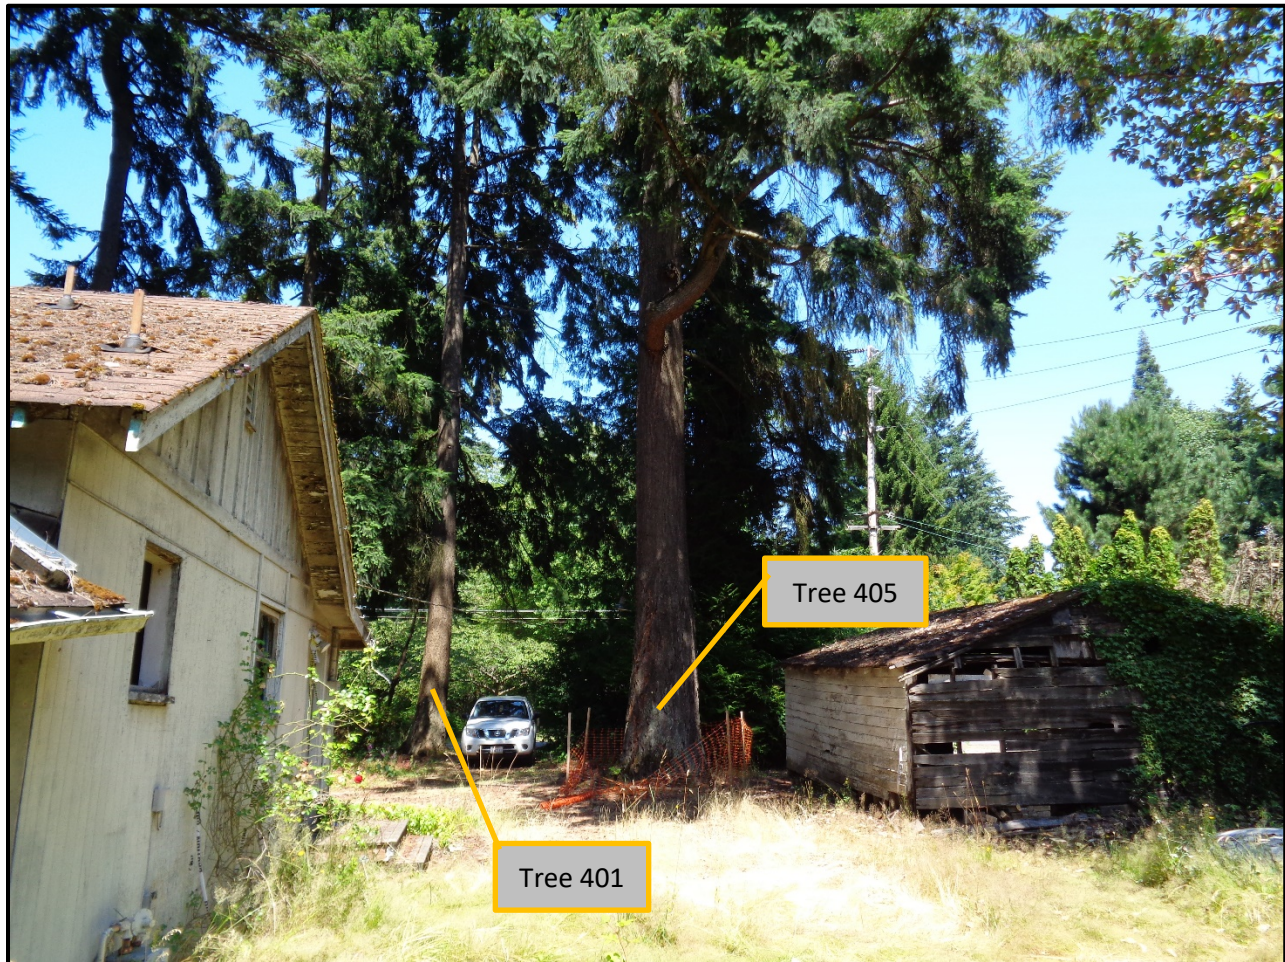
Photograph 1. A view looking north at some of the trees near the driveway. The existing house and shed can also be seen.

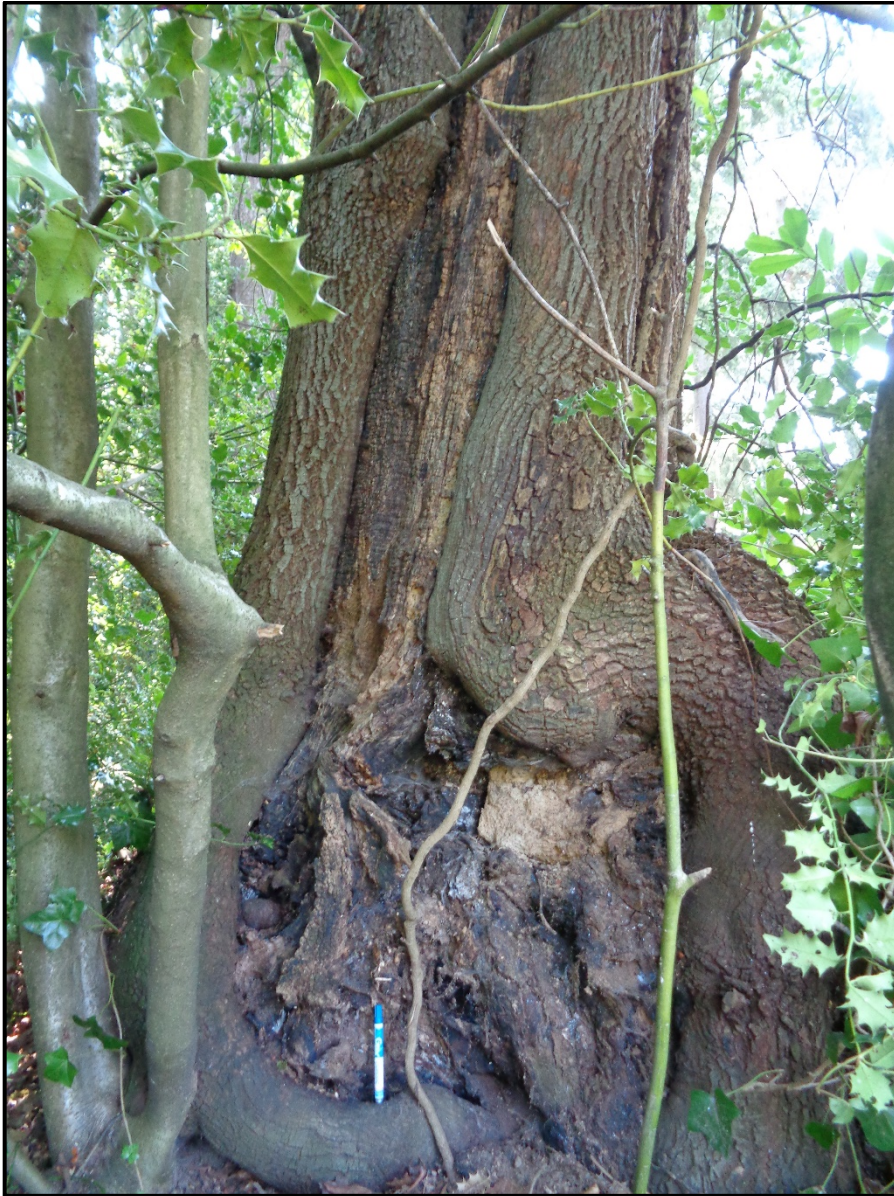
Photograph 2. A large "L" shaped wound with associated decay and significant response growth on tree 430, an Exceptional bigleaf maple. This tree is considered in "fair" structural condition despite this defect due to the good response growth; it is a species characteristic of bigleaf maples to often survive with large wounds for long periods of time.

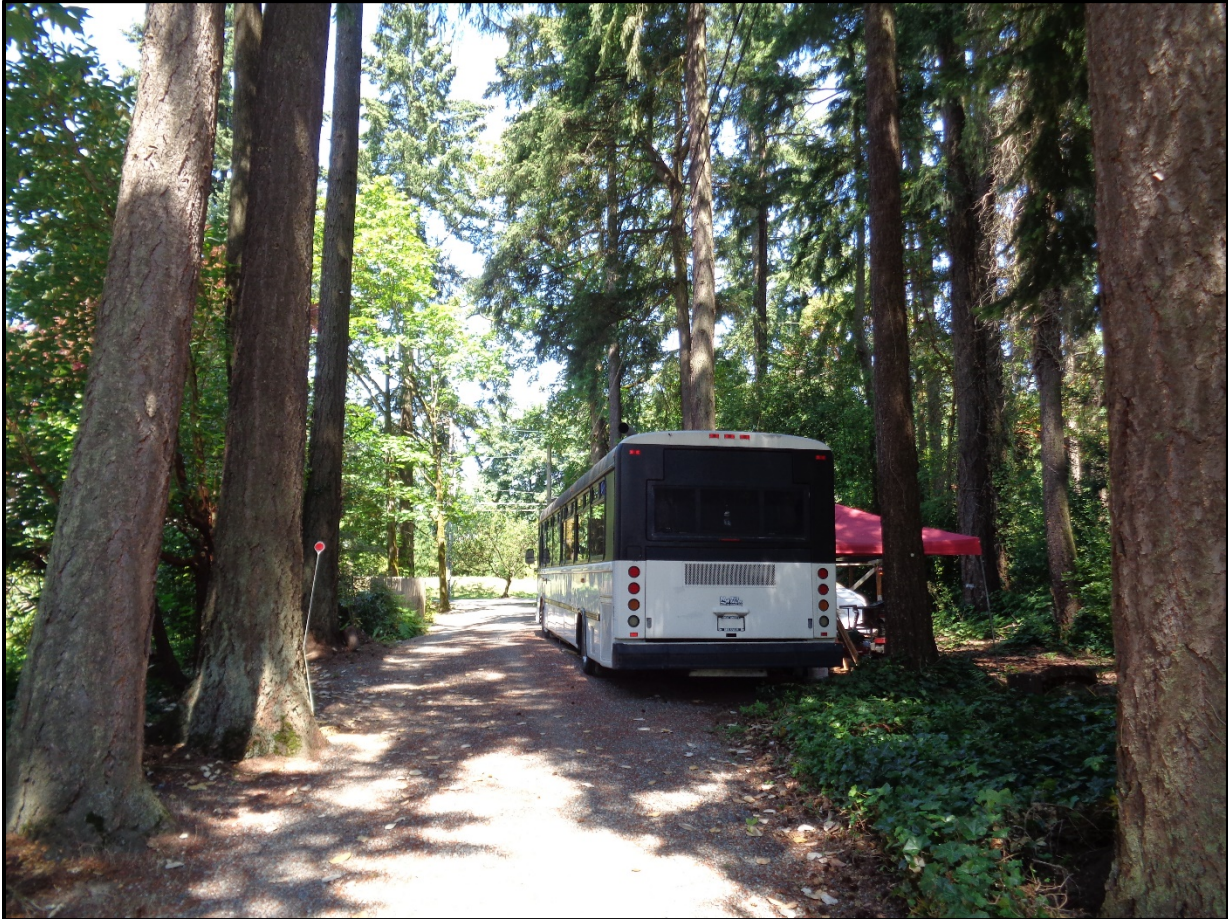
Photograph 3. A view looking north along the driveway at the western edge of the property. To the left, the most densely forested portion of the property, which is likely an exceptional grove. Some of the adjacent site trees assessed are visible on the left side of the driveway.

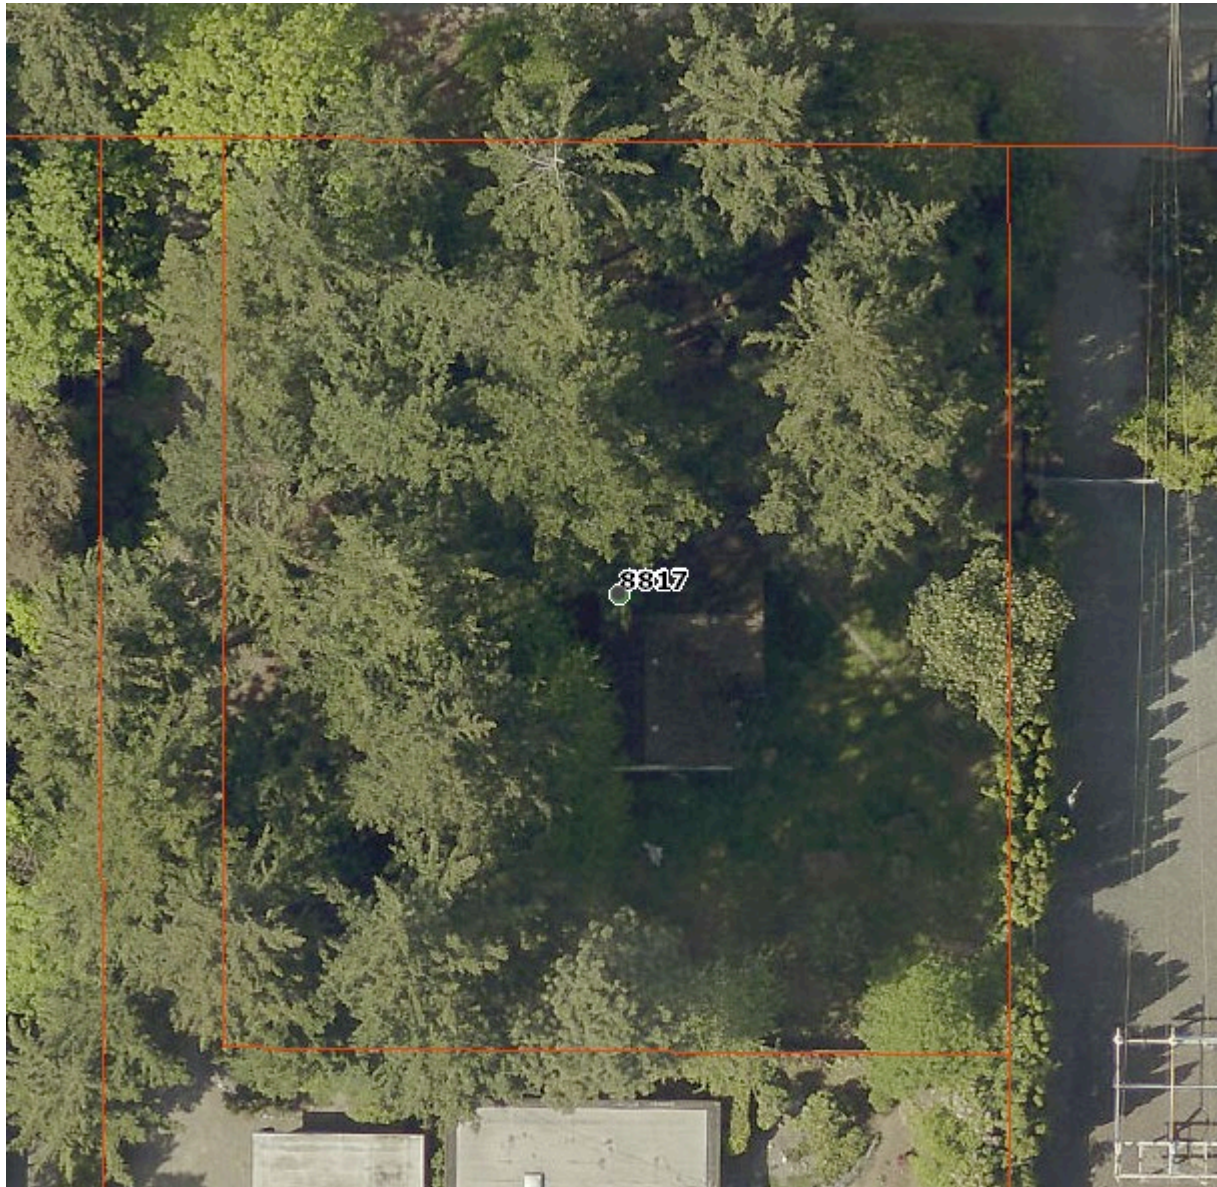
Photograph 4. An aerial view of the property from King County iMap. Contiguous tree canopy covers a large portion of the site, resulting in Exceptional Grove status for many of the trees on the property.

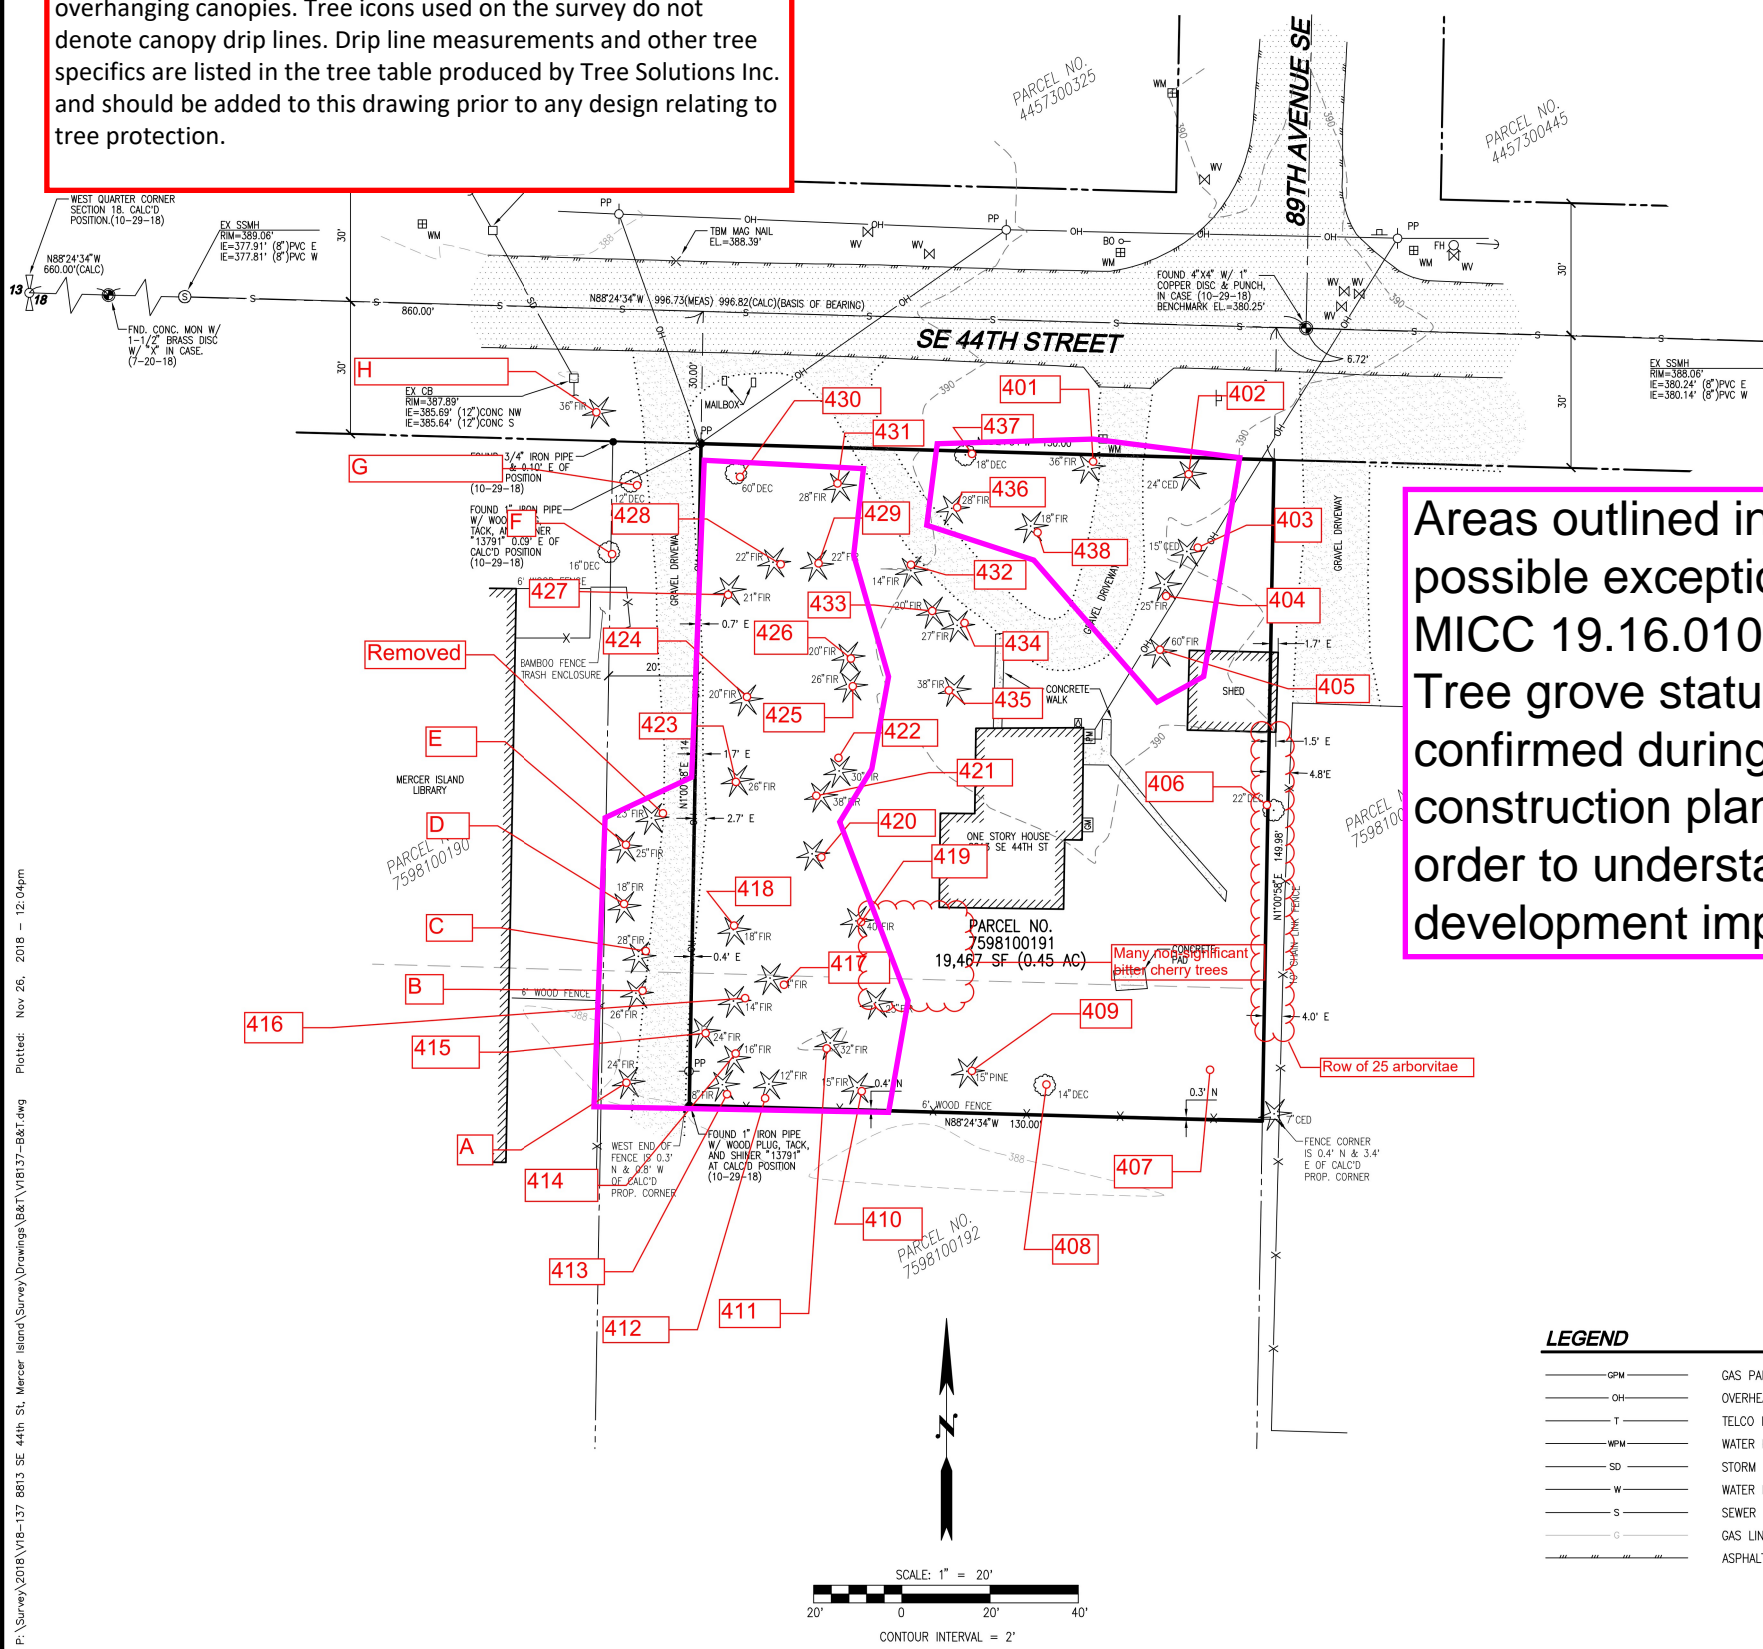
Tree Inventory
July 29, 2020

Areas outlined in purple denote possible exceptional groves Y MICC 19.16.010 "Definitions." Tree grove status should be confirmed during the construction planning process in order to understand permissible development impacts.
