Arborist Report

To: Offe Engineers, Constantine Builders
Site: 8817 SE 44th St, Mercer Island, 98040
Re: Tree Inventory for proposed parcel division
Date: Feb. 18, 2021
Project Arborist: Joseph Sutton-Holcomb
ISA Certified Arborist #PN- 8397A
ISA Qualified Tree Risk Assessor
Referenced Documents: "Tree Plan," "Demolition/Common Utility Plan"
Offe Engineers (dated 02.18.2021)
Attached: Table of Trees
Tree Site Map
Exception Request Letter (per MICC 19.10.060.A.3)
Tree Retention Worksheet

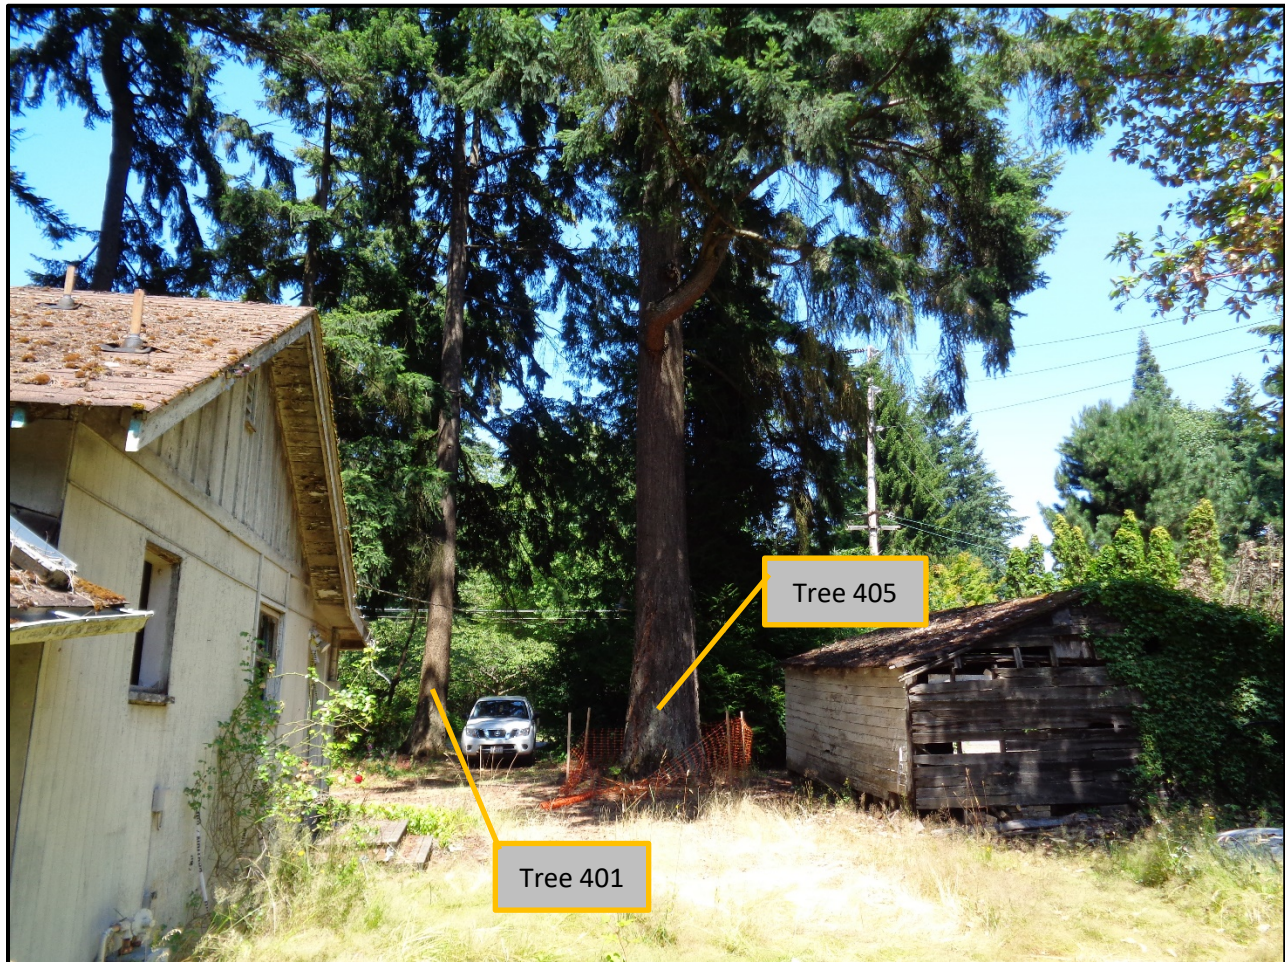
Photograph 1. A view looking north at some of the trees near the driveway. The existing house and shed can also be seen.

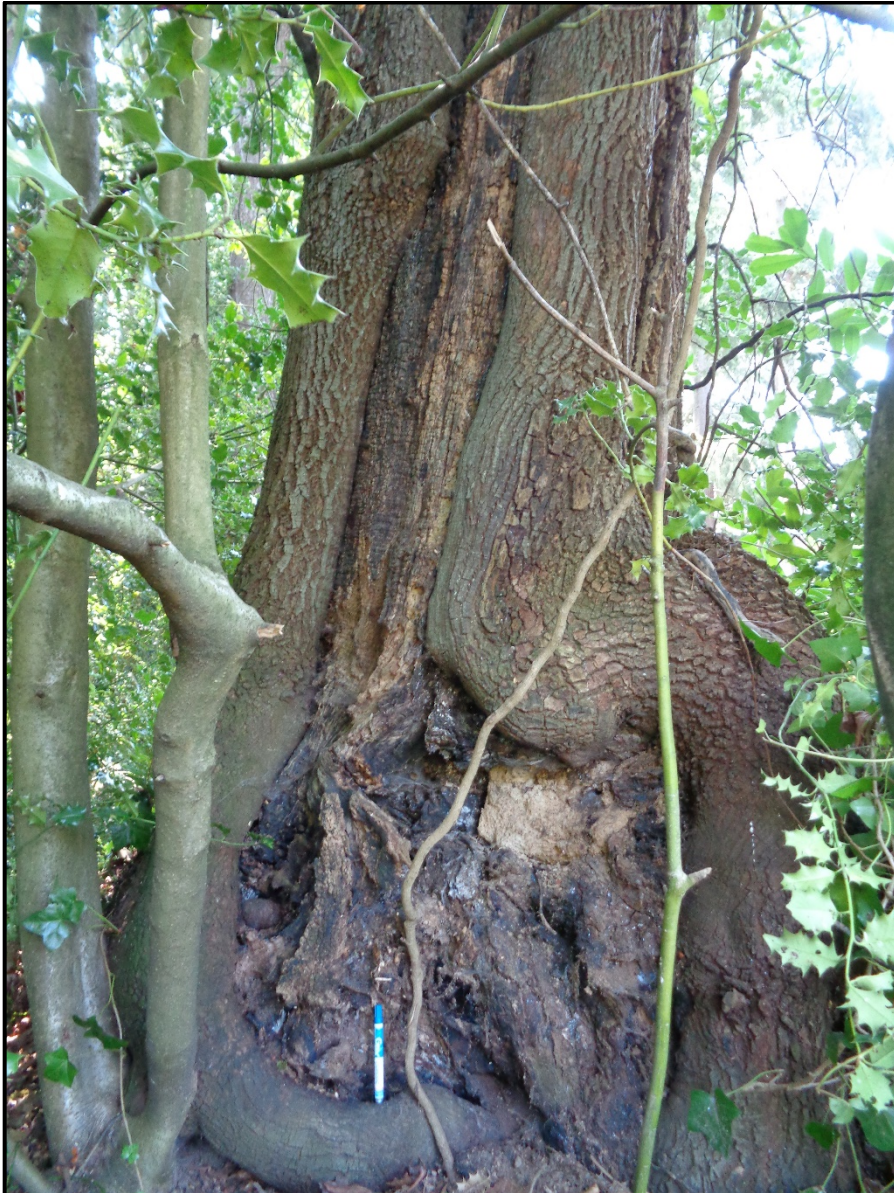
Photograph 2. A large "L" shaped wound with associated decay and significant response growth on tree 430, an Exceptional bigleaf maple. This tree is considered in "fair" structural condition despite this defect due to the good response growth; it is a species characteristic of bigleaf maples to often survive with large wounds for long periods of time.

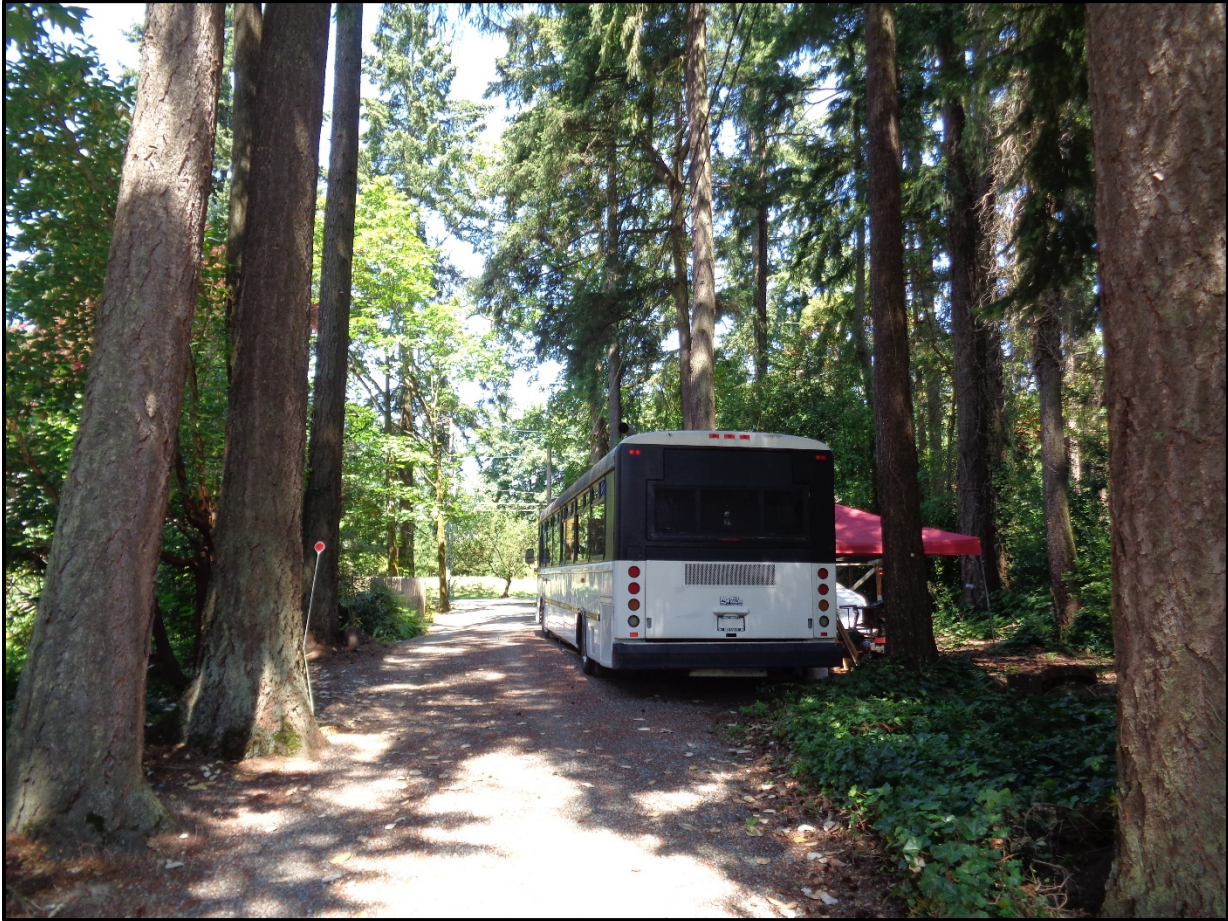
Photograph 3. A view looking north along the driveway at the western edge of the property. To the left, the most densely forested portion of the property, which is likely an exceptional grove. Some of the adjacent site trees assessed are visible on the left side of the driveway.

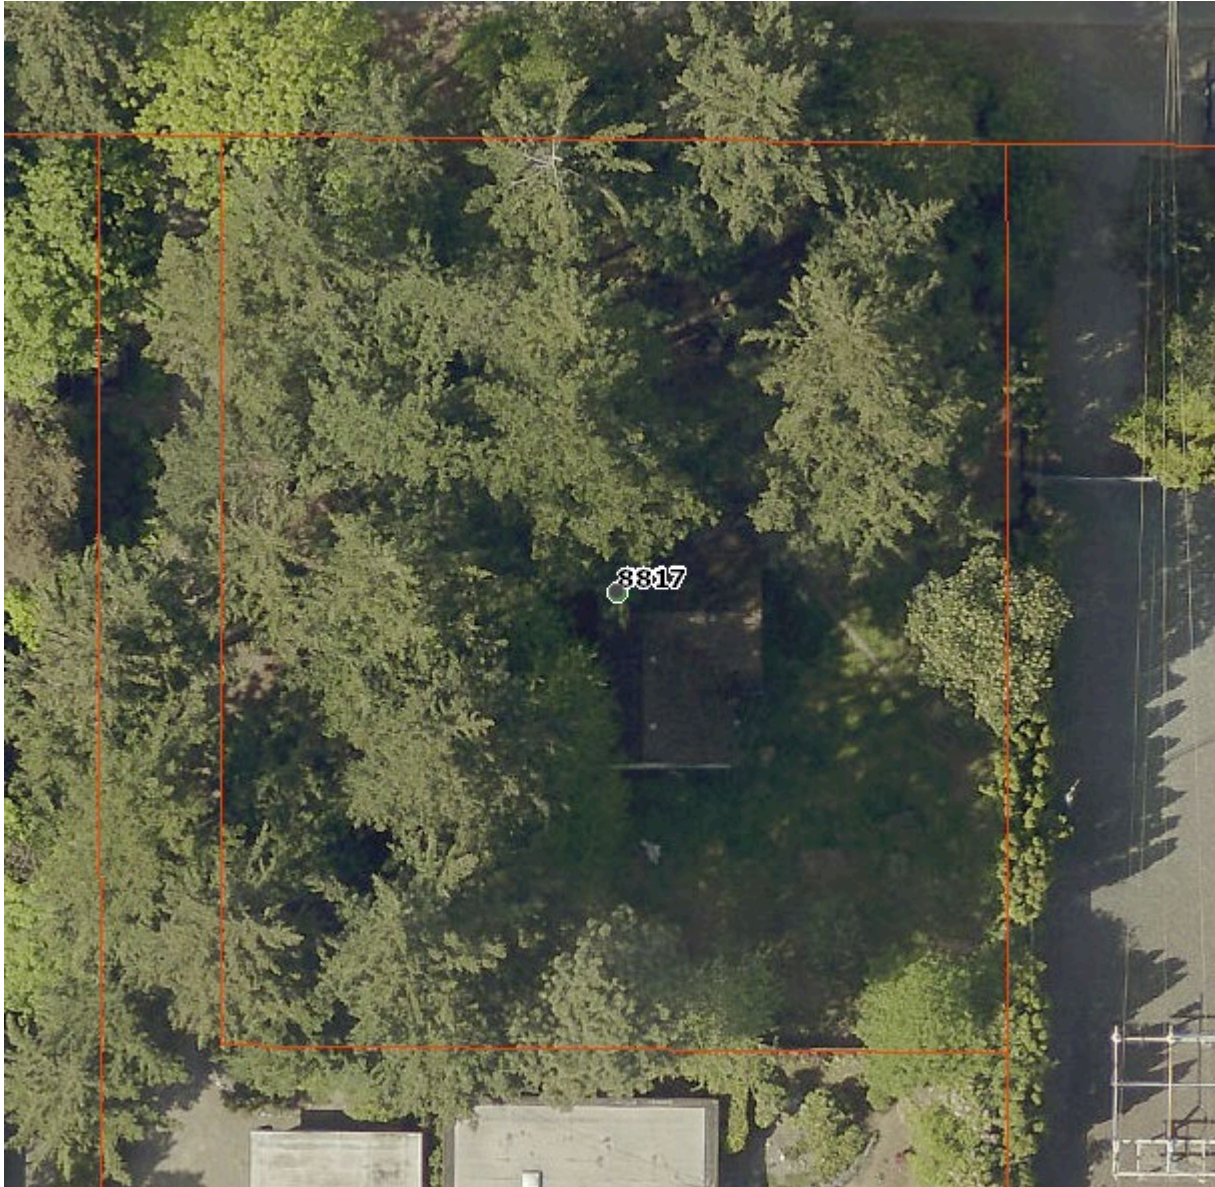
Photograph 4. An aerial view of the property from King County iMap. Contiguous tree canopy covers a large portion of the site, suggesting Exceptional Grove status for many of the trees on the property.
