**Project:** Pre-construction assessment for lot re-development at 4001 W Mercer Way, Mercer Island, WA. Parcel number 3623500365.

**Objectives:** Evaluate health of existing trees and establish criteria for the preservation of those to be retained.

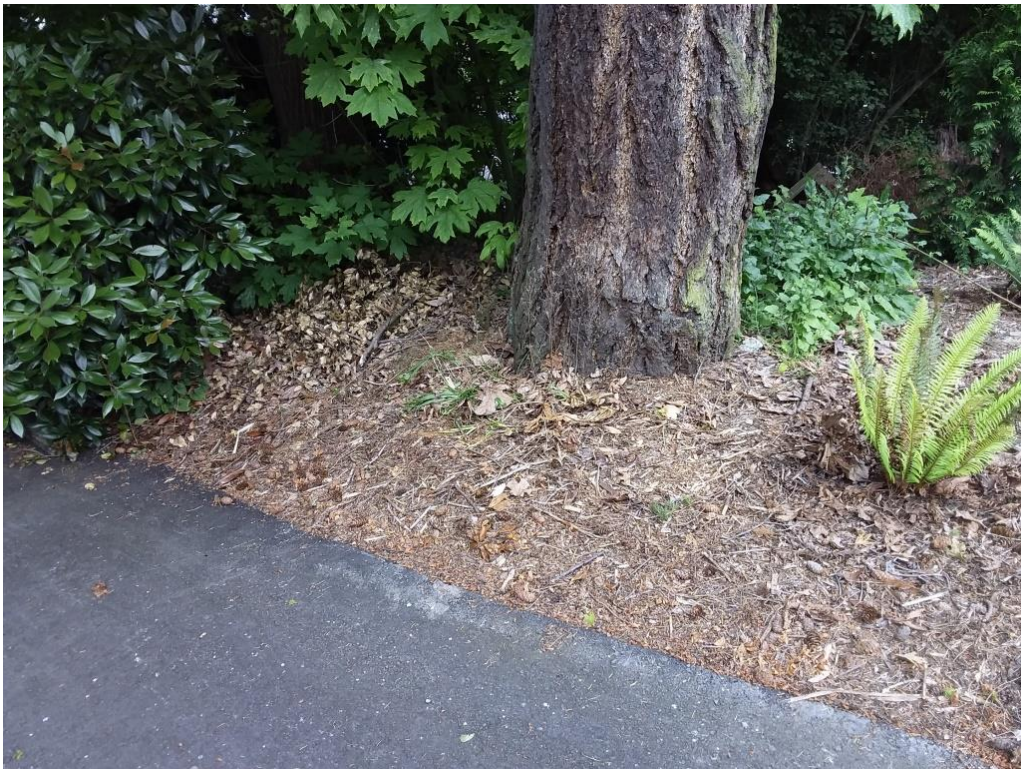
- 2) Douglas fir 36" DSH, 90' tall standing 19' SSE of the #1 tree and 4' W of the entrance drive which was newly paved (Figure 5). The tree has abnormal basal structure. It is in fair condition with average color and new growth in the mid lower canopy, somewhat below average new growth in the upper, and normal amounts of deadwood present. The majority of its canopy is on the south side mostly likely due to phototropism and canopy pressure from the removed maple.

The #2 fir has most of the same issues as the #1 tree. It is not exhibiting as severe of a canopy decline as its sister but it is noticeable. At this moment the tree has a **possible likelihood of catastrophic failure** and a fairly strong case could be made for a **probable likelihood of catastrophic failure**. Conservatively it is rated as a **moderate risk** but even a small change in its circumstances will push it over the edge into the **high risk** category.

Figure 5. Photo of base of #2 fir showing malformation and proximity of the new pavement.

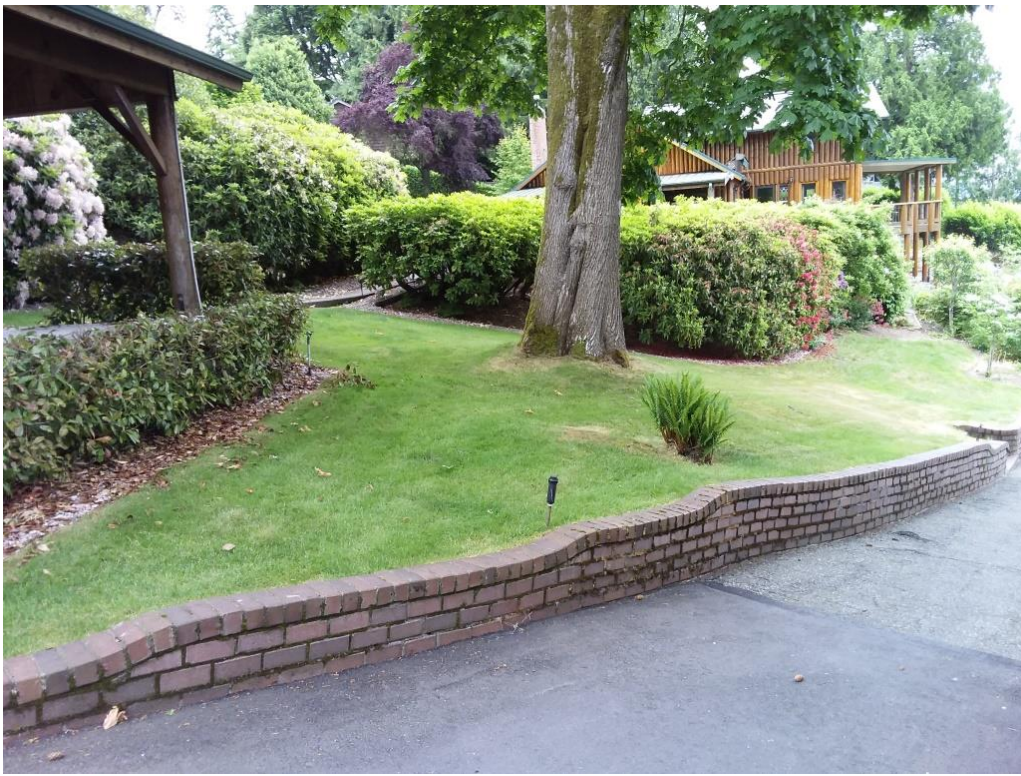
- 10) Big Leaf Maple 42" DSH, 75' tall, 28' radial spread standing in an island bordered by a brick retaining wall 12' to its west, a brick and concrete path 15' to its east, and the SW corner of the carport which is 15' NNE of its base as shown in Figure 6. The tree exhibits excellent health and structure for its species and age.

Figure 6. Photo of the large maple standing in its 'island'.

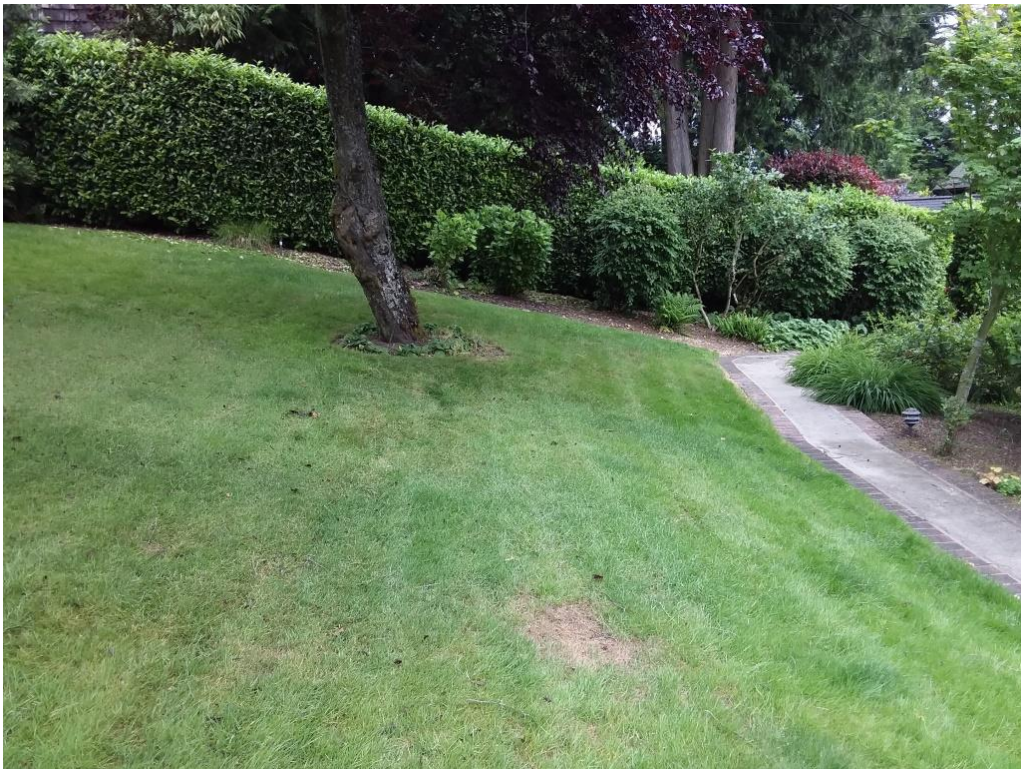
- 12) Flowering plum 18" DSH, 20' tall, 14' radial spread standing 12' E of the brick and concrete path and 21' N of the south side property line (Figure 1 and 7). The tree is in decline with advanced decay at its base (Figure 8), multiple cankers along the stem, and several breakout points with visible decay (Figure 9).

Figure 7. Photo showing placement of #12 plum.

Although the #12 plum is not within the construction impact region it is not worth putting much energy into preserving. Weight reduction at the extremities is the minimum required. Removal would not be a terrible idea.

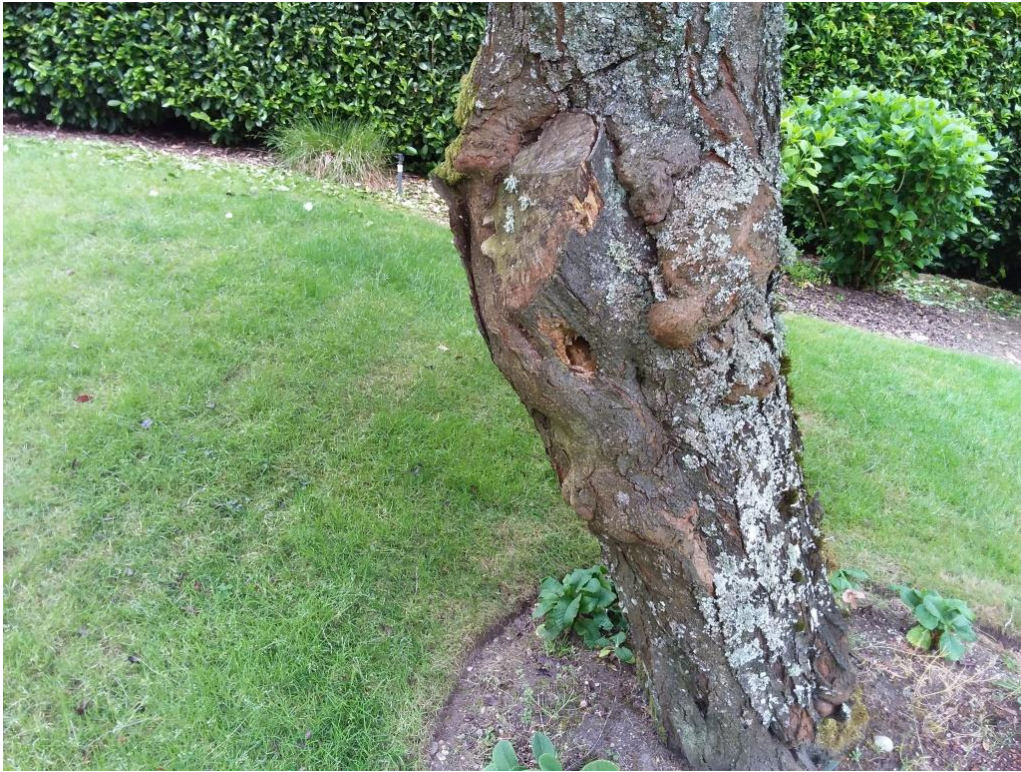
The #12 plum is in quite poor condition with advanced decay throughout its stem and scaffolds. It has a **probable likelihood of stem or large scaffold failure**. However it has no real targets within reach and therefore is a **low risk**.

Figure 8. Photo of base of the #12 plum showing decay and cankers.

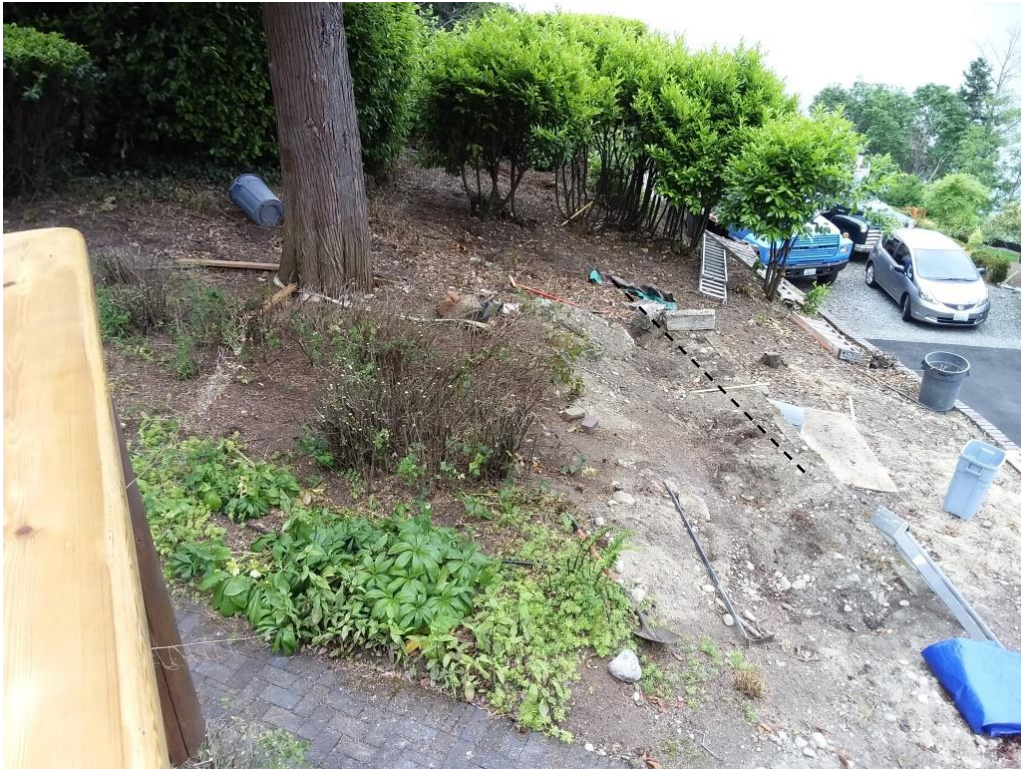
- 13) Western Red Cedar 34.5" DSH, 65' tall standing 20' N of the south line, 15' E of a 4' tall concrete retaining wall, 12' SW to a floating brick patio with a brick path cutting 45 degrees to the NW from it (Figures 10 and 11). The tree has several laterals which are upturning into subordinate spars (Figure 12). The upper canopy is slightly stunted, the mid-lower has the majority of the canopy density, and its color is fine as shown in Figure 13.

Figure 10. Photo showing the location of the retaining wall on the west side of the #13 cedar (black dashed line).

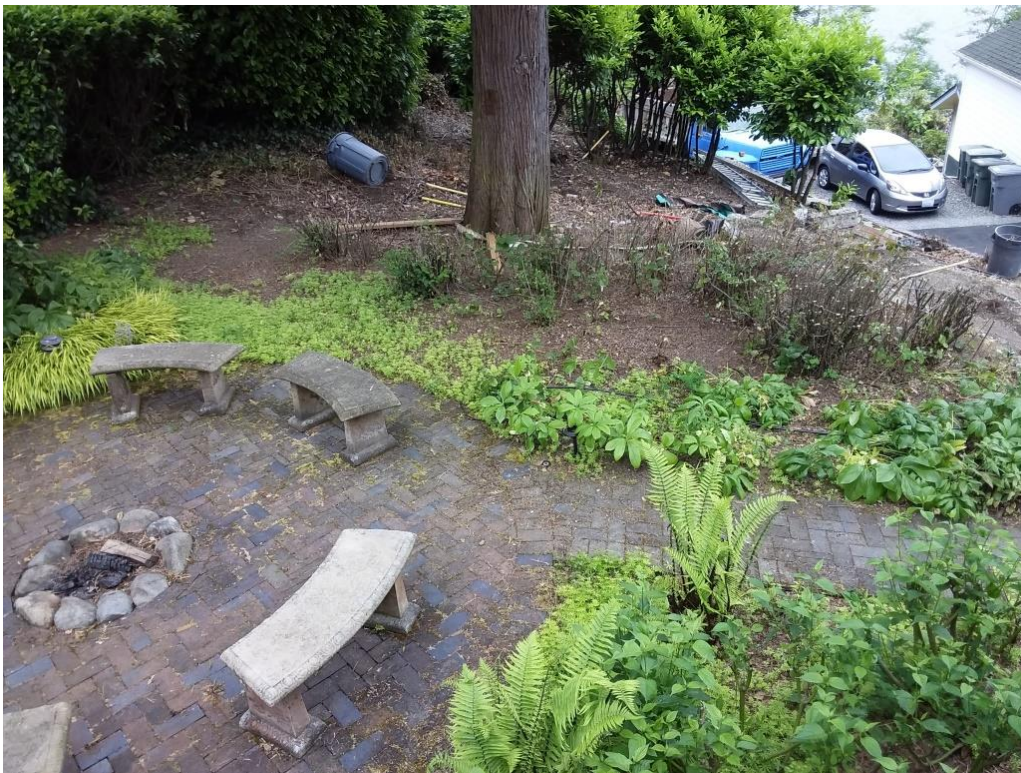
Figure 11. Photo showing layout around the base of the #13 tree.

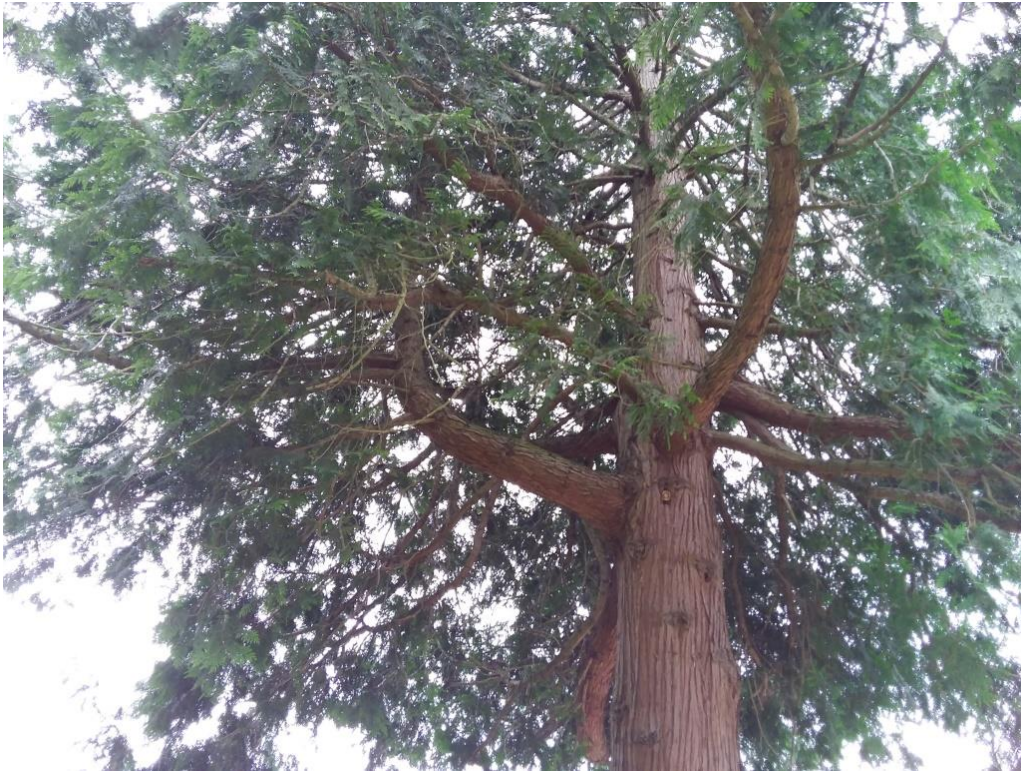
Figure 12. Photo looking up into the lower canopy of the cedar. The upturning lower spars are clearly visible.

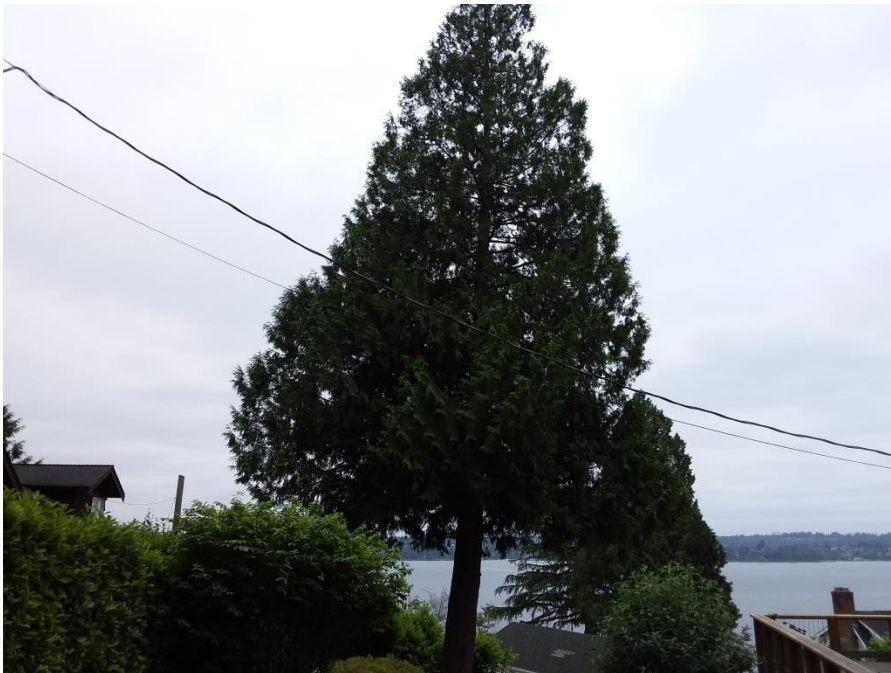
Figure 13. Photo of canopy formation on #13 cedar.

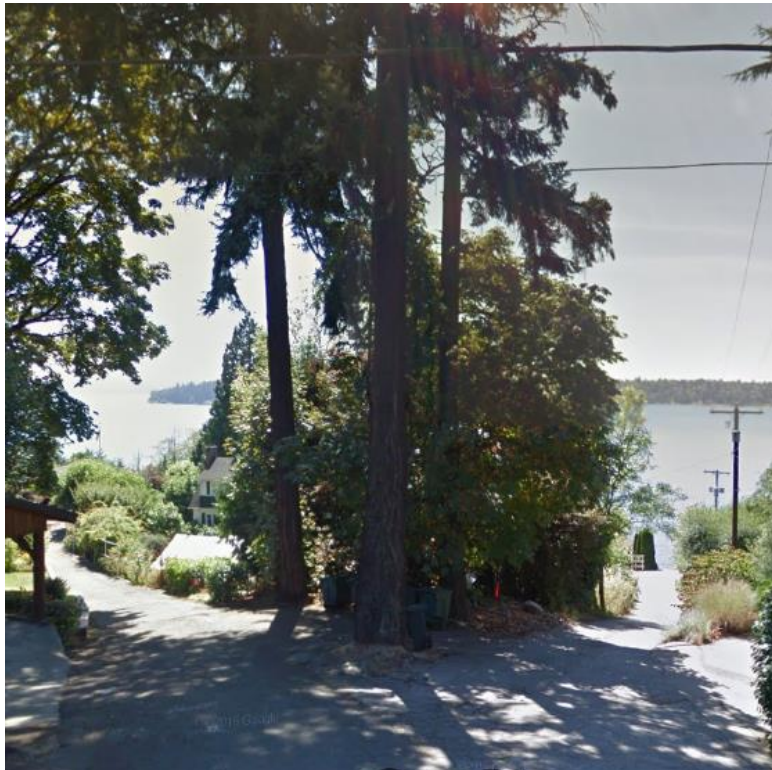
The #1 Douglas fir was significantly impacted by the 2018 street improvement work. In 2016 it was one of three firs in its location (Figure 16). The pavement for edge of Freeman Avenue/40<sup>th</sup> Street was 4-5' away from its base (Figure 17). After the reworking of the street entrance in 2018 the edge was less than 3' away (Figures 18 and 19). It is likely that the impact was closer to 24" from its base figuring in the cut for the edge forms. The extraction of the third fir's stump also contributed to the #1 tree's root damage.

Figure 16. Google Street view image from August 2016 showing the three firs present.

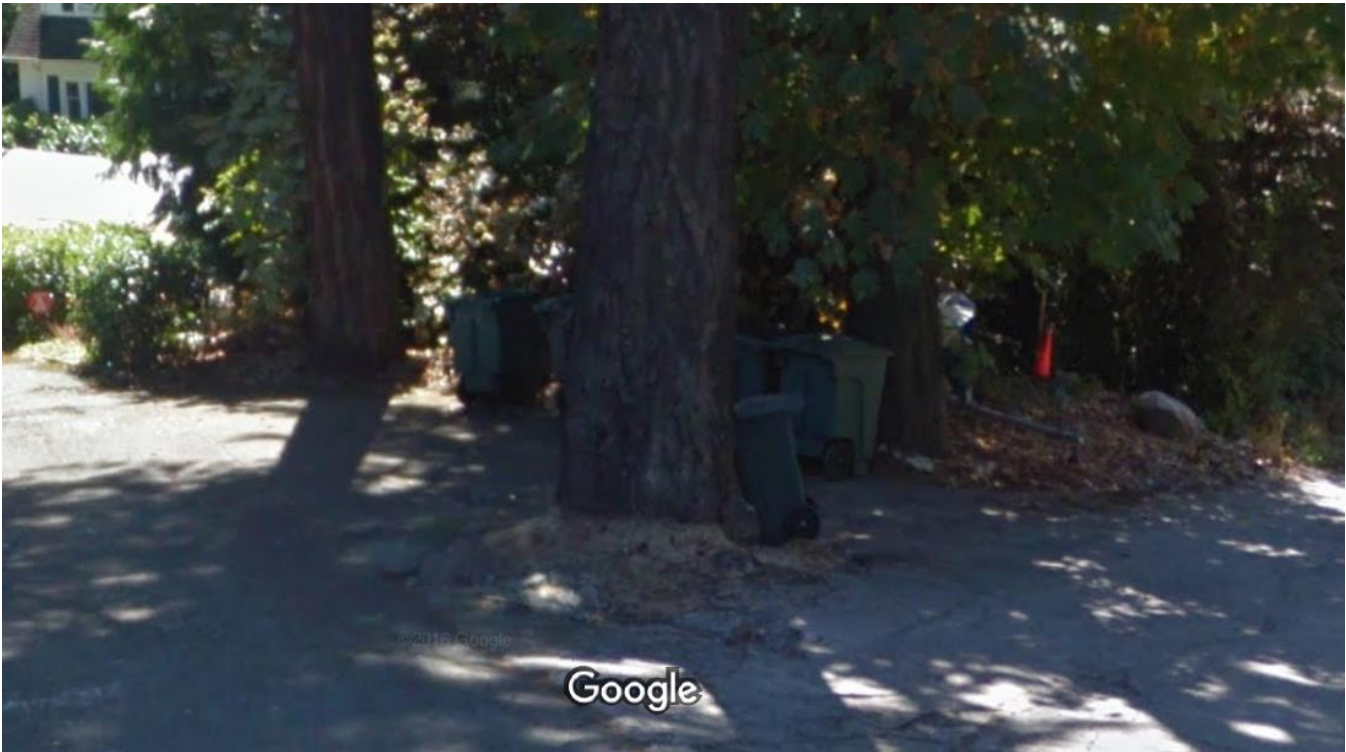
Figure 17. Close up of the bases of the three firs showing how the pavement wrapped around the trees. Note the distance that the edge of the road is from the #1 fir.

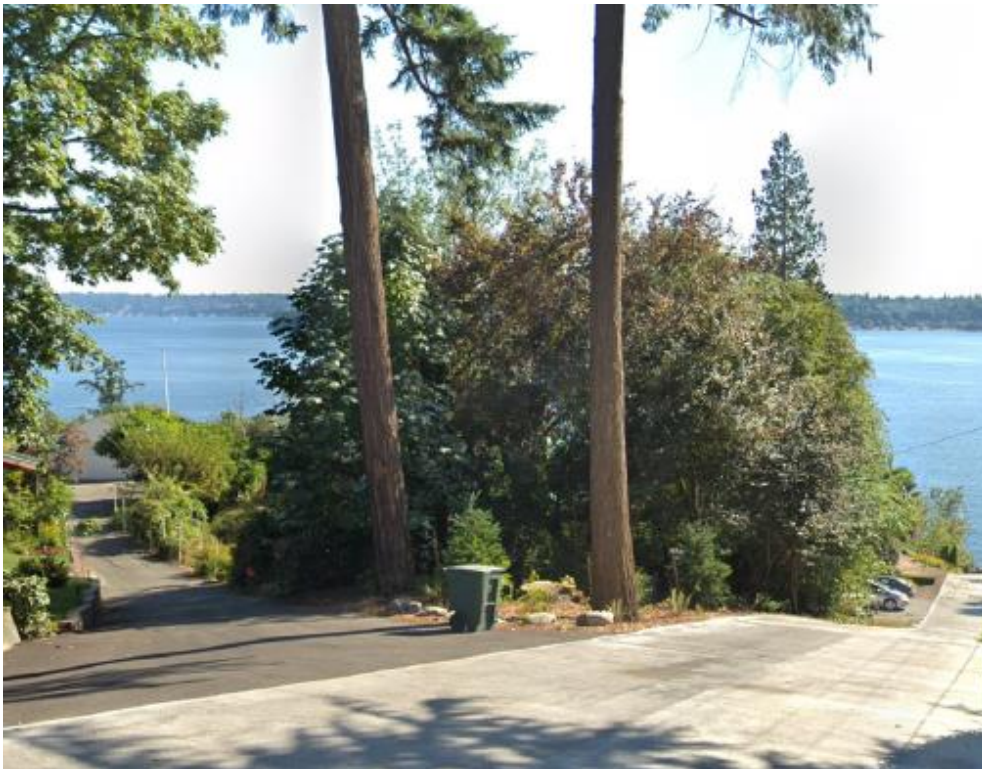
Figure 18. Street View image from July 2018 showing the new layout of the Freeman Avenue/40<sup>th</sup> Street entrance.

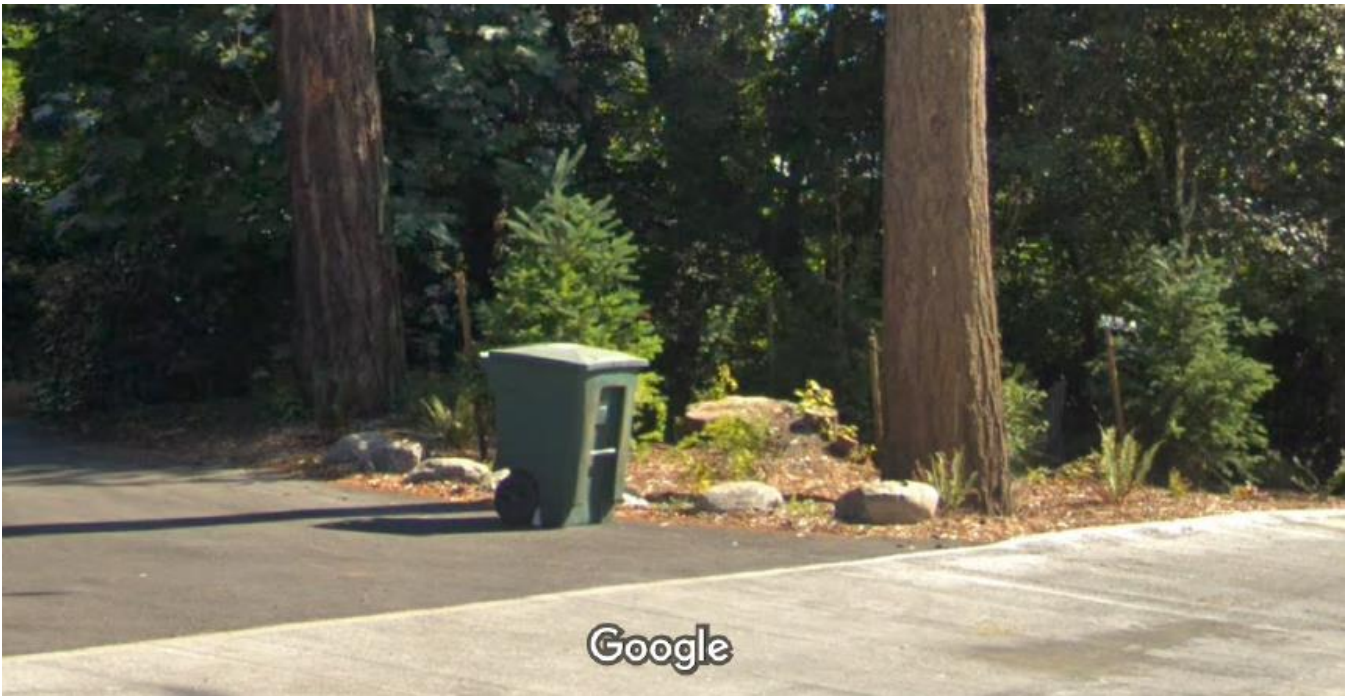
Figure 19. Close up of the image showing the new proximity of the of the street edge to the #1 fir and the driveway entrance to the #2 fir.
