November 16, 2021

Project: Updated pre-construction assessment for lot re-development at 4001 W Mercer Way, Mercer Island, WA. Parcel number 3623500365.

Objectives: Evaluate health of existing trees and establish criteria for the preservation of those to be retained.

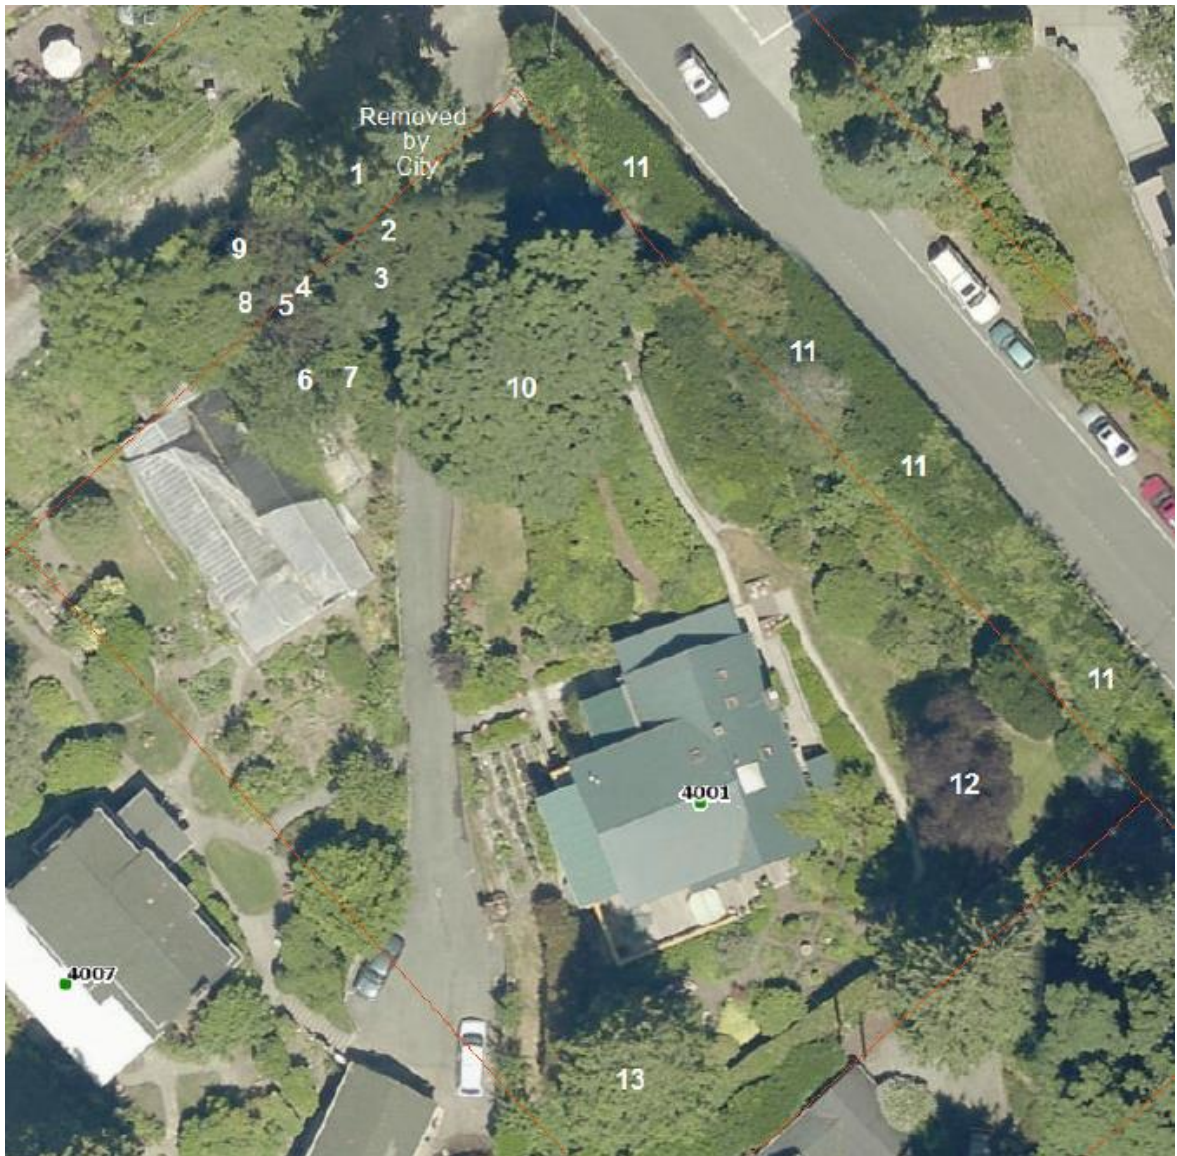
Figure 1. Aerial photo showing rough locations of trees. White numerals match those listed in the Description section.

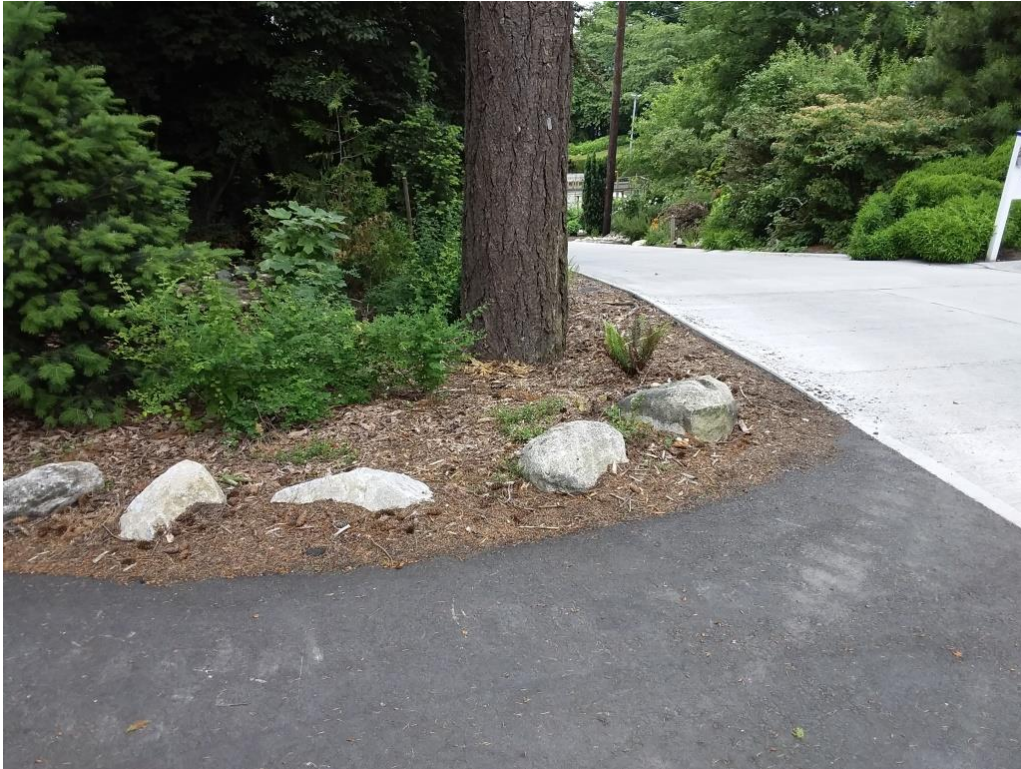
- 1) Douglas Fir (*Pseudotsuga menziesii*) 29.5” DSH, 85’ tall standing in the corner of the main drive and the entrance drive. There has been recent root disturbance within 4’ of the base of the tree on its north side (Figure 2) from when the City of Mercer Island repaved the main entrance drive in 2018. A fungal fruiting body (most likely *Heterobasidion annosum*) is growing on the north face at the base (Figure 3). The tree is in advanced decline and exhibits limited to no new growth, die back and dead branches throughout the canopy, and weak color and shown in Figure 4. A large Big Leaf maple and another Douglas fir were removed at the time of the paving event. Both were around 6’ away from this tree. Four evergreen saplings were planted in the space between this tree and the #2 fir. The fir was previously tagged as #115. It was removed in 2020 by the City of Mercer Island.

The #1 Douglas fir was significantly impacted by the 2018 street improvement work. In 2016 it was one of three firs in its location (Figure 16). The pavement for edge of Freeman Avenue/40th Street was 4-5' away from its base (Figure 17). After the reworking of the street entrance in 2018 the edge was less than 3' away (Figures 18 and 19). It is likely that the impact was closer to 24" from its base figuring in the cut for the edge forms. The extraction of the third fir's stump also contributed to the #1 tree's root damage.

Figure 2. Photo of base of #1 fir showing repaving encroachment.

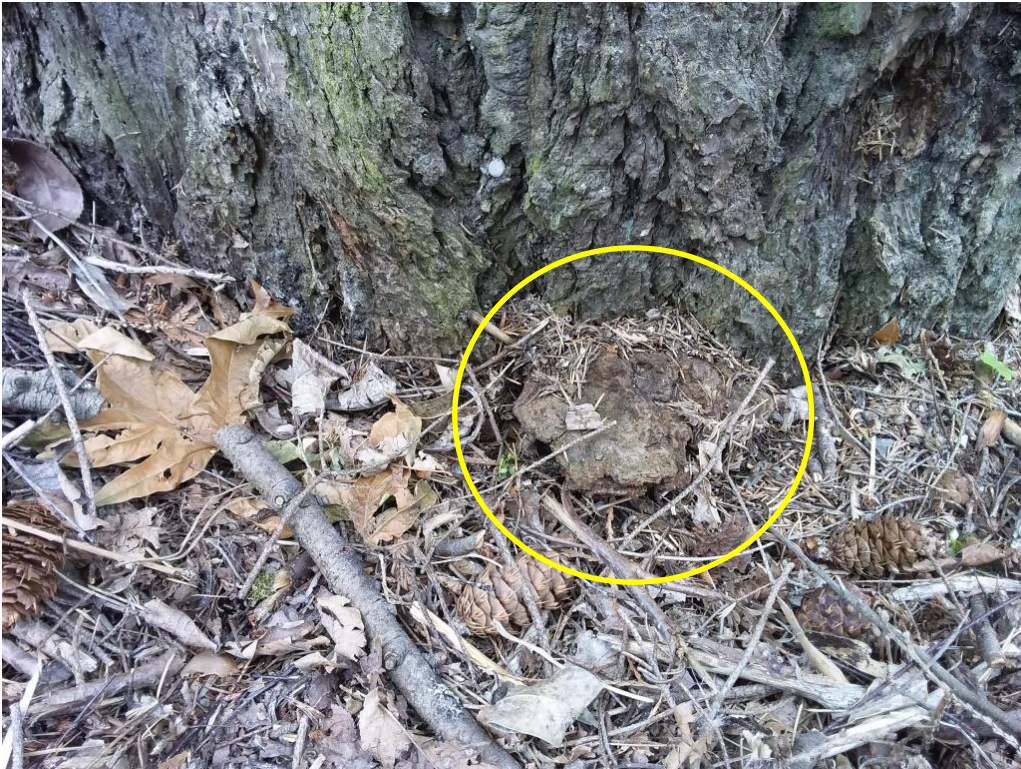
This tree is fully exposed to the region's storm winds which come in from the south and southwest. These are often magnified by an almost wind tunnel effect the lake creates between the island and mainland Seattle. It now has brown rot fungal bodies at its base and rapidly declining canopy. Taking all this into account the tree has a **probable likelihood of catastrophic failure**.

Figure 3. Photo of fungal fruiting body at base of #1 fir.

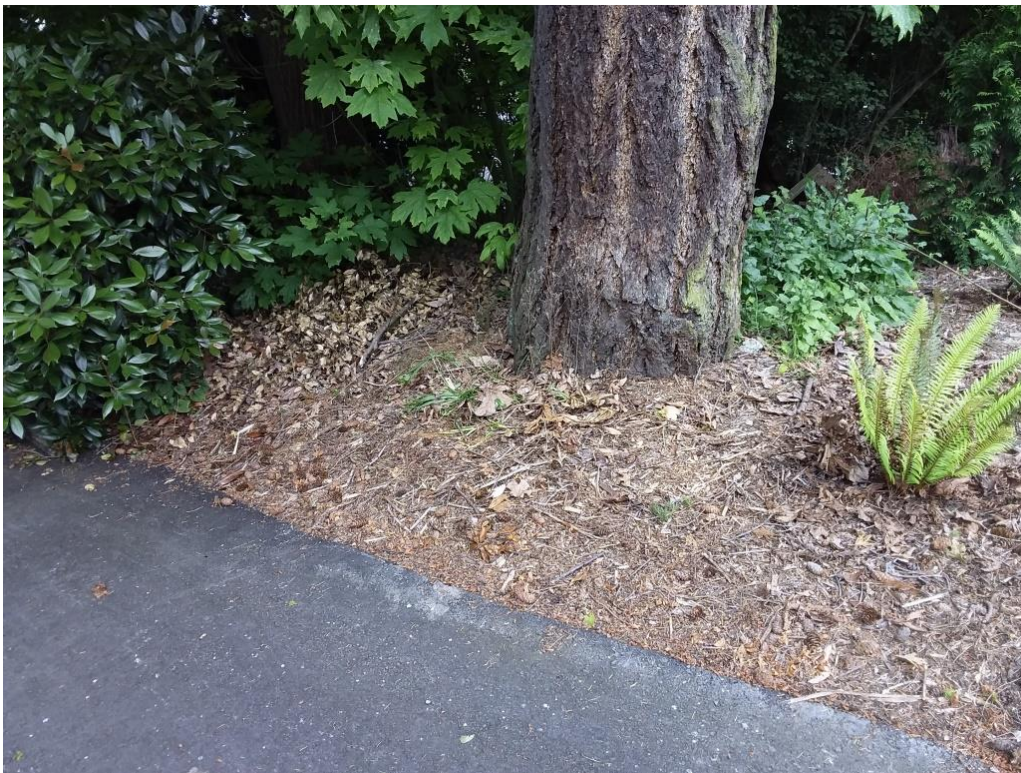
- 2) Douglas fir 36" DSH, 90' tall standing 19' SSE of the #1 tree and 4' W of the entrance drive which was newly paved (Figure 5). The tree has abnormal basal structure. It is in below average condition with weak color and limited new growth and normal amounts of deadwood present. The majority of its canopy is on the south side mostly likely due to phototropism and canopy pressure from the removed maple.

The #2 fir has most of the same issues as the #1 tree. It is not exhibiting as severe of a canopy decline as its sister but it is noticeable. At this moment the tree has a **possible likelihood of catastrophic failure** and a fairly strong case could be made for a **probable likelihood of catastrophic failure**. Conservatively it is rated as a **moderate risk** but even a small change in its circumstances will push it over the edge into the **high risk** category.

Figure 5. Photo of base of #2 fir showing malformation and proximity of the new pavement.

The #2 fir has already experienced a degree of impact from the City road improvement work and is exhibiting signs of stress because of it. Great care will have to be taken when removing the driveway. The fir likely has roots reaching beneath and they can be easily damaged. This work should be completed under arborist oversight. Once the asphalt is removed it would help the tree to do a deep root feed thereby providing a means to combat stress and at the same time decompacting the soil. Covering the newly exposed area with 6-8" of arbor mulch would be an excellent idea.

Protection fencing for the #2 tree will have to be set up after the driveway is removed. It should be set against the brick retaining wall on the far side of the driveway at least 28' from the base of the tree and then brought back past where the NE corner of the greenhouse had been to within 10' of the #4 and #5 trees. It should turn down slope and cross 10' out from the #8 tree and then curve around it at the limit of its CRZ and continue to the edge of the road.

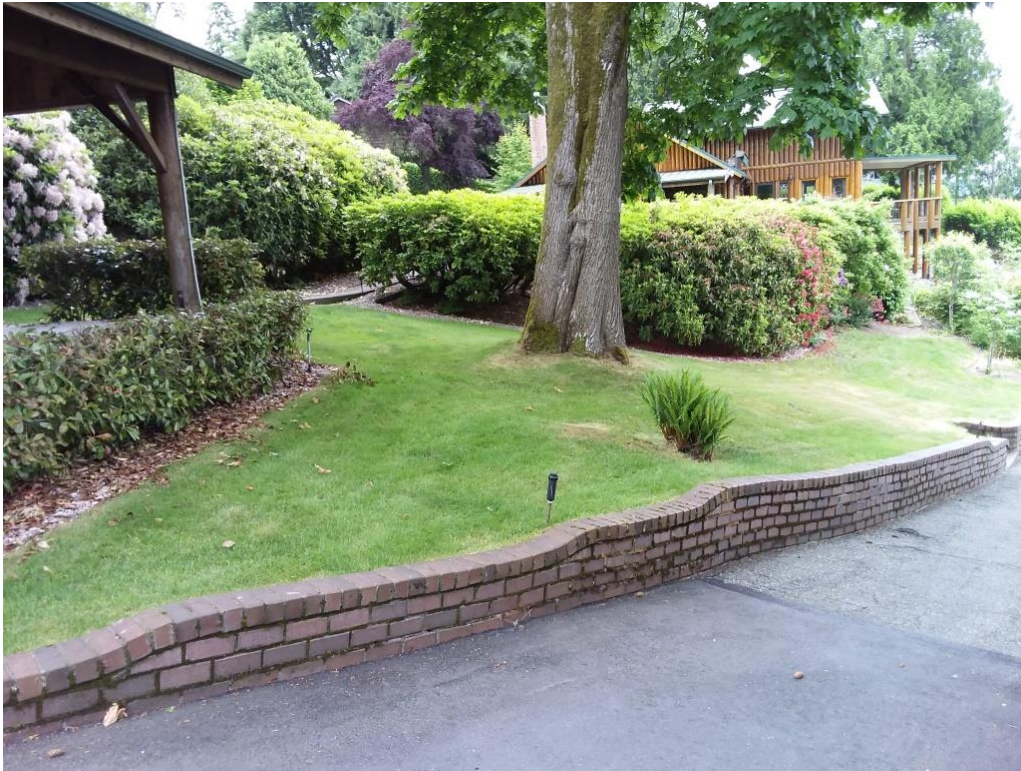
- 10) Big Leaf Maple 42" DSH, 75' tall, 28' radial spread standing in an island bordered by a brick retaining wall 12' to its west, a brick and concrete path 15' to its east, and the SW corner of the carport which is 15' NNE of its base as shown in Figure 6. The tree exhibits excellent health and structure for its species and age.

Figure 6. Photo of the large maple standing in its 'island'.

Fencing for the #10 tree can be set along the top of the brick wall for its length. An arborist will have to oversee the demolition of the carport (if it will be) as it much of it stands inside the maple's CRZ. It is doubtful the tree has roots beneath the edifice but it is highly likely they wrap close in to the concrete. Once the carport is removed the exposed soil should be covered in 6-8" of arbormulch.

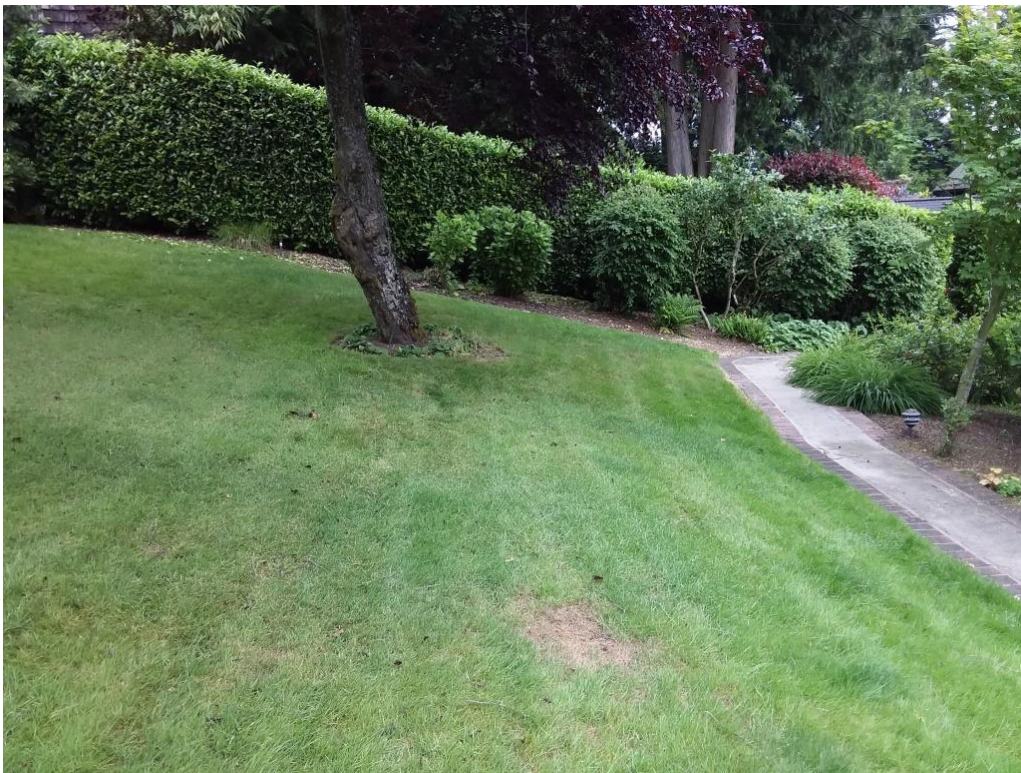
Figure 7. Photo showing placement of #12 plum.

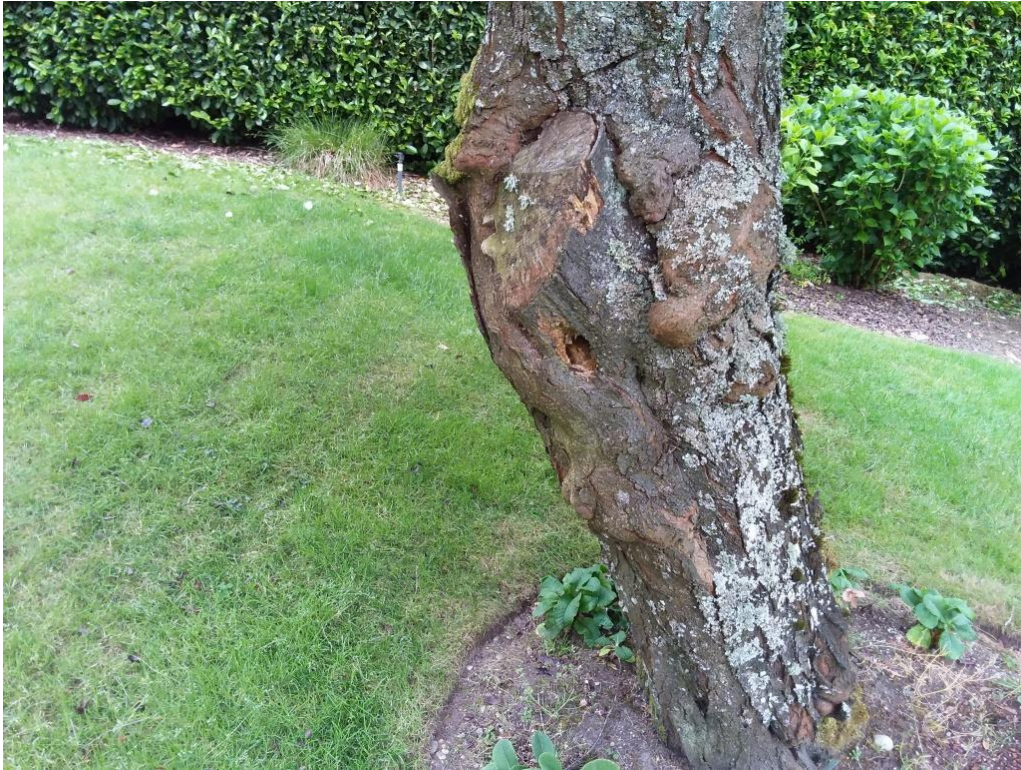
- 12) Flowering plum 18" DSH, 20' tall, 14' radial spread standing 12' E of the brick and concrete path and 21' N of the south side property line (Figure 1 and 7). The tree is in decline with advanced decay at its base (Figure 8), multiple cankers along the stem, and several breakout points with visible decay (Figure 9).

The #12 plum is in quite poor condition with advanced decay throughout its stem and scaffolds. It has a **probable likelihood of stem or large scaffold failure**. However it has no real targets within reach and therefore is a **low risk**.

Figure 8. Photo of base of the #12 plum showing decay and cankers.

Although the #12 plum is not within the construction impact region it is not worth putting much energy into preserving. Weight reduction at the extremities is the minimum required. Removal would not be a terrible idea.

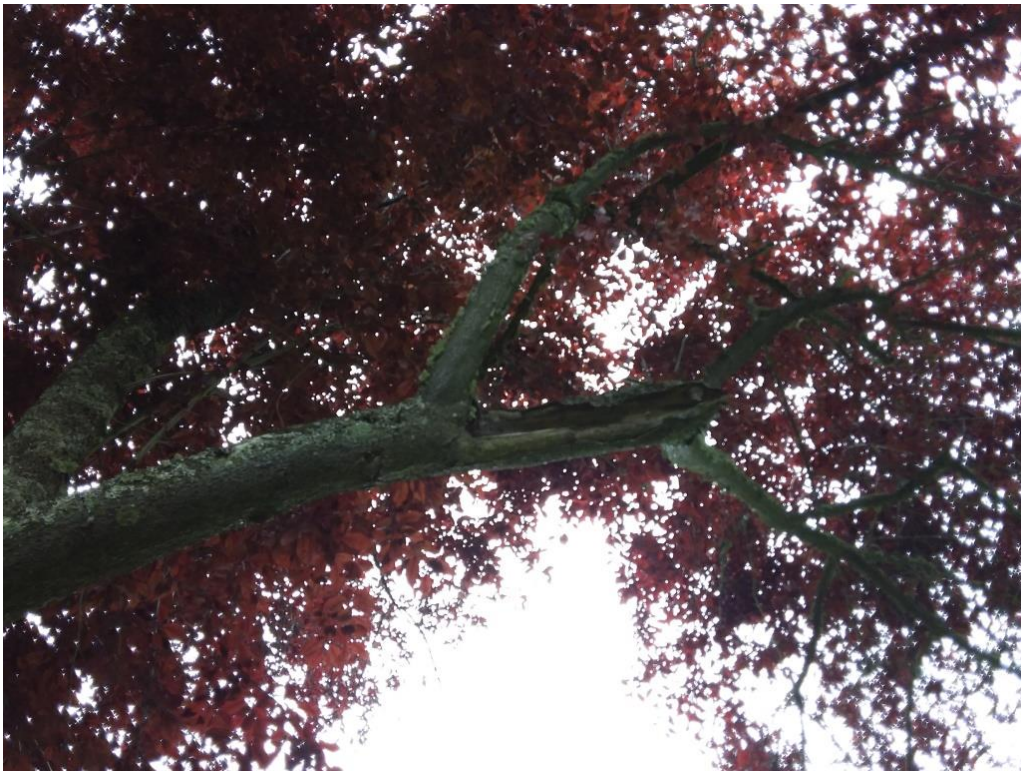
Figure 9. Photo of breakout point with associated decay.

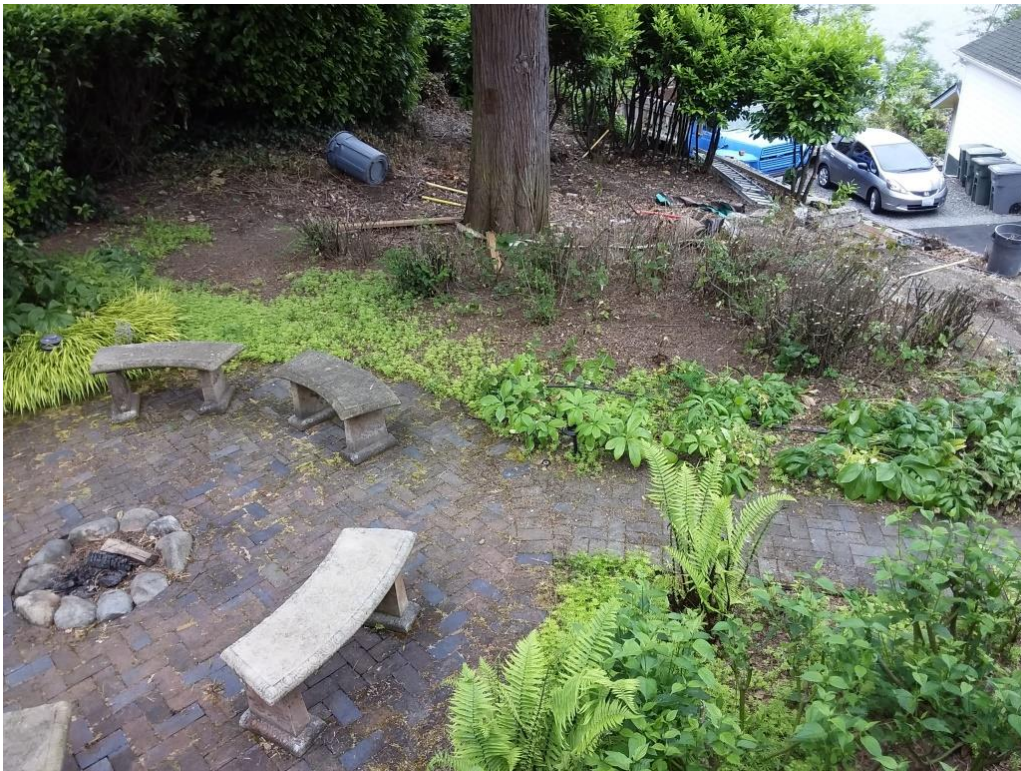
Figure 11. Photo showing layout around the base of the #13 tree.

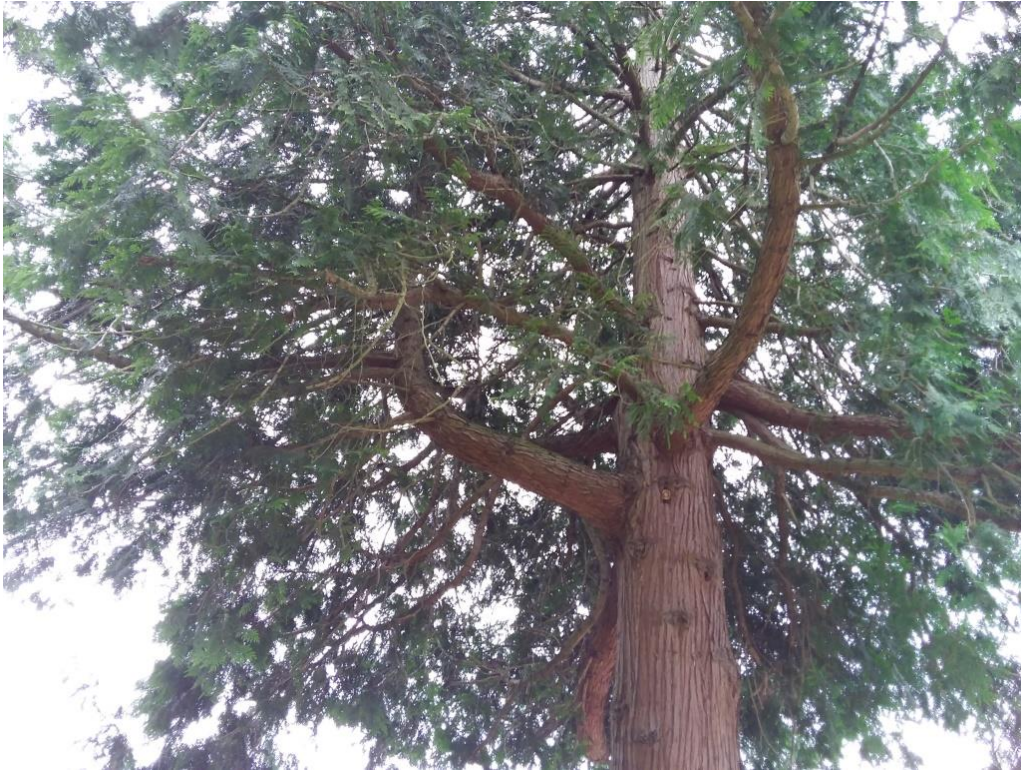
- 13) Western Red Cedar 34.5" DSH, 65' tall standing 20' N of the south line, 15' E of a 4' tall concrete retaining wall, 12' SW to a floating brick patio with a brick path cutting 45 degrees to the NW from it (Figures 10 and 11). The tree has several laterals which are upturning into subordinate spars (Figure 12). The upper canopy is slightly stunted, the mid-lower has the majority of the canopy density, and its color is fine as shown in Figure 13.

Figure 12. Photo looking up into the lower canopy of the cedar. The upturning lower spars are clearly visible.

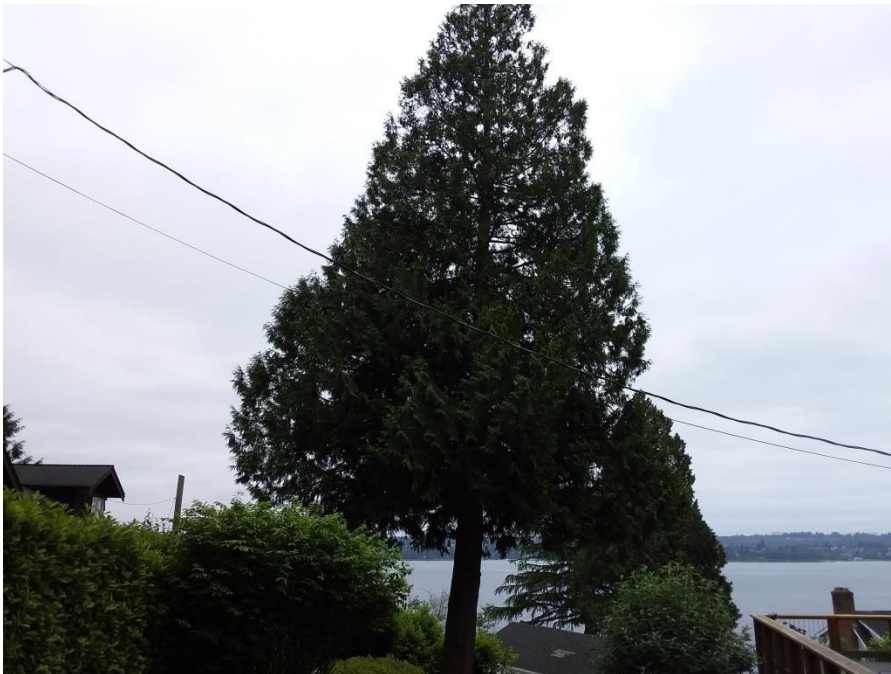
Figure 13. Photo of canopy formation on #13 cedar.

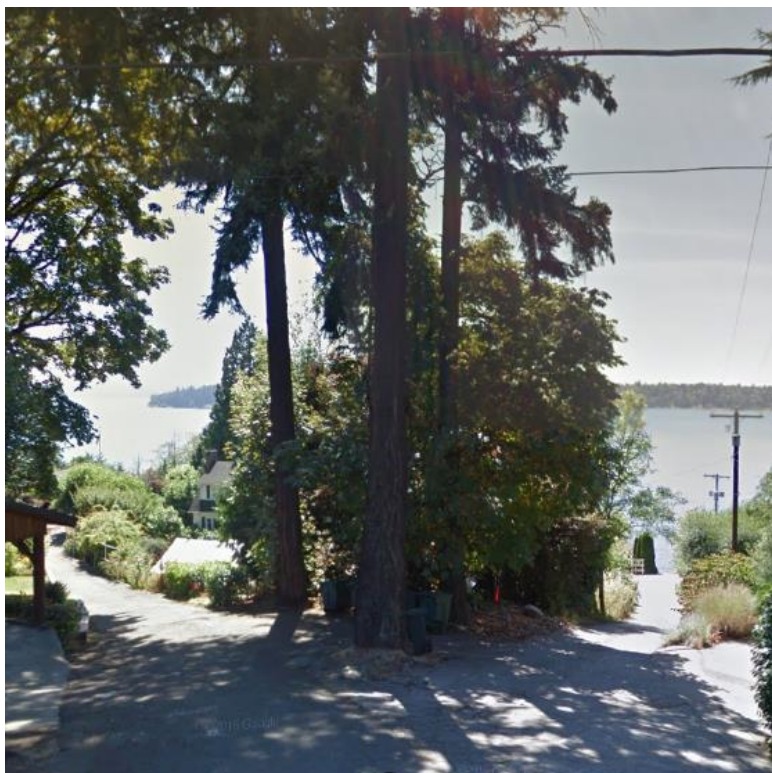
Figure 16. Google Street view image from August 2016 showing the three firs present.

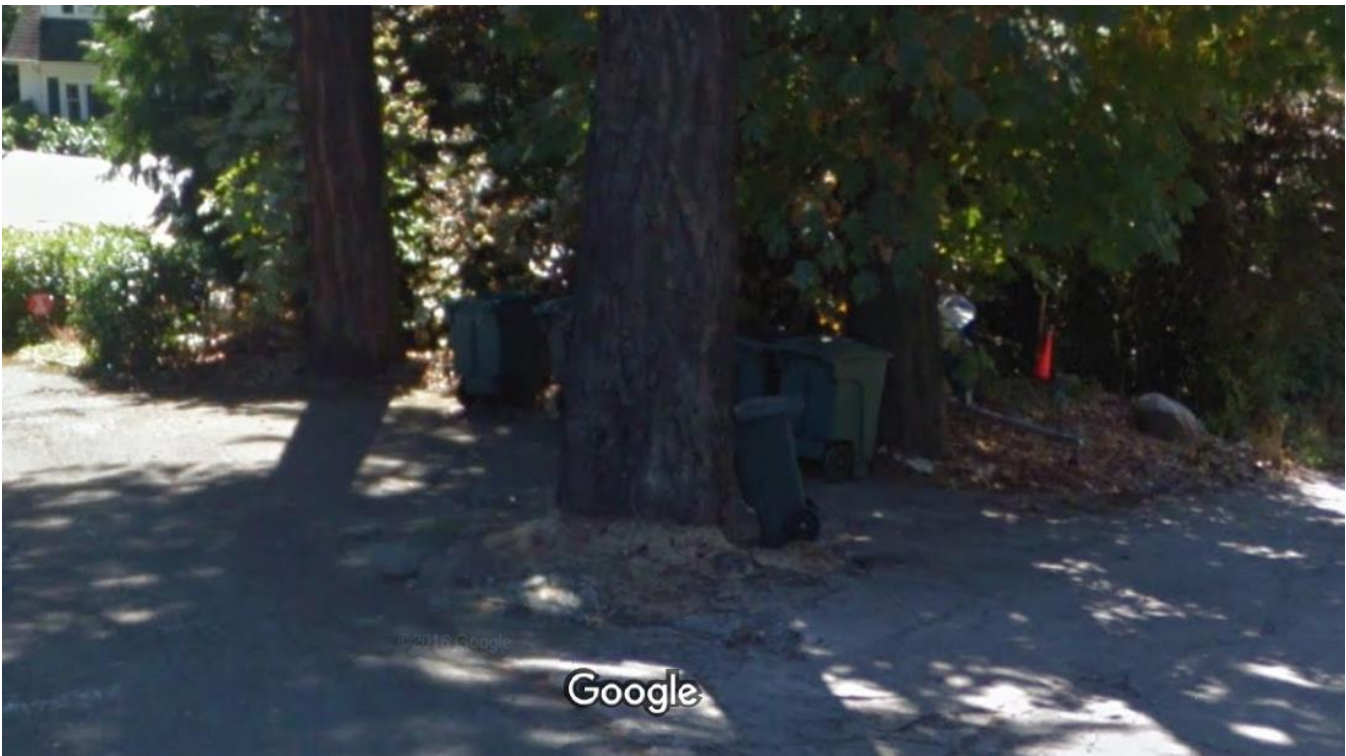
Figure 17. Close up of the bases of the three firs showing how the pavement wrapped around the trees. Note the distance that the edge of the road is from the #1 fir.

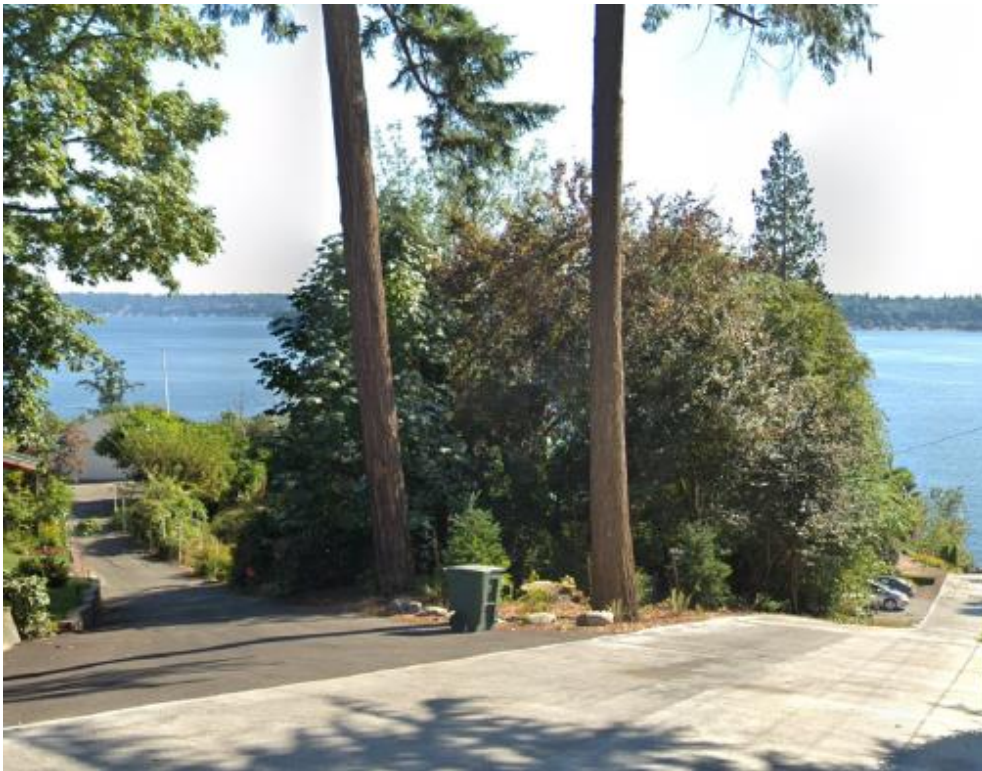
Figure 18. Street View image from July 2018 showing the new layout of the Freeman Avenue/40th Street entrance.

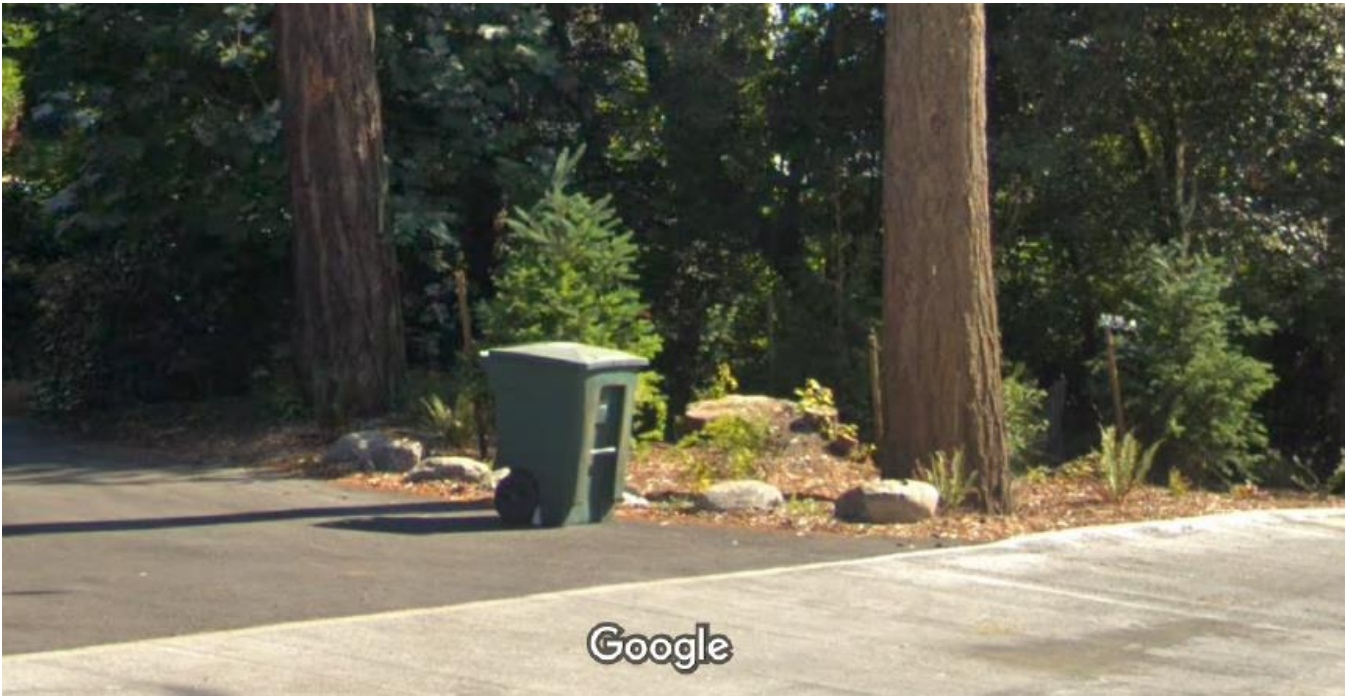
Figure 19. Close up of the image showing the new proximity of the of the street edge to the #1 fir and the driveway entrance to the #2 fir.

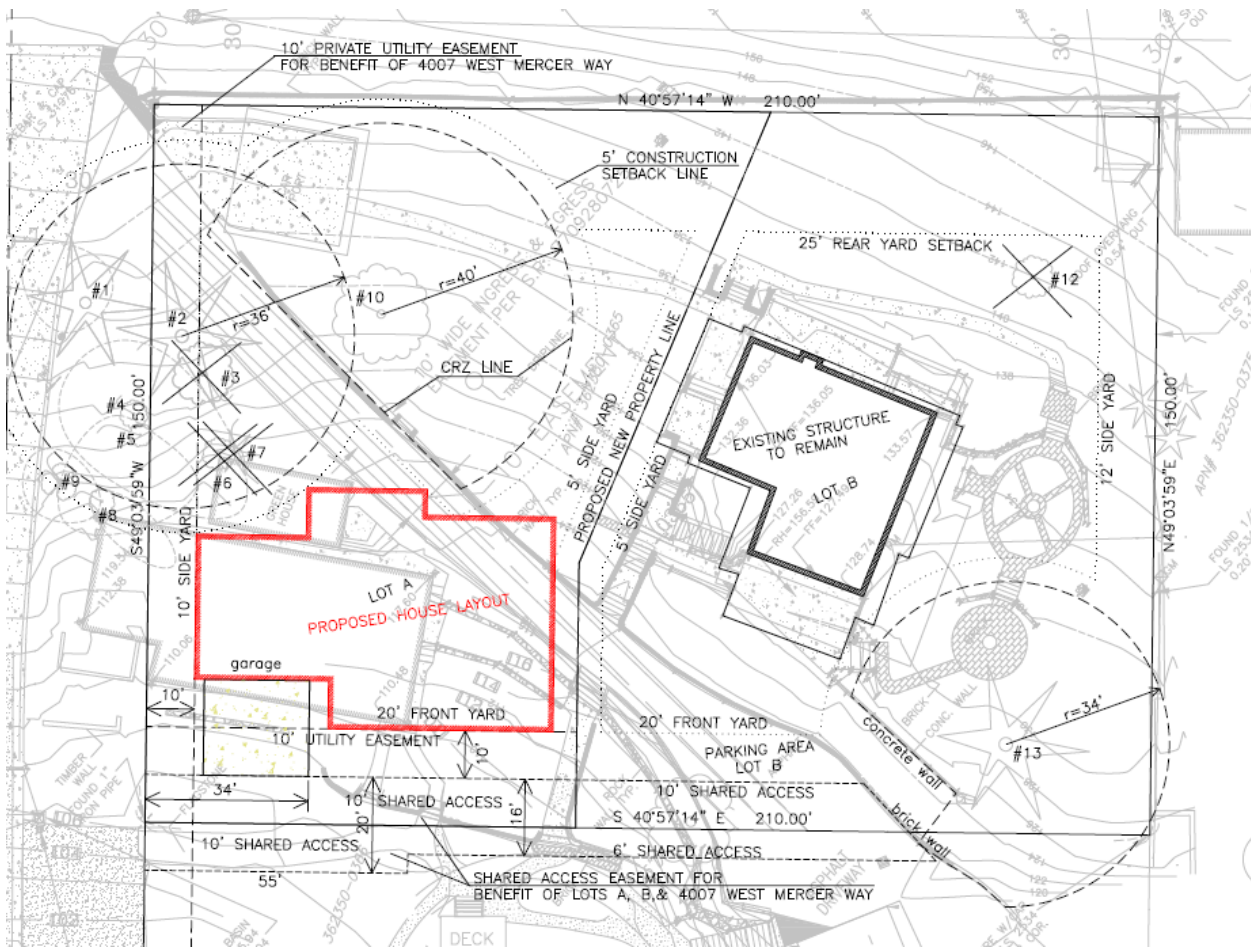
Construction Impact Analysis: The owners have generated a short plat which retains the existing house on Lot B and crafts a space for a new home on Lot A (Figure 20). In this scenario the existing driveway and carport will be removed along with the garden shed. A fairly deep excavation will have to be made to create a building pad. The new house will likely be built into the existing slope with tall concrete walls formed out for the lower story. A full 10' of space around the perimeter of the house location will have to be accounted for to allow safe building space for forms and retention walls.

Figure 20. Excerpt from the proposed plan set showing the new property layout.
