LAYTON TREE CONSULTING, LLC

ARBORIST REPORT/TREE PLAN

7621 SE 22nd Street
Mercer Island, WA

March 30, 2020

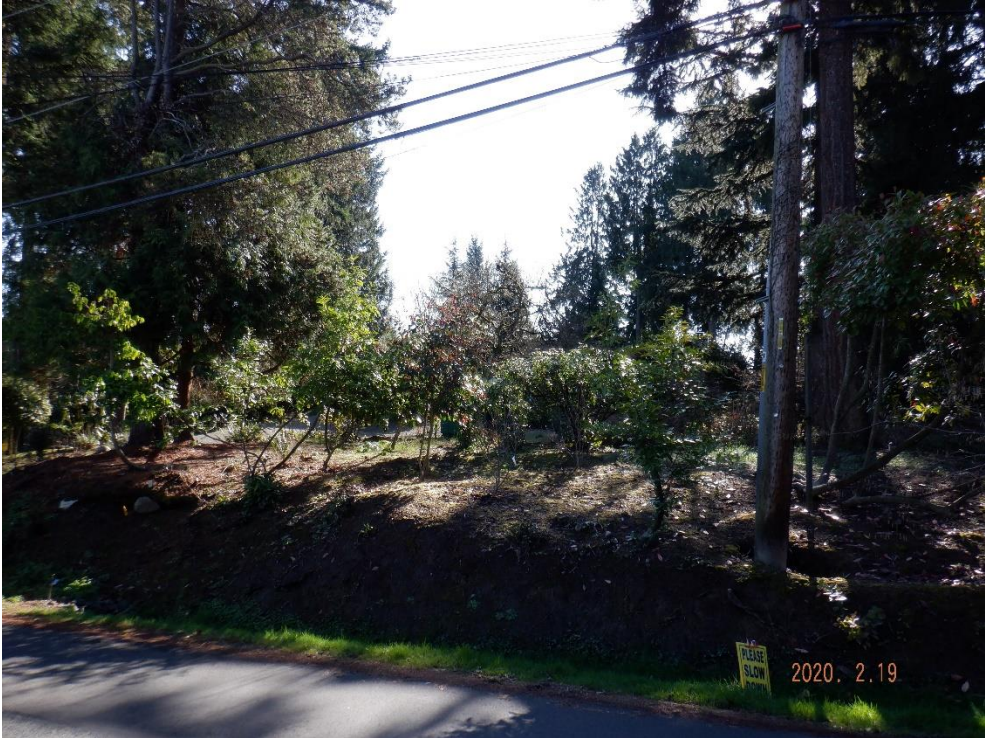
Front of property, Tree #1 on right, Trees #23 and #24 on left

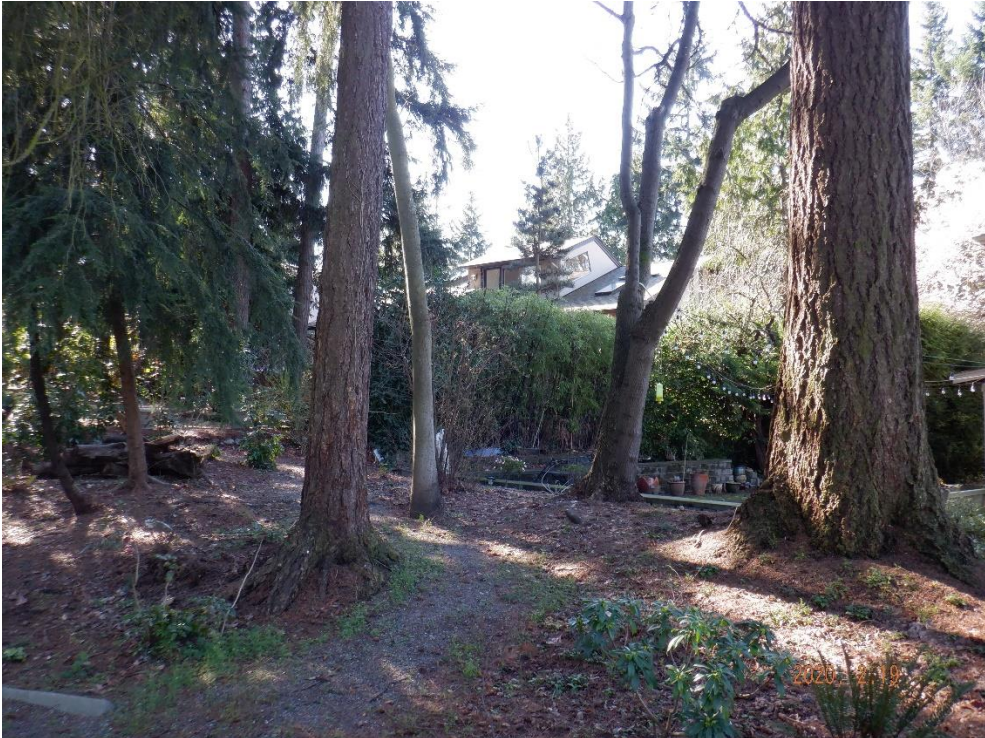
Trees #4, #5, #6 and #7

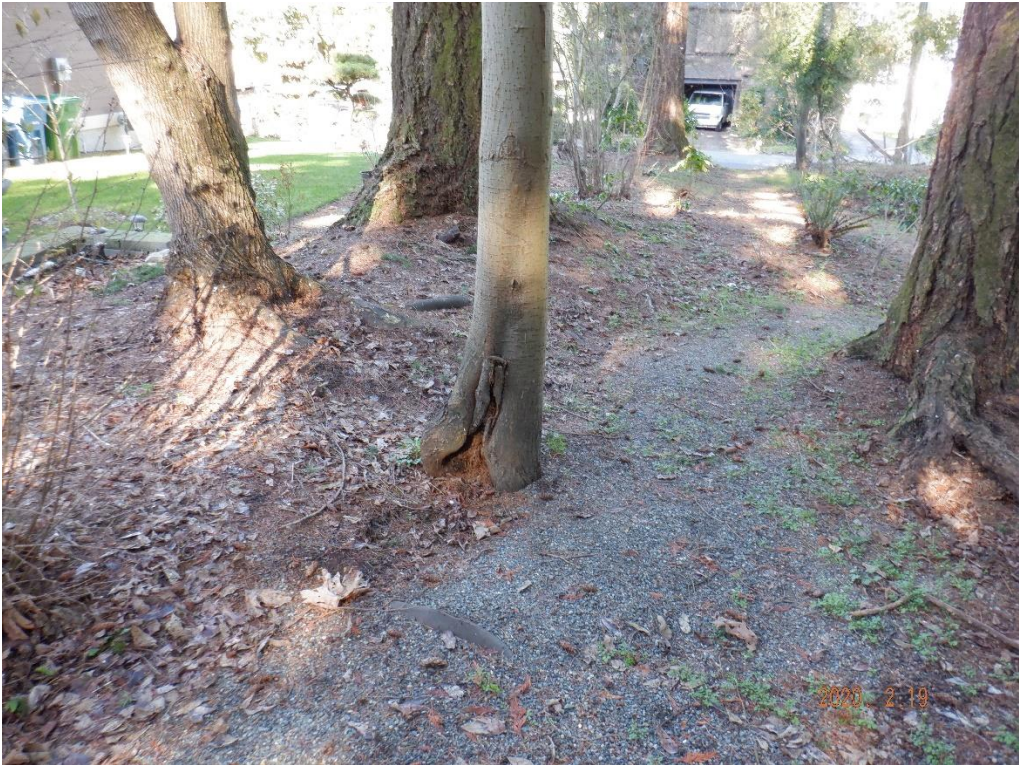
No ‘poor’ condition or high-risk trees were identified on the subject property. With the exception of Tree #7, all assessed trees are in fair to good condition. The attached map indicates the condition of subject trees. Tree #7 is a semi-mature Scouler’s willow. It is suppressed by the larger surrounding trees. There is obvious decay at the root crown. Condition is rated as ‘fair-to-poor’.

Lower trunks of trees on west perimeter, note rot at root crown of Tree #7, Tree 31 and #2 in background

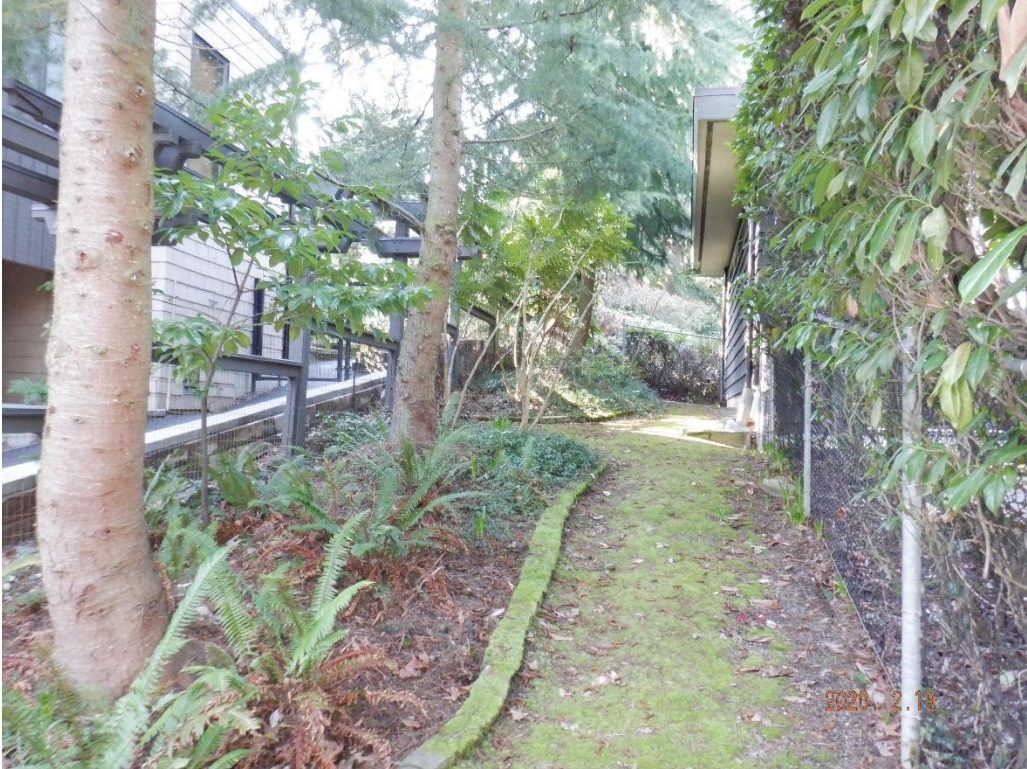
Lower trunks of young Deodar cedar trees

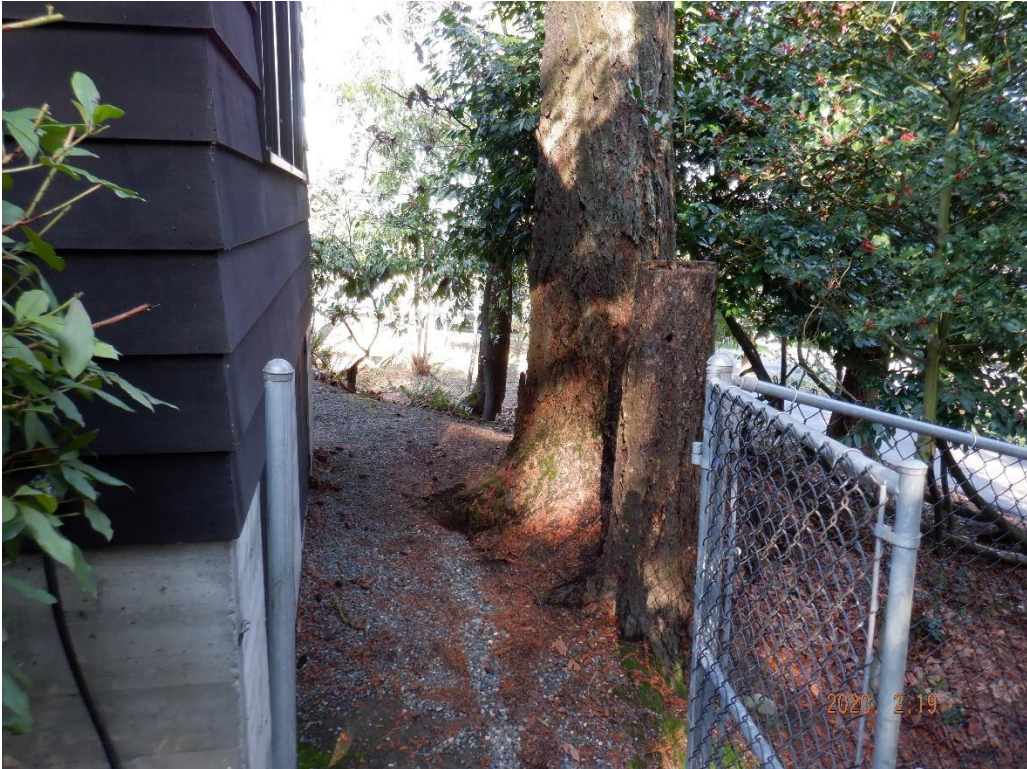
Tree #13 located close to existing structure

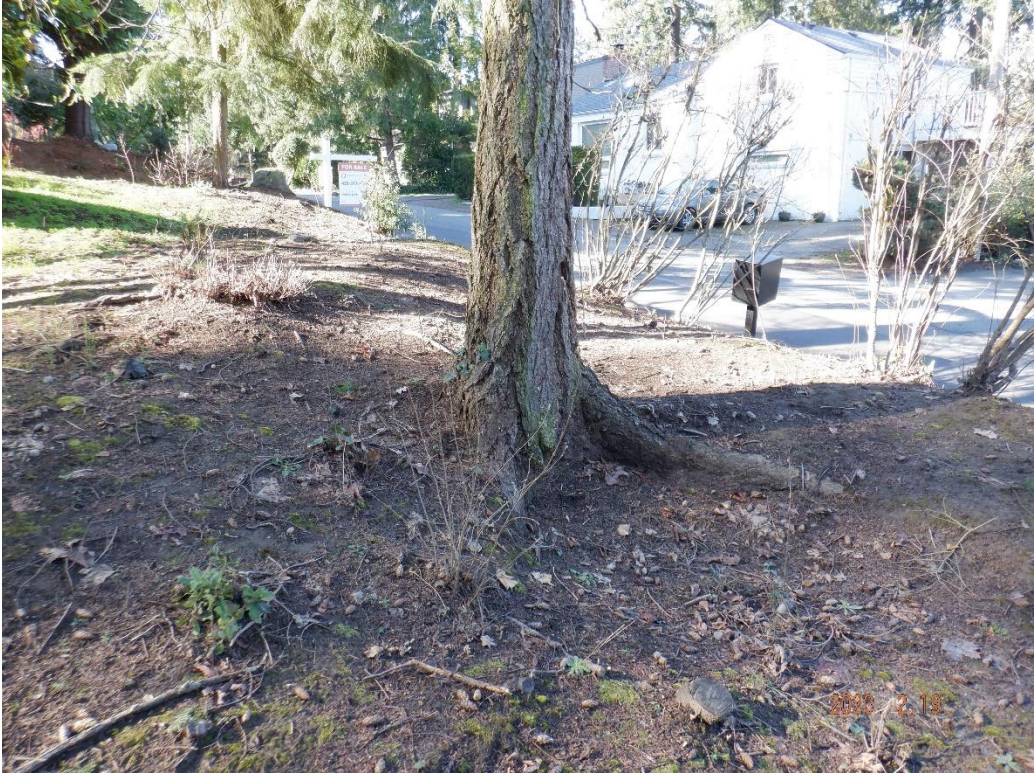
Lower trunk of Tree #21

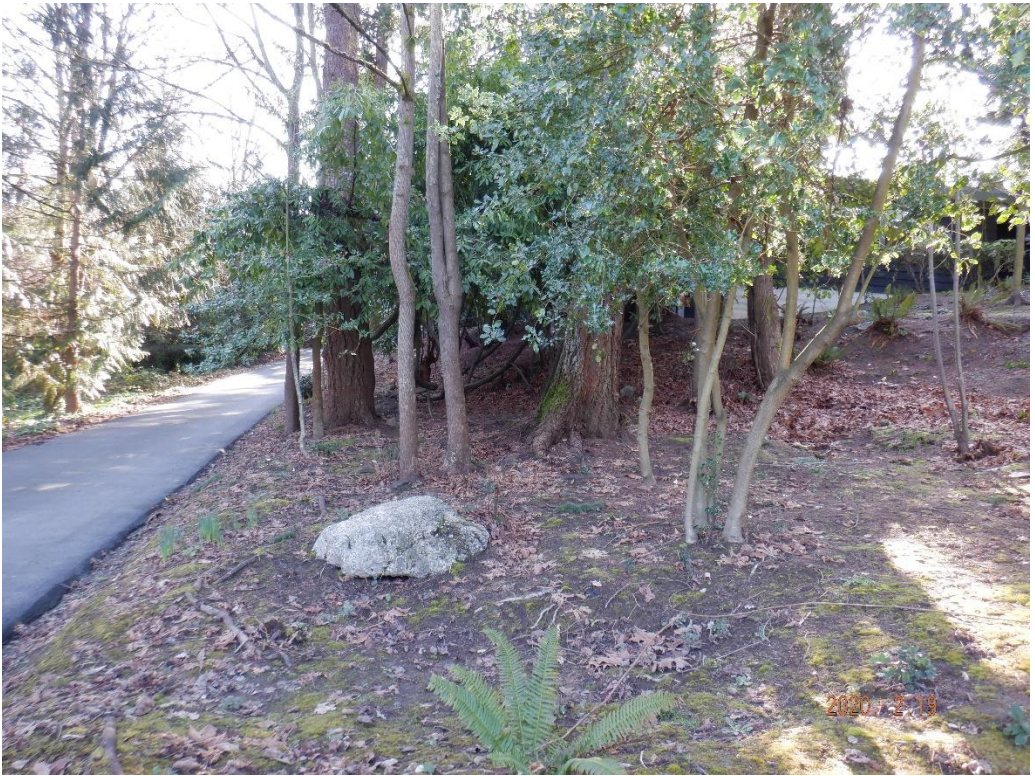
Looking south down east property line

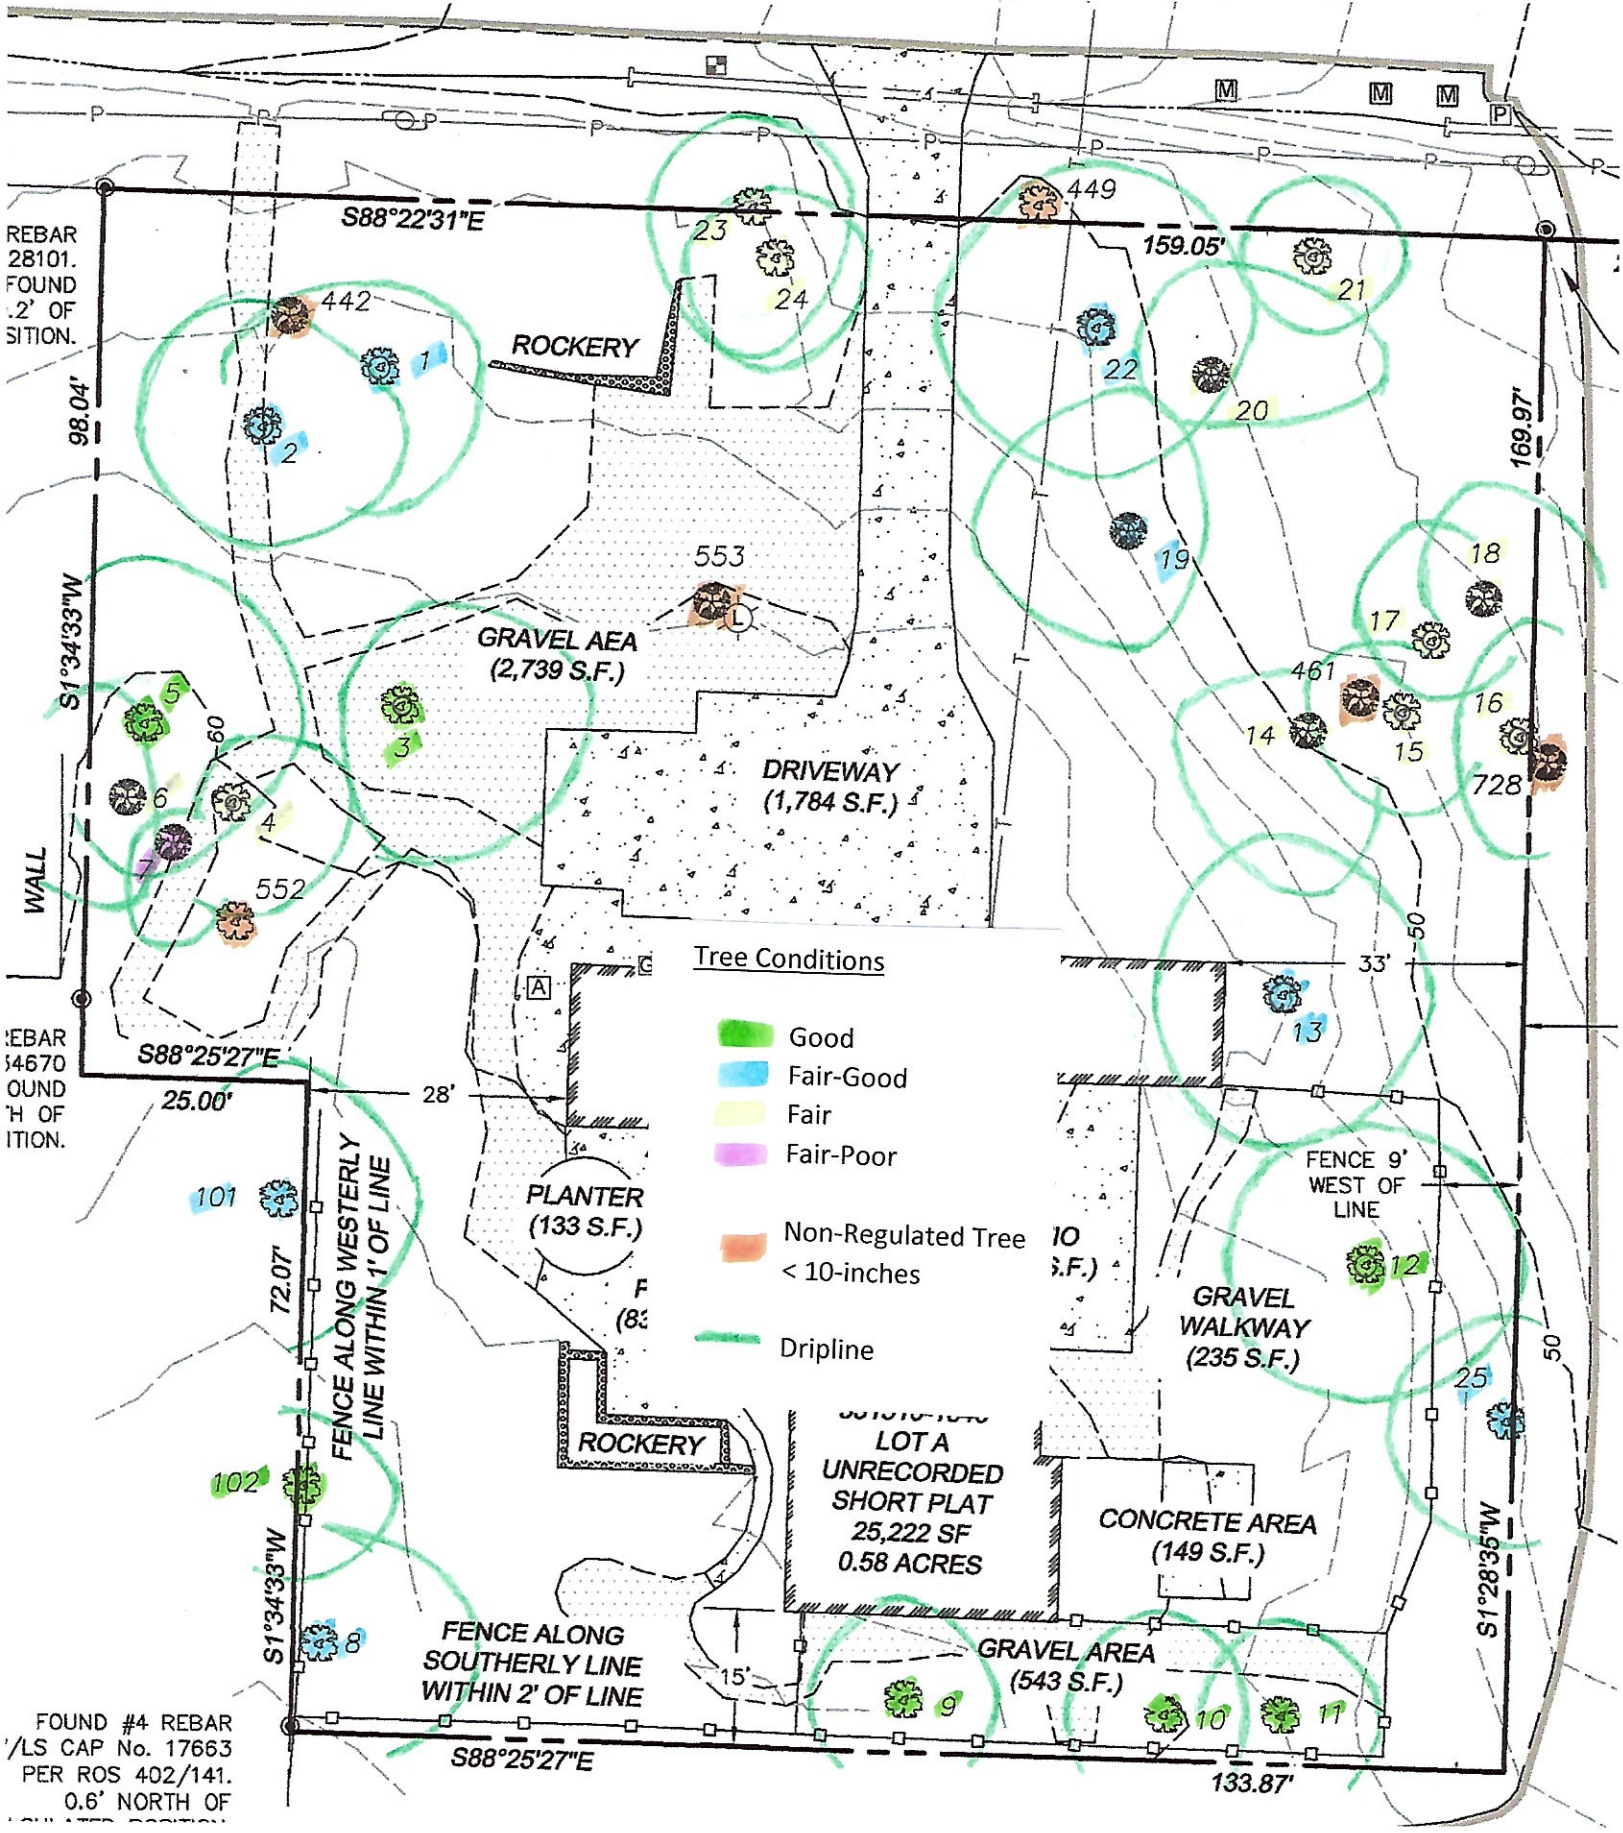
7621 SE 22ND ST - TREE CONDITIONS/DRIPLINE MAP

The extent of driplines (farthest reaching branches) for the subject trees can be found on the tree summary table at the back of this report. The driplines have been delineated on the attached map. The information on the attached maps and in this report shall be used by the project architect to create the final tree retention plan sheet for City submittal, once the final site design has been completed.

- Tree protection fencing shall be erected per attached tree plan prior to moving any heavy equipment on site. Doing this will set clearing limits and avoid compaction of soils within root zones of retained trees.
